COMMISSION OF  
INQUIRY INTO THE  
AIR ONTARIO CRASH  
AT DRYDEN, ONTARIO

Final Report

Volume I

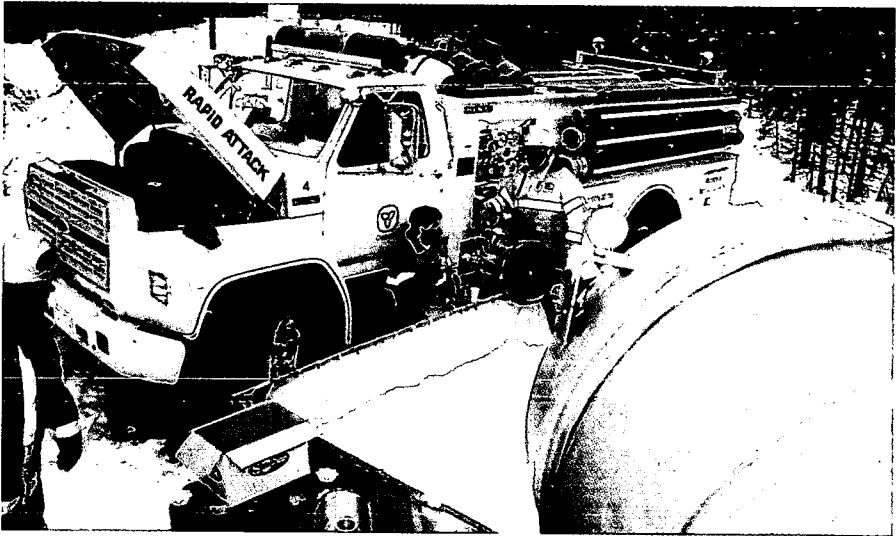
These photographs, taken by one of the fire-fighters in mid-afternoon March 10, 1989, convey the intensity of the fire which, by this time, is nearly extinguished.

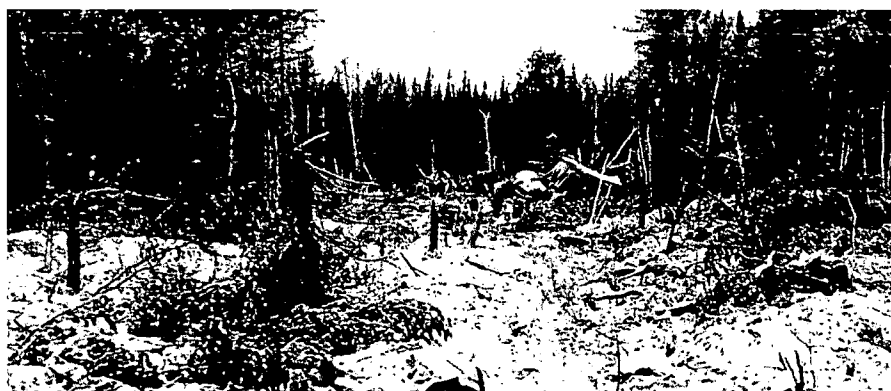
The wreckage trail looking east from the site of the crash

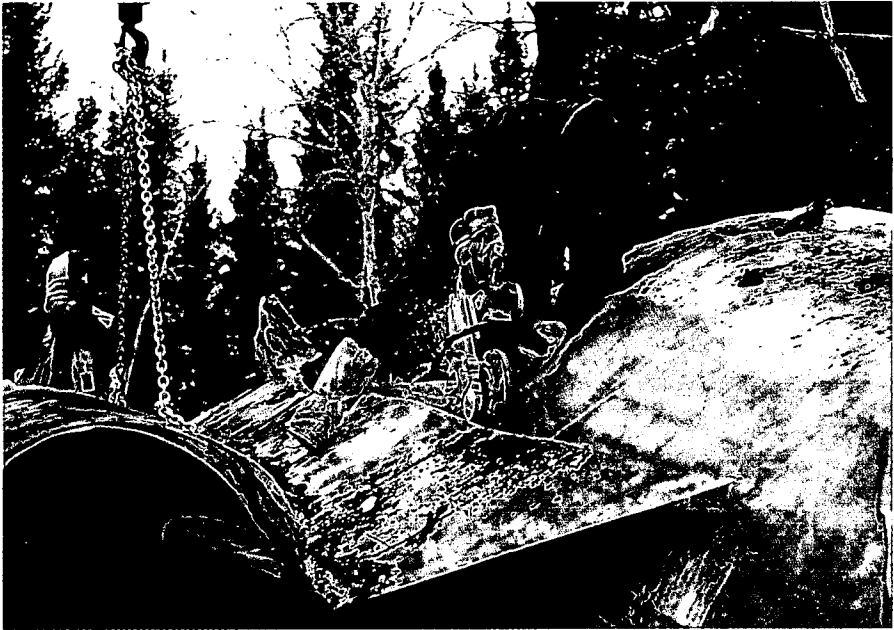
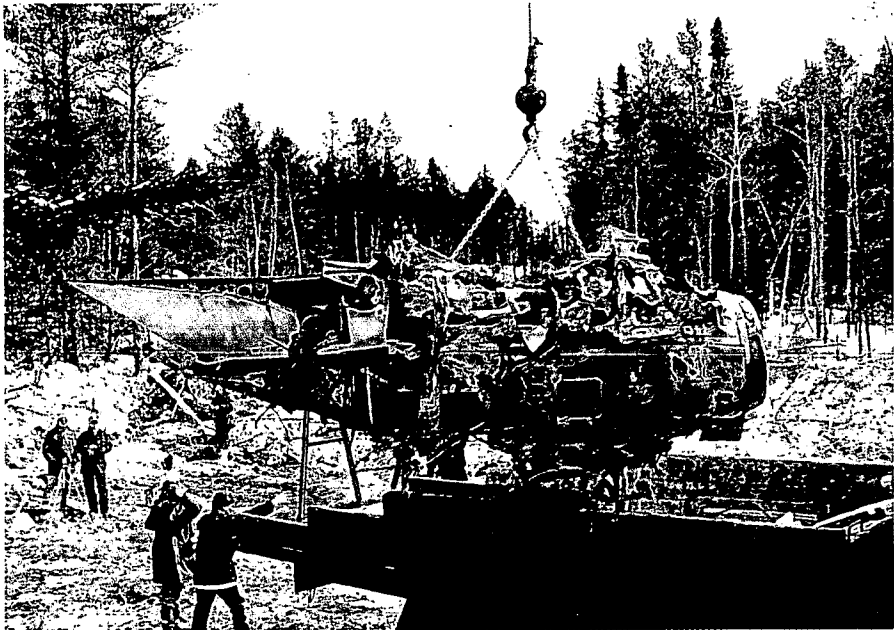
The wreckage was carefully photographed in situ at the crash site by the investigators: top, right engine; bottom, rear section of the right side of the fuselage.

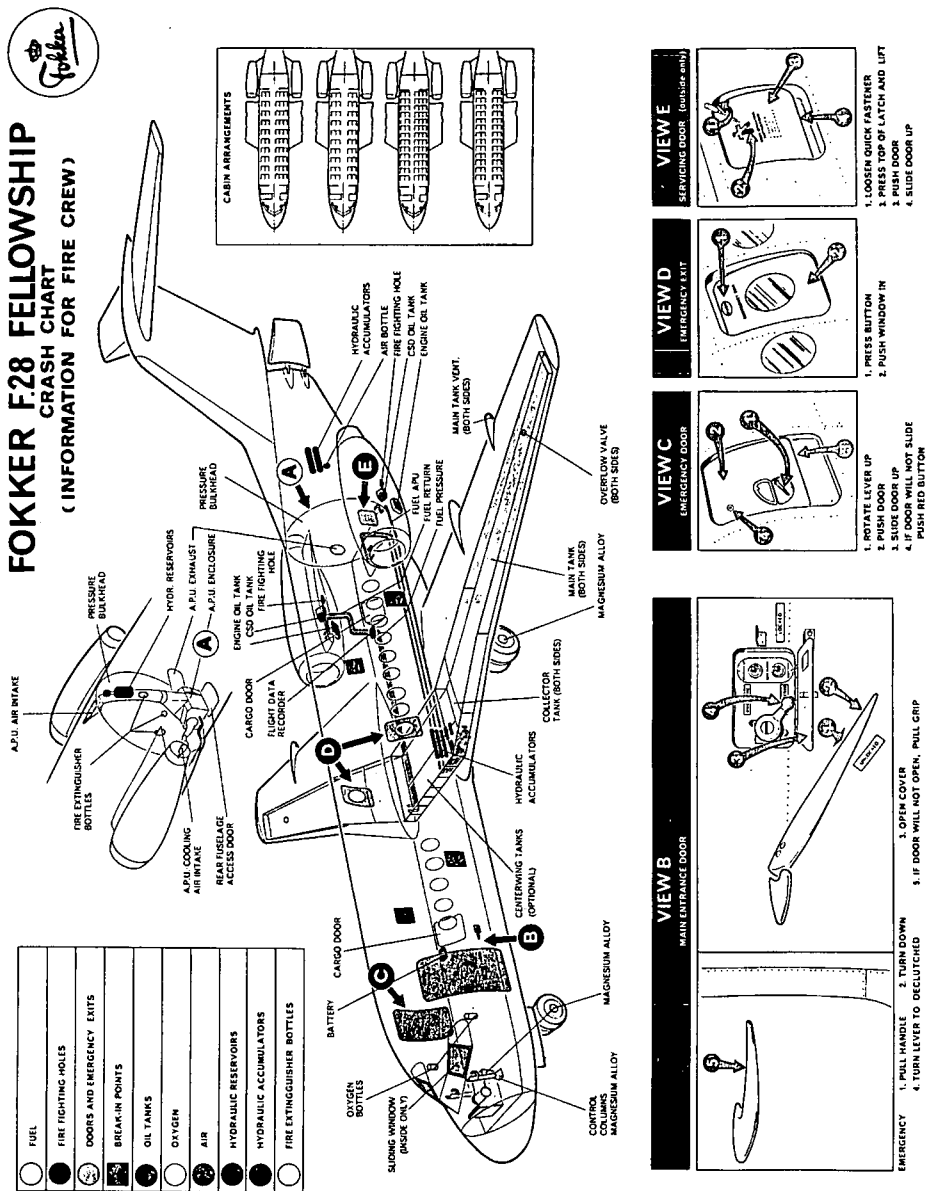
Figure 9-2 Fokker F-28 Crash Charts

It is reasonable to assume that if the Dryden CFR unit had been more familiar with F-28 aircraft through study of its crash chart and a thorough familiarization of the critical aspects of the aircraft, including the aircraft flight recorders, all of the crew, including the fire chief, may have been more alert to the need to attempt to control the aircraft fire and preserve the aircraft structure. Testimony revealed that the CFR fire-fighters did not know where the F-28 aircraft flight recorders were located. Clearly the chances that the recorders might have been saved from destruction, and the information therein used in analysing the cause of this crash, would have been increased had the Dryden CFR unit had crash charts. It was estimated that the recorders were exposed to an average temperature of 850°C for two hours, which destroyed the tapes. Reducing the time that the recorders were exposed to high temperatures would have increased the likelihood that the information stored in them would have been recovered.

As a result of this crash and the testimony heard before this Inquiry regarding the unavailability of crash charts, Mr Henry Moore, director, Airport Safety Services, Transport Canada, testified that in August 1989 his staff conducted a survey to determine the availability of crash charts on a national basis. Based on that survey, Mr Moore stated that Transport Canada was not “as well prepared” as it should be regarding crash charts. As a result of this survey, Transport Canada issued a policy directive instructing all Transport Canada Regions as follows:

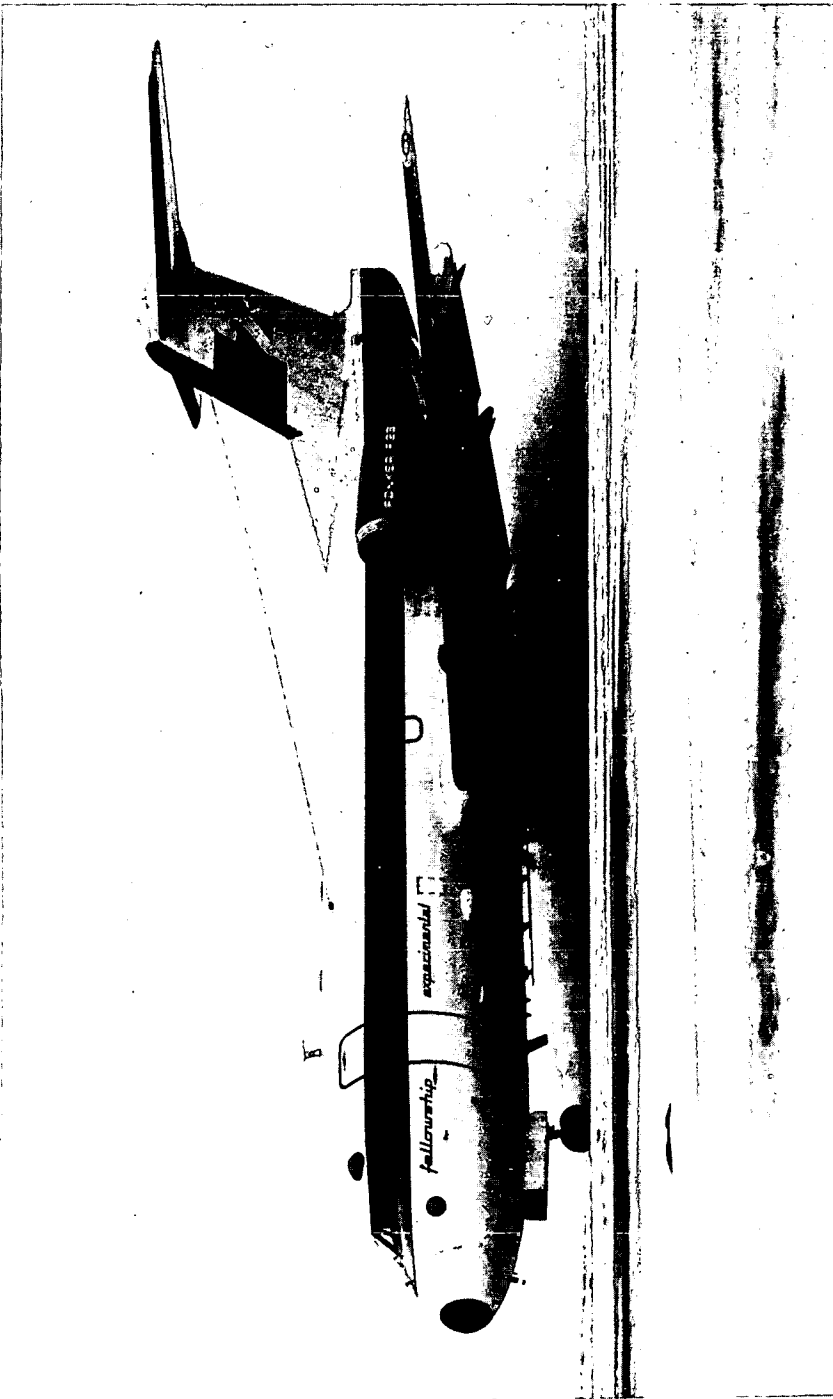
Figure 12-1 F-28 during Slush Test, February 5, 1968

Fokker provided to this Commission certification report no. V-28-7, together with photographs taken by Fokker, which describes and demonstrates the testing and conclusions. Shown below as figure 12-1 is one of the photographs provided by Fokker Aircraft showing the F-28 during slush tests moving at high speed in slush. Mr van Hengst, who was present during the tests, described in detail during his evidence before the Commission the findings of Fokker Aircraft. He also advised that he is not aware of any operators who have reported contamination entering the engines on slush-covered runways.

There is some possibility that snow, slush, or ice that left the wing upper surface during the takeoff run was ingested into the engines. The Piedmont operations manual, in the section on adverse weather, contains information regarding ice that may form on the upper surface of the wings while the aircraft is on the ground. The ice forms either because of warm fuel, which can cause snow to melt, with the water subsequently refreezing; or because of extremely cold fuel, as may be the case after long flights at very low ambient temperatures, which causes water condensation or rain to freeze. It is stated in the manual that "[d]uring take-off this ice may break away and at the moment of rotation enter the engine causing compressor stall and/or engine damage" (p. 3A-24-1). During testimony, however, no one described seeing anything that could be taken to be unusually large amounts of ice or snow separating from the wing of C-FONF during the takeoff roll. Moreover, there was no damage found during examination of the engines that showed they had ingested slush or ice. (For details, see the section on engine investigation in chapter 10 of this Report, Technical Investigation.) During manufacturer's certification tests of the F-28 Rolls-

Royce engines, as described in chapter 10, it was demonstrated that the engines were able to ingest great quantities of water with no apparent difficulty. Bearing this point in mind along with the fact that most witnesses testified that the engines were operating normally throughout the takeoff run, it is probable that if the engines ingested snow, slush, or ice from the wings during takeoff, the ingestion could have caused only a fleeting abnormality and perhaps an uncommon noise.

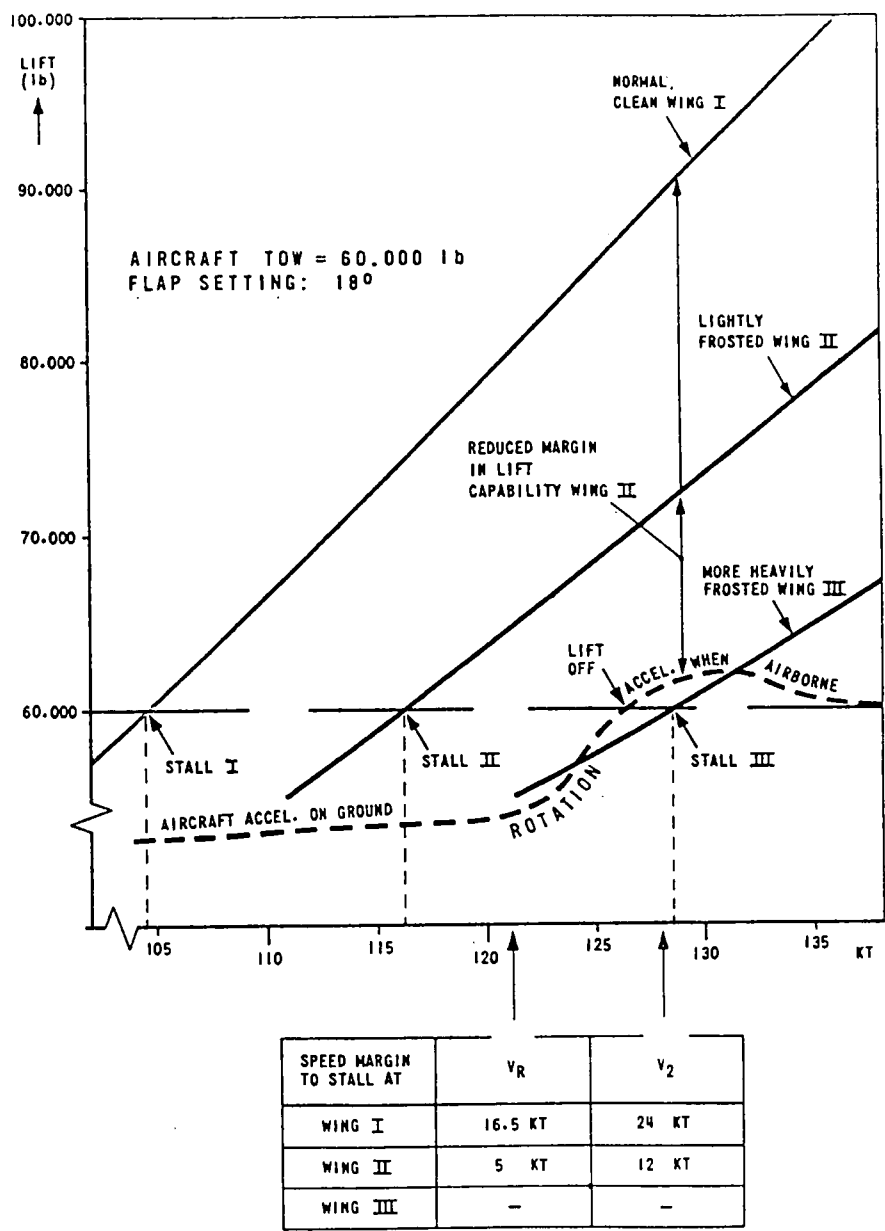
Figure 12-3 Comparative Margins for Two Arbitrarily Chosen Frost-Contaminated Wings and the Normal Clean Wing

Up to a point, as figure 12-3 indicates, the more the wings were contaminated the greater the loss of lift. For example, during takeoff at a weight of 60,000 pounds, with  $18^\circ$  of flap and with a clean wing, the stalling speed of the aircraft was about 104 knots. With the wing lightly frosted, the stalling speed was about 117 knots, and with the wing heavily frosted, about 128 knots. The  $V_R$  speed (takeoff rotation speed)<sup>5</sup> for the aircraft was 121 knots and the  $V_2$  (takeoff safety speed)<sup>6</sup> was 127 knots. With a clean wing, the speed margin at rotation speed before stall was approximately 17 knots. With a lightly frosted wing, the margin was 5 knots. With a heavily frosted wing, the wing was in a stalled condition as it was rotated.

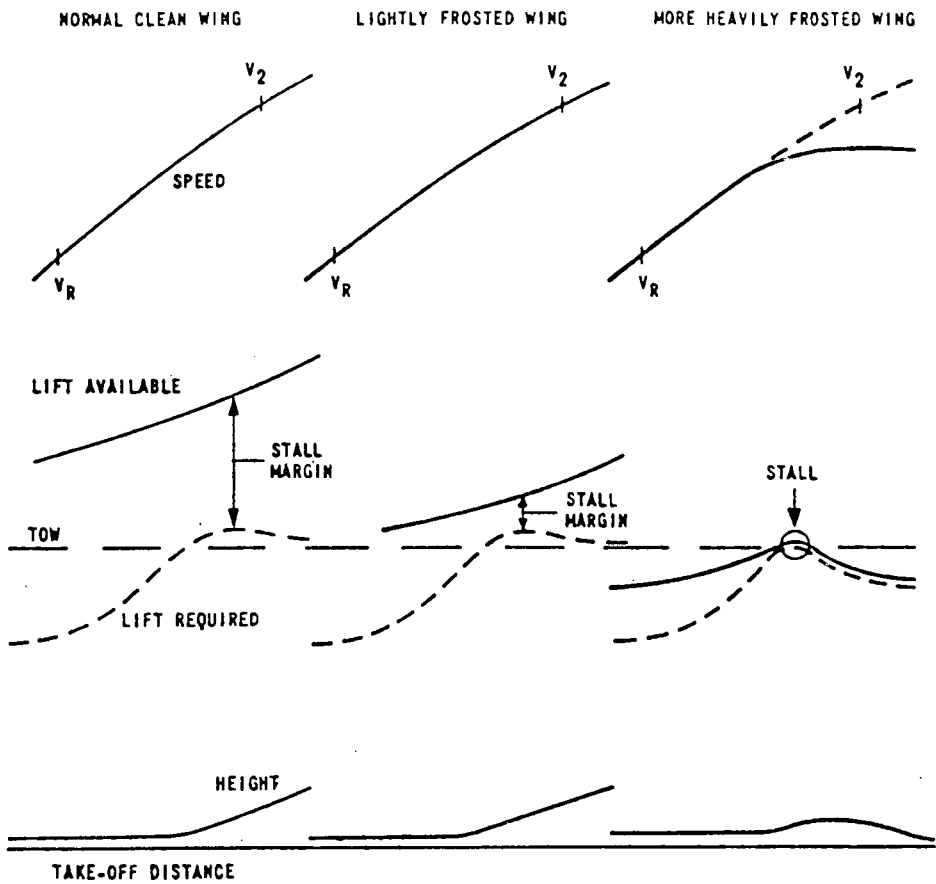
Figure 12-4 Comparative Stall Margins<sup>1</sup>

Figure 12-4 describes the decrease in stall margin between a normally clean wing and a lightly frosted wing and demonstrates that an aircraft

with more heavily frosted wings is unable to sustain flight because the wing is in a stall condition at rotation.

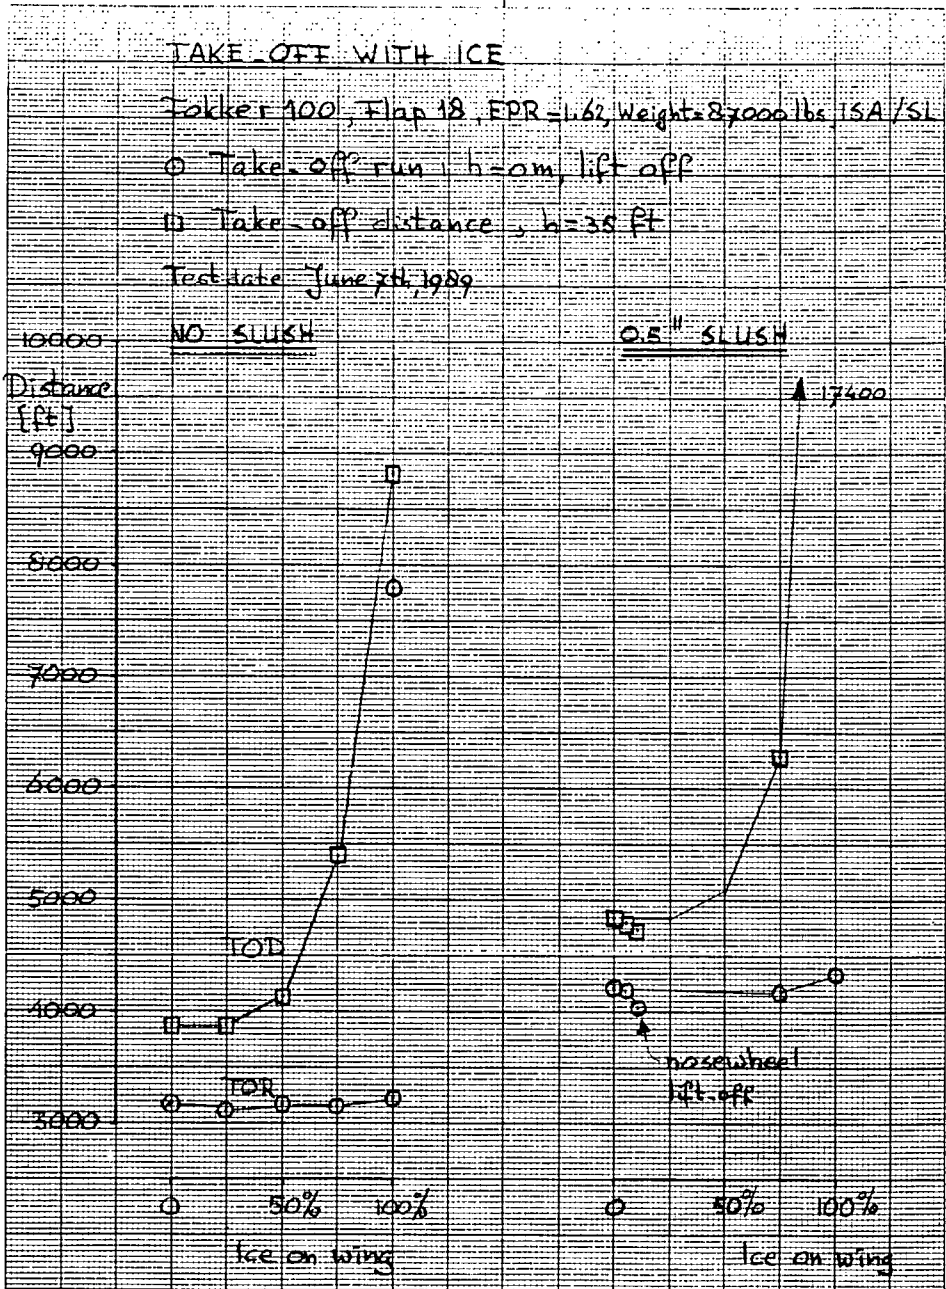
Figure 12-5 Fokker 100 Simulation of Takeoff with Ice, Flaps 18°

Figure 12-5 describes the Fokker 100 simulator with  $18^\circ$  of flap at sea level taking off with power and weight equal to full power on an F-28 at 63,500 pounds. By loading up the wing with contamination from 0, representing a clean wing, to 1.00, representing contamination in an amount equal to 1–2 mm diameter particles per square cm of wing surface, but with no runway slush, the takeoff run of the F-28 ranged between 3100 and 3250 feet. However, as contamination on the wing increased from 0.5 to 1.00, the takeoff distance increased from approximately 4150 to 8800 feet.

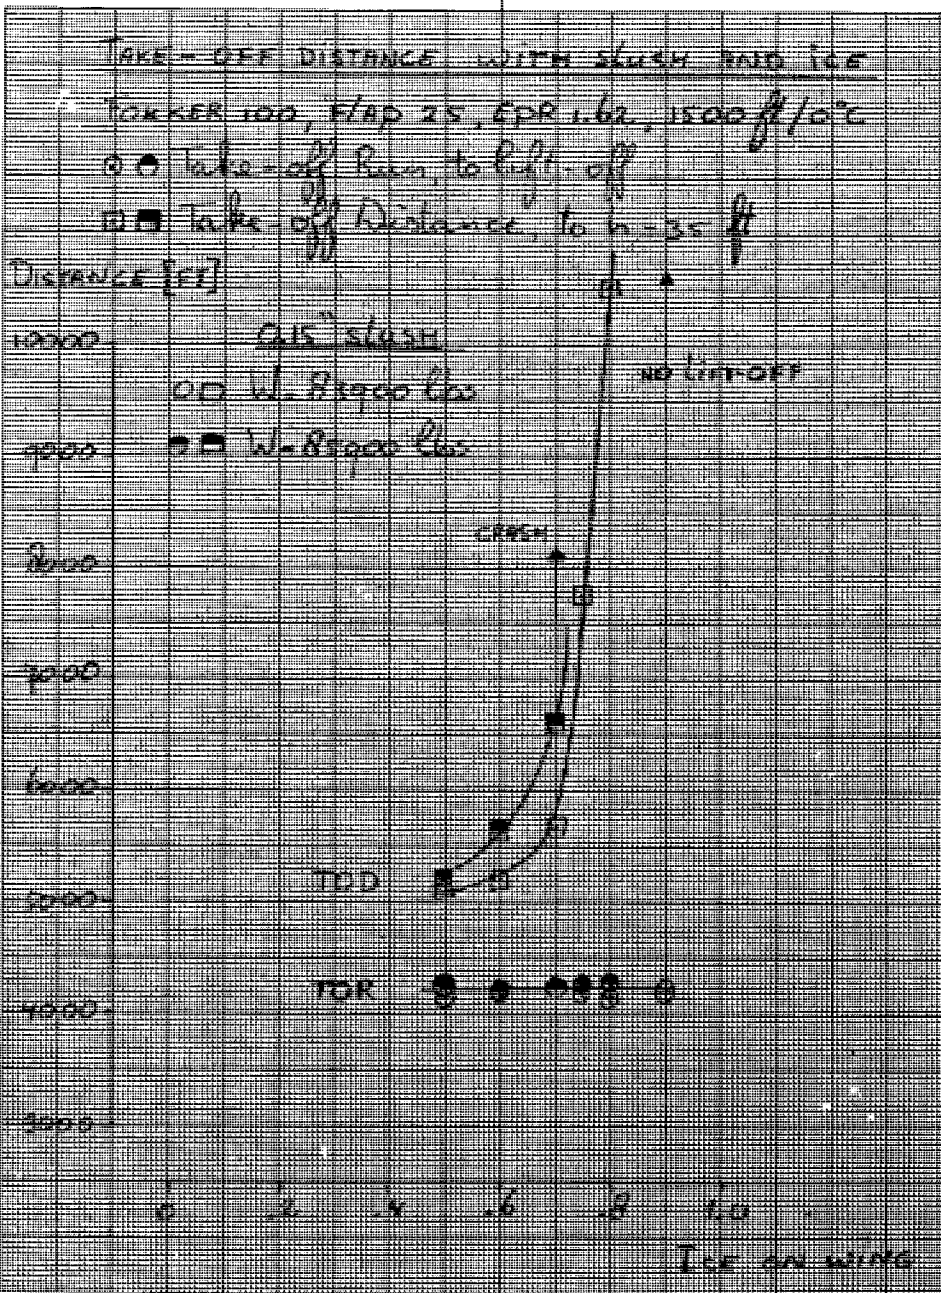
Figure 12-6 Fokker 100 Simulation of Takeoff with Slush and Ice, Flaps 18°

Figure 12-6 provides information that reflects the runway slush condition assumed to exist at Dryden at the time C-FONF crashed. All takeoffs were conducted with runway slush of 0.15 inches equivalent water depth (EWD) and flaps set at  $18^\circ$ . Takeoff runs increased from 4400 to 6000 feet and takeoff distances increased from 5100 to 7900 feet as wing contamination increased from 0 to 0.8.

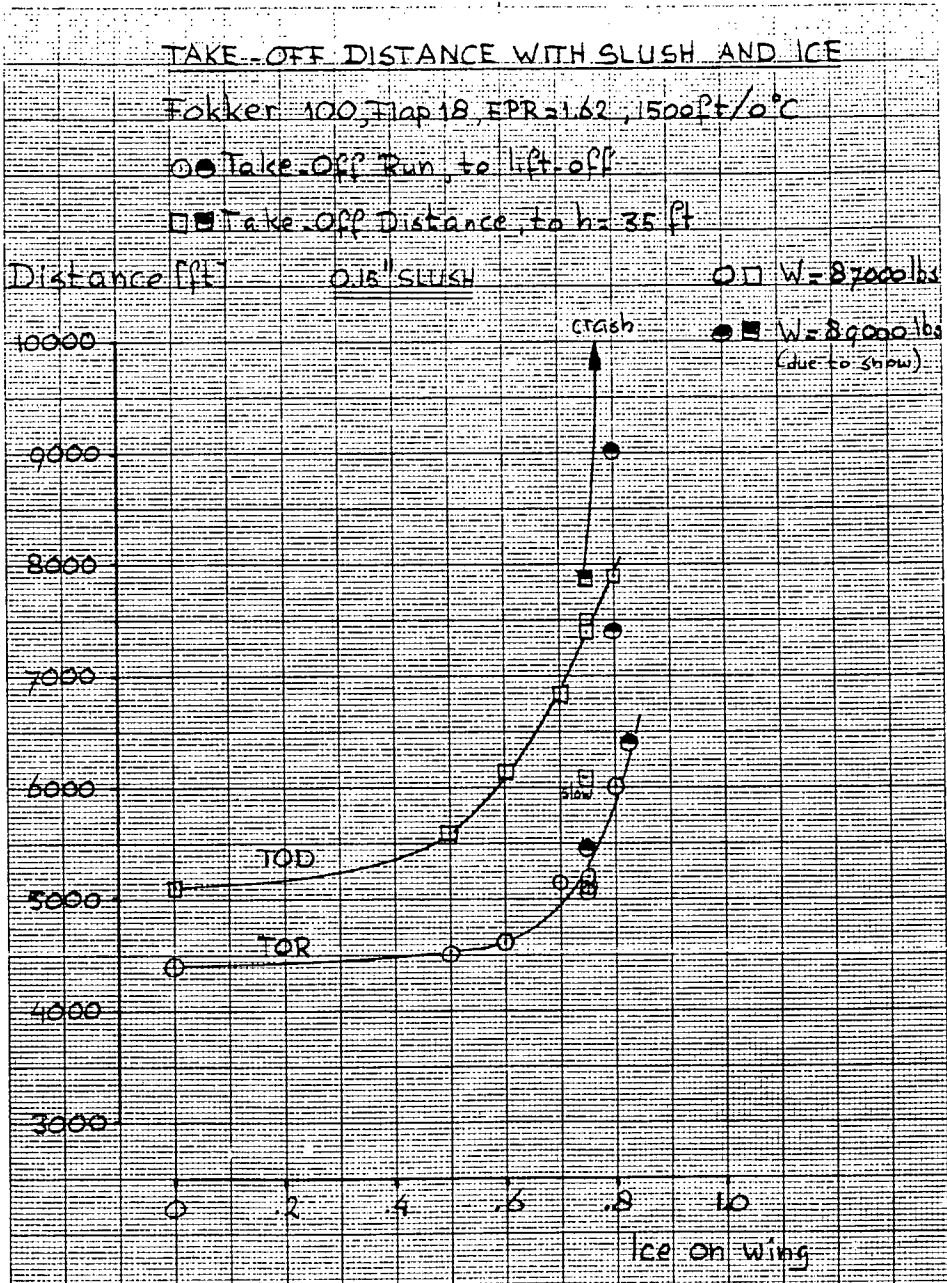
Figure 12-7 Fokker 100 Simulation of Takeoff with Slush and Ice, Flaps 25°

Figure 12-7 demonstrates the estimated takeoff performance of C-FONF utilizing  $25^\circ$  of flap in 0.15 inches of EWD of slush. Although the takeoff run performance is better at a  $25^\circ$  flap setting than it is at  $18^\circ$ , with higher amounts of wing contamination the takeoff distance required continues to be high or even increases, and at 0.8 wing-contamination level the aircraft failed to lift off.

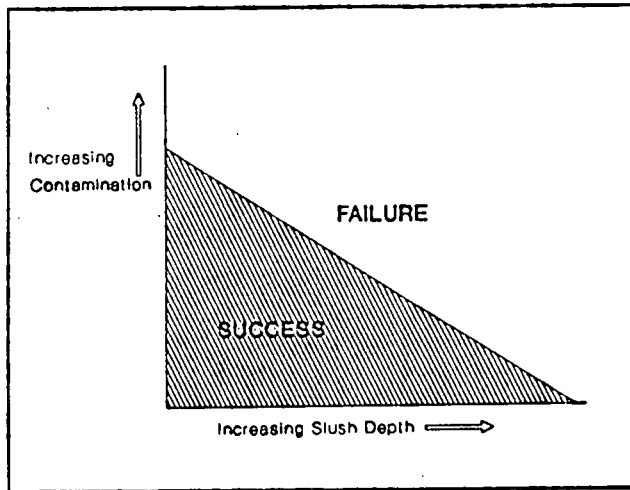
Figure 12-8 A Boundary Condition Plot for Successful Takeoff

The two “various boundary” plots in the “Flight Dynamics” report (p. 77) represent the crux of the performance investigation. They show that it is possible to define two boundary conditions, in terms of combinations of slush depth and wing-contamination factor, that can lead to catastrophic results during attempted takeoffs. A boundary condition here means “a continuous relationship between level of contamination and runway slush depth which represents the dividing line” between a successful or unsuccessful takeoff (pp. 73–74). This boundary relationship, which is illustrated in the “Flight Dynamics” report, is reproduced below as figure 12-8. The “various boundary” plots (figures 6 and 7 in the “Flight Dynamics” report) can be interpreted according to figure 12-8, below.

Figures 8a–10b of the “Flight Dynamics” report illustrate in detail the various test runs. A review of the figures reveals that there are well-defined boundaries of slush depth and contamination level that either allow or prevent the aircraft from flying successfully. For example, with a rotation speed ( $V_R$ ) of 122.5 knots, a slush depth of 0.25 inches, and a wing-contamination level of 0.65, the aircraft flies away. At 0.68 wing contamination, the aircraft gets airborne, but, 500 feet beyond the end of the runway, it is only at 10 feet. At 0.69 contamination, the aircraft returns to the runway and runs off the end. In another example, with a rotation speed of 127.5 knots, a slush depth of 0.10 inches, and a wing-contamination level of 0.823, the aircraft flies away despite two bursts of stick-shaker. At 0.824 wing contamination, the aircraft height never exceeds 5 feet, and it eventually returns to the surface 1100 feet beyond

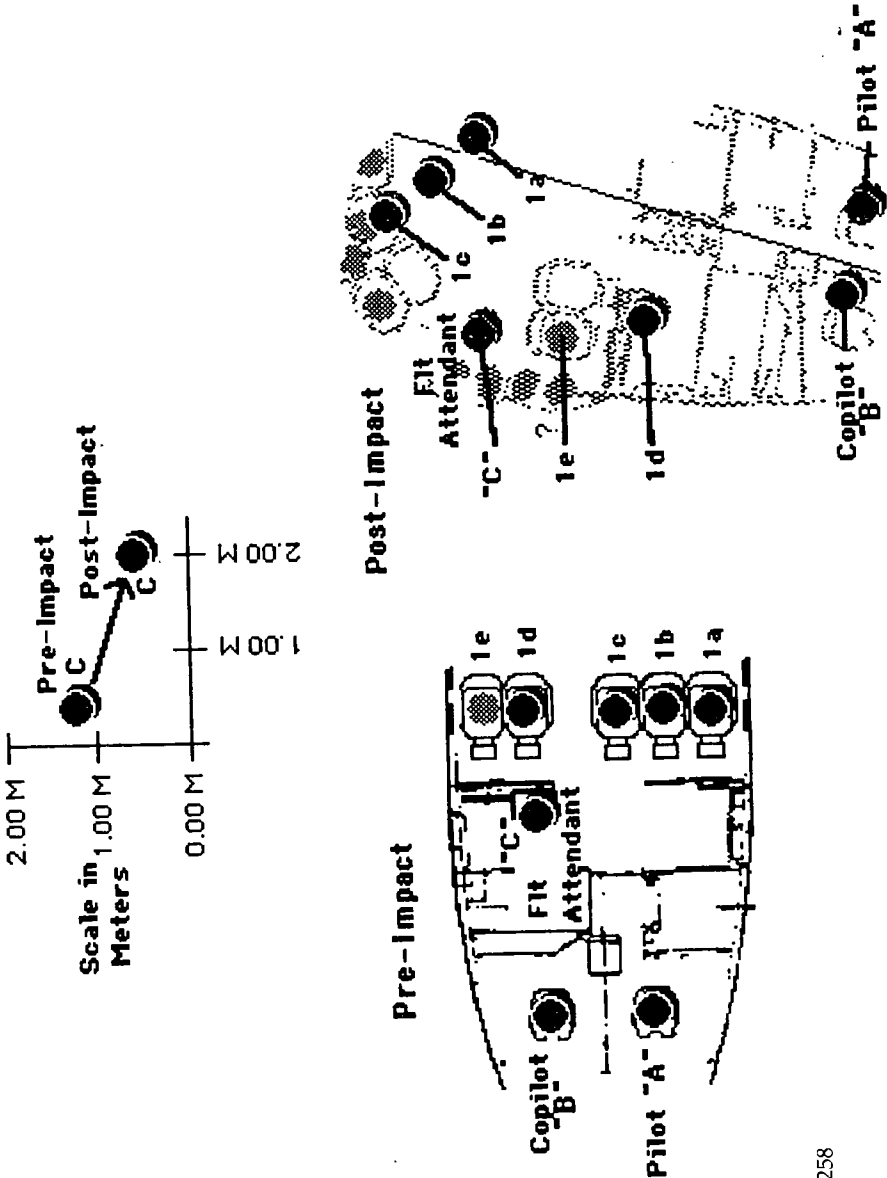
Figure 22-1 Pre- and Post-Accident Locations of Individuals Seated in Forward Positions on Flight 1363

Although other factors may have intervened to cause her head injury during the breakup sequence, it is beyond dispute that, had she been secured by a shoulder harness, her upper body would have been markedly better restrained and protected from injury caused by forward motion on impact. This, after all, is the function of a shoulder harness.

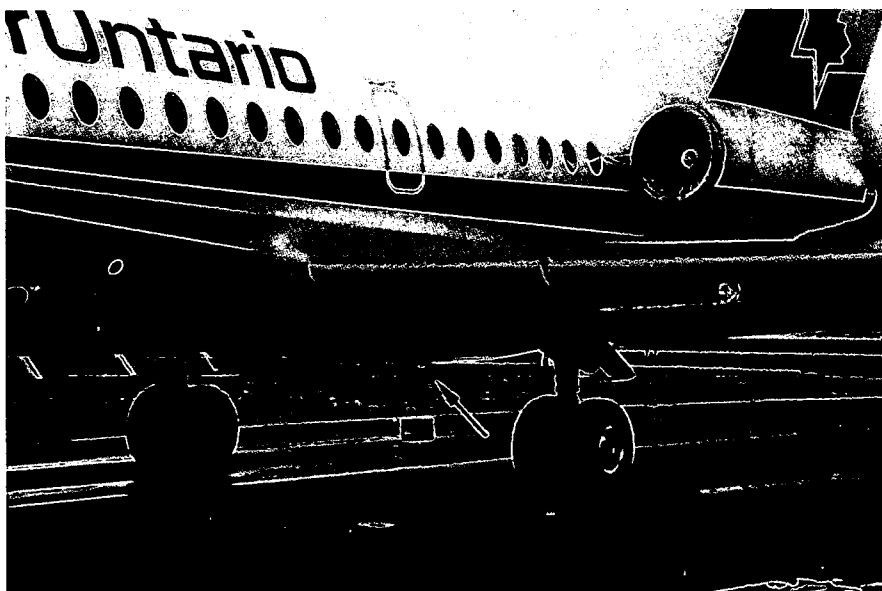
- 3.2 During the second search phase, numerous pieces of the red lens from the rotating beacon were found just beyond the first tree strike, 126 m off the end of Runway 29. This beacon is normally mounted on the belly, in the centre of the fuselage, just aft of the main landing gear inboard doors. Figures 3 and 4 show the location of the rotating beacon on the belly of the fuselage of another F28, C-FONG. Figure 5 shows the numerous pieces of the broken red lens recovered from the vicinity of the first tree strikes. All other pieces of wreckage found during the second search were located within either the upper or lower part of the wreckage trail.

**Figure 3 - View of Fokker F28, C-FONG, showing the location of the anti-collision light mounted on the fuselage belly (arrow).**

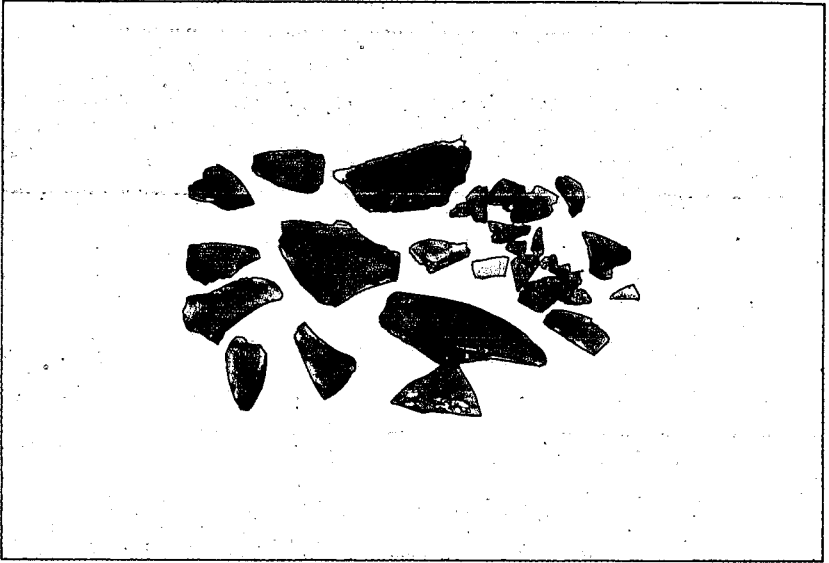
- 4.1 The aircraft flight path was reconstructed based upon the physical evidence of the clipped tree tops and the location of wreckage. A total of eighteen tree tops were clipped starting at 126 m from the end of runway 29. Pieces of the red lens from the rotating beacon were found adjacent to the first tree. The position and elevation of the eighteen clipped trees were determined during the ground survey and recorded in UTM co-ordinates and heights ASL. The tree positions were then plotted on a Dryden Site Plan (Figure 7) and the heading was determined to be 290 degrees magnetic based on the fact that the aircraft had to contact each tree. The aircraft maintained this heading or ground track for 600 m until it came into contact with a substantial number of trees at the top of a small knoll. A profile (Figure 8) of the flight path showed that the elevation of the eighteen tree tops remained relatively constant at 413 m ( $\pm 1.5$  m).

**Figure 5 -** Photo of all the pieces of the red lens from the anti-collision light recovered from the vicinity of the first clipped trees off the end of Runway 29.

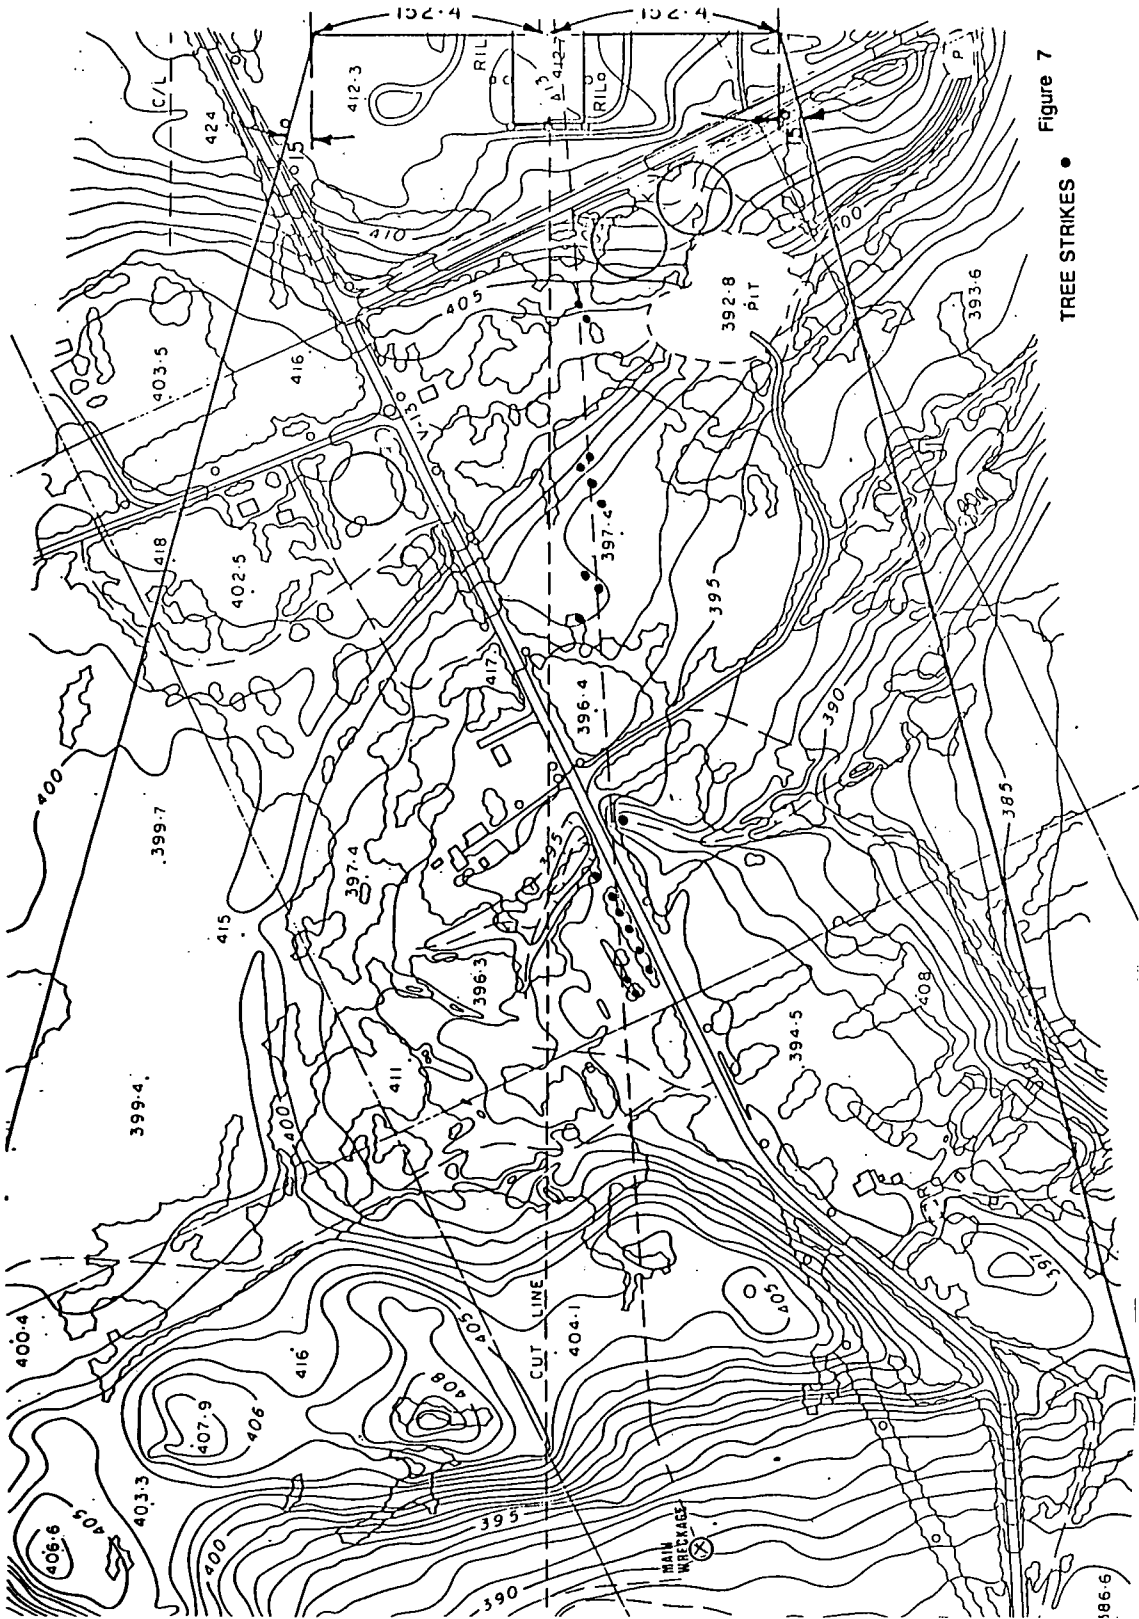
Figure 7  
TREE STRIKES

- Figure 7 - Dryden Site Plan showing the tree strikes of the end of Runway 29 and the location of the accident site with respect to the airport.
- Figure 8 - Drawing of Aircraft Flight Path Profile showing the tree strikes off the end of Runway 29 and the relative elevations of the tree strikes.

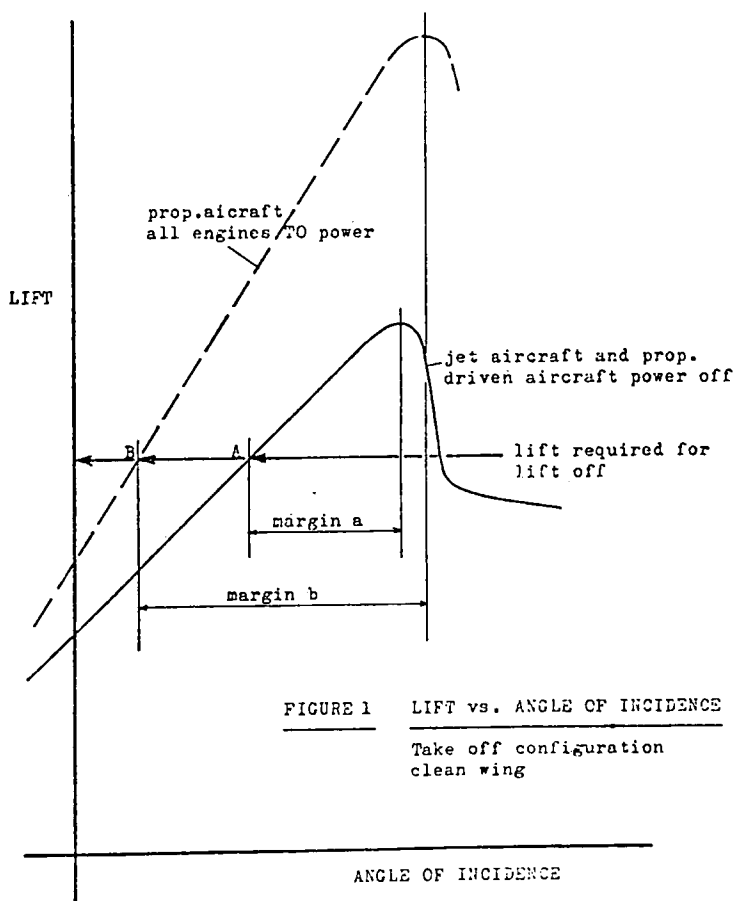
In figure 2, which is based on windtunnel tests simulating the full scale frost or light freezing rain type roughness on the windtunnel model, a considerable reduction is shown in both maximum lift capability and stall incidence of a contaminated wing compared with the clean wing in figure 1.

The propeller aircraft, lifting off at the same incidence, B, has a considerably reduced reserve against stalling; the margin b in figure 1 is reduced to margin b' in figure 2. This situation will however escape notice in flight, at least with all engines operating, as the behaviour of the aircraft is essentially the same as with a clean wing. This is more the case as the difference in wing drag due to the assumed roughness will not be critical under these conditions.

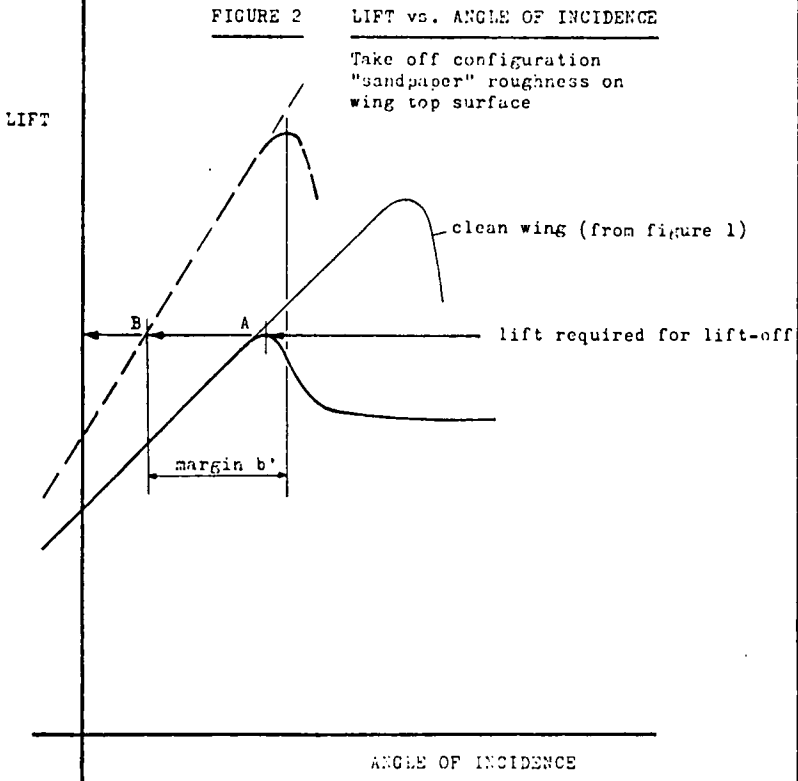
The jet aircraft, however, will be in a stalled condition when it is rotated up to and beyond the incidence at point A. Consequently, it will show characteristics quite different from those at a "normal" take-off.

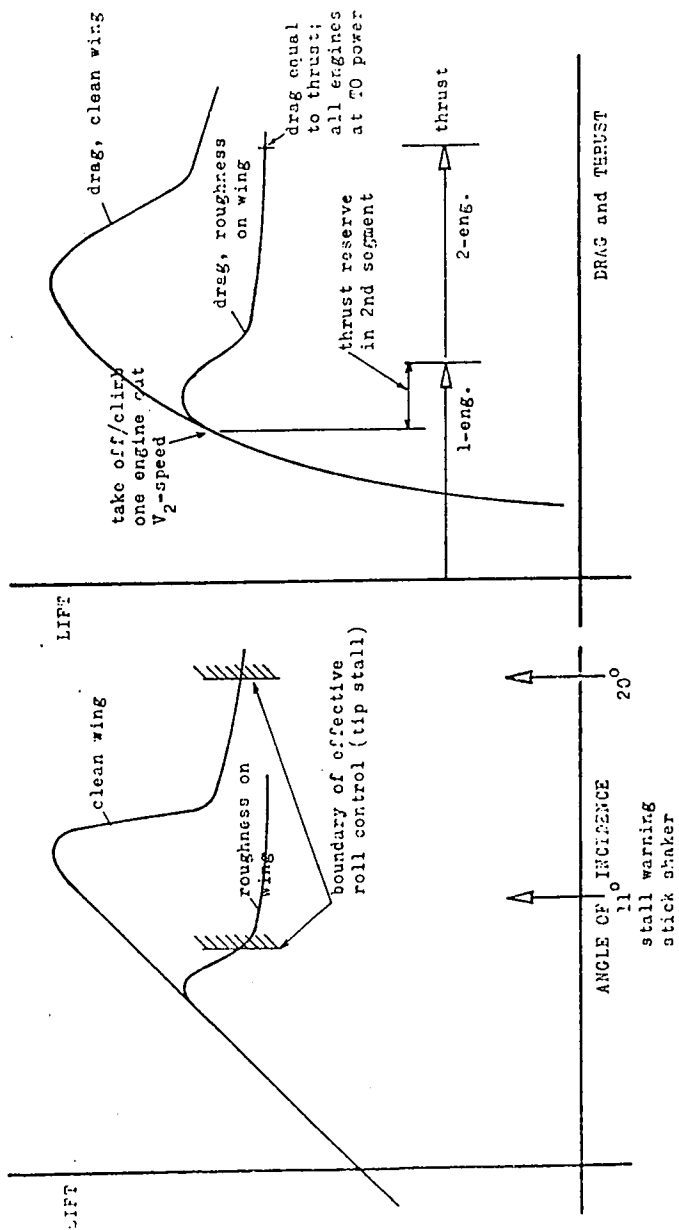
The wing stall developed under these conditions is particularly dangerous because the inherent good stalling characteristics of the clean wing are lost. An uncontrollable roll accompanies the asymmetric stall provoked by roughness, and in addition a tremendous increase in drag develops upon slight overrotation of the aircraft. The latter is very likely to happen in ground proximity when the aircraft does not appear to gain its customary height. Both effects are further illustrated in figure 3.

With frost roughness present on the wing upper surface the characteristic of slow stall progression towards the wing tip is lost and uncontrollable roll may develop at angles of incidence as low as 10 degrees, as indicated in the left graph of figure 3.

FIGURE 3 FOKKER F26 EFFECT OF "SANDPAPER" ROUGHNESS ON TAKE OFF/CLIMB

In the interest of flight safety complete removal of relatively thick layers of snow and ice from wing and tail surfaces is very common. However, also sandpaper-like roughness caused by thin deposits due to frost or light freezing rain must be completely removed prior to take-off, in particular of jet propelled aircraft.

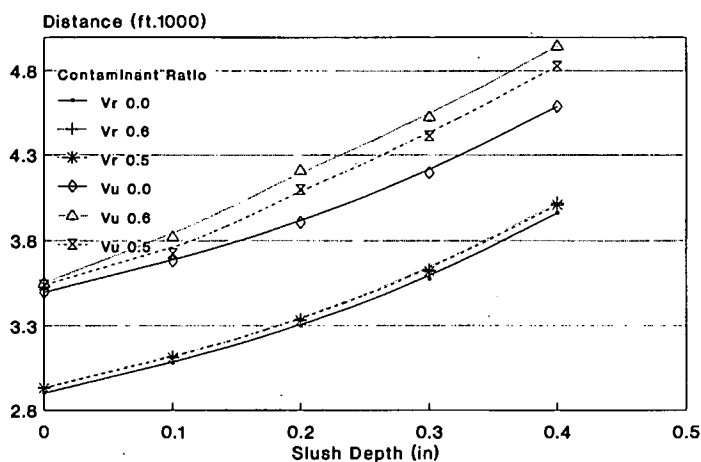
Initial plots, Figures 4 to 6 are presented to clarify some of the effects of flying surface and runway contamination described earlier. Figure 4 shows the effect of runway slush and wing contamination on the take-off distances to both rotation and lift-off. It can be seen that while the presence of slush changes the distance required to reach  $V_r$  significantly, wing contamination has very little effect, almost all the traces for distance to rotation overlay each other. This is definitely not so for the distance to lift off. As the level of wing contamination increases, the distance penalty to unstick increases quite rapidly due to the marked increase in drag produced by the contaminated wing at high angles of attack. This characteristic represents a situation in which the full extent of performance loss may not be apparent until the aircraft is rotated; prior to this the reduction in acceleration is little more than could be attributed to a slush layer. Figure 5 is presented to indicate the reasons for this effect. It shows that as contamination level increases, even in the absence of slush, the distance the aircraft has to travel between  $V_r$  and the unstick point increases only slowly until a dramatic 'knee' is reached (numerically at just over 0.6 contamination ratio). This is coincident with the aircraft being at or beyond  $C_{Lmax}$  for the contaminated wing at its rotation angle of 10 degrees and having to generate the necessary lift by increasing speed rather than  $C_L$ . The low acceleration rates available once the drag rise caused by wing contamination has been encountered mean that excessive distance has to be consumed for this to occur. A secondary effect can be seen in the same figure by examining the trace of Theta (body angle). At first moderate increases for Theta at lift off are enough to compensate for the loss of  $C_L$  due to contamination, but a point is reached, at about 0.58 contamination ratio, when the rate of increase in theta steepens noticeably. This is related to the reduced lifting capability of the wing as indicated earlier in Figure 2.

Figure 4 Effect of Contamination and Slush on the Distance Required to Reach  $V_r$  and  $V_u$

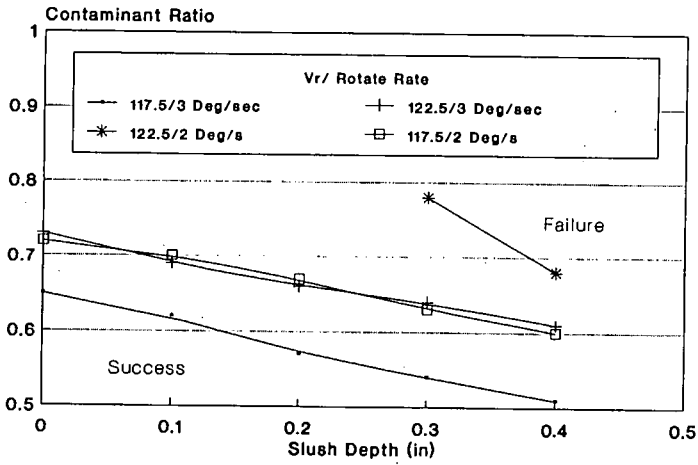
Figure 6 indicates a boundaries for a condition in which the aircraft will simply fail, in the distance available, to leave the ground and will run off the end of the runway. It also shows that any reduction in the rotation speed will have an adverse effect on the available performance. At somewhat lesser levels of both factors, another boundary was found to exist, defining a condition wherein the aircraft would at first leave the runway, but fail to climb out of ground effect and settle back to the surface (Figure 7). This boundary existed for all conditions of rotation speed and rotation rate tested, and is annotated to indicate the effects of varying the various aircraft handling parameters on the placement of the boundary. When this condition was met it was possible, by making subtle changes in the assumed pilot control strategy after the initial lift off (eg, rate of pitch, response to stick shaker) to cause the model to fly for considerable distances at very low altitudes, but it was not possible to make it fly except by assuming extremes in pilot behaviour.

Figure 6 Various Boundary Plots at Different Values of  $V_r$  and Rotation Rate for Overrun Case
