COMMISSION OF  
INQUIRY INTO THE  
AIR ONTARIO CRASH  
AT DRYDEN, ONTARIO

Final Report

Volume I

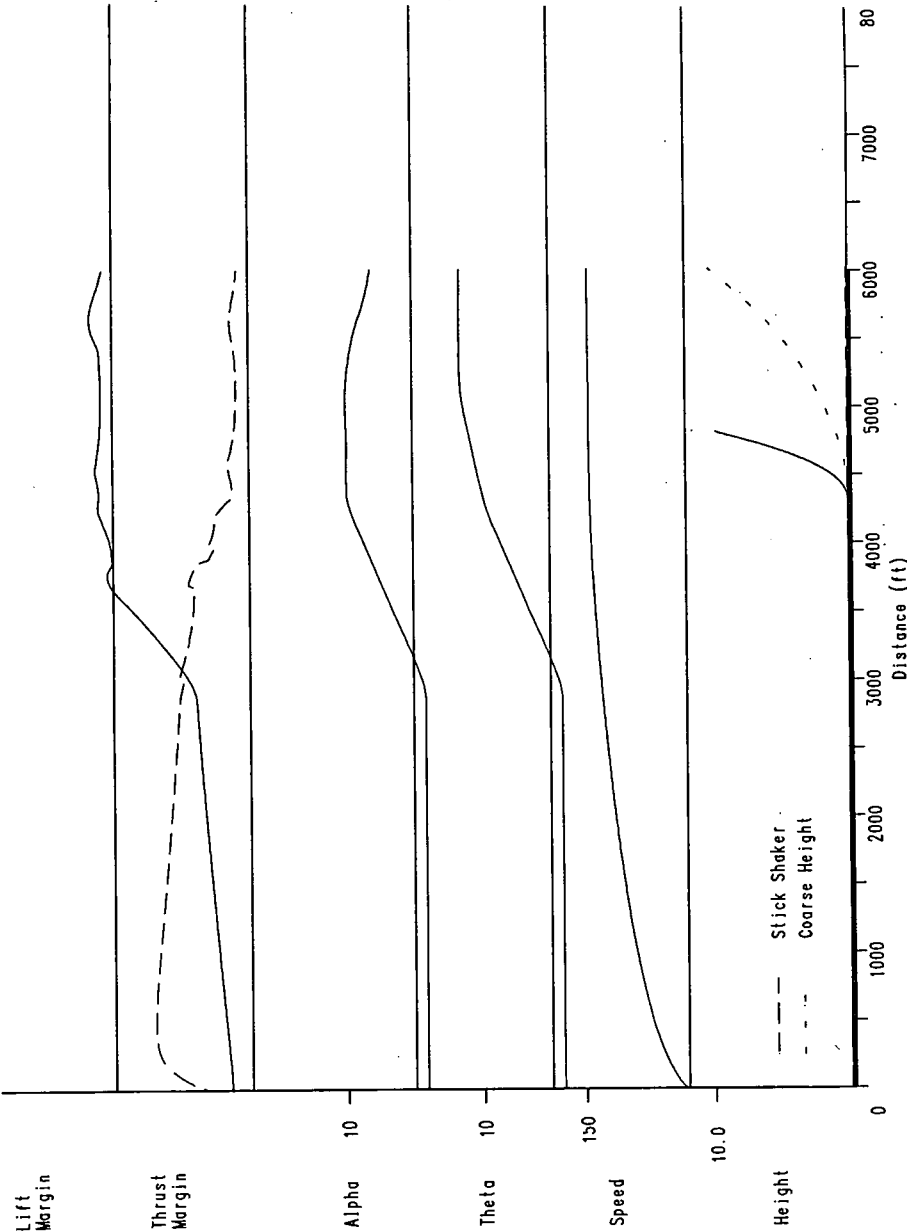
The final sets of Figures provided with this section are intended to illustrate the effects and observations made earlier in the text. Figure 8, a,b and c shows the overall effects of increasing contamination factor in a gross way. The rotation speed here was 122.5 kt and slush depth 0.25 in. At 65% contamination the aircraft flies away normally, at 68% the machine sinks following the initial lift off, due both to the loss of lift with height and the pilot's reaction to stick shaker, but then climb away. Note that the scale of the height trace is such that at 6500 feet (500 feet beyond the end of the runway) the aircraft is still only at 10 feet. In 7c, contamination now being set at 69% the aircraft returns to the runway and subsequently runs off the end. The series in Figure 9 a,b and c shows that fine graduation of the contaminant level creates subtle differences in the aircraft responses. This set of plots refers to a much shallower slush layer (0.1 in) and an incremented rotation speed of 127.5 kt. Figure 9a indicates that at 82.3% contamination the aircraft flies away despite two bursts of stick shaker, while by the time contamination is at 82.4% the machine never exceeds about 5 ft, eventually returning to the surface some 1100 feet beyond the end of the runway. When there is 0.1% additional contamination the result is a short hop and an over-run. Finally, Figure 10 a and b demonstrate the remarkable sensitivity to assumed pilot behaviour noted earlier. The only difference in these two runs is that the angle to

F-28 Take Off Simulation Weight 64227 Slush depth (in) 0.25 Contamination (%) 65.0

Figure 8a Successful Take-Off

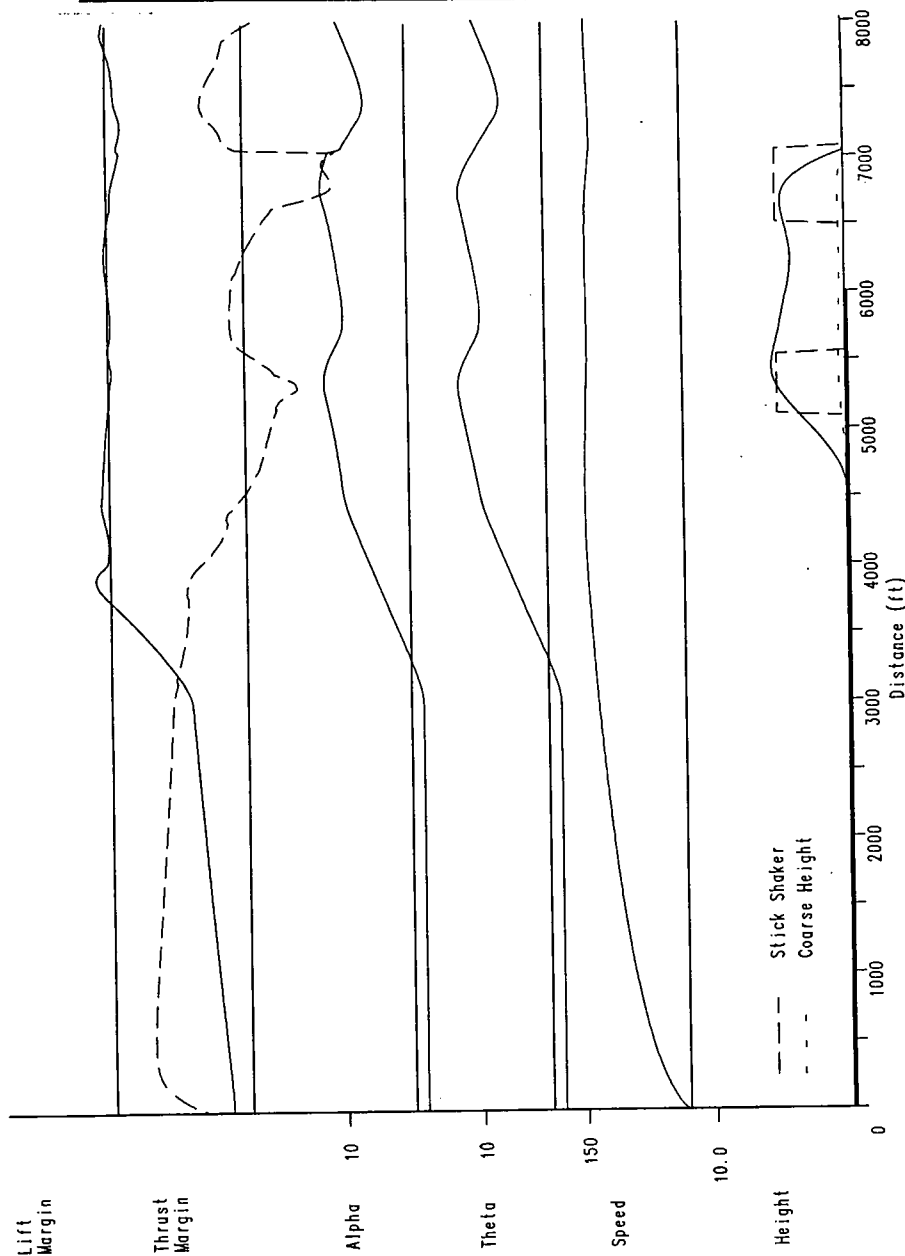
which the aircraft is un-rotated following the initial hop is two degrees lower in 9b than 9a, the latter strategy resulting in a second lift-off and climb out and this at a very high level of contamination.

F-28 Take Off Simulation Weight 64421 Slush depth (in) 0.10 Contamination (%) 82.4

Figure 9b Unsuccessful Take-Off at 82.4 % Contamination, Identical Technique  
The Aircraft Flew over 2400 feet before Crash

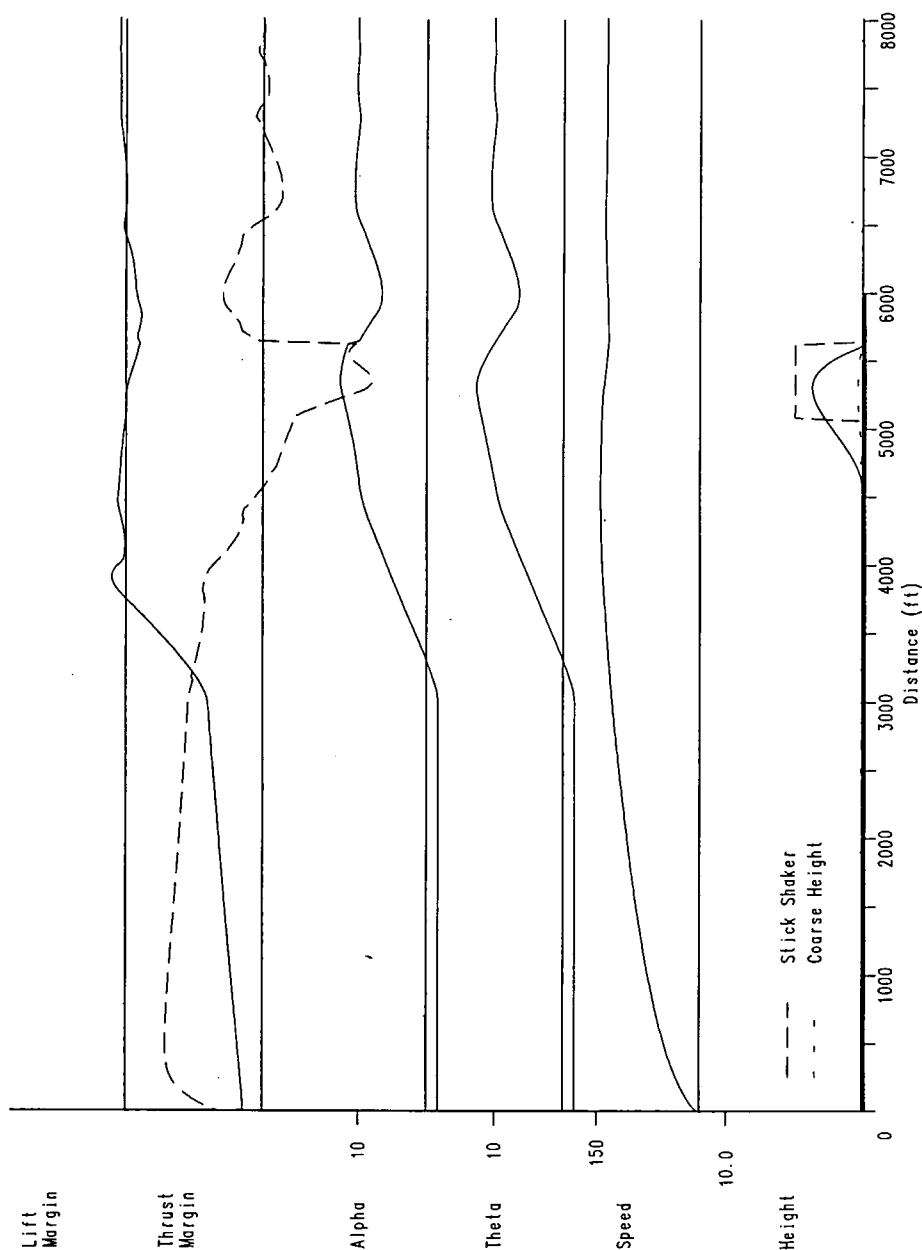
Figure 9c At 82.5% Contamination the Take-Off Becomes a Short Hop and Runway Overrun

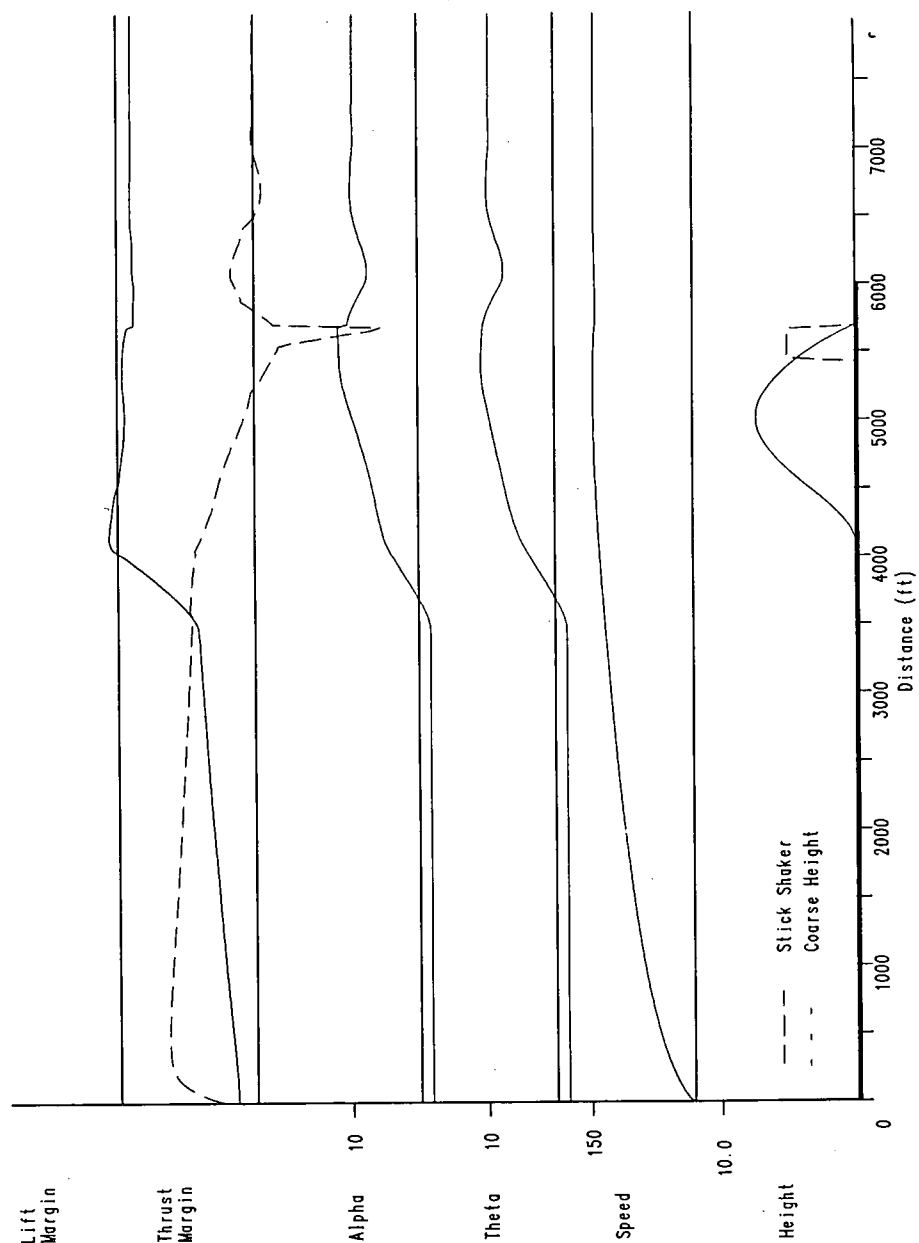
F-28 Take Off Simulation Weight 64584 Slush depth (in) 0.10 Contamination (%) 97.0

Figure 10b Slight Change in Technique Causes Overrun

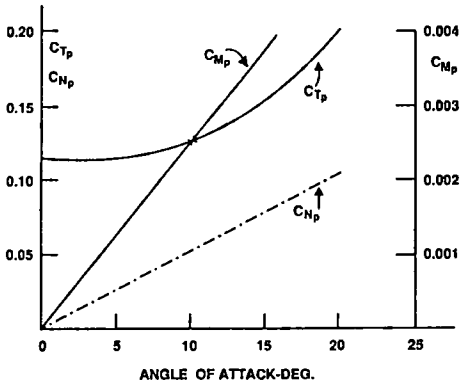
FIGURE 7

In order to separate the propeller from the total wing forces, and to compare unpowered wing characteristics with those with the wing immersed in a slipstream, the isolated propeller data were estimated from Reference (5) and (Figure 7) and were removed from the wind tunnel balance data as follows:

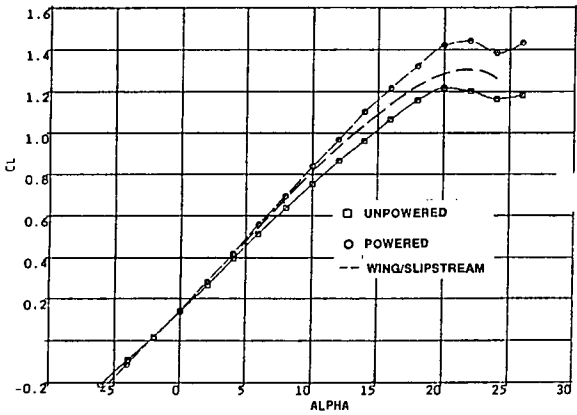
FIGURE 8

The drag polar (Figure 8) indicates significantly less drag due to the effects of the slipstream flow, particularly at low values of  $C_L$  ( $< 0.4$ ), and near zero lift the wing actually produces a thrust. This has been attributed to the effects of slipstream rotation (Ref. 7), with the wing acting as a flow straightener. This result should probably be taken with caution, however, since no direct measurement of propeller thrust or normal force was available.

There appears to be a nose-down change in pitching moment when propeller forces are removed, since neither thrust or normal force are contributing (Figure 8c). The slipstream interaction evidently produces a lesser slope of the  $C_m$  vs  $\alpha$  curve, and more nose-down moment, compared with the unpowered wing. A partial explanation of this change is given in Reference 4, and is attributed to changes in chordwise pressure distribution over the region of the wing covered by the slipstream.

REMOVAL OF PROPELLER REACTIONS FROM THE CLEAN, POWERED WING,  $C_{Tp} = 0.115$ ,  $Re = 1.3 \text{ m}$

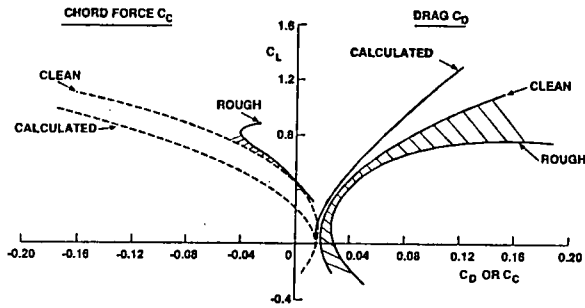
FIGURE 12

$C_c$  and  $C_D$  can also be determined from the parabolic drag polar relationship (Ref. 9). Figure 12a shows the relationship between unpowered wing drag  $C_D$  and chord force  $C_c$ , and the effects of distributed roughness on both parameters, for the unpowered wing. It appears that roughness has a relatively larger effect on drag than on chord force.

COMPARISON OF DRAG AND CHORD FORCE FOR CLEAN AND ROUGHENED UNPOWERED WING (50 GRIT SANDPAPER)
