REVISED FINAL REPORT

Accident on 6 November 2002 in Luxembourg to the Luxair Fokker 27 Mk050 registered LX-LGB

REVISED ISSUE: JULY 2009

Report N° AET-2009/AC-01

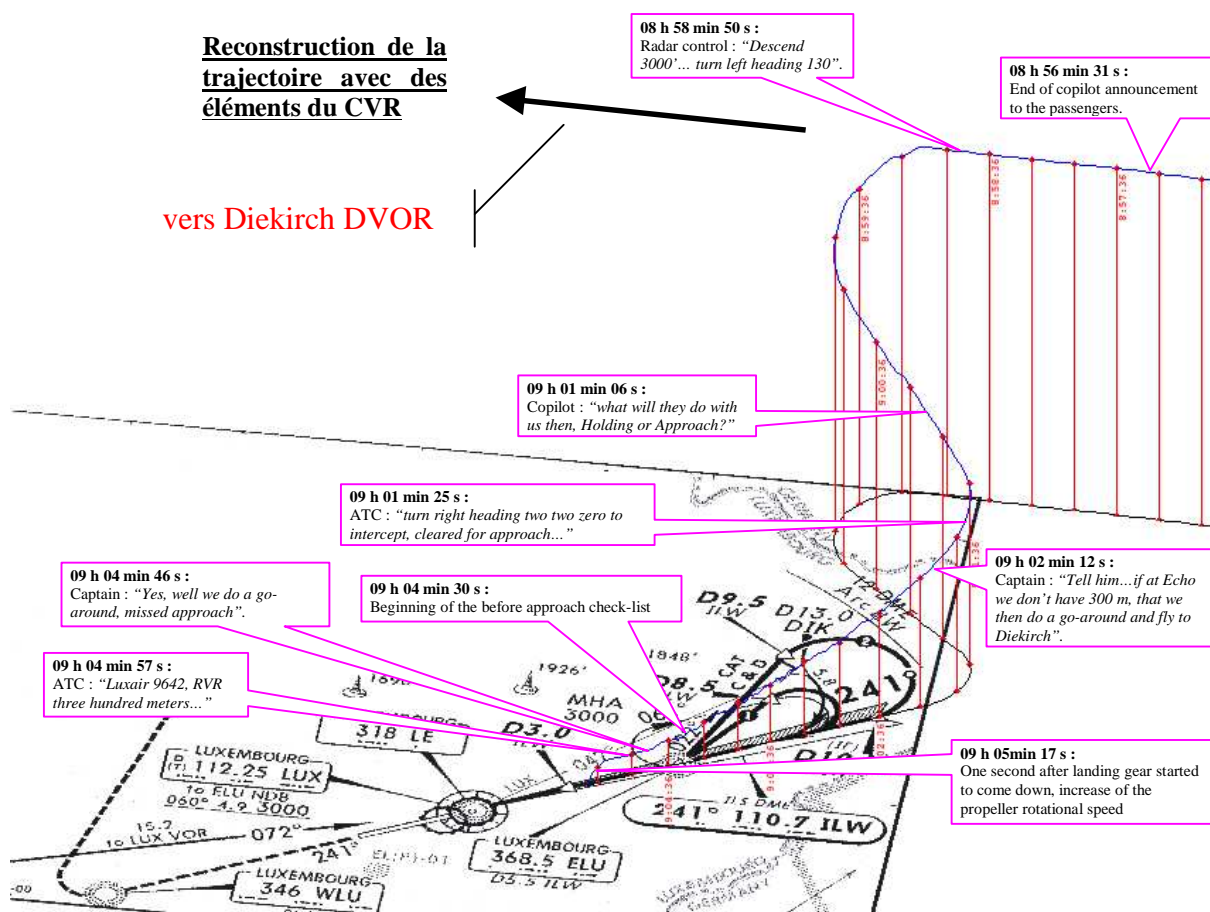
This three dimensional trajectory has been made up on the basis of Luxembourg radar data. Synchronisation precision between DFDR and CVR is one second.

The vertical profile of the trajectory shown in appendix 17 represents radar data illustrating that the final descent of the aircraft started markedly after the ELU beacon.

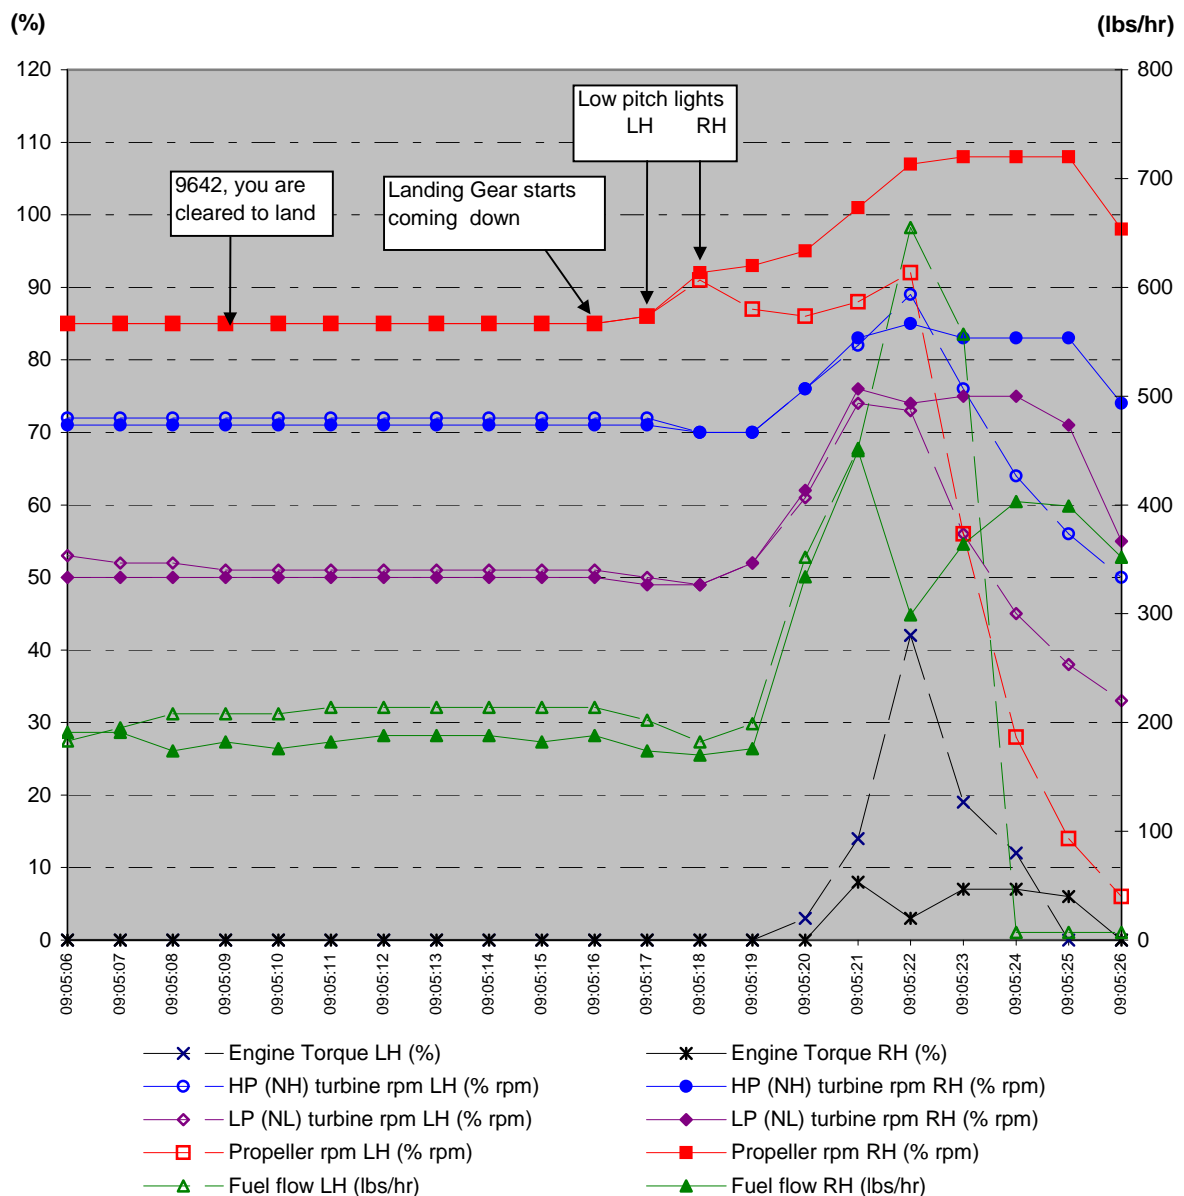
According to the engine manufacturer's information, the HP (NH) values for Flight Idle in flight are 74%. Flight Idle corresponds to zero torque, which is easily recognized for the recorded engine parameters. It can be noted that the engines never stabilised on this setting.

Analysing all the data recorded (19 approaches available) on the DFDR, this HP value of 74% can be found for all flights where the engines are on flight idle with a zero torque value.

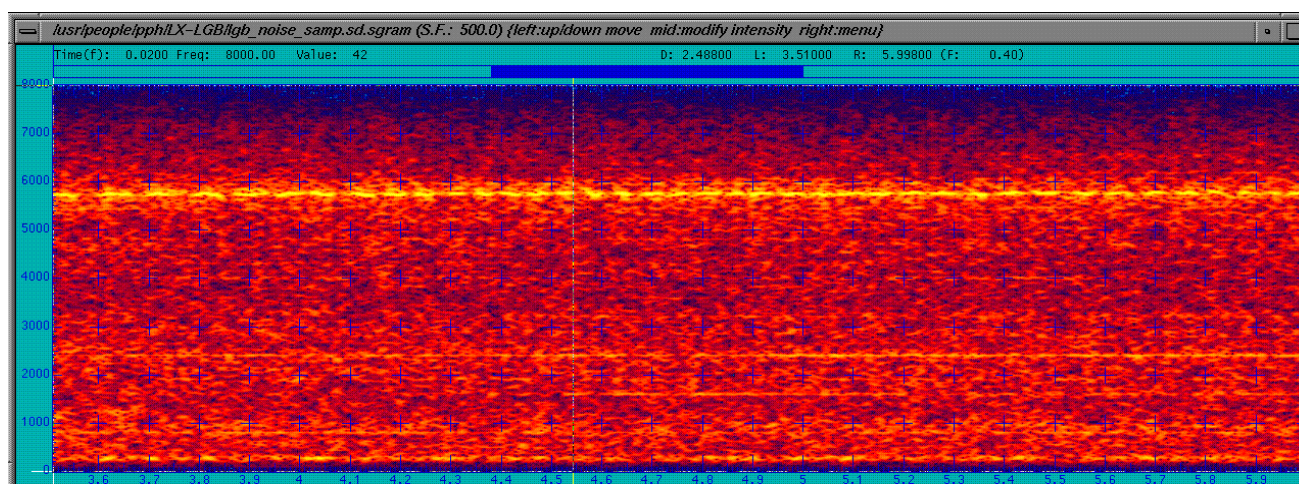
Fig. 1: Représentation Temps – Fréquence du bruit de fond du LX-LGB en vol. Time – Frequency representation of the background noise on LX-LGB in flight.

As shown in the previous figures, LX-LGB in flight (Fig.1) shows a signal with more noise than on LX-LGC on the ground (fig.2). Higher frequencies (around 5,700 Hz) match with the turbine noise whereas the global background noise has a wide range spectrum, consistent with aerodynamic noise.

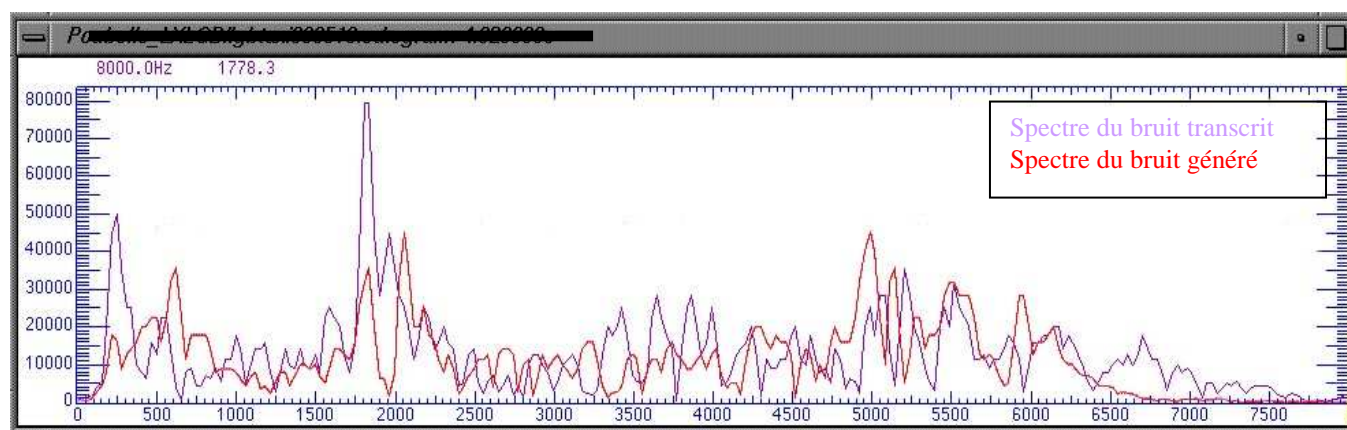
Fig. 5: Comparaison des composantes fréquentielles des bruits transcrit (en mauve) et généré (en rouge). Spectrum comparison between the transcribed noise (in mauve) and the generated noise (in red)

On retrouve les mêmes composantes fréquentielles, notamment aux basses fréquences et autour de **2000** et **5000** Hz.

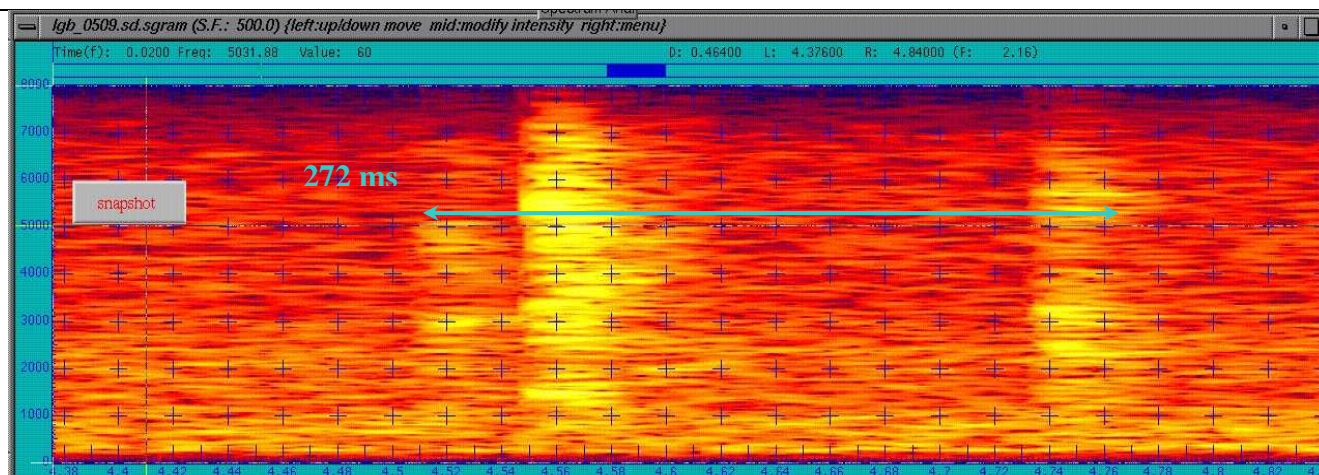
This noise occurs as the crew members talk about the flaps position. After this communication and this noise, the FDR data show that the flaps extended to ten degrees.

Fig. 13: Représentation Temps – Fréquence du bruit transcrit. Time – Frequency representation of the transcribed noise.

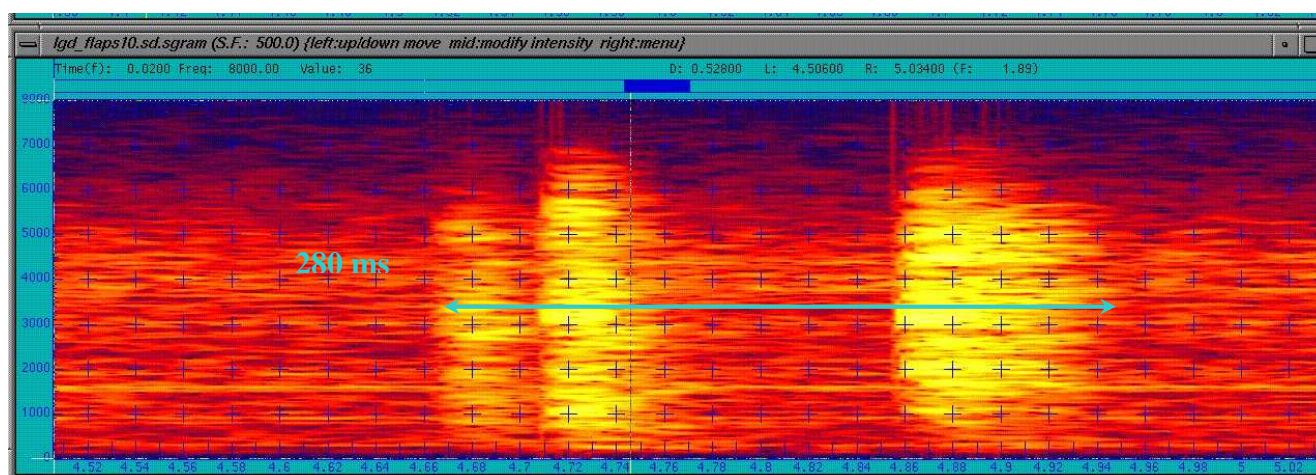
As seen in figure 14, the same frequencies are visible, especially for low frequencies and around 2000 and 5000 Hz.

Fig. 14: Représentation Temps-Fréquence du bruit généré. Time – Frequency representation of the generated noise.

The preceding figures illustrate the similarities between the two noises, where the same signature shape and rates are found.

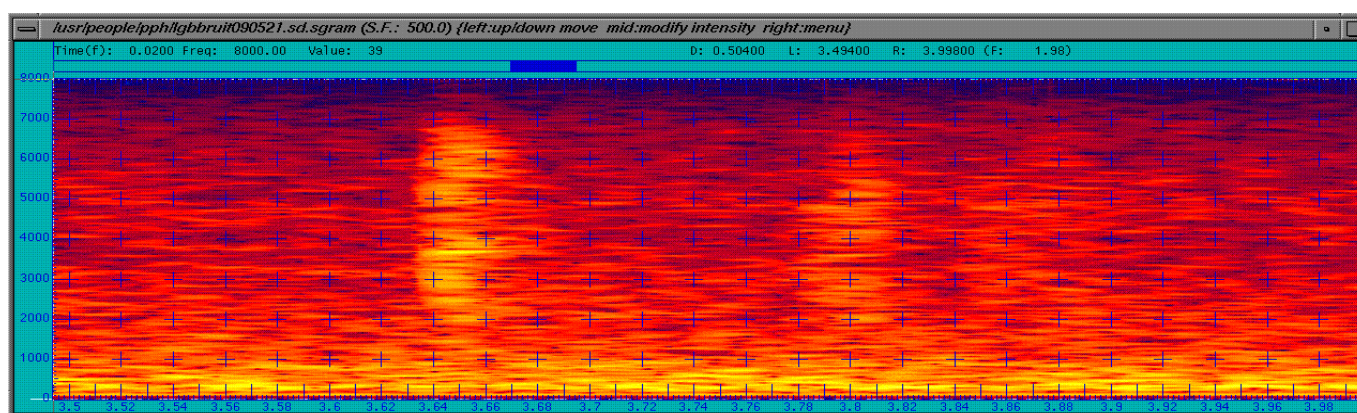
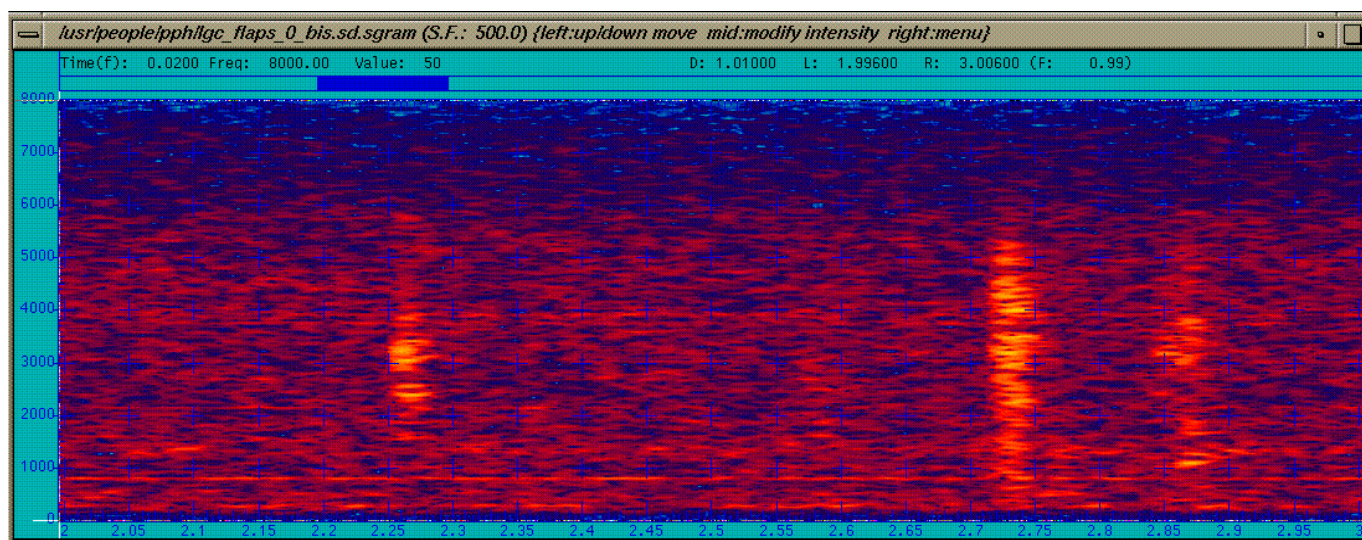
Fig. 22 : Représentation Temps – Fréquence du bruit. Time – Frequency representation of the noise.

Fig. 23 : Représentation Temps – Fréquence du bruit de la commande des volets ramenée en position 0°. Time – Frequency representation of the flaps command noise moved to 0°.

This noise occurs just before the FDR data show that the flaps returned to the retracted position. When listening to this noise, it sounds similar to the noise of the flaps control. However, this could not be validated by the tests performed due to the small similarities between the frequency spectra (not represented here).

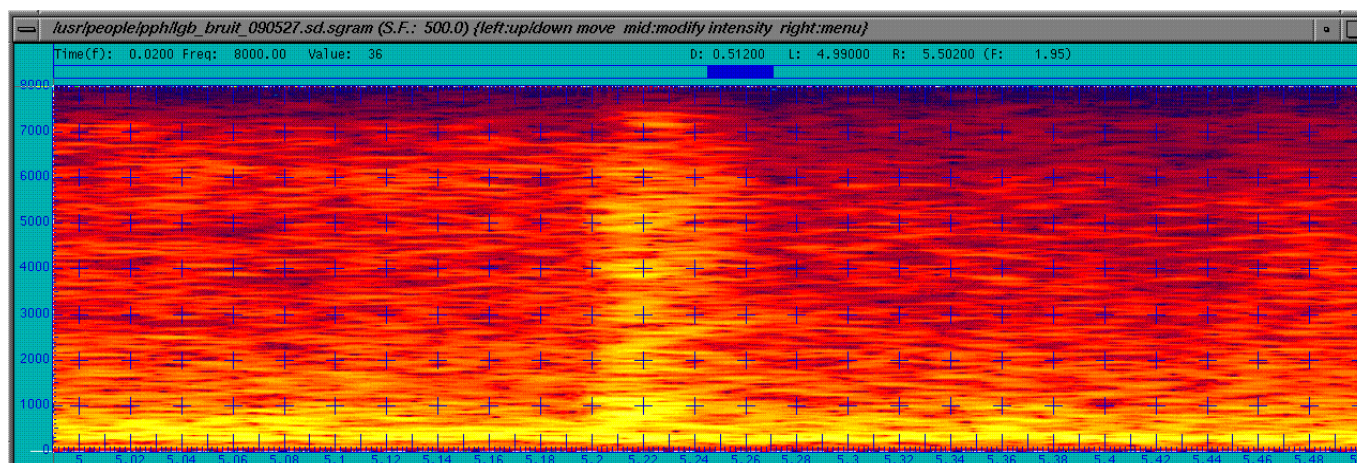
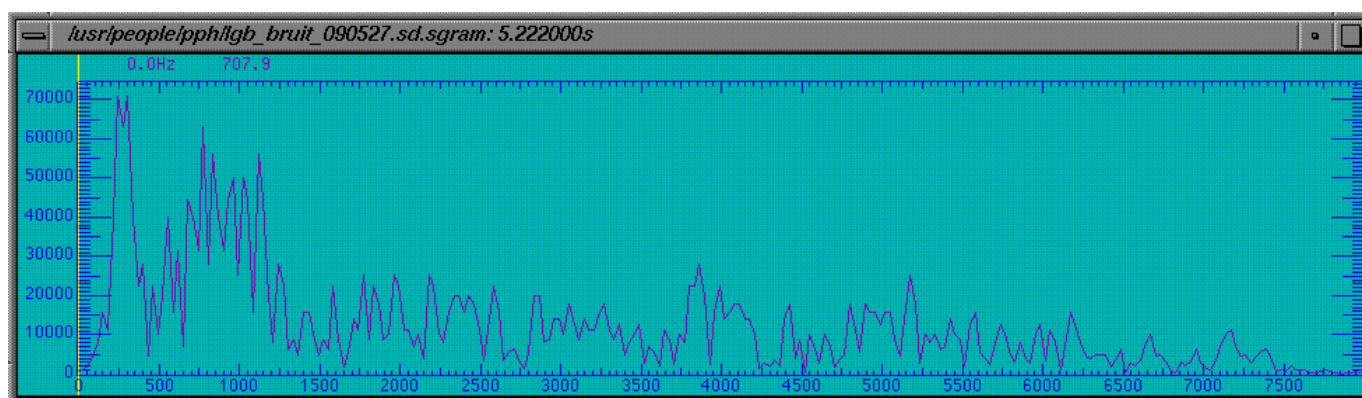
Fig. 23 : Représentation Temps – Fréquence du bruit. Time – Frequency representation of the noise.

Fig. 24 : Spectre du bruit inconnu. Spectrum of the unidentified noise.

Ce bruit, caractérisé par de fortes énergies en basses fréquences, n'a pas pu être identifié par les essais.
