FINAL REPORT

Taxiing Accident involving

**McDonnell Douglas DC8-62
Registration Mark: N1808E at**

AIB/AAI/CAS.004

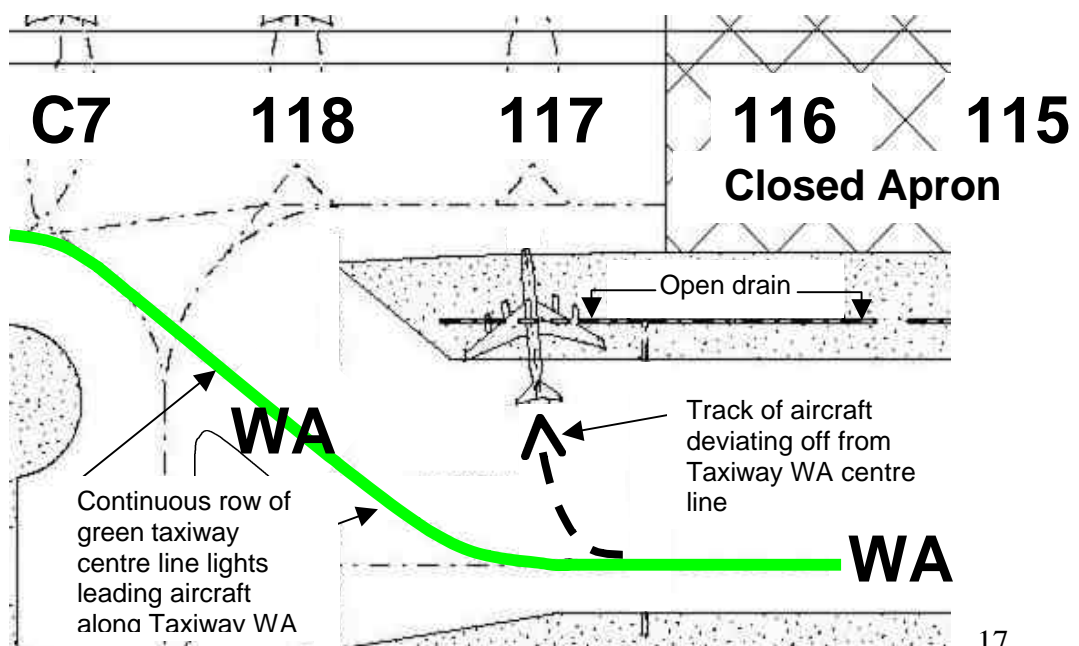
2.2.1.5 At this moment, all three crew members saw the ground marshaller in position at Bay 117 on the right of the aircraft. Instead of continuing to follow the green taxiway centre line lights on Taxiway WA, the PIC turned the aircraft to the right to go directly to Bay 117 even though there was no turn signal from the marshaller or instruction to turn from ATC. At the location where the aircraft turned right, there was no aircraft parking bay guidance marking on the ground to indicate that the aircraft should turn. After turning right the aircraft went onto the paved area adjacent to the taxiway and subsequently onto a grass area between Taxiway WA and the parking apron. The flight crew did not see the grass area although the aircraft's landing lights were on. They only realised that the aircraft was on the grass after the aircraft's nose gear had gone across the drain. The PIC had not noticed the grass area as there were no "blue edge lights" to indicate the edge of the taxiway. The unmarked paved area adjacent to the taxiway may have given the PIC the impression that the entire length between the aircraft and Bay 117 was paved.

2.2.1.6 In summary, the crew was aware of the NOTAM that required aircraft to be towed in to Bay 117 during hours of darkness. However, they were unsure of the location of Bay 117. There were no instructions from the ATC as to what they could expect when they reached the end of the centre line guidance lights. They also did not stop at the end of the centre line guidance lights to verify their position or to ask ATC for instructions. The PIC was disorientated. Although the crew was referring to the airport charts, they missed Bay 117 initially. The flight crew's unfamiliarity with the apron area where Bay 117 was located contributed to their missing Bay 117. On the way back towards the Terminal 1 West Apron, ATC only asked the crew to follow the green lights and did not ask to find out what had caused the crew to miss Bay 117 earlier. Without additional instructions from ATC and while the PIC was looking out for a tow tug to lead the aircraft to Bay 117, the marshaller's raising his wands to help indicate the position of Bay 117 prompted the PIC to decide to turn the aircraft and go directly towards Bay 117.
