# Investigation Report

AX001-1-2/02  
May 2004

Kind of occurrence: Accident  
Date: 1 July 2002  
Location: (near) Ueberlingen/Lake of  
Constance/Germany  
Type of aircraft: Transport Aircraft  
Manufacturer/Model: 1. Boeing B757-200  
2. Tupolev TU154M  
Injuries to persons: 71 fatalities  
Damage to aircraft: Both aircraft destroyed  
Other damage: Damage to open field and forest  
Source of Information: BFU Investigation

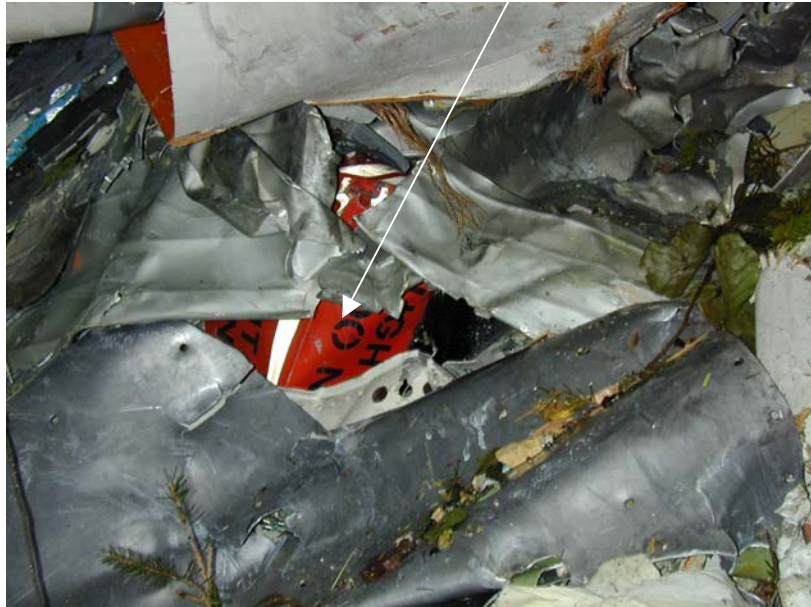
exhaust of APU

The FDR and the CVR were recovered from the aft part of the fuselage.

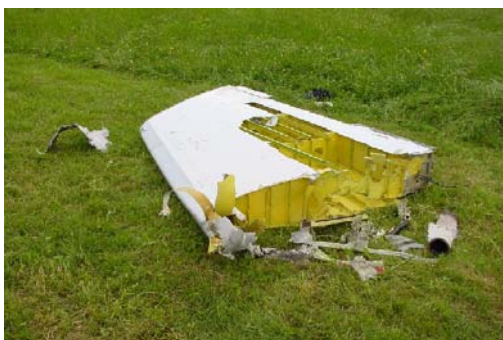
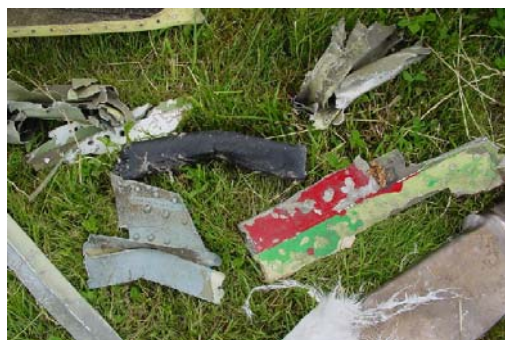
West of Altheim, debris of both airplanes was found on an area of about 4 km<sup>2</sup>. The top part of the B757-200's vertical stabilizer was found in the immediate vicinity of two parts of the Tu-154's left wing leading edge of about 30 cm in width each.
