App K - Crashworthiness Analysis by Cranfield Impact Centre (CIC)

Eighteen Safety Recommendations have been made.

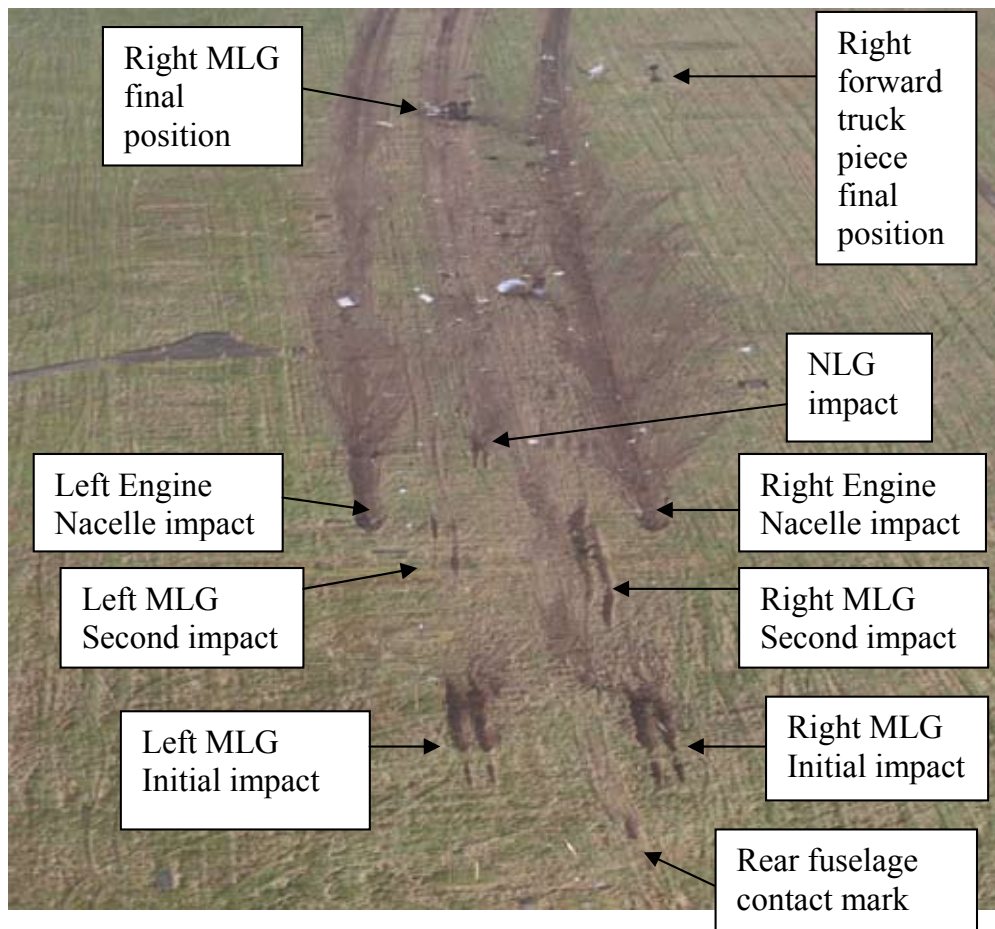
Figure 22

The initial impact of the aircraft was approximately 110 m inside the airfield's perimeter fence. The first ground marks (Figure 22) were made by the rearmost wheels, followed by all the main wheels as the trucks tilted forward, at which time the maximum vertical acceleration spike of 2.9g was recorded on the DFDR. The touchdown into soft soil produced impact gouges with a depth of up to 0.45 m from the right gear and 0.36 m from the left gear. There was also a mark from the contact with the rear fuselage as the aircraft continued forward.

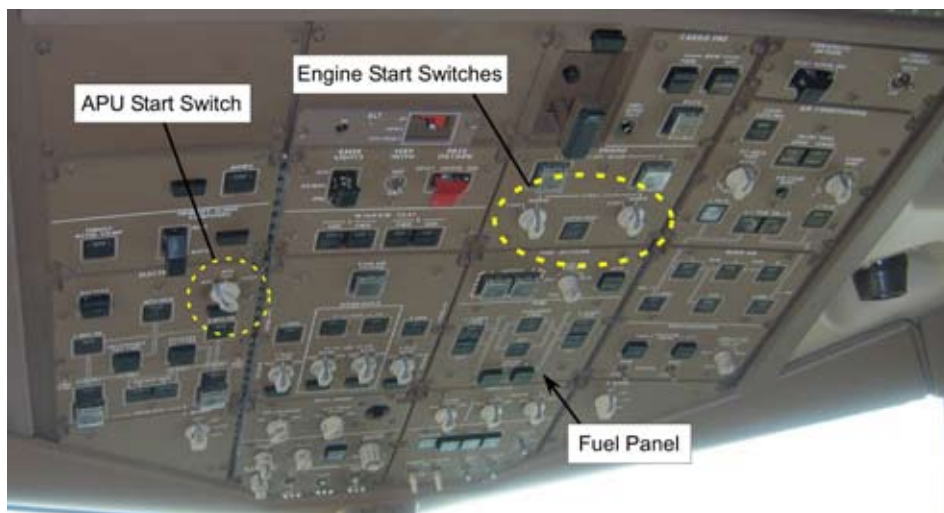
Figure 24

Engine thrust levers - Both engine thrust levers were in the full thrust position.

Flaps - FLAP 25 selected.

Overhead panel shortly after the accident

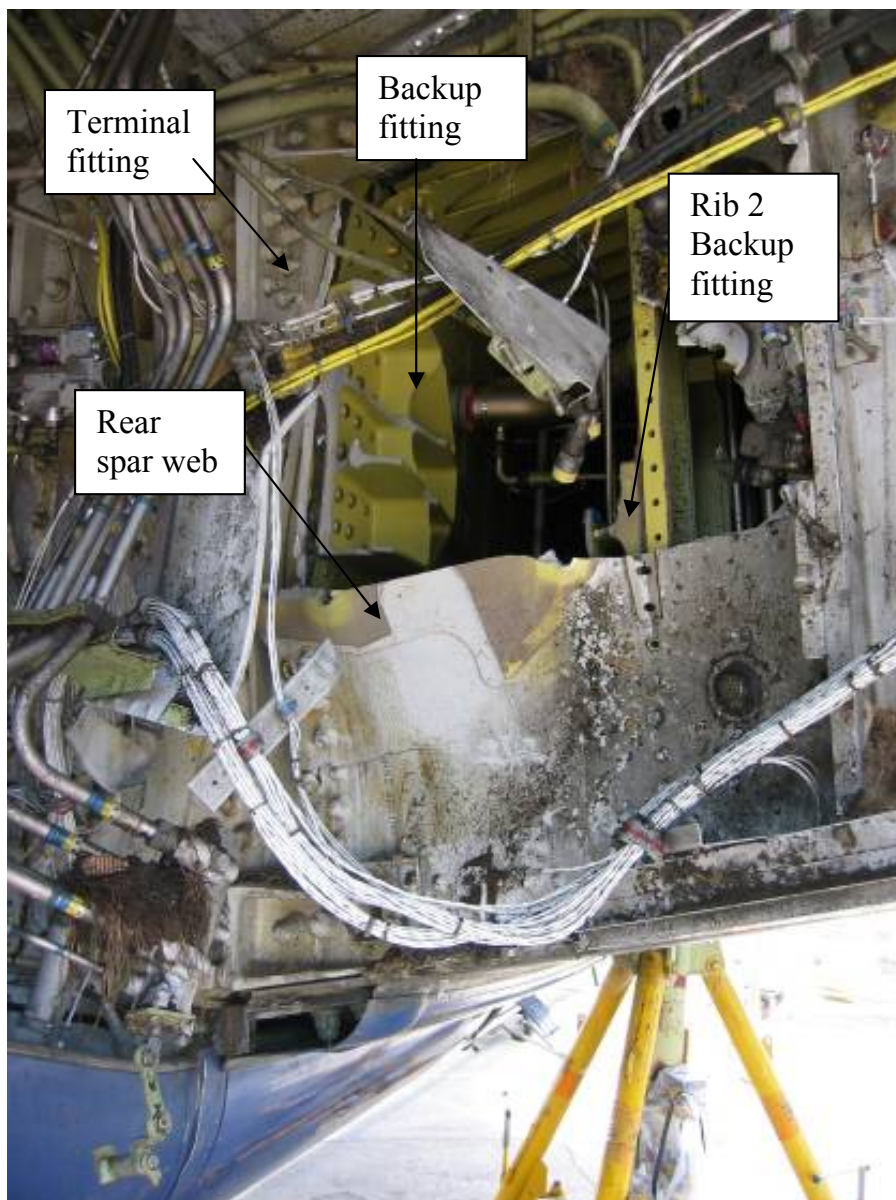
Figure 28

Right rear spar showing missing drag brace attachment point and centre fuel tank structure

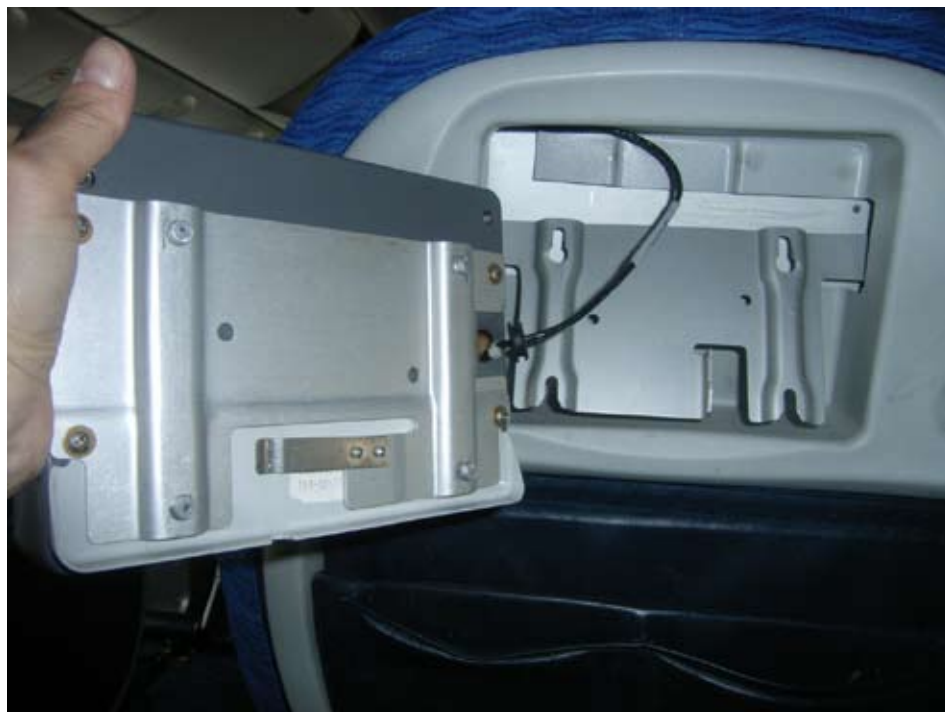
Figure 40

In the Business Economy section, nine of the 32 seat back video monitors had separated; of these, eight remained suspended by their electrical harness but one had separated completely and was found on the cabin floor (Figure 39).

Video monitor attachment fittings

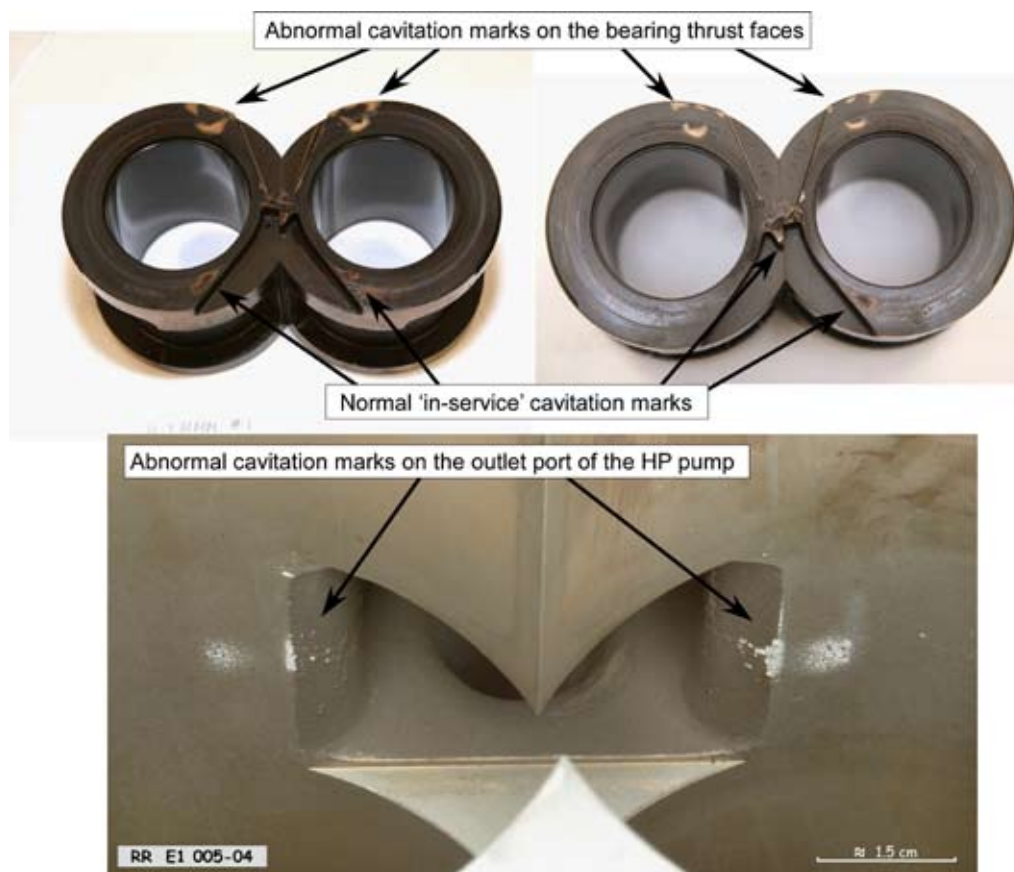
Figure 41

Strip of the HP gear pump did not reveal any mechanical discrepancies other than some unusual marks on the delivery sides of both pumps which the manufacturer described as being indicative of 'cavitation' (Figure 41). The marks comprised slight, but distinct, erosion of the dry film lubricant on the bearings and also of the outlet ports: they appeared fresh and bright.

Advice from the pump manufacturer was that these marks, at this location, were highly unusual. However, local cavitation erosion was to be expected at various known positions, mainly associated with the inlet side of the pump; the marks were hardly ever seen at the outlet ports. A series of tests had been carried out originally to certify the pump. Part of the tests involved running a pump at very low inlet pressures for several minutes. When the unit was stripped, marks were present which were almost identical to those which had been found on the pumps from G-YMMM. (Appendix E 'Explanation of Cavitation'.)

Apart from the marks, which would have had no effect on pump operation, no other abnormalities were found in either MEP from G-YMMM.

Cavitation markings on the HP pumps from G-YMMM

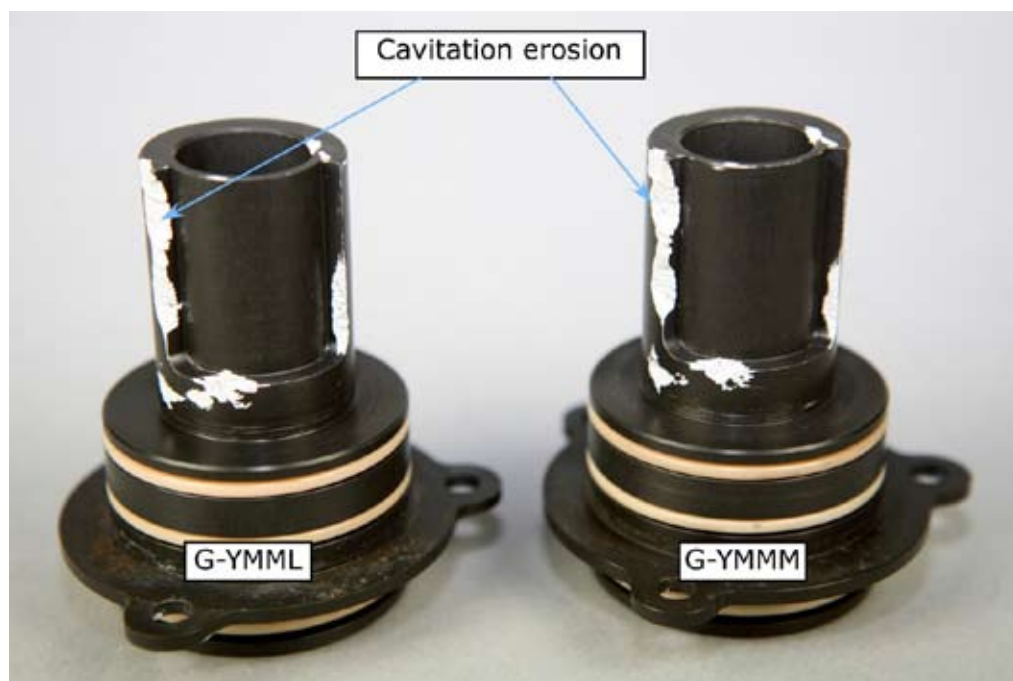
Figure 42

Inspection of the boost pumps revealed cavitation erosion on the re-prime pump stator and discoloration of the surface treatment on the re-prime impeller, which was assessed to have been caused by cavitation erosion. A comparison of this damage was carried out against boost pumps removed from another of the operator's aircraft, G-YMML (Figure 42). All the boost pumps from both aircraft, which had a similar service history, displayed the same cavitation damage to the re-prime stator and impeller. The pump manufacturer demonstrated that this type of damage was normal for pumps of this age.

Cavitation wear marks on the re-prime pump stator

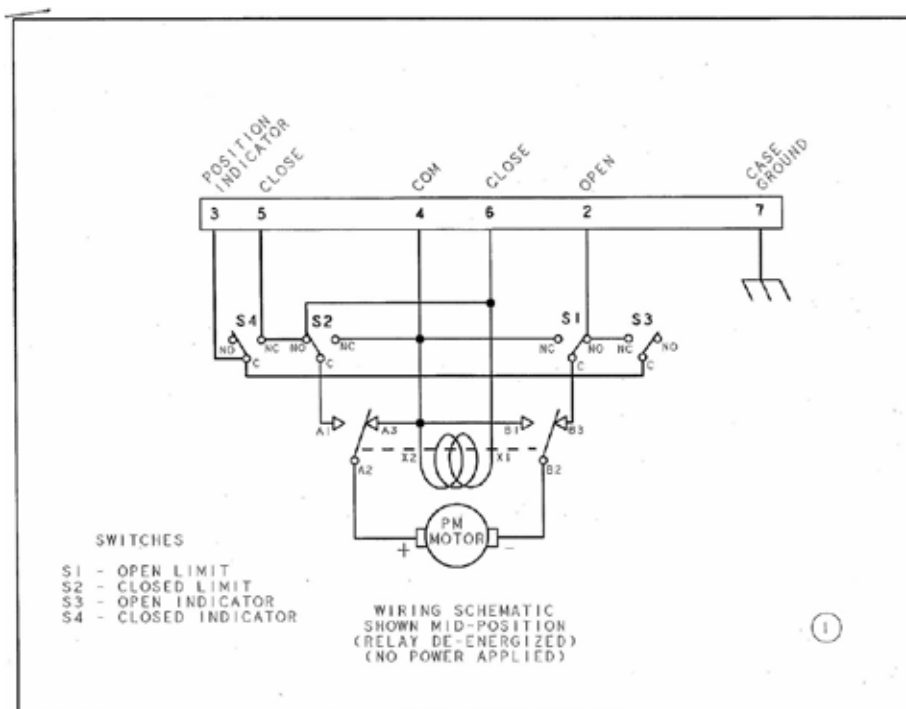
Figure 43

DFDR data during the accident flight showed the cross-feed valves in the CLOSED position and the spar valves in the OPEN position throughout. In addition, all the valve electrical actuators passed the ATP and were assessed as being in a good condition. It was established that on all the actuators the position indicator pin (pin 3) would only supply 28 volts once the actuator had moved to its limit of travel. This was confirmed by applying a 28 volt supply to the actuator when it was in an intermediate position and ensuring that there was an open circuit (0 volt) on the position indicator pin (pin 3) (Figure 43). In addition to the tests detailed in the ATP, two further tests were carried out on the actuators.

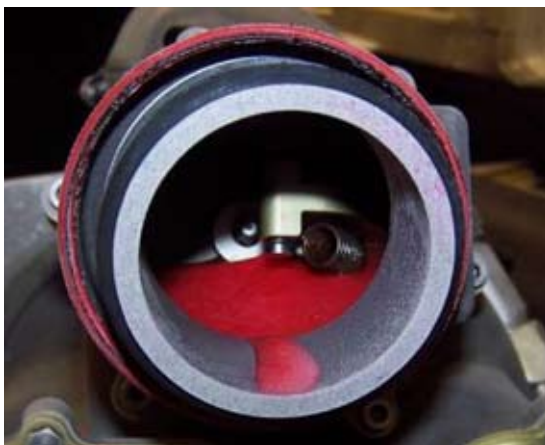
Figure 51

To explore this theory, a number of tests were carried out using dyed water that had been frozen in a check valve housing (Figure 51). In one test, compressed air was applied to the valve which started to open when the pressure was approximately 3 to 4 psi. On another test, with the housing fitted to the rig, it was possible to achieve a flow of 28,000 pph. At the end of these tests the ice chip was still located in the housing.

Dyed ice in check valve housing

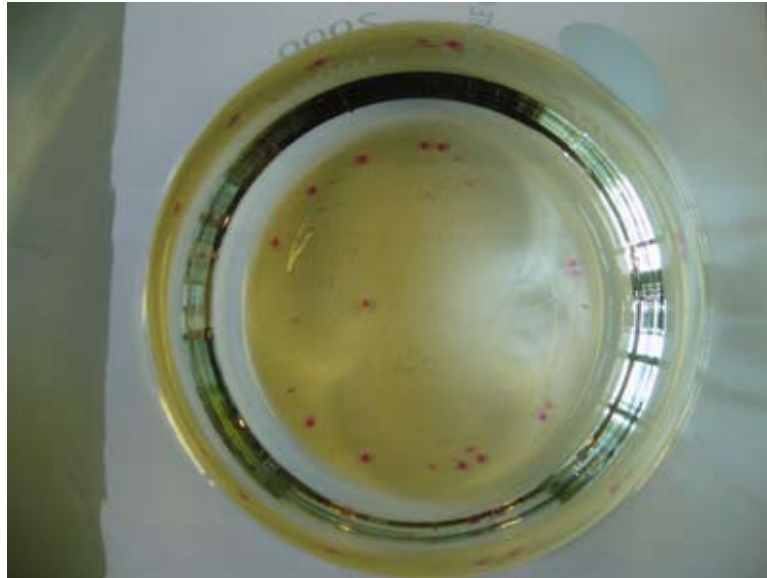
**Figure 59**

Small water droplets were observed in the fuel samples taken from the engine fuel filters and housings. The amount of water was too small to measure and so was classified by reference to the QinetiQ fuel appearance table as being 'small'. Figure 59 is a reconstruction of the QinetiQ description of 'small' using water coloured with food dye.

Reconstruction of a 'small' amount of dyed water in aviation turbine fuel

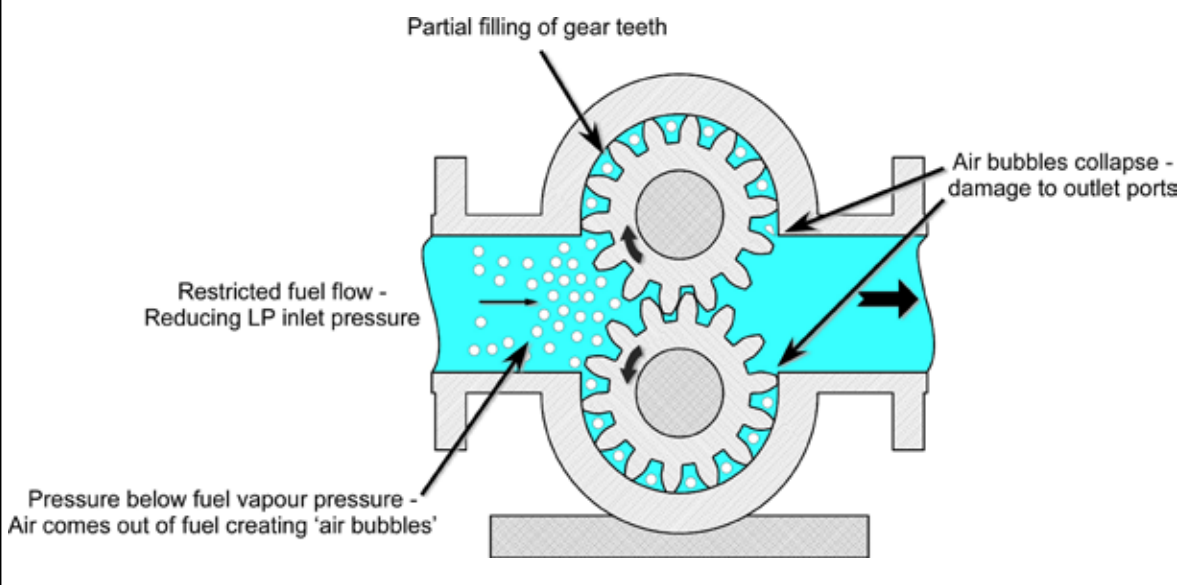
- Picture 4

Cavitation can occur with the presence of fuel vapour or air bubbles in the fluid and, given the low inlet pressure and high velocities, a certain amount of cavitation erosion is not unusual. The erosion is caused by the collapse of the bubbles which occurs violently and creates a shock wave of fluid. Striking a solid surface, the shock wave can cause progressive damage if it persists. In the case of the HP pumps fitted to G-YMMM, a degree of ‘normal’ cavitation damage is expected on the bearings where the teeth mesh and on the teeth themselves (Picture 4). The rate of erosion is a known quantity and does not affect operation of the pump within its overhaul life.

The inlet pressure to the pump should be maintained such that formation of air/vapour bubbles is minimised and, on most jet aircraft, this is achieved by the combination of aircraft booster and engine low pressure pumps. However, even if these are working correctly, a restriction in fuel flow upstream can result in the HP pump lowering its inlet pressure to the point at which a large quantity of air and vapour bubbles are formed. This gives rise to a mixture of fluid and gas bubbles filling the gear teeth. As these gear teeth open to the high pressure outlet port of the pump, the gas bubbles collapse and the high pressure fuel in the outlet port rapidly fills the available space. Both these actions result in shock waves being formed that cause damage to the outlet port and the delivery side of the bearing faces. This is the abnormal cavitation damage seen on both HP pumps from G-YMMM.

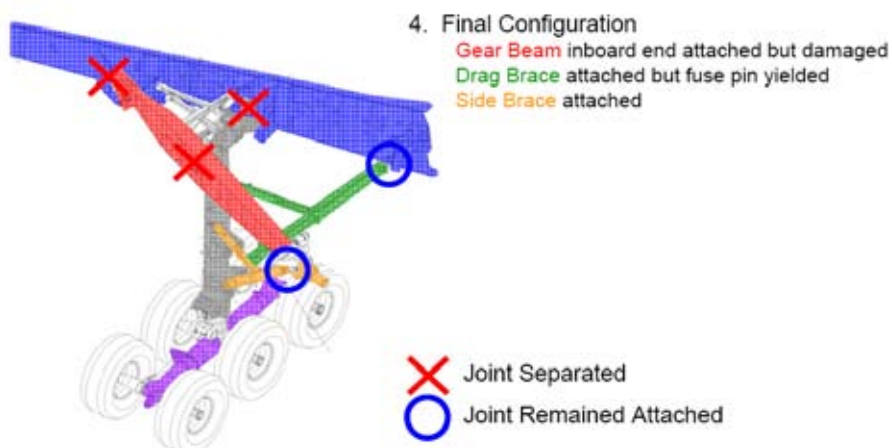
4. Final Configuration: Gear beam inboard end damaged but still attached, drag and side brace both folded but still attached.

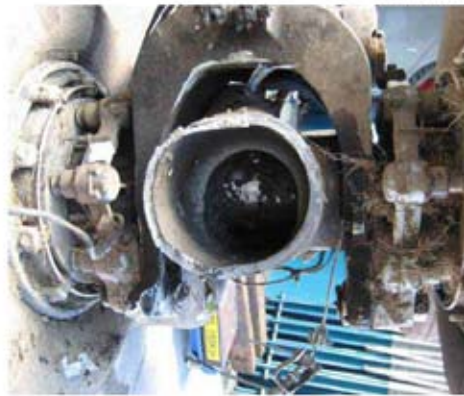
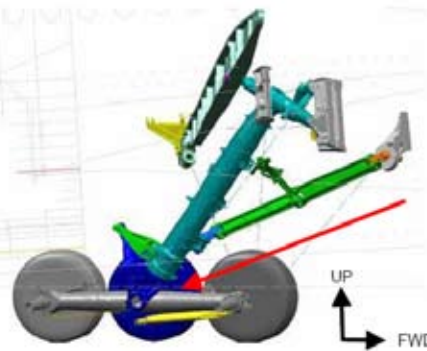
Truck Beam reaches pitch up limit on Shock Strut/Inner Cylinder and fractures

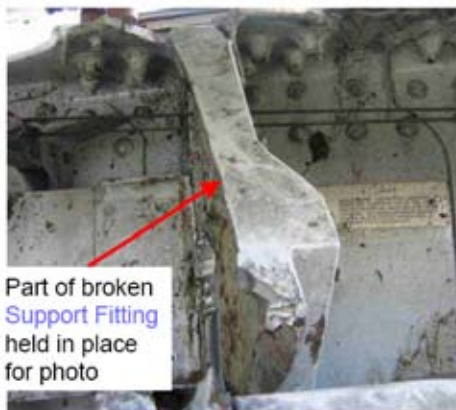
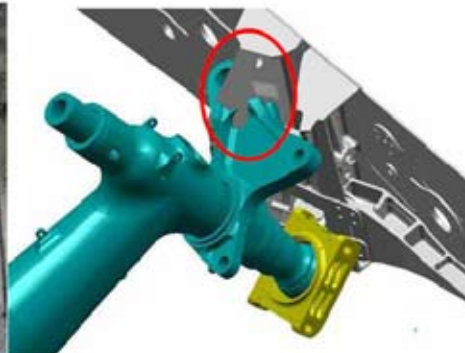
3. Shock Strut / Retract Arm Jams on and destroys upper part of inboard Trunnion Support Fitting

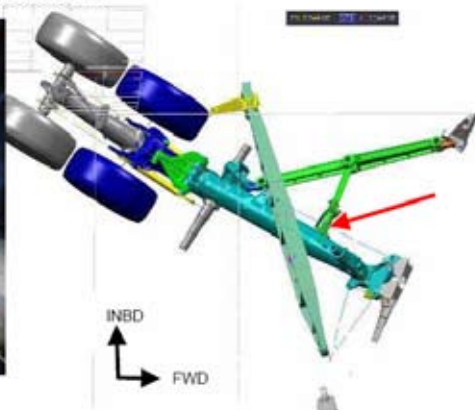
Gear continues twisting until Retract Actuator drives through Drag Brace Lock Link. Drag Brace separation – occurs sometime after this

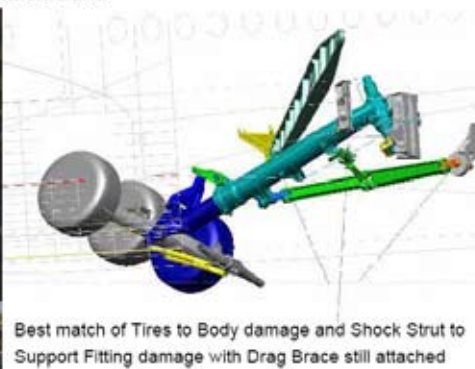
4. Aft Body impact completed after failure of Drag Brace Fitting to Rear Spar attachment

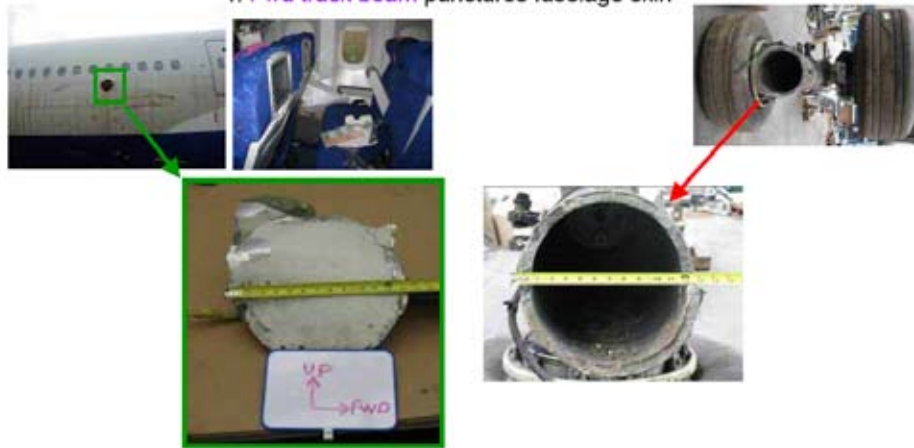
4. Fwd truck beam punctures fuselage skin

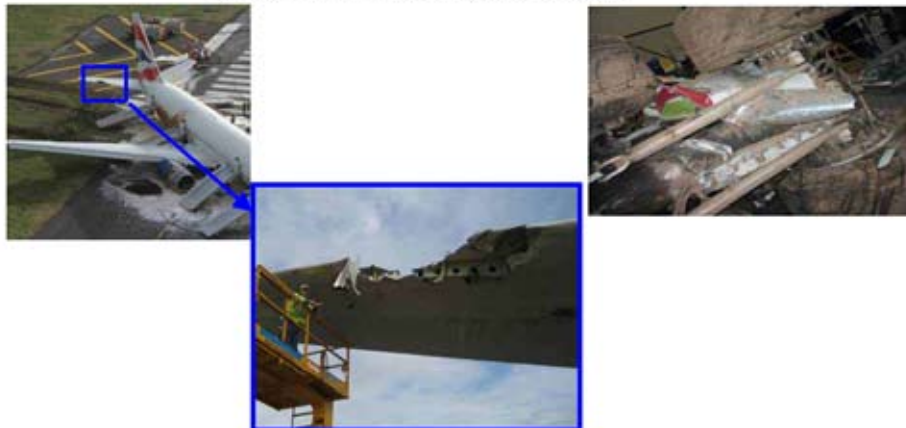
4. Right MLG strikes horizontal stabilizer

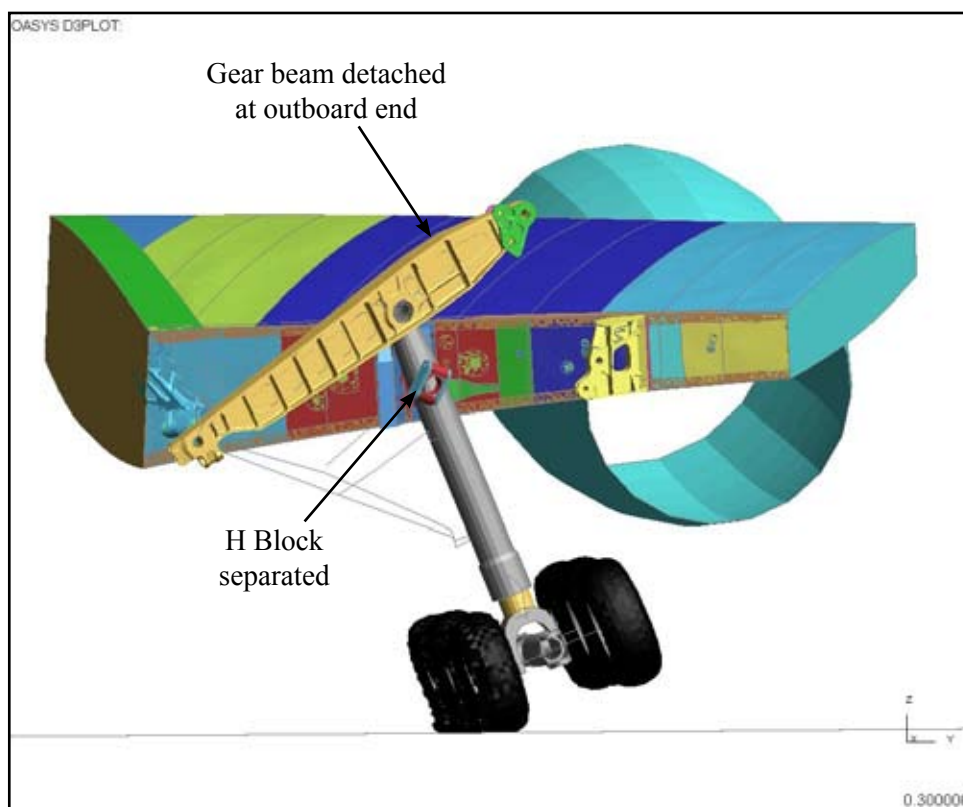
The first fuse pin failure occurred at the outboard end of the Gear Beam followed by failure of the fuse pins at the lower (H block) and upper housing positions. Thereafter, the gear beam rotated around its pivotal axis at the hanger link end. The drag brace fuse

Figure 66 shows a view from behind the right wing during the impact sequence, at the point when the outboard end of the gear beam and the lower and upper housings have failed.

View from rear of right wing – Run B (TIME = 0.30 SECS)
