## AIRCRAFT ACCIDENT REPORT AND EXECUTIVE SUMMARY

**AIRCRAFT ACCIDENT INTERIM REPORT**

**Name of Owner** : British Airways PLC  
**Name of Operator** : British Airways  
**Manufacturer** : Boeing Company  
**Model** : B747- 400  
**Nationality** : United Kingdom  
**Registration Marks** : G-BNLL  
**Place** : OR Tambo International Airport (FAOR)  
**Date** : 22 December 2013  
**Time** : 2043Z

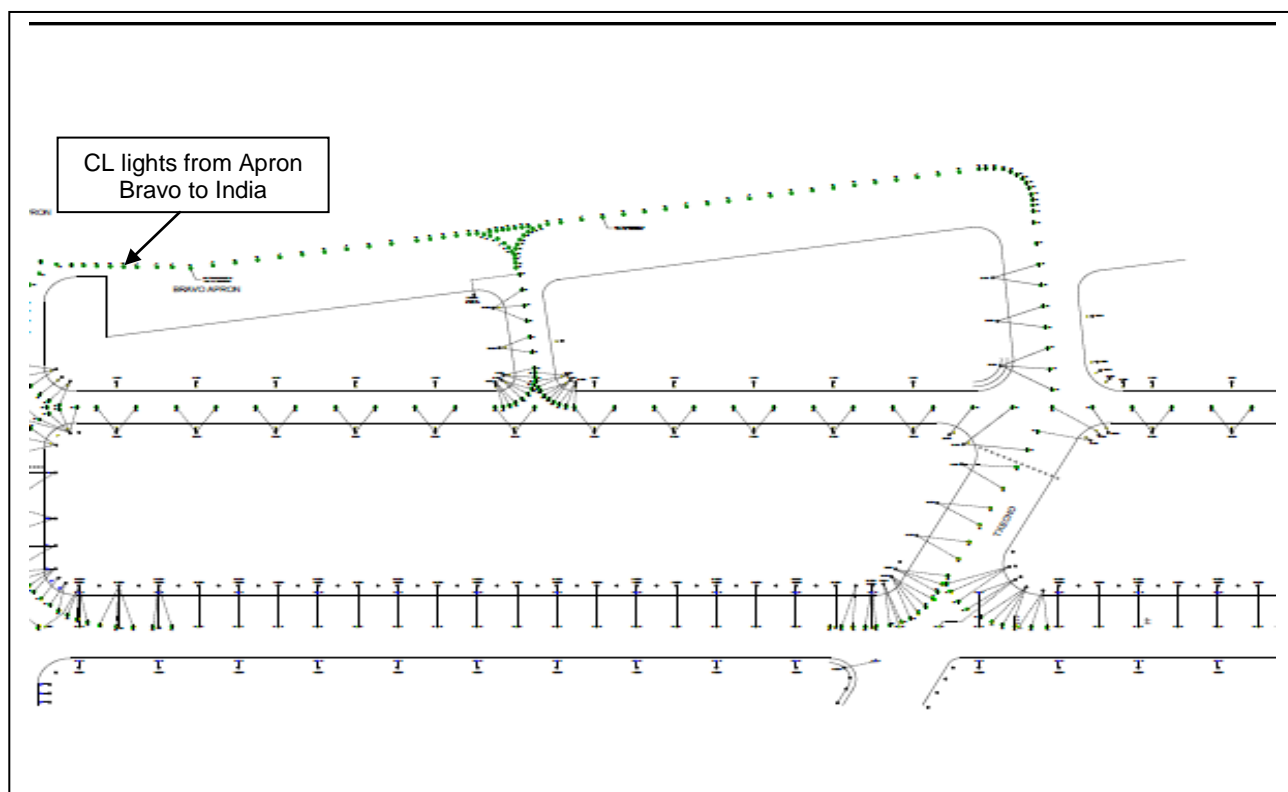
Figure 16 Centreline lights installed on taxiway Bravo from apron Bravo

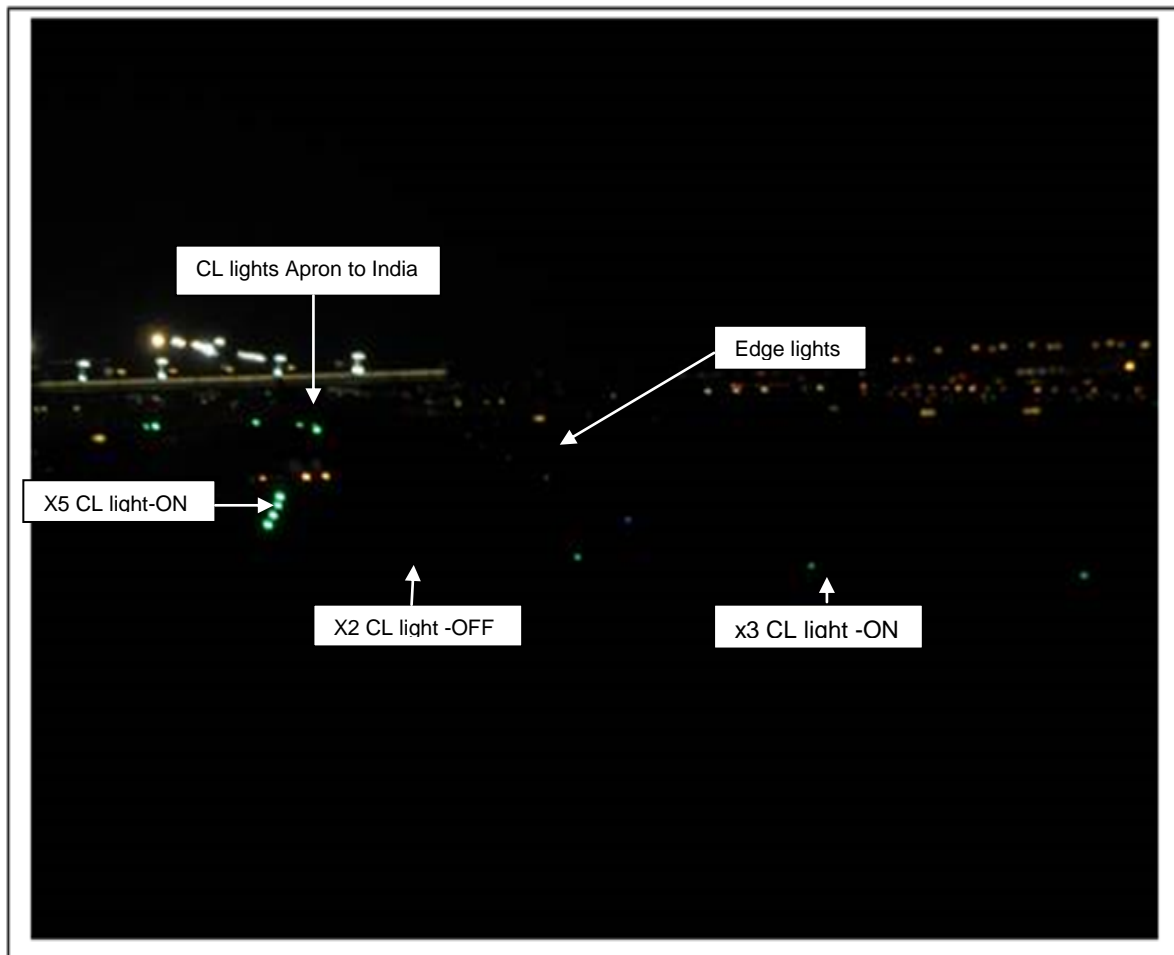
- The investigation determined the taxiway centreline lighting situation as follows:
  - The investigation did find centreline lights installed on taxiway Bravo.
  - A total of 15 centreline lights were counted and switched on (serviceable). Below is a picture taken on the night in question.
  - The picture was taken from the intersection area of Bravo and Mike showing the 15 green centreline lights installed on Bravo.

Figure 17 Green centreline and blue edge lights illuminating on taxiway Bravo

- Below are short descriptions of the condition of centreline lights installed:
  - There were 3 centreline lights switched on when leaving the apron;
  - There were 4 centreline lights switched on at the intersections of Bravo, Lima and India;
  - There were 5 lights centreline lights switched on in the straight line prior to the split between Bravo and Mike;
  - There were 3 centreline lights switched on in the straight line leading to the Category 2 holding point.

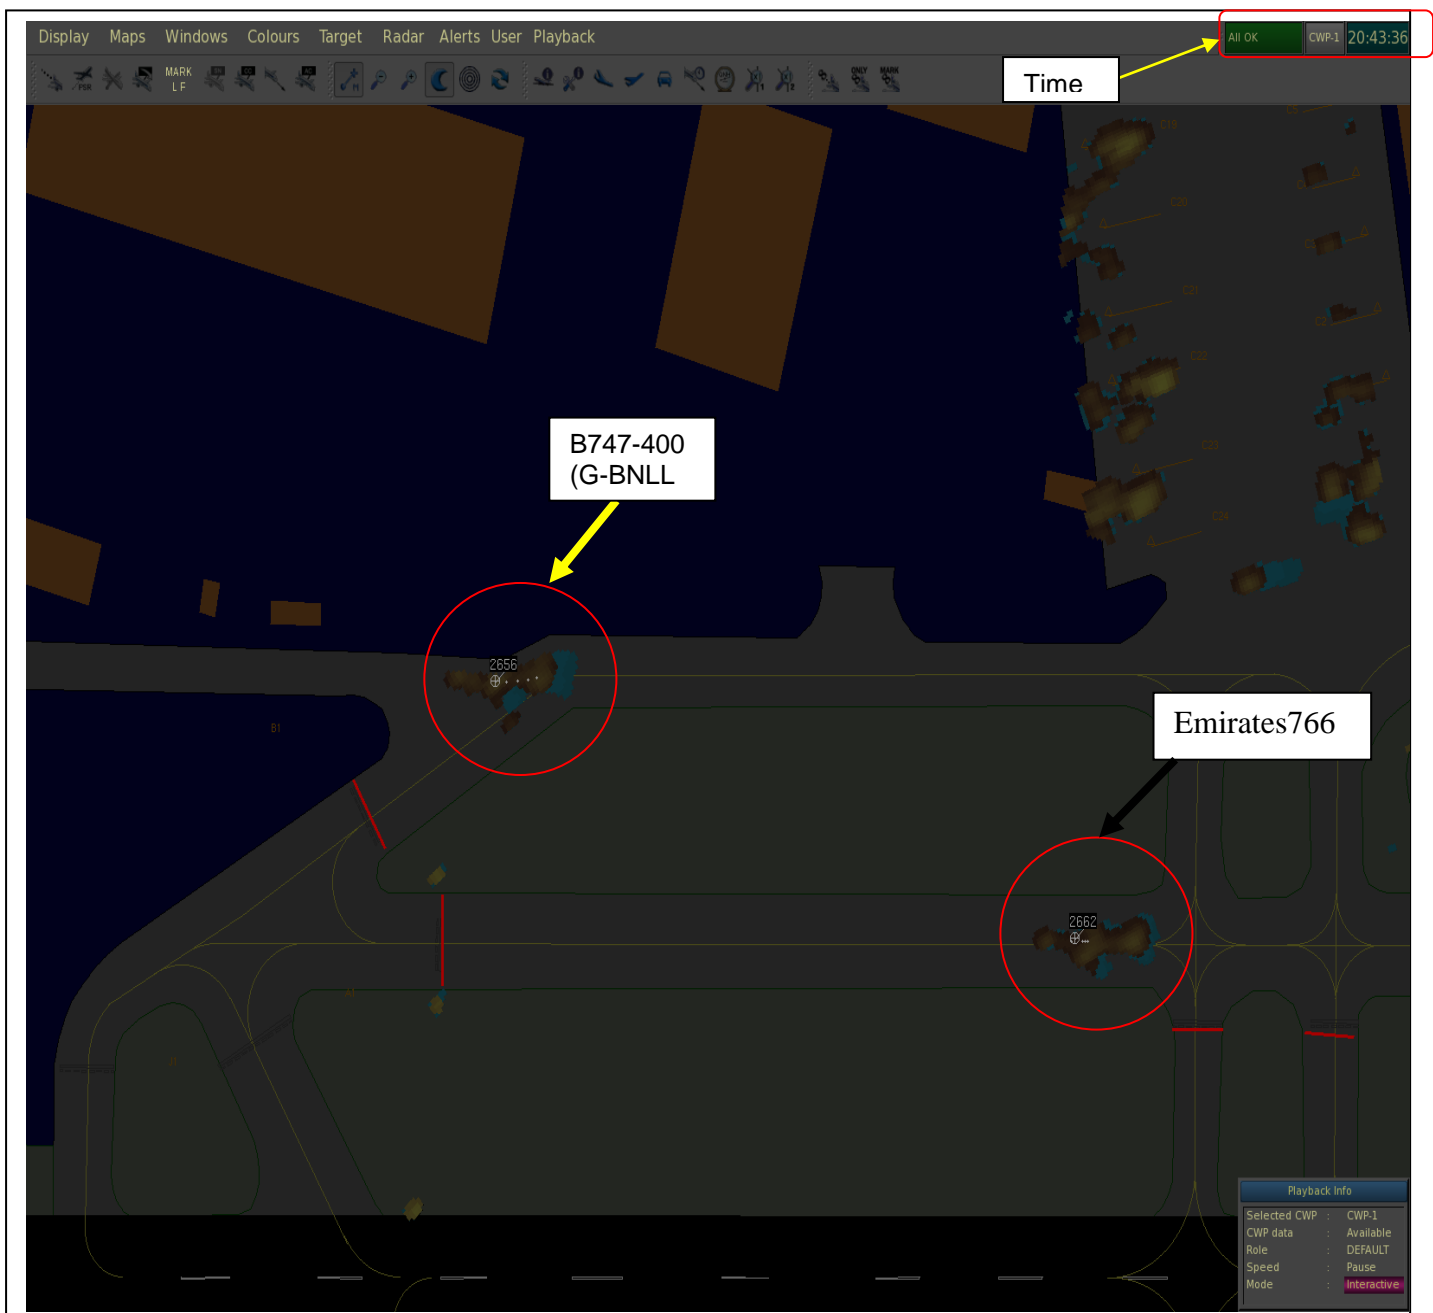
Figure 30 A-SMGCS image of BA034 proceeding onto Mike

1.11.4.10 The FDR and A-SMGCS show that at 20.43:36 UTC (22.43:36 local time), the BA034 aircraft was taxiing (ground speed 14.3 kts), turning slightly to the left ( $\pm 0.5$  degrees).

**Note:** At this point (GPS reading E28.23149 S26.14426) the aircraft heading was 213.8 degrees and it was entering the intersection/junction area of taxiway Bravo and aircraft stand taxilane Mike. The width of Bravo is 30 metres and Mike is 18 metres. The observation here is that the centreline continues straight ahead, but the right-hand edge line is not continuing straight; it decreases at an angle.

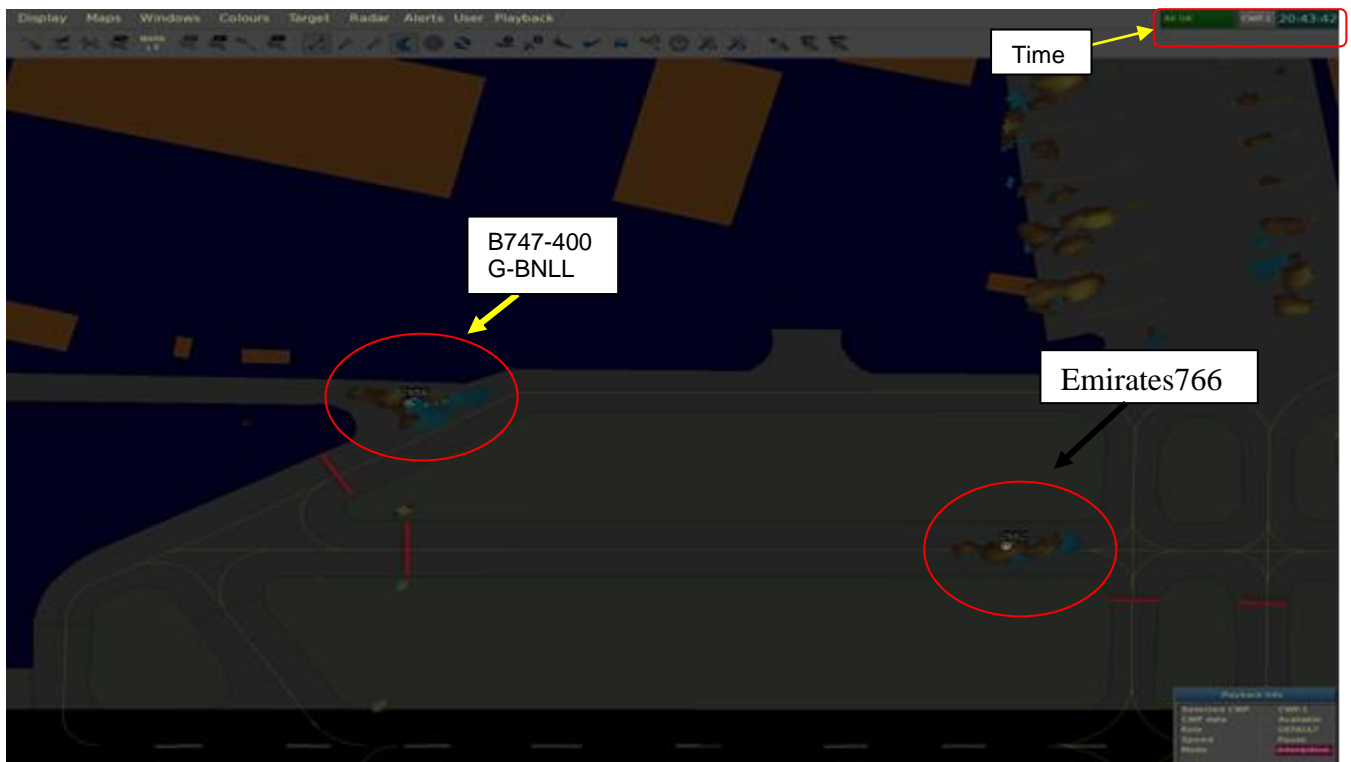
1.11.4.11 The A-SMGCS images below show the sequence of events that followed when the B747-400 aircraft crossed the intersection/junction of Bravo and Mike, intending to go straight ahead.

Figure 32 A-SMGCS image of BA034 proceeding to Mike

Figure 33 A-SMGCS image of BA034 proceeding to Mike

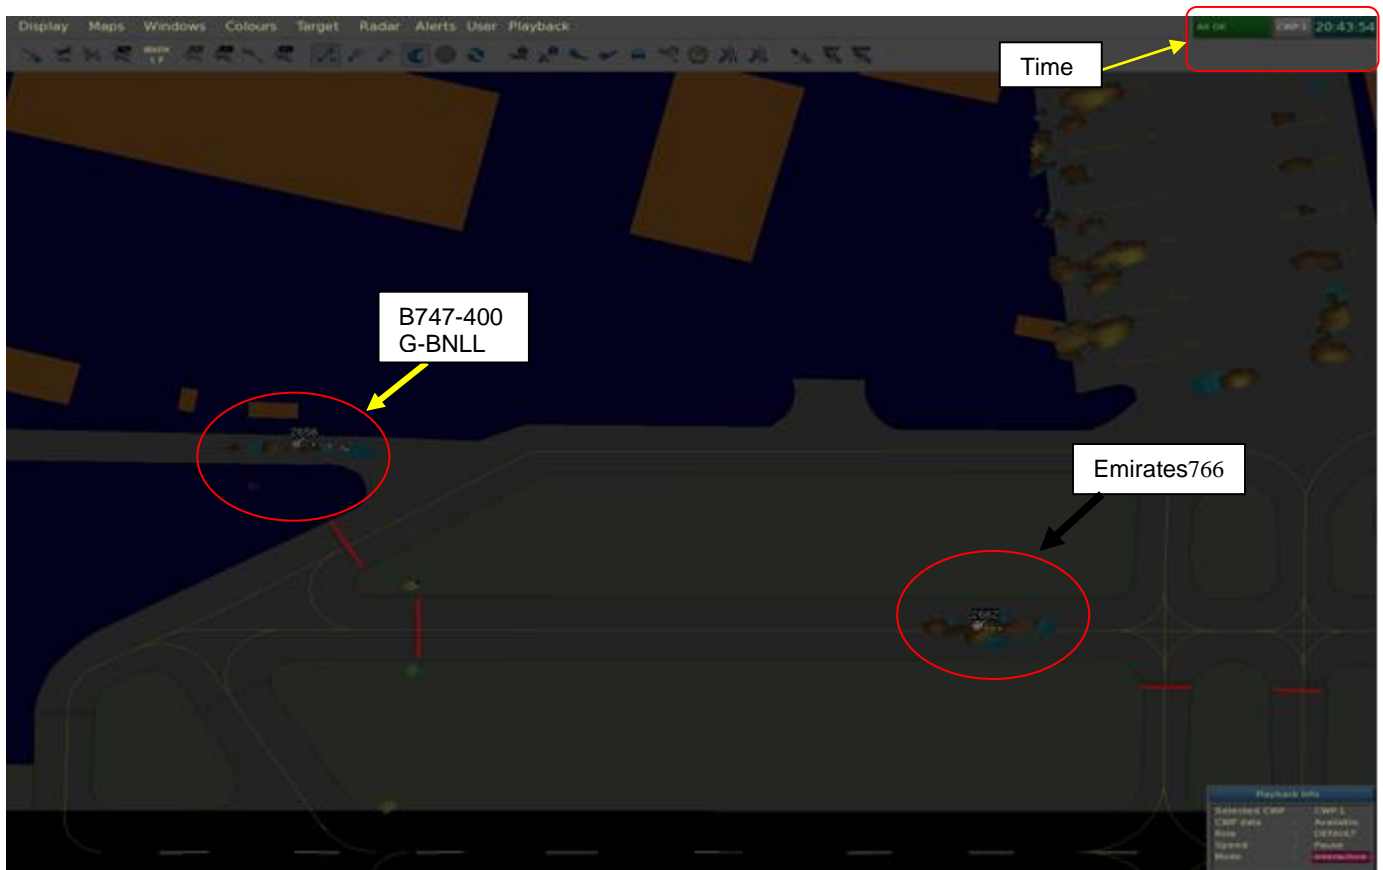
Figure 35 A-SMGCS image of BA034 on Mike
