**KOMITE NASIONAL KESELAMATAN TRANSPORTASI  
REPUBLIC OF INDONESIA**

**Aircraft Accident Investigation Report**

**PT. Trigana Air Service**

**ATR 42-300; PK-YRN**

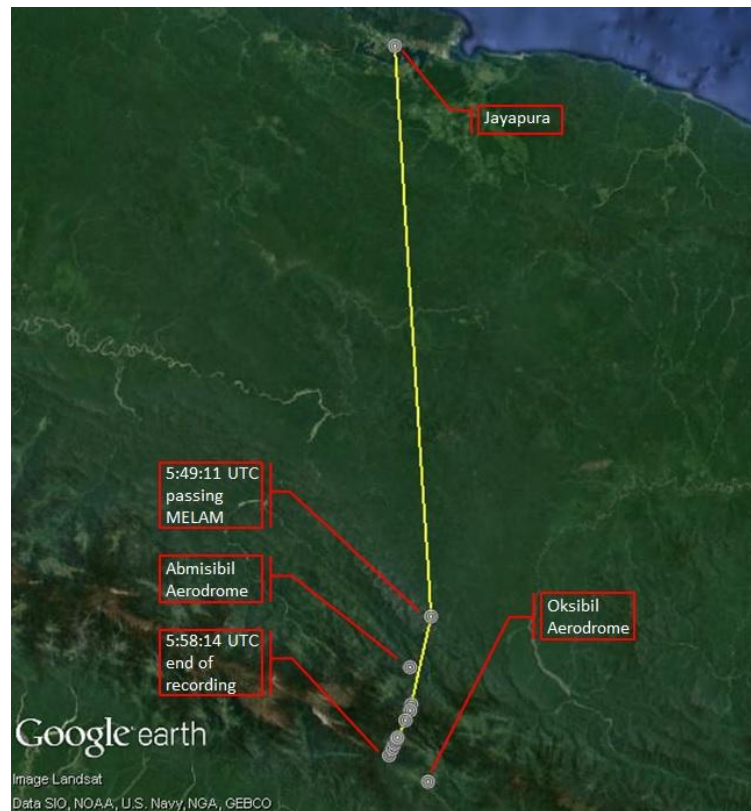
**Figure 15: Predicted flight path from Jayapura to aircraft final position**

Utilizing the Geocontext profiler, Google Earth, CVR data and the operator visual flight guidance, the investigation developed predicted flight path of the aircraft started from flight Jayapura to Oksibil. Assume the cruising speed was 200 knots therefore the figure below is to describe the predicted flight path from Jayapura to Oksibil.

The CVR recorded at 5:49:11 UTC, the aircraft was passing point MELAM and the altitude was approximately 11,500 feet.
