# Aviation Investigation Final Report

<b>Location:</b>	Heyburn, Idaho	<b>Accident Number:</b>	WPR22FA151
<b>Date &amp; Time:</b>	April 13, 2022, 08:32 Local	<b>Registration:</b>	N928JP
<b>Aircraft:</b>	Cessna 208B	<b>Aircraft Damage:</b>	Substantial
<b>Defining Event:</b>	Collision during takeoff/land	<b>Injuries:</b>	1 Fatal
<b>Flight Conducted Under:</b>	Part 135: Air taxi & commuter - Non-scheduled

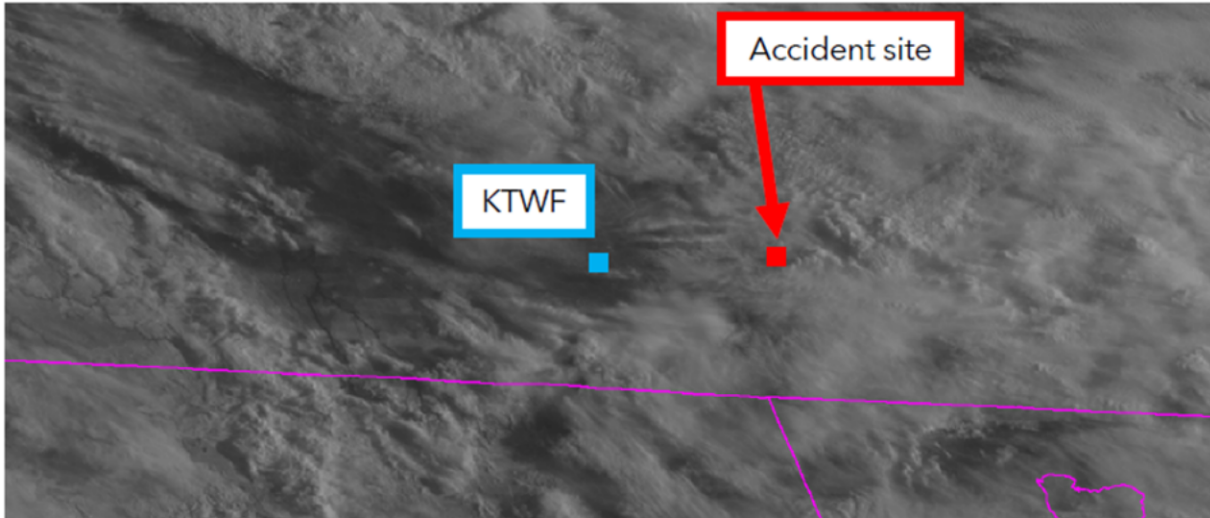
Geostationary Operational Environmental Satellite visible and infrared data were obtained from an archive at the Space Science Engineering Center at the University of Wisconsin-Madison in Madison, Wisconsin, for the period from 0600 MDT through 1200 MDT and reviewed. (Figure 5)

Figure 5. GOES-17 visible image at 0830 MDT at 2X magnification with the accident site highlighted with a red square and cloud cover indicated above the accident site. The cloud cover was moving from west to east with cloud cover remaining over the accident site.

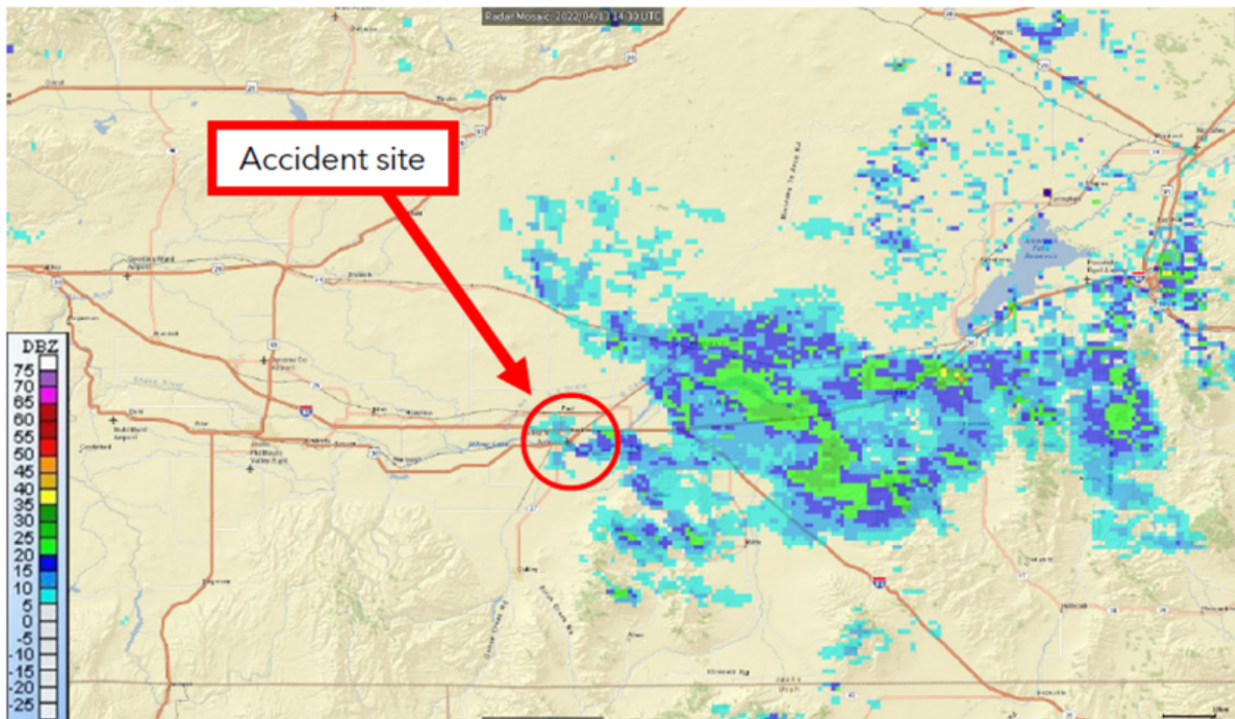
A regional view of the National Weather Service National Reflectivity Mosaic is included as Figure 6 for 0830 MDT with the approximate location of the accident site marked by a red circle. The image depicted 10 to 20 dBZ echoes above the accident site.

Figure 6. National Reflectivity Mosaic for 0830 mdt.
