Crash During Approach to Landing
Empire Airlines Flight 8284
Avions de Transport Régional
Aérospatiale Alenia ATR 42-320, N902FX
Lubbock, Texas
January 27, 2009

**NTSB/AAR-11/02
PB2011-910402**

NTSB/AAR-11/02
PB2011-910402
Notation 8093A
Adopted April 26, 2011

Aircraft Accident Report

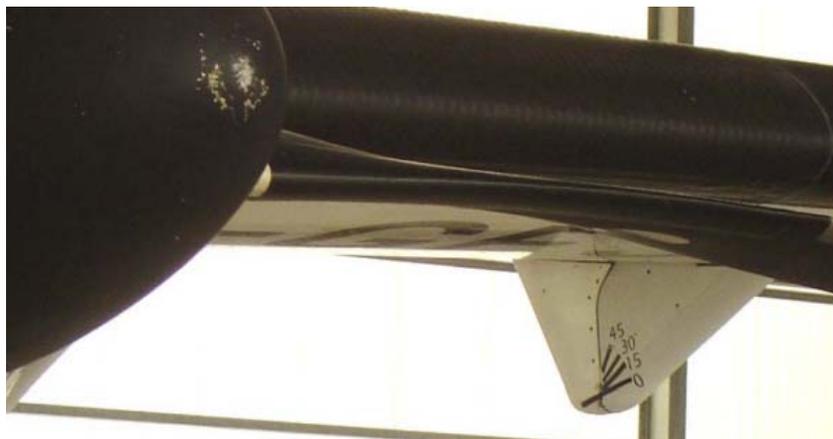
In addition to the cockpit flap position indicator, exterior flap position fairings mounted on the wings (one per wing) are visible to each flight crewmember through their respective side windows. These fairings are also marked with lines and numbers for the four flap positions, providing flight crews with a visual indication of the actual position of each flap. Figure 3 shows the exterior flap position fairing. The wing flap position fairings are illuminated by the wing lights during nighttime use. If a flap asymmetry occurs, the actual positions of the right and left flaps will be indicated on the respective flap position fairings.

Figure 3. Exterior flap position fairing.

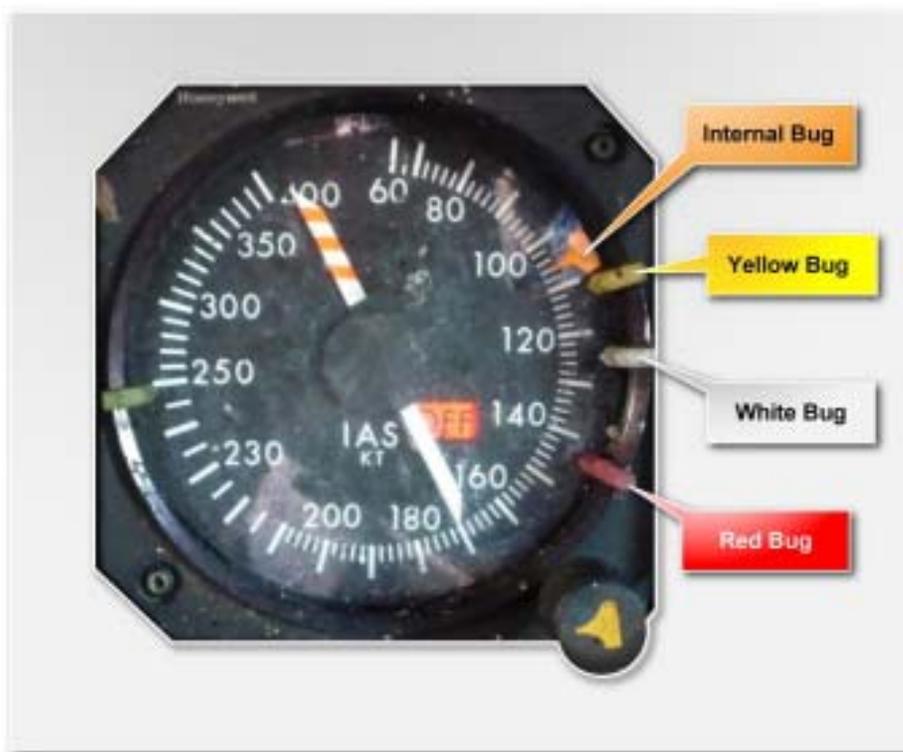
The other three indices, which are located on the outside of the glass face of the airspeed indicator, are color coded for use in referencing certain airspeeds during takeoff or landing and are manually positioned by the pilot. Unlike the internal bug's function, the pilot's positioning of these three indices (yellow, white, and red) does not affect any other systems or displays. The ATR 42 pilot handbook states that, for an approach, the yellow bug should be set to reference V_{ga} , which is the approach airspeed for 30° flaps plus 5 kts (not corrected for wind effect).²⁵ Similarly, the white bug should be set to reference V_{mLB0} normal, which is the minimum airspeed for an approach with 0° flaps in nonicing conditions, and the red bug should be set to reference V_{mLB0} icing, which is the minimum airspeed for an approach with 0° flaps in icing conditions. Figure 4 is an airspeed indicator showing the needle pointer; selector knob; and internal, yellow, white, and red bugs.

Figure 4. Airspeed indicator showing needle pointer; selector knob; and internal, yellow, white, and red bugs.
