Papua New Guinea

Runway overrun
Misima Airport, Papua New Guinea
31 August 2010
P2-TAA
Cessna Aircraft Company Citation C550

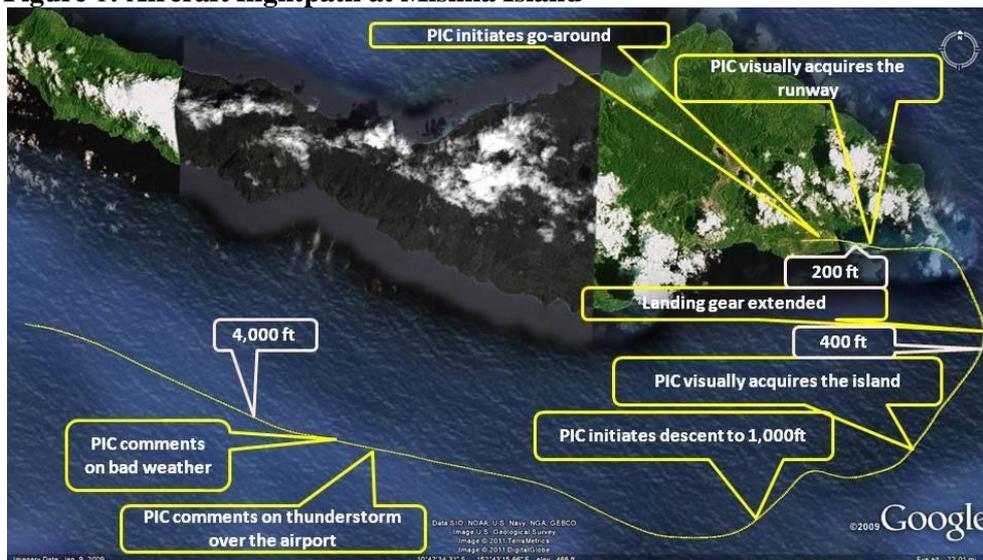
Figure 1: Aircraft flightpath at Misima Island

According to the copilot, the information contained in the PIC's descent and approach briefing was routine in nature. Prior to the top of descent, the PIC indicated his intention to conduct a Global Positioning System (GPS) arrival until obtaining visual reference and then to conduct a visual approach (Figure 1). The copilot reported that there was no discussion about decision heights in case of a missed approach, or of runway decision points in the case of a baulked landing.³ There was also no briefing about contingency planning in case of encountering instrument meteorological conditions during the visual approach.

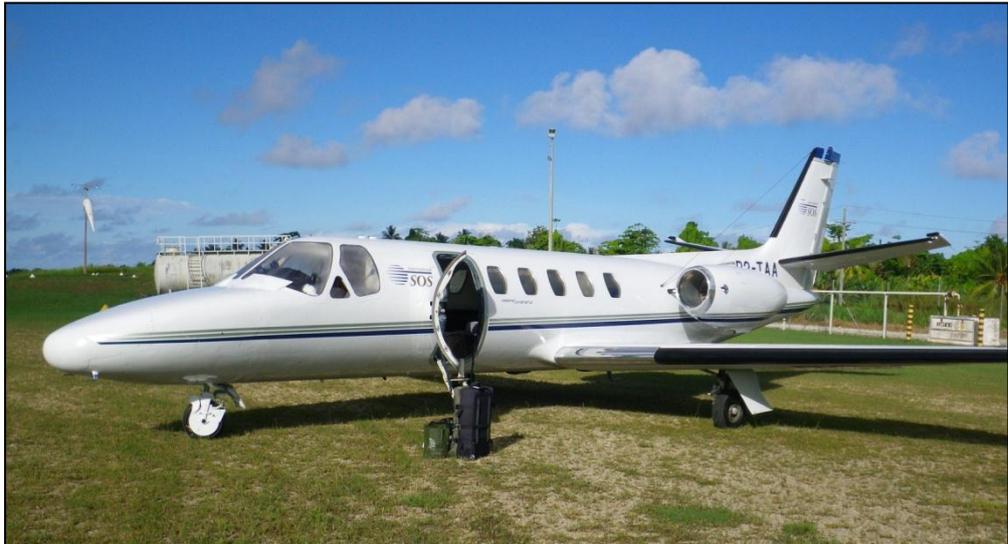
Figure 2: P2-TAA

The aircraft was a pressurised, twin-engine turboprop aircraft that was configured with six passenger seats and a stretcher for medevac operations (Figure 2). Basic aircraft details are summarised in Table 1.

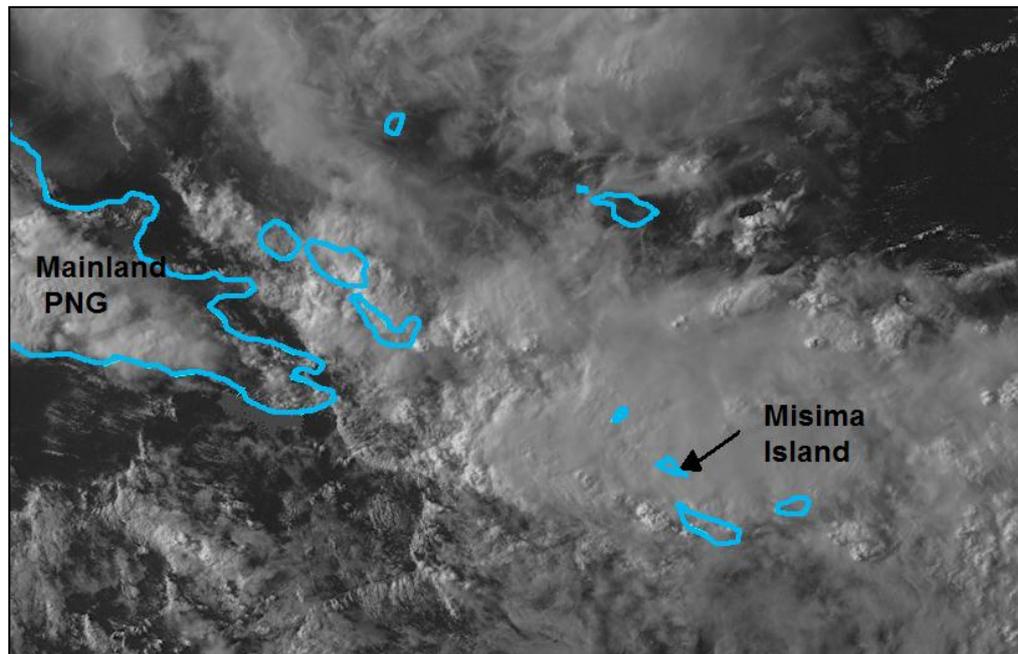
Figure 3: Satellite image

The Australian Bureau of Meteorology (BoM) supplied a satellite image of the region at the time of the accident, which showed cloud cover in the area of Misima Island (Figure 3). The BoM estimated the wind to have been south-easterly to easterly at 15 to 20 kts in the area of Misima Island at that time. Local wind can vary due to the influence of the surrounding topography and/or constructions, passing thunderstorms, and so on.

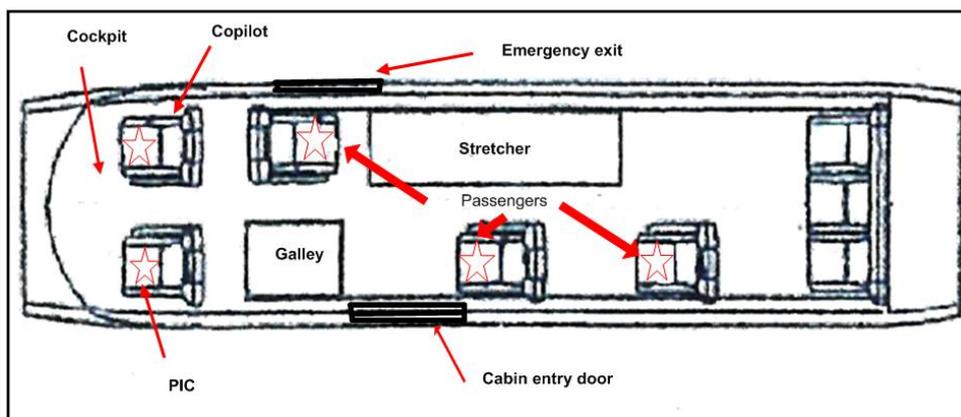
Figure 15: Cabin layout showing occupant seating positions

The aircraft was configured with six passenger seats, two crew seats and a stretcher. The cabin entry door was located just forward of the left wing and an emergency exit was located on the right side, adjacent to the forward right passenger's seating position. The occupant's seating positions for the flight are indicated in Figure 15.

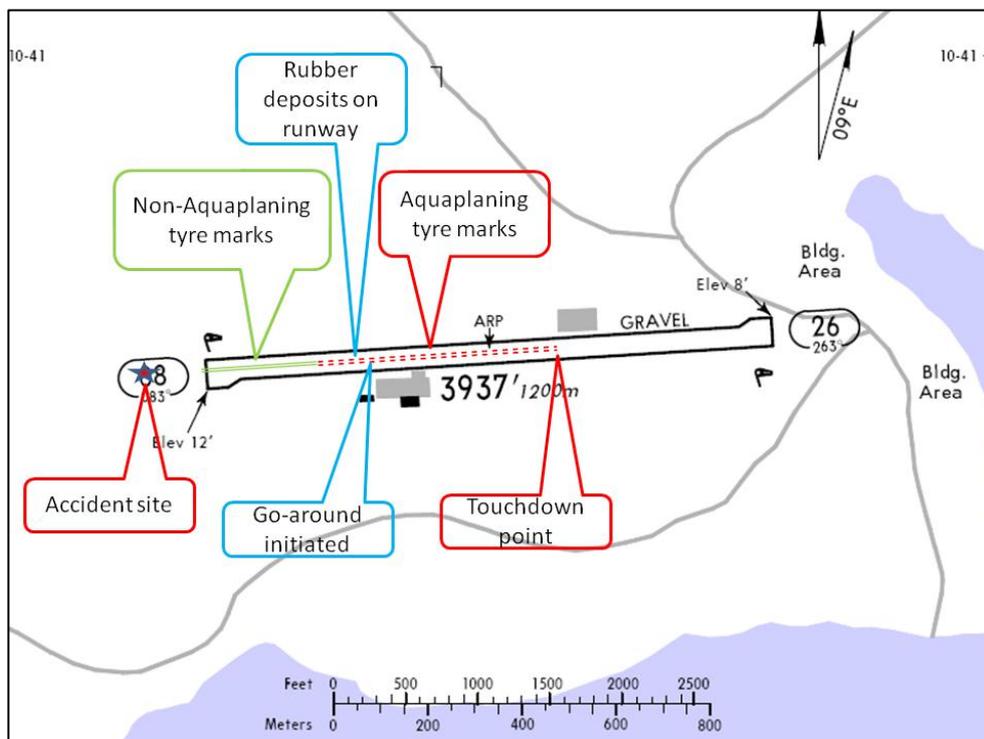
Figure 18: Runway wheel track marks

The dynamic aquaplaning that was experienced after touchdown would have severely compromised the aircraft's braking until established below its aquaplaning speed of about 80 kts, resulting in the use of additional runway to that expected. At that speed, the aircraft would have used about an additional 220 m of runway during the at-test up to 5 seconds taken for the engines to accelerate from idle to full power. With 260 m of runway remaining at that time, the remaining 40 m of runway once established at full power would have been insufficient to allow the aircraft to accelerate to 109 kts and pass over the trees at the end of the runway by at least 35 ft (Figure 18).

The nomination by the PIC of a baulked landing decision point, as routinely applied by the chief pilot, would have increased the likelihood of an early decision to discontinue the landing and, had that decision been made, have avoided the accident. Such decision points have application in all operations to length-limited runways.
