**AVIATION INVESTIGATION REPORT
A12C0005**

LOSS OF CONTROL AND COLLISION WITH TERRAIN

**KEYSTONE AIR SERVICE LIMITED
PIPER PA31-350 NAVAJO CHIEFTAIN, C-GOSU
NORTH SPIRIT LAKE, ONTARIO
10 JANUARY 2012**

Report Number A12C0005

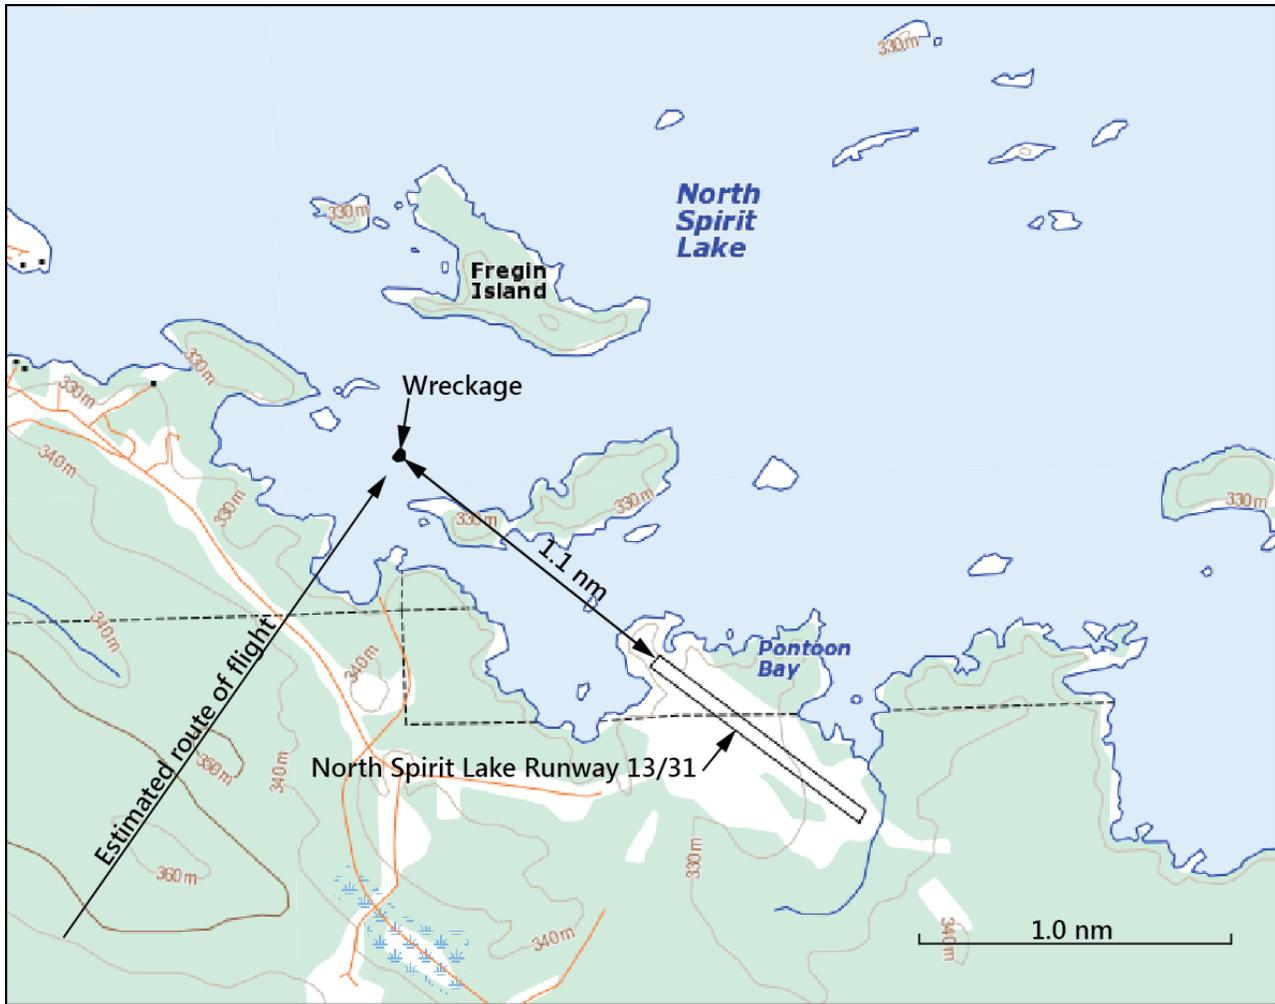
Figure 1. Wreckage location

Ice was accumulating on the aircraft's windshield during the delay. The pilot called again several minutes later to ask whether snow clearing was completed. The airport foreman advised the pilot that approximately 60% of the runway had been cleared and that the equipment was in the process of exiting the runway. The pilot commenced the approach. During the approach, the aircraft banked to the left and then steeply to the right, and then struck the ice at about 0957 (Figure 1).

TSB investigators arrived on scene approximately 26 hours after the accident. The aircraft struck the frozen surface of the lake in a right-wing-low attitude at both a high rate of descent and forward speed. Contents of the aircraft, such as baggage and cargo, were found strewn halfway up the wreckage trail, indicating an early breakup of the cockpit and cabin area. The wreckage trail was generally aligned with the extended centreline of the runway. It was approximately 380 feet long, and the aircraft had come to a rest in an upright position, facing a southeasterly direction (Photo 1). Damage to the propellers suggests that the engines were producing power at the time of the impact. A post-impact fire consumed a majority of the aircraft.
