Collision with water – Aero Commander 500S VH-WZU

26 km north-north-west of Horn Island, Queensland | 24 February 2011

ATSB Transport Safety Report
Aviation Occurrence Investigation
AO-2011-033
Final

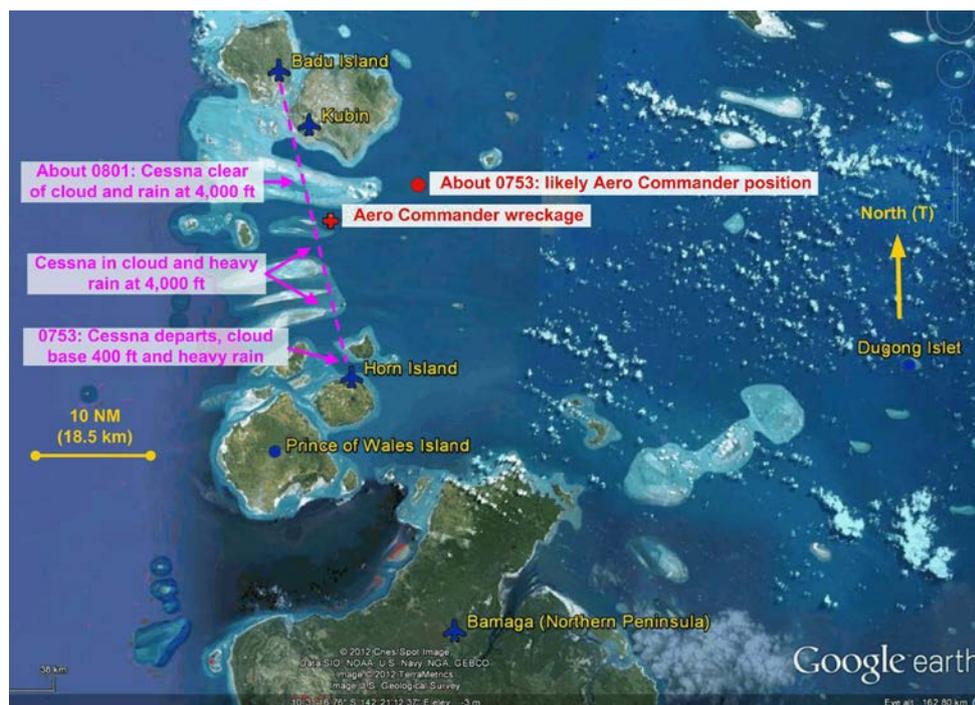
Figure 2: Location of the wreckage

On about 10 October 2011, a crayfish diver located aircraft wreckage on the seabed 14 NM (26 km) north-north-west of Horn Island in about 15 m of water (Figure 2), and he reported the matter to police on 20 October. Due to weather conditions and local tides, a police dive team was unable to examine the site for several weeks. On 12 November 2011, police divers confirmed that the aircraft was the missing Aero Commander. They found no evidence of the pilot.
