Accident Report

7th October 2012
V.C, Bird International Airport, Antigua (TAPA)
Britten-Norman BN2A-26
Registration VP-MON
Montserrat Airways Limited doing business as
Fly Montserrat

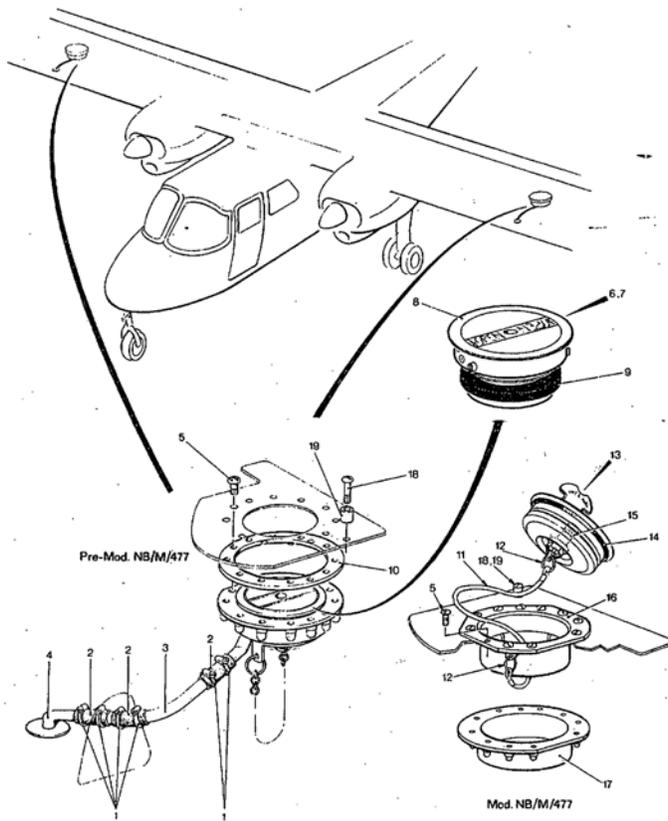
Figure 6
Fuel filler cap details

March 1971 saw the introduction of Modification NB/M/477. This was a simplified design, manufactured by Shaw Aero Devices, which incorporated a shallower cap that fitted into an 'adapter ring' in the wing skin. The design deleted the rainwater drain and relied on an 'O' ring seal close to the top of the cap to keep rainwater out. A recessed tab in the top of the cap, when rotated, operated three tangs that extended beneath the attachment ring at the base of the filler neck, thus securing the cap in position. The spindle on which the tab rotated incorporated an adjustable spring mechanism that governed the tension of the cap when in position, such that a higher tension caused a higher contact pressure between the seal and the adapter plate. Figure 6, from the Illustrated Parts Catalogue (IPC) shows the salient details of both filler cap types, with Figure 7 showing the modified cap in greater detail. Both filler cap types were attached to the filler necks by a chain or lanyard.

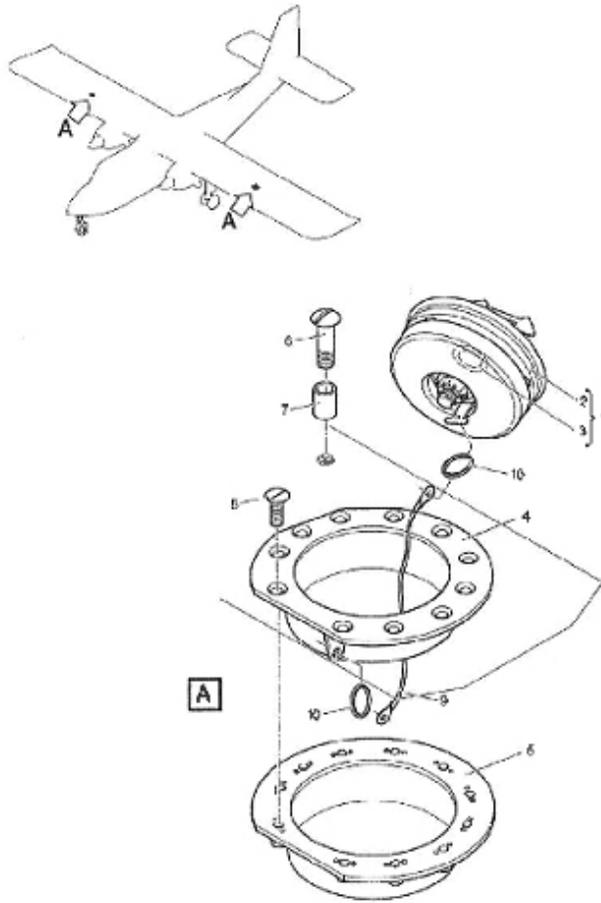
Figure 7
Additional details of Modification NB/M/477

The modification was offered as a customer option but was not installed at build until the introduction of the BN-2B Islander series in 1978. This production change may have been influenced by the fact that the King Aircraft components were no longer available. On those aircraft that were modified in service it was not necessary to physically remove the circular channel at the base of the filler neck. However, it was necessary to blank off the pipe that drained the channel at the point where it passed through the tank wall.
