*This document is an English translation of the Final Report on the fatal accident involving the Falcon 50EX aircraft registered F-GLSA that occurred on October 20, 2014 at Vnukovo Airport, Moscow.*

## **INTERSTATE AVIATION COMMITTEE**

### **AIR ACCIDENT INVESTIGATION COMMISSION**

#### **FINAL REPORT**

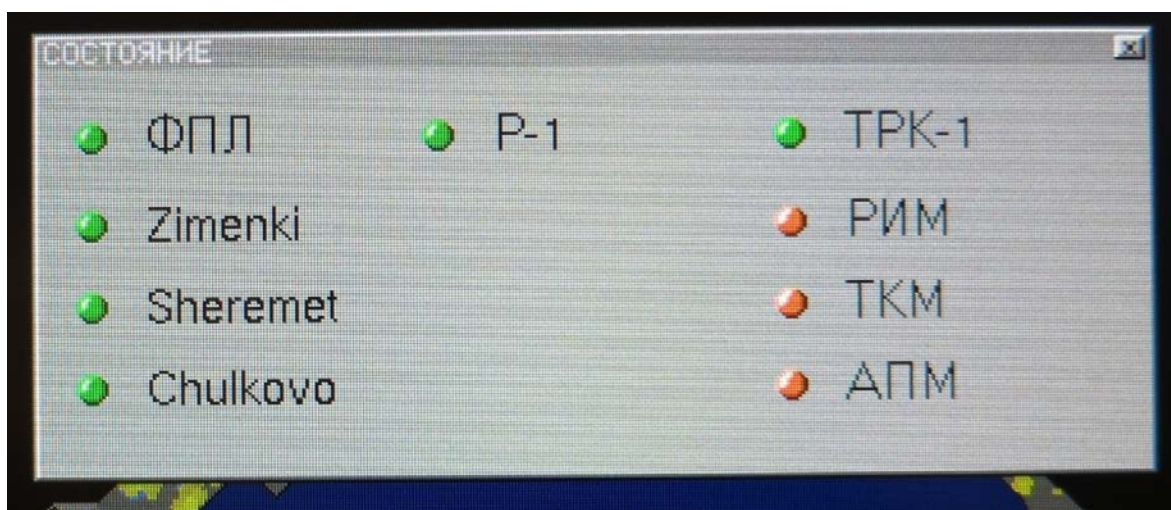
Figure 9. System Status Window at Ground Controller Working Position

1. No RIM, TCM or APM alert monitoring on (Figure 9).

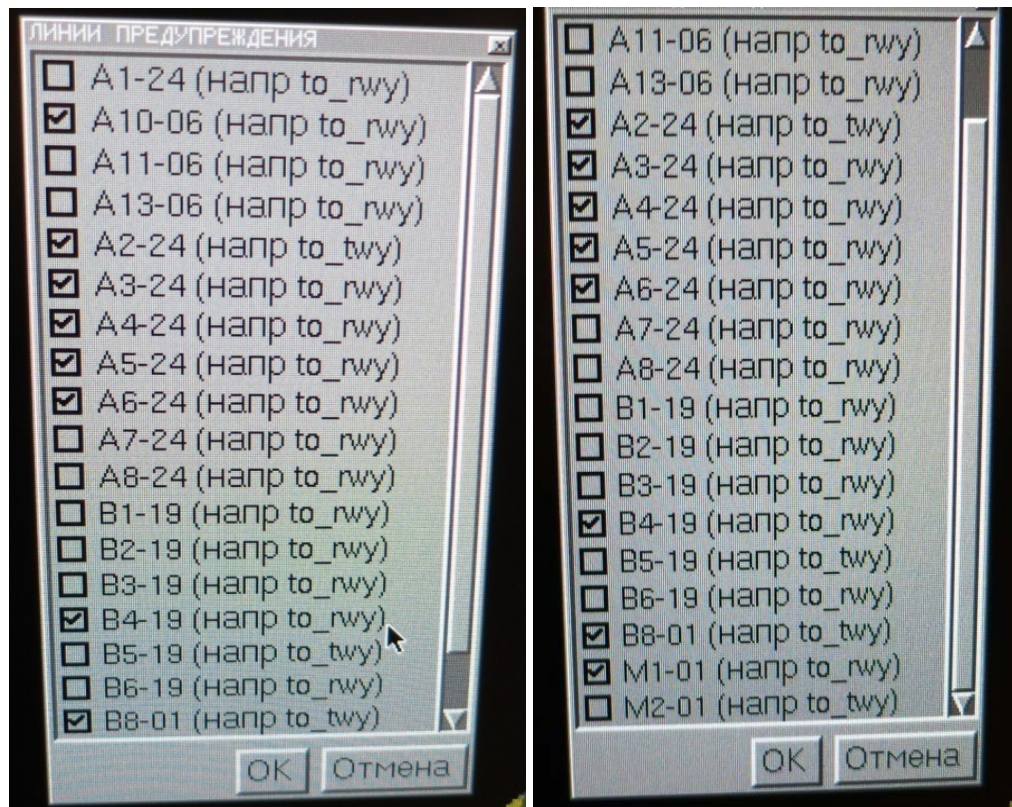
Figure 10. Reserved Lines (ticked lines are activated) at Ground Controller WP

Not activated were the following reserved lines: A1-24 (to-RWY)<sup>16</sup>, A11-06 (to-RWY), A13-06 (to-RWY), A7-24 (to-RWY), A8-24 (to-RWY), B1-19 (to-RWY), B2-19 (to-RWY), B3-19 (to-RWY), B5-19 (to-RWY), B6-19 (to-RWY) and M2-01(to-RWY).

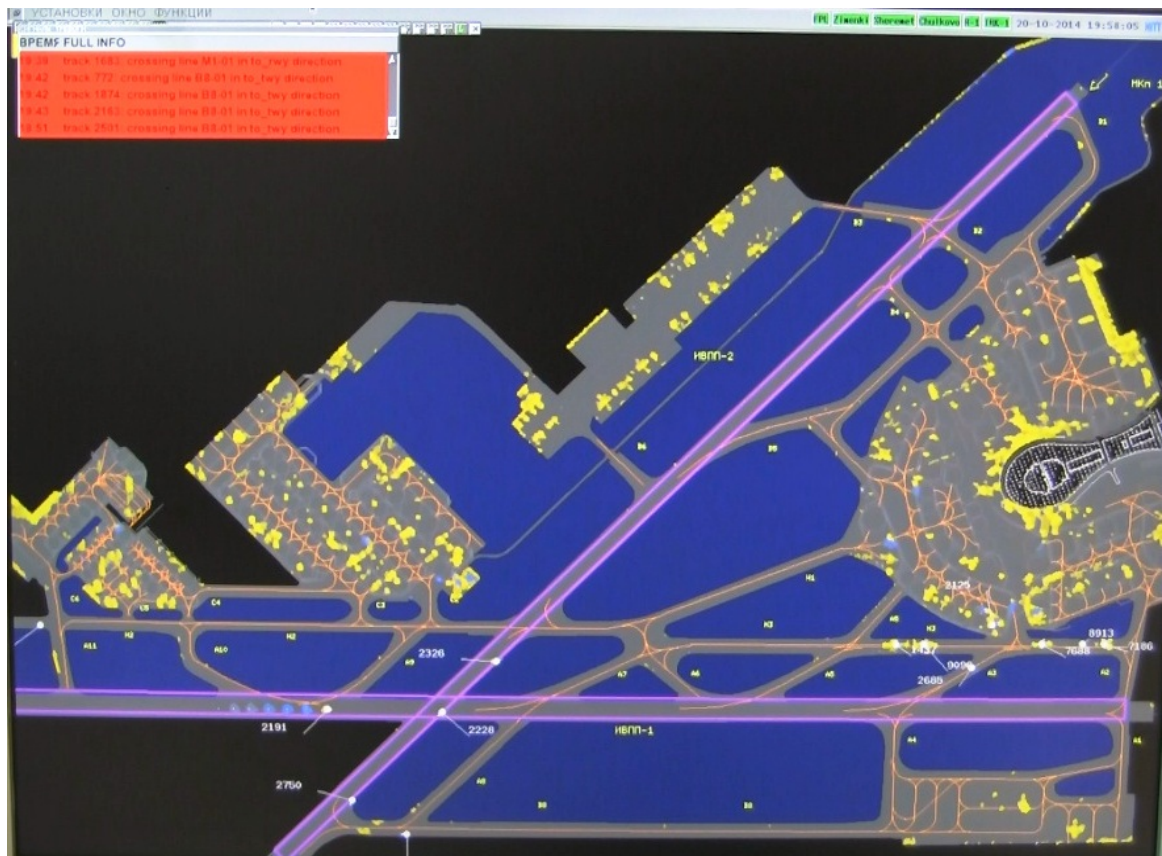
Figure 14. TRADIS indicator on ground controller's working position before the accident

4. The status of system technical charts is shown in Figure 12. The charts are not activated. Thus, though the Reserved Lines were on (alert messages appearing) but their indication on the screen was disengaged.

The indicator does not show the Reserved Lines as the system technical charts were deactivated.

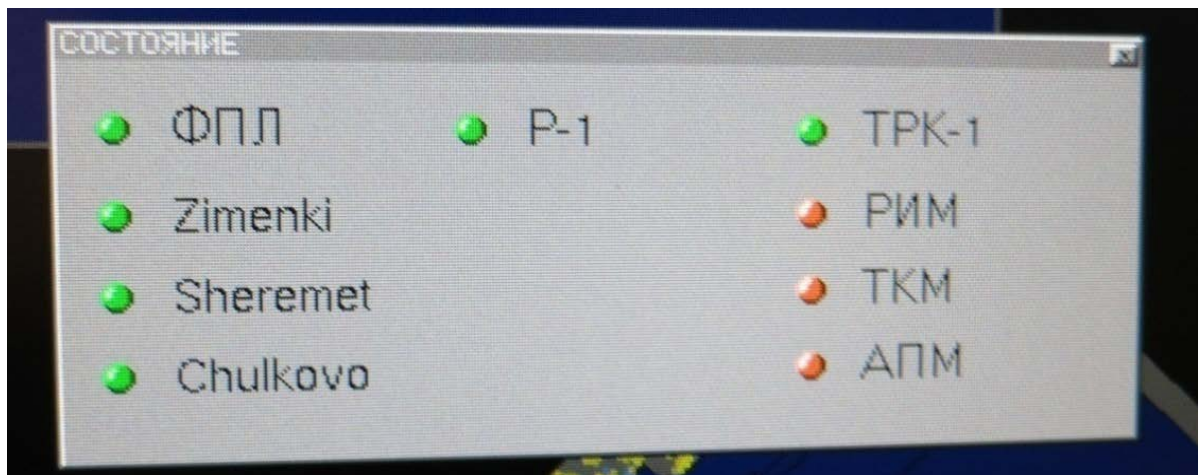
Figure 15. System Status Window at Departure ATS and Departure ATC working positions

1. RIM, TCM or APM alert monitoring off (Figure 15).

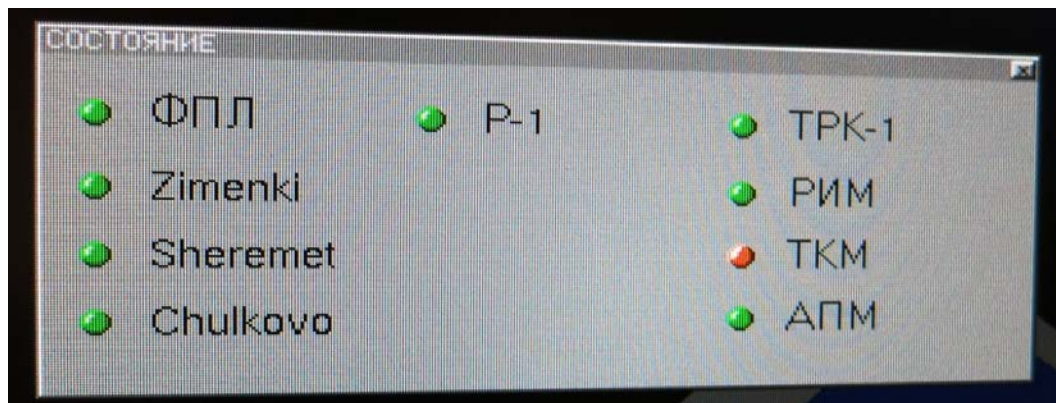
Figure 20. System Status Window at Supervisor WP

1. TCM alert monitoring off, RIM and APM alert monitoring on (Figure 20).

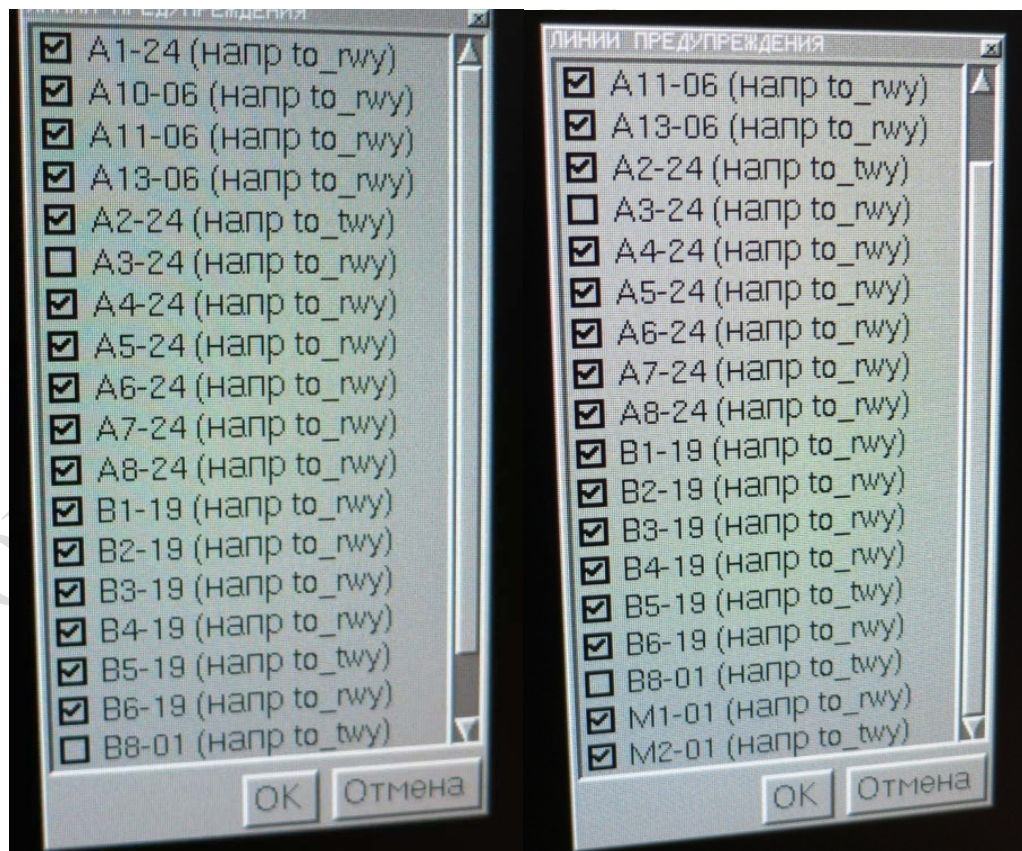
Figure 21. Reserved Lines at Supervisor WP (ticked lines are activated)

Not activated were the following reserved lines: A3-24 (To-RWY) and B8-01 (To-RWY).

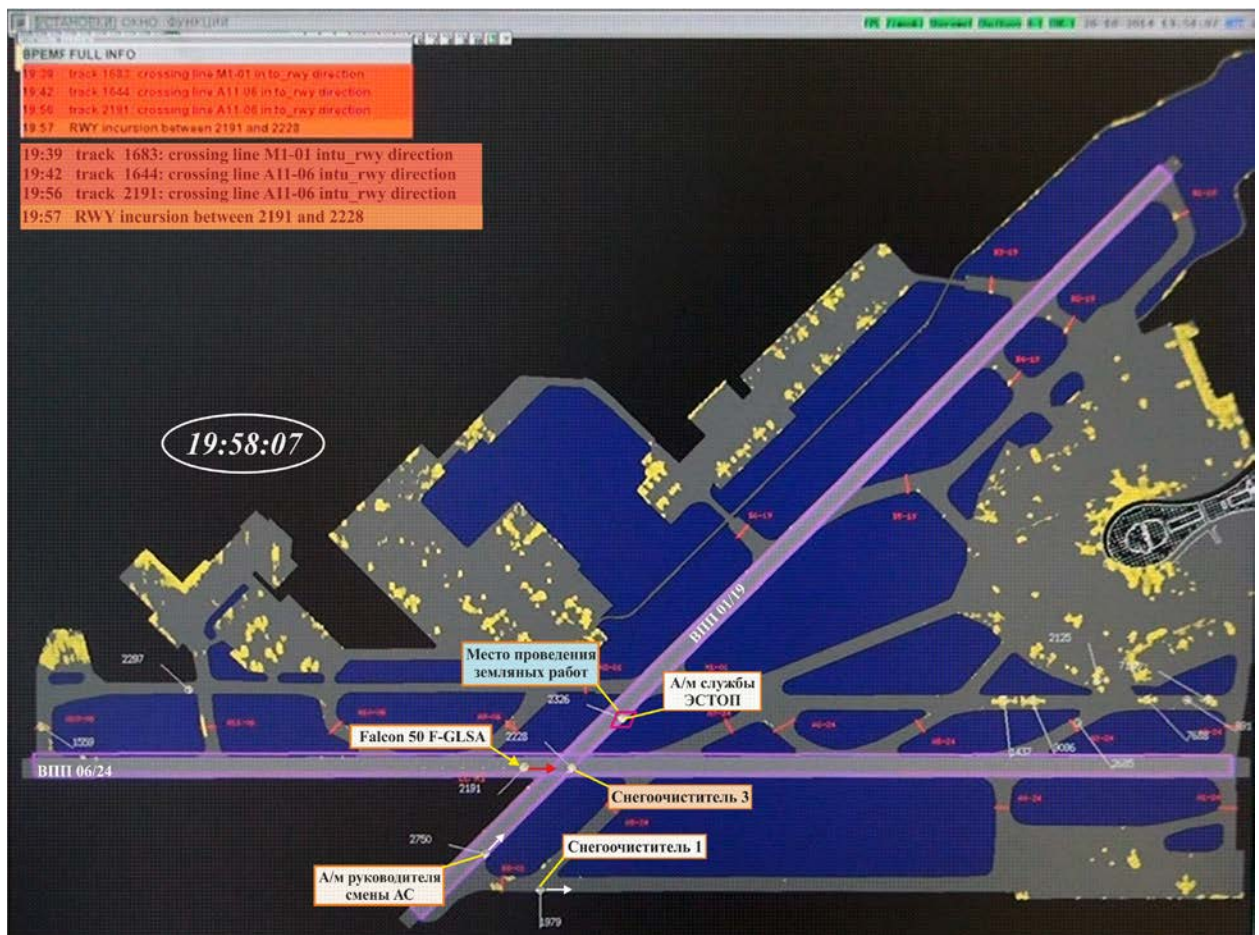
Figure 24. TRADIS indicator on supervisor's working position before the accident

The indicator shows alerts of Reserved Lines crossing:

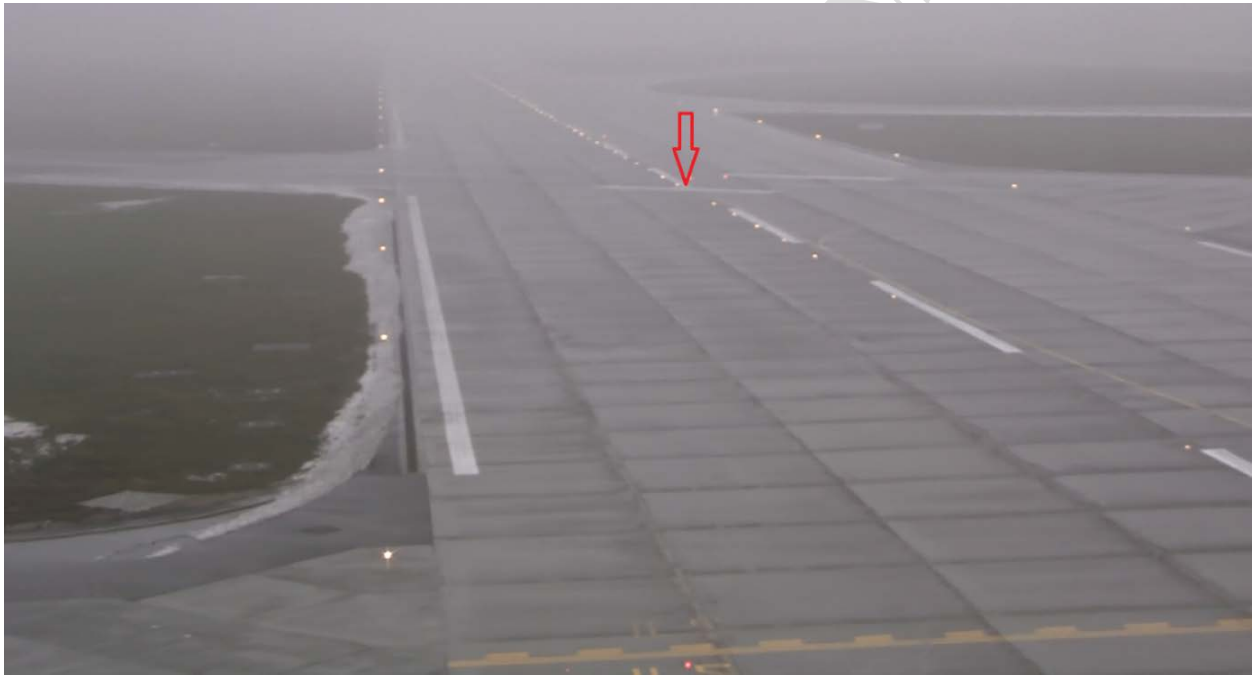
Figure 29. Crossing of RWY 1 and RWY 2 (marked by arrow) (picture taken along RWY 24)

The aircraft collided with the snowplow 3 SUPRA 5001, garage number 377 at the crossing of RWY 1 and RWY 2 at a point with the following coordinates: N 55°35'29.66", E 37°15'41.12" (Figure 29).

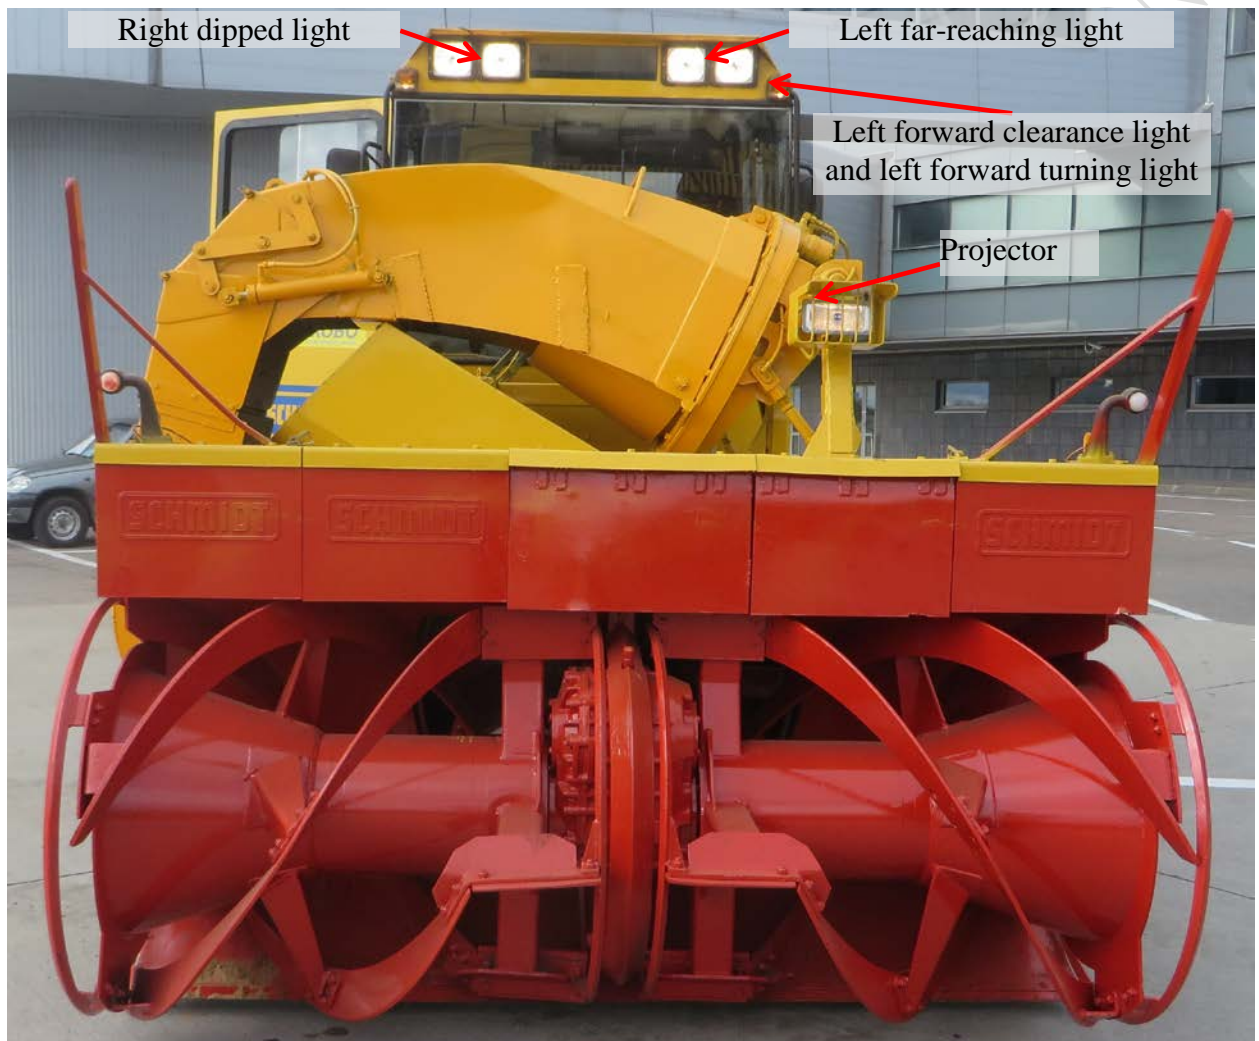
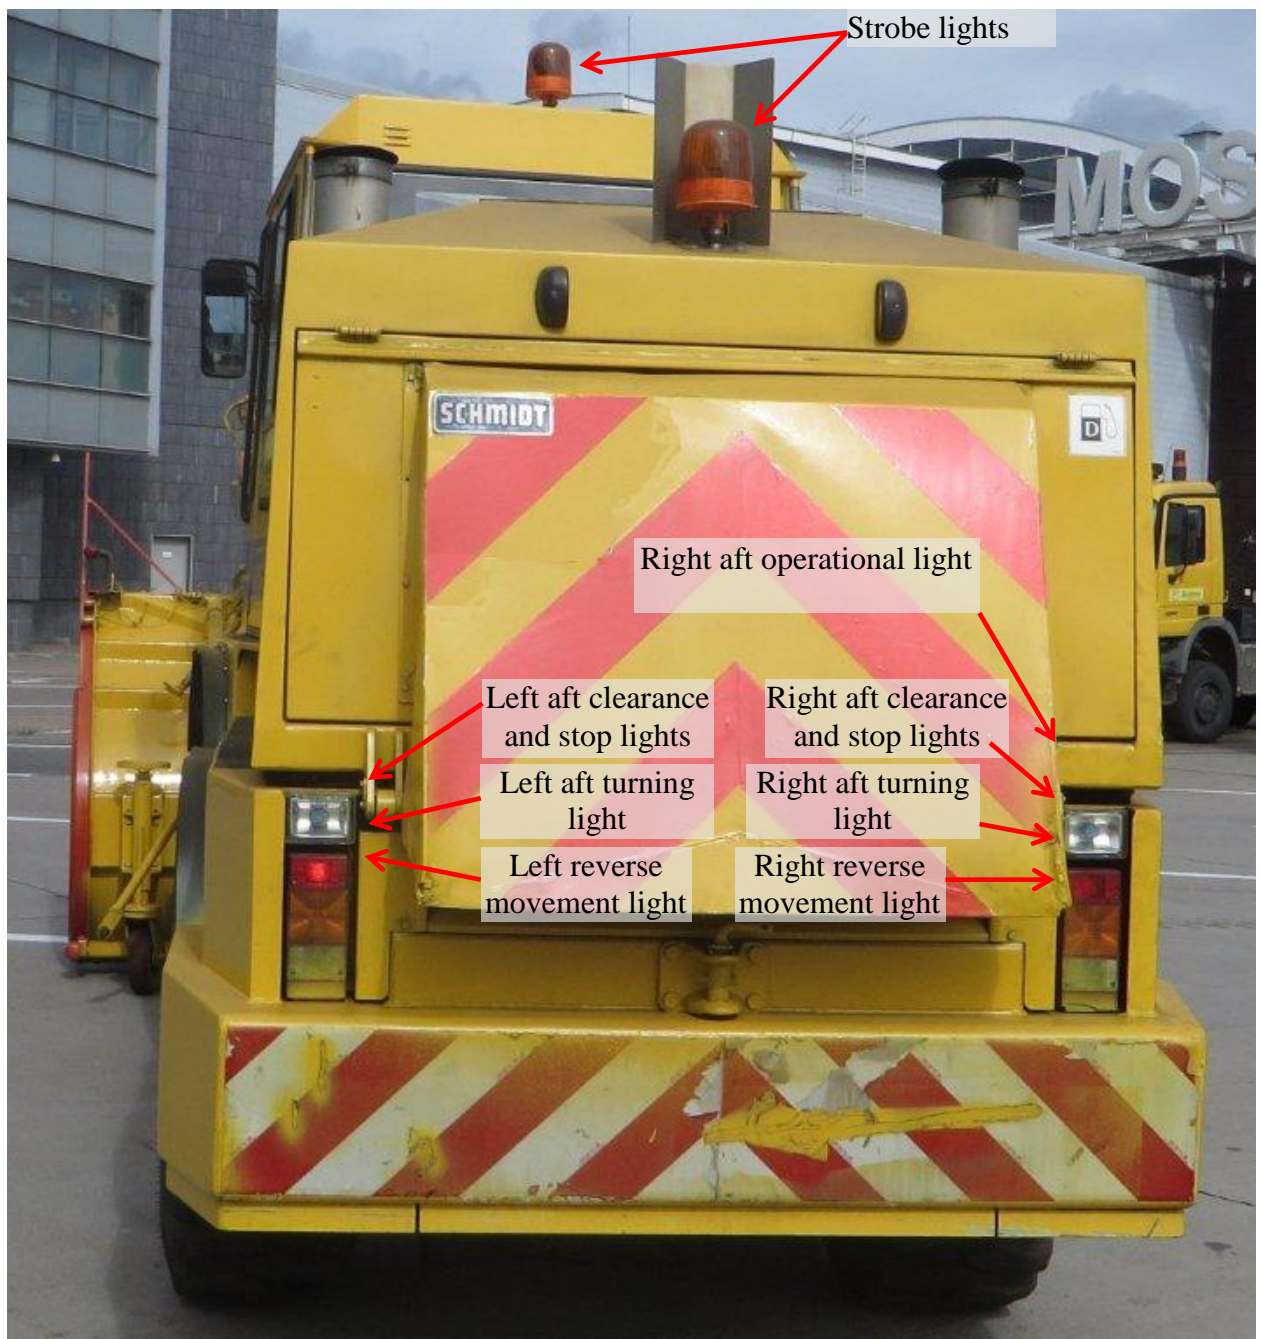
the time of its collision with the Falcon 50EX F-GLSA aircraft, the snowplow lights (Figure 46b and Figure 46c) were in the following condition:

- strobe light, right dipped headlight and left far-reaching headlight, left aft clearance and stop light, left forward clearance light and aft operational light were lit;
- projector light, right and left reverse movement lights, left and right turning lights, right aft clearance and stop lights, and aft operational light bulbs did not reveal any signs of filament destruction or being under voltage.

Other lights were missing.

Figure 46b. Snowplow lights schematic (forward)

Figure 46c. Snowplow lights schematic (aft)

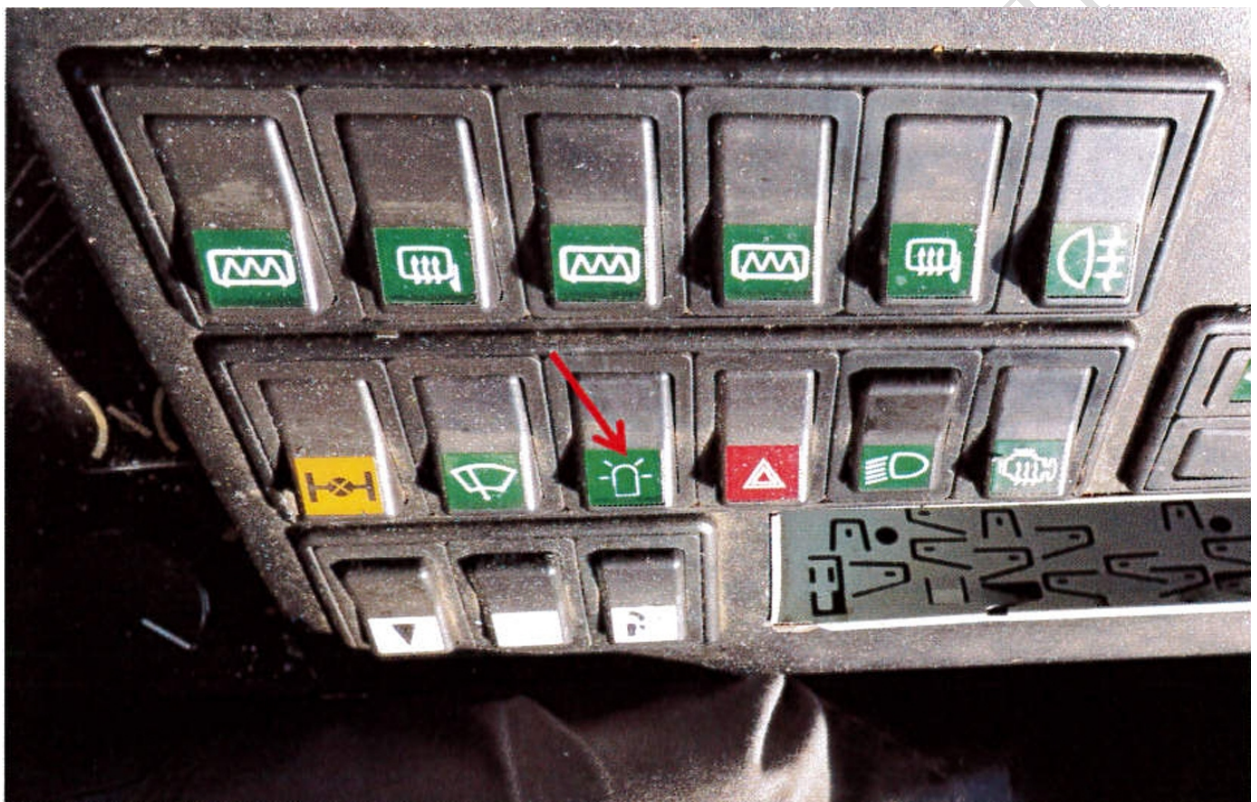
Figure 53. Strobe lights activation switch (marked with an arrow) on the cab control panel in the SCHMIDT SUPRA-5001, state number 377

Notes: amber strobe lights installed (Figure 53).

The strobes activation switch is mounted in the snowplow driver's cab.

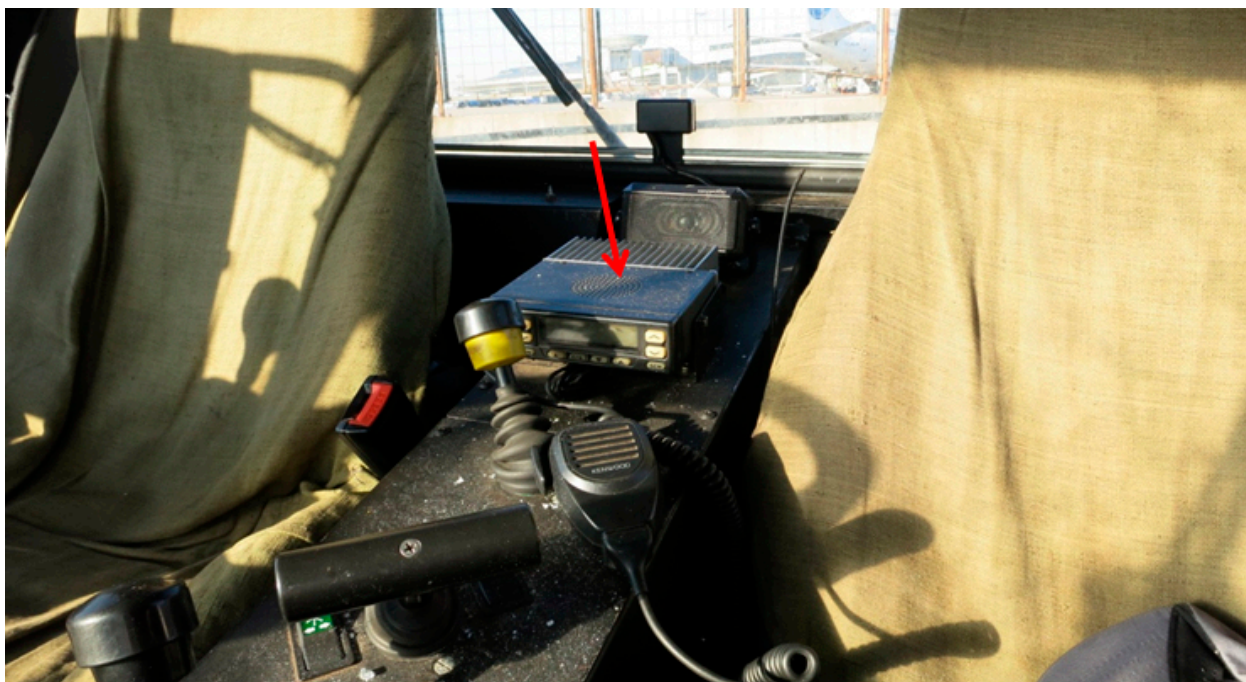
Figure 54. Kenwood radio station in the cab of SCHMIDT SUPRA-5001, state number 377 (marked by the arrow)

As per Para 11.3 of the Airdrome Service and Vnukovo ATC Center Interaction Procedure the drivers of airdrome vehicles shall be constantly listening to the radio exchange on the Departure Control frequency. However, airdrome vehicles including snowplow 3 were not fitted with relative equipment.

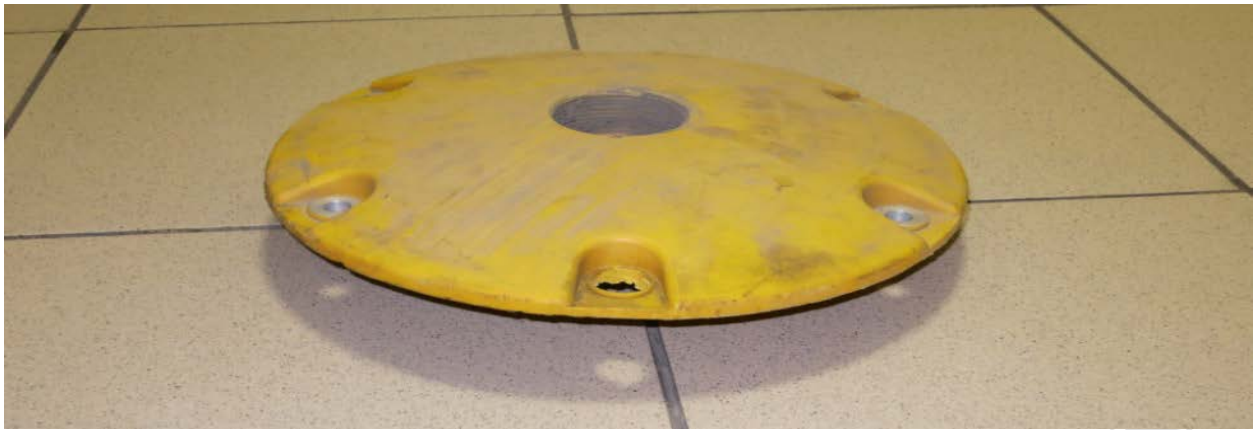
Figure 58. Fragment of runway light (basement)

While operating on the right side of RWY 2, driver of snowplow 1 detected a fragment (basement) of the runway light (Figure 58). The driver reported the runway light fragment detection via radio to the airdrome service shift supervisor. The path of vehicles movement before the runway light was detected is shown in Figure 59.

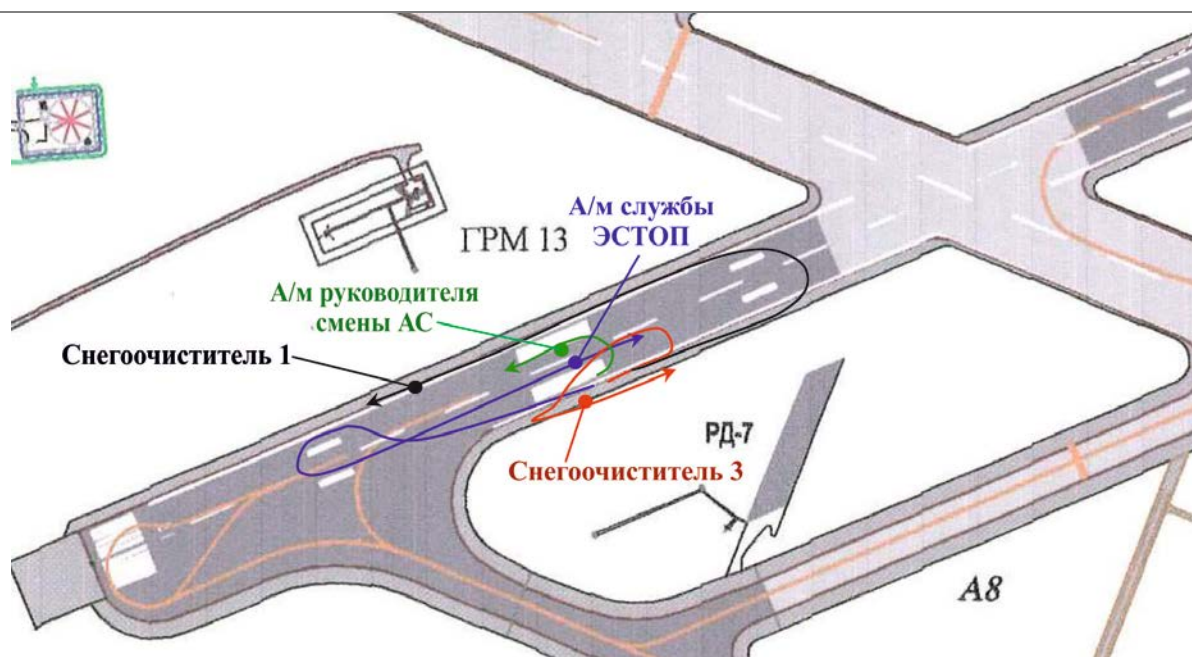
Figure 65. Paths of airdrome service vehicles and electrical and lighting service car

At 19:53:33 without reaching the big crossing the airdrome vehicles started turning left. The vehicles traffic pattern is shown in Figure 65.

Having analyzed the path of snowplow 3 after the turn (at 19:53:33) it can be assumed that after turning towards threshold 01 of RWY 2 snowplow 3 driver lost situational awareness completely as the following movement of his vehicle (Figure 65) could not be explained from a logical point of view:

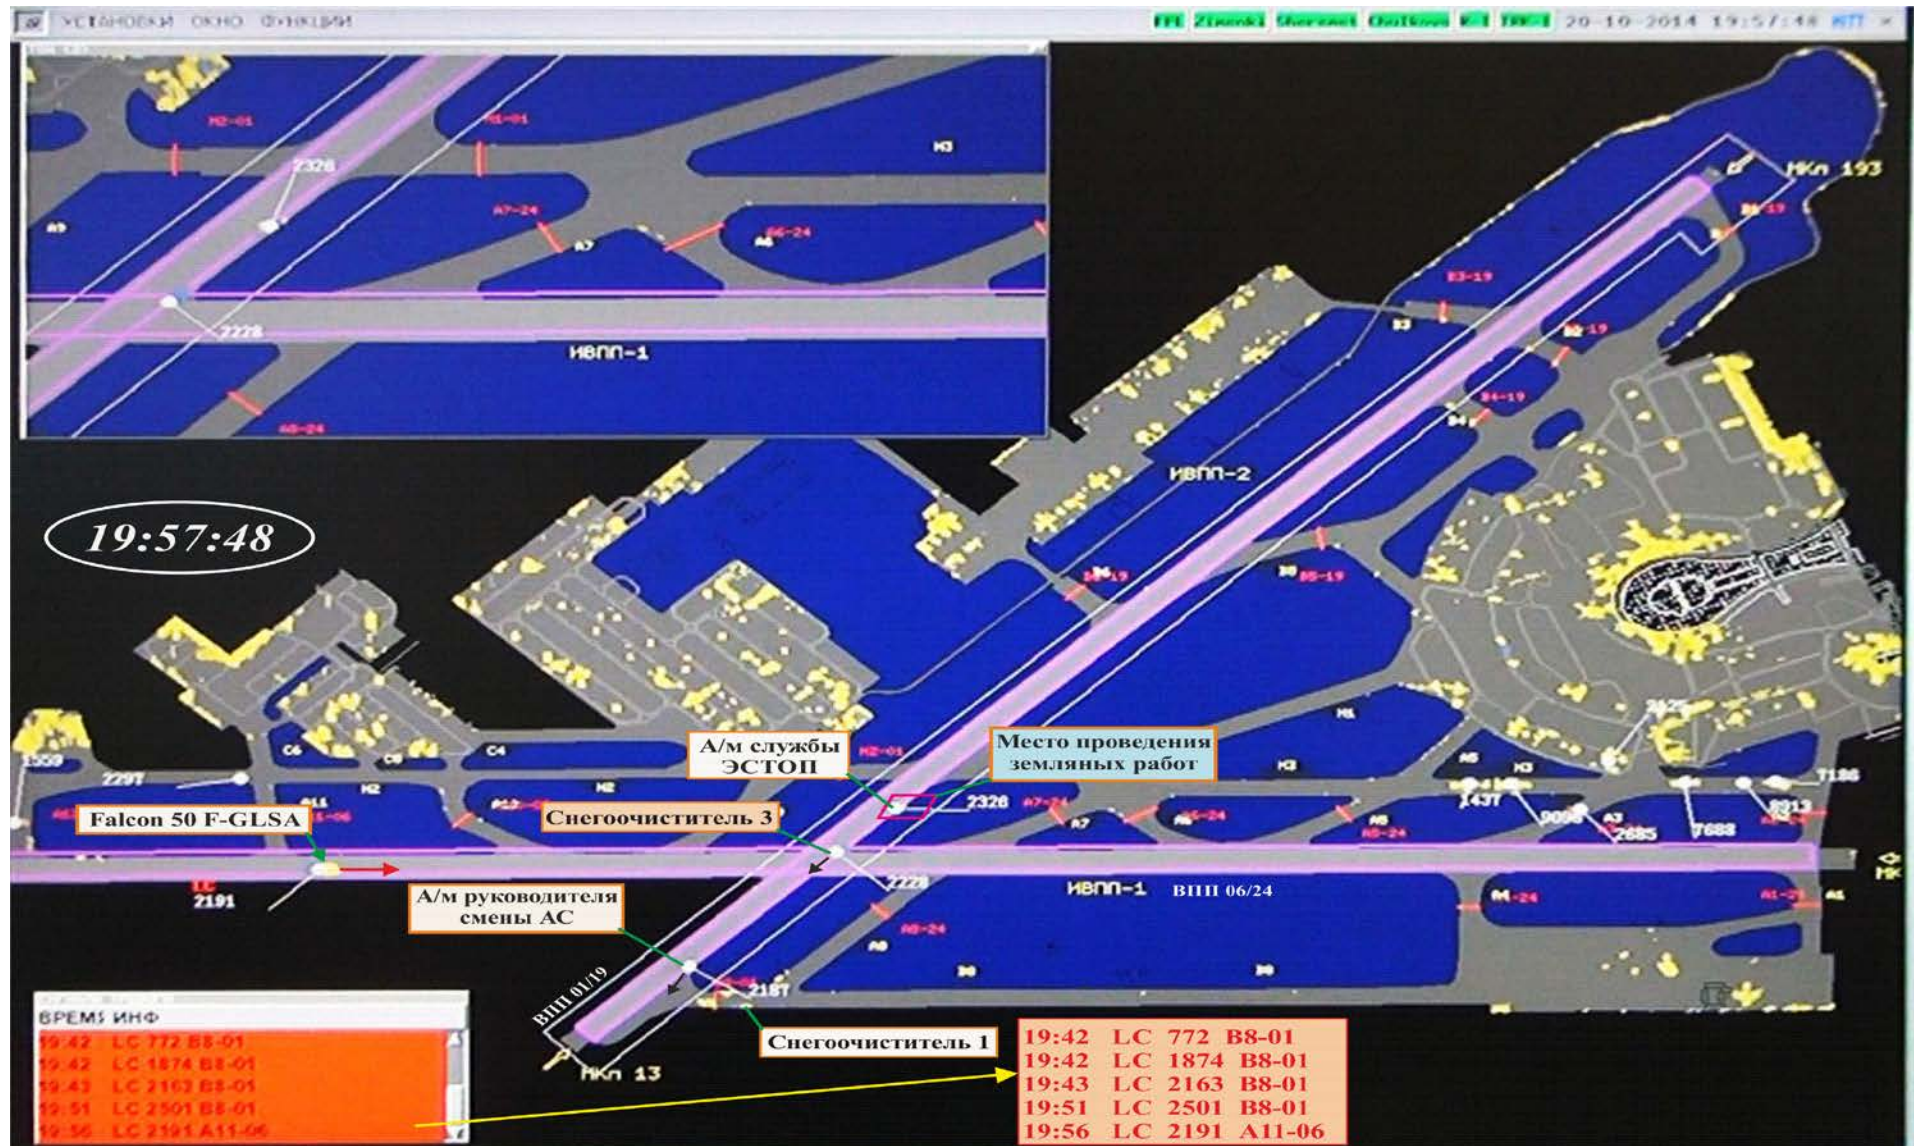
Figure 76. Location of objects at airdrome Vnukovo as viewed from the departure controller screen at 19:57:48

In the course of the takeoff roll snowplow 3, at 19:57:48, at a speed of approximately 20 km/h, without the request and without being cleared by the departure controller, started crossing RWY 1 (Figure 76). By that time the airfield surveillance and control subsystem A3000 had assigned track number 2228 to snowplow 3 and it was already identified with that number at controllers' working positions.

At 19:57:49, after the start of the takeoff roll, snowplow 3 having been identified as track 2228, with the RIM mode activated (see Section 1.8.2.1) a Pre-Alert was shown on the ATC shift supervisor's position followed by an Alert a second later. The ATC shift supervisor's monitor (if radar information was being displayed) should have shown respective messages (see below for details). The RIM mode was deactivated on the working positions of the Ground and Departure controllers.

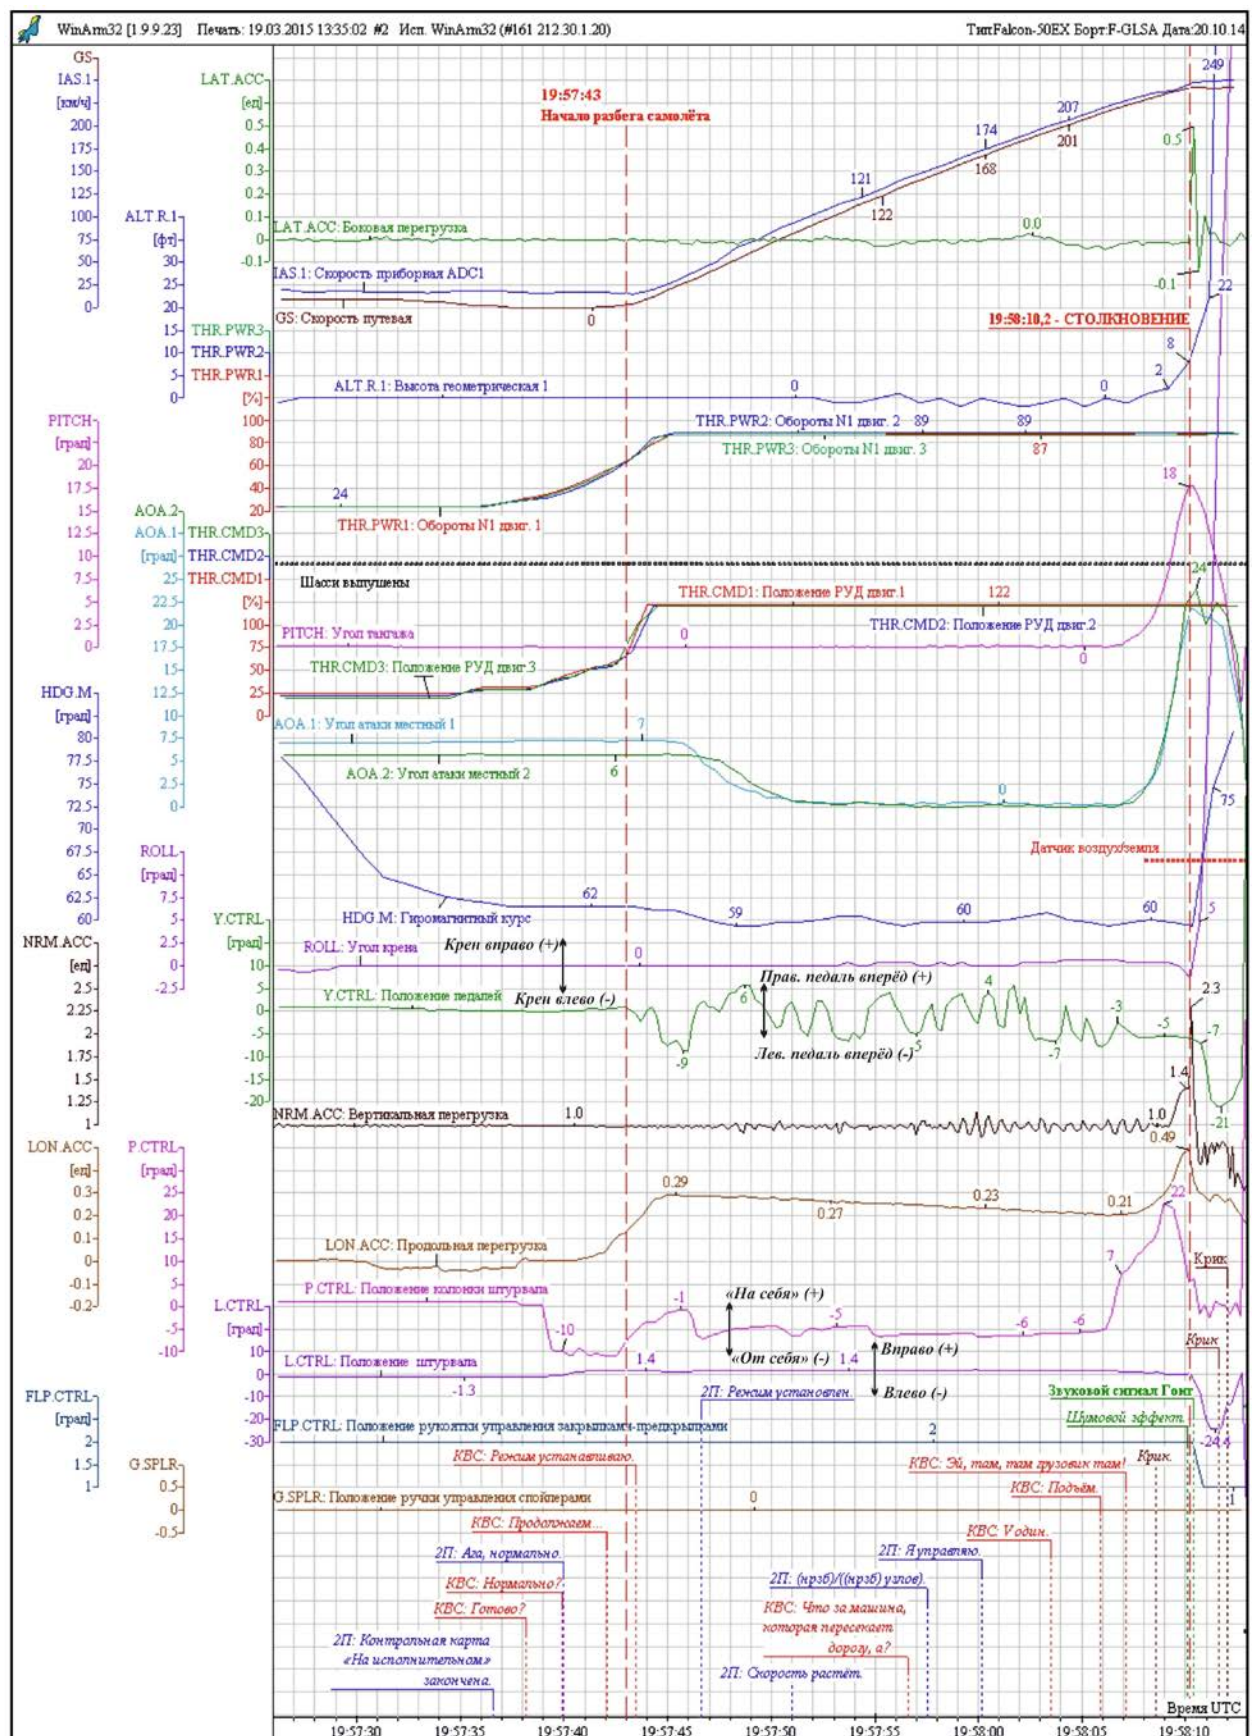
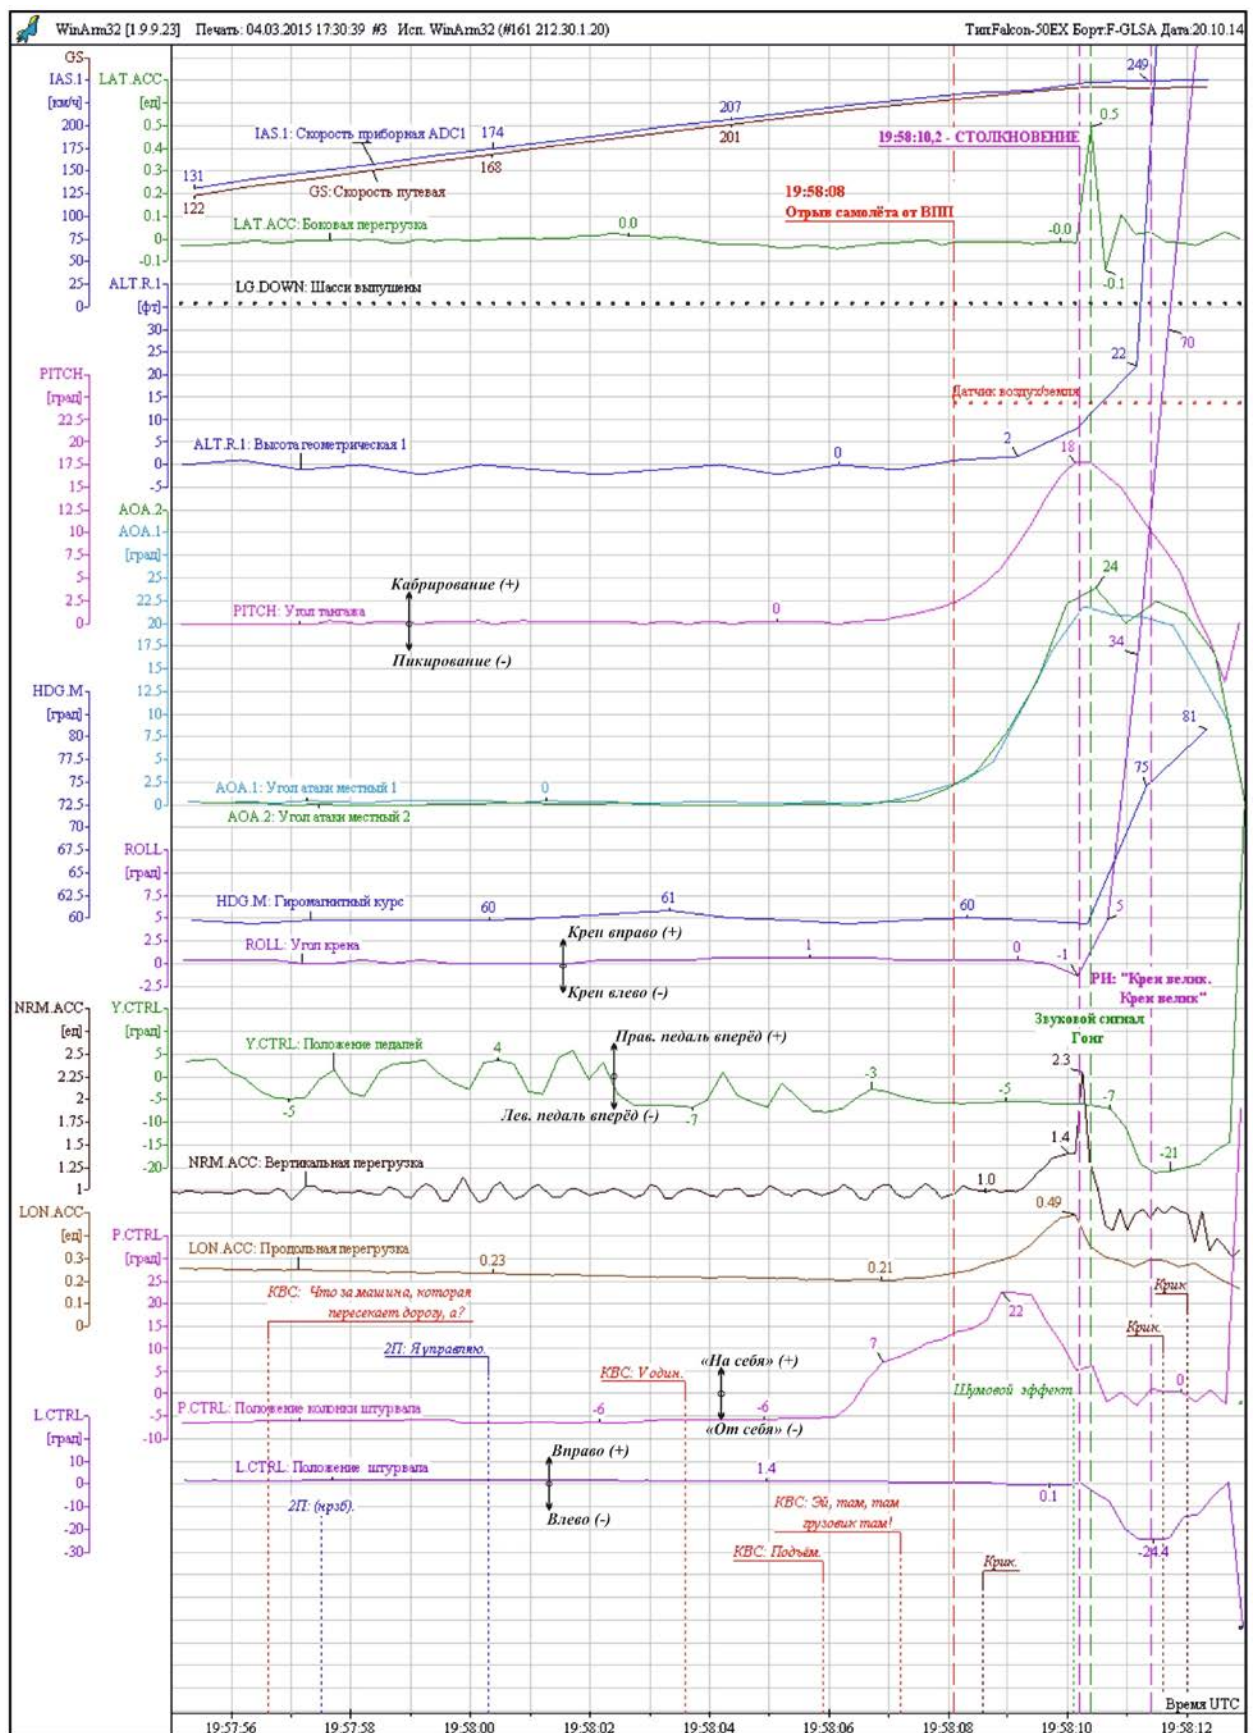
At 19:57:57 (14 seconds after the start of the takeoff roll) the PIC saw an object that he identified as a car, confirmed by his phrase: "*C'est quoi la bagnole qui croise la route eh?*" ("*What's the car crossing the road, eh?*") (Figures 77 to 79).

At 19:58:04 at a speed of approximately 110 kt (204 km/h) the PIC called out reaching decision speed «*V one*», and then at 118 kt (218 km/h) reported rotation speed: «*Rotate*» and then the FO started pulling up the control column (Figure 77 and Figure 78).

At 19:58:07 at 123 kt (227 km/h), approximately 210 m before snowplow 3 the PIC shouted: «*Eh beh y-a, y-a un camion là!*» ("*Hey there's, there's a truck there!*") (Figure 78 and Figure 82).

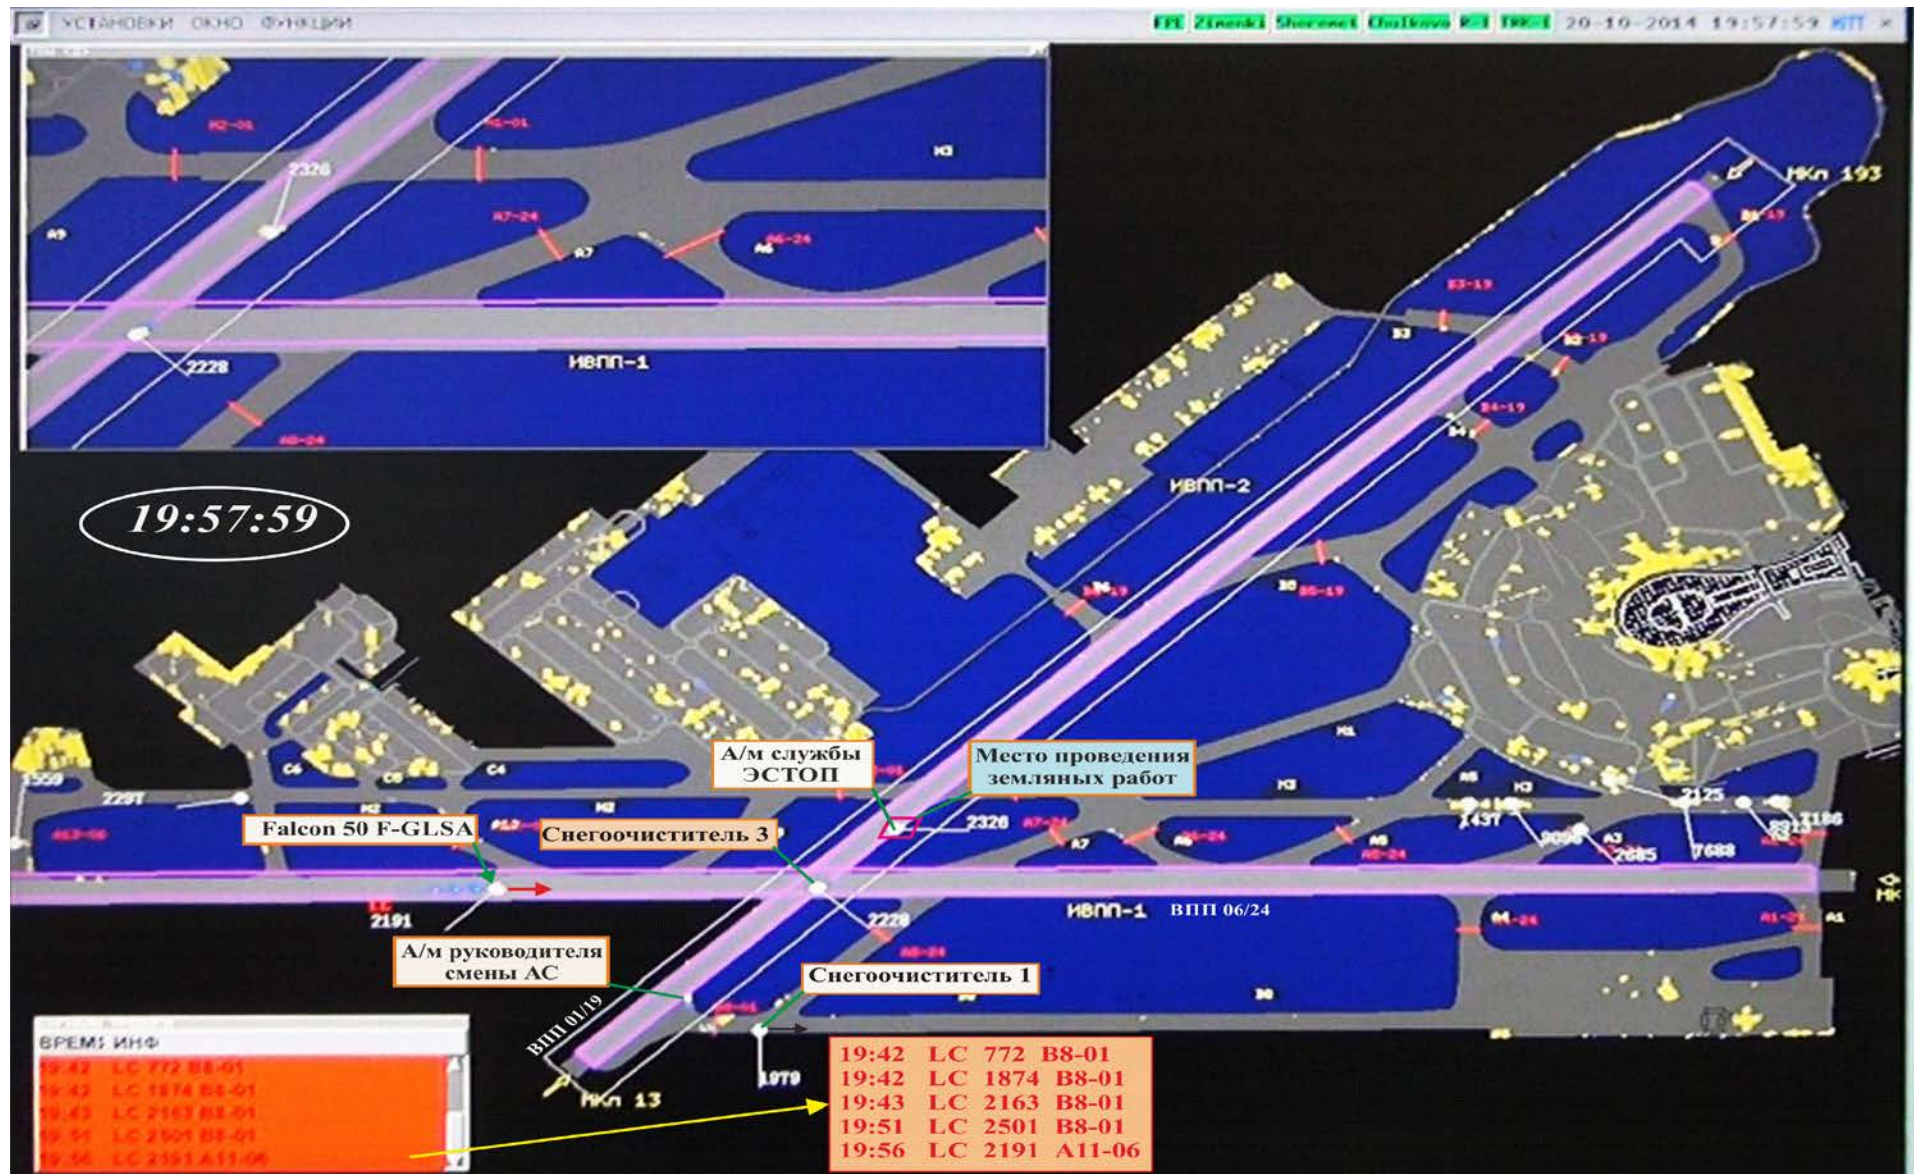
Figure 80. Location of objects at airdrome Vnukovo as viewed from the departure controller screen at 19:57:59

At 19:57:59 snowplow 3 passing a bit (5-6 meters) of RWY 1 centerline stopped near the big crossing, at about 1570 m from threshold 06 of RWY 1 (Figure 80).
