*This document is an English translation of the Final Report on the fatal accident involving the Falcon 50EX aircraft registered F-GLSA that occurred on October 20, 2014 at Vnukovo Airport, Moscow.*

## **INTERSTATE AVIATION COMMITTEE**

### **AIR ACCIDENT INVESTIGATION COMMISSION**

#### **FINAL REPORT**

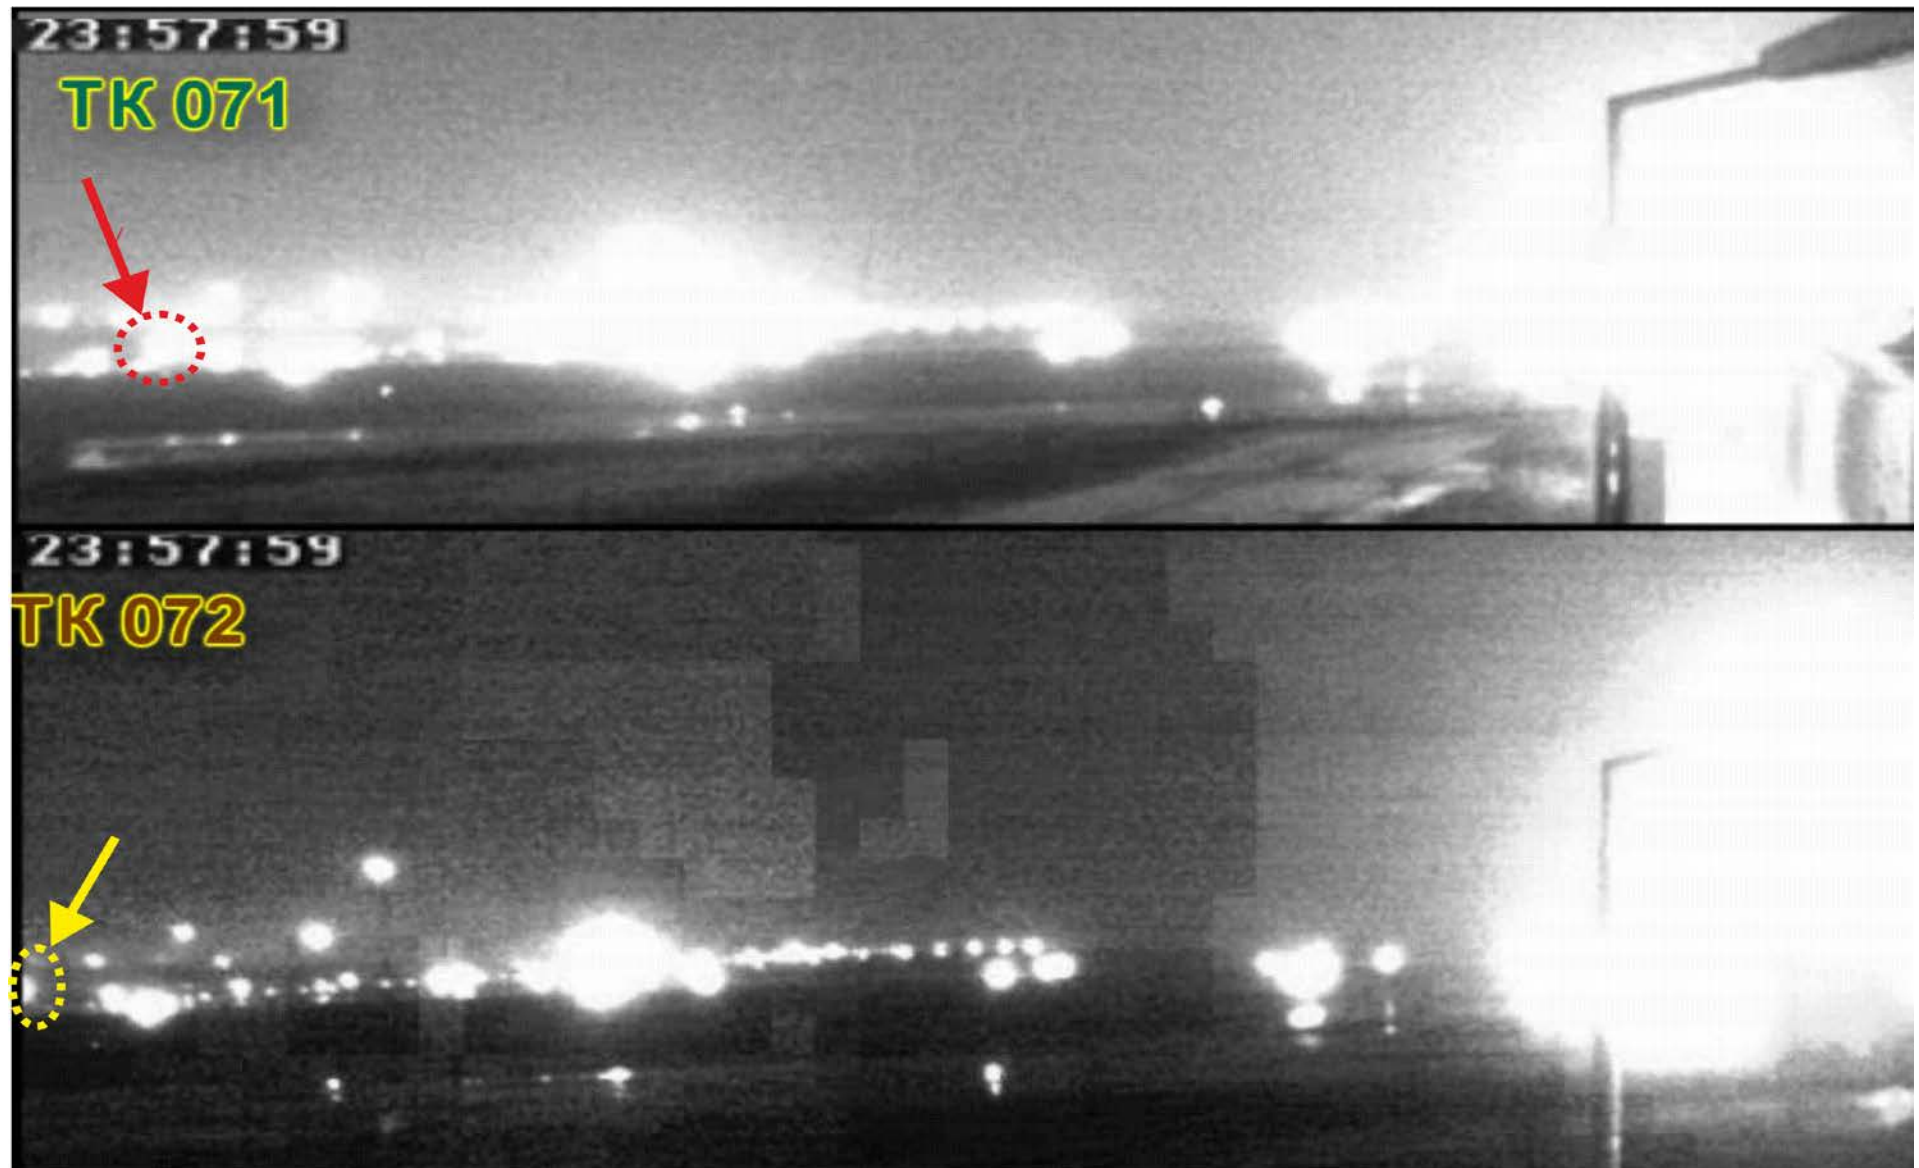
Figure 81. Snowplow 3 stopping at 23:57:59 (19:57:59 UTC) at RWY 06 crossing

Based on the records of two surveillance cameras installed near Checkpoint 4 it was determined that strobe lights and headlights of snowplow 3 were constantly on (Figure 81).

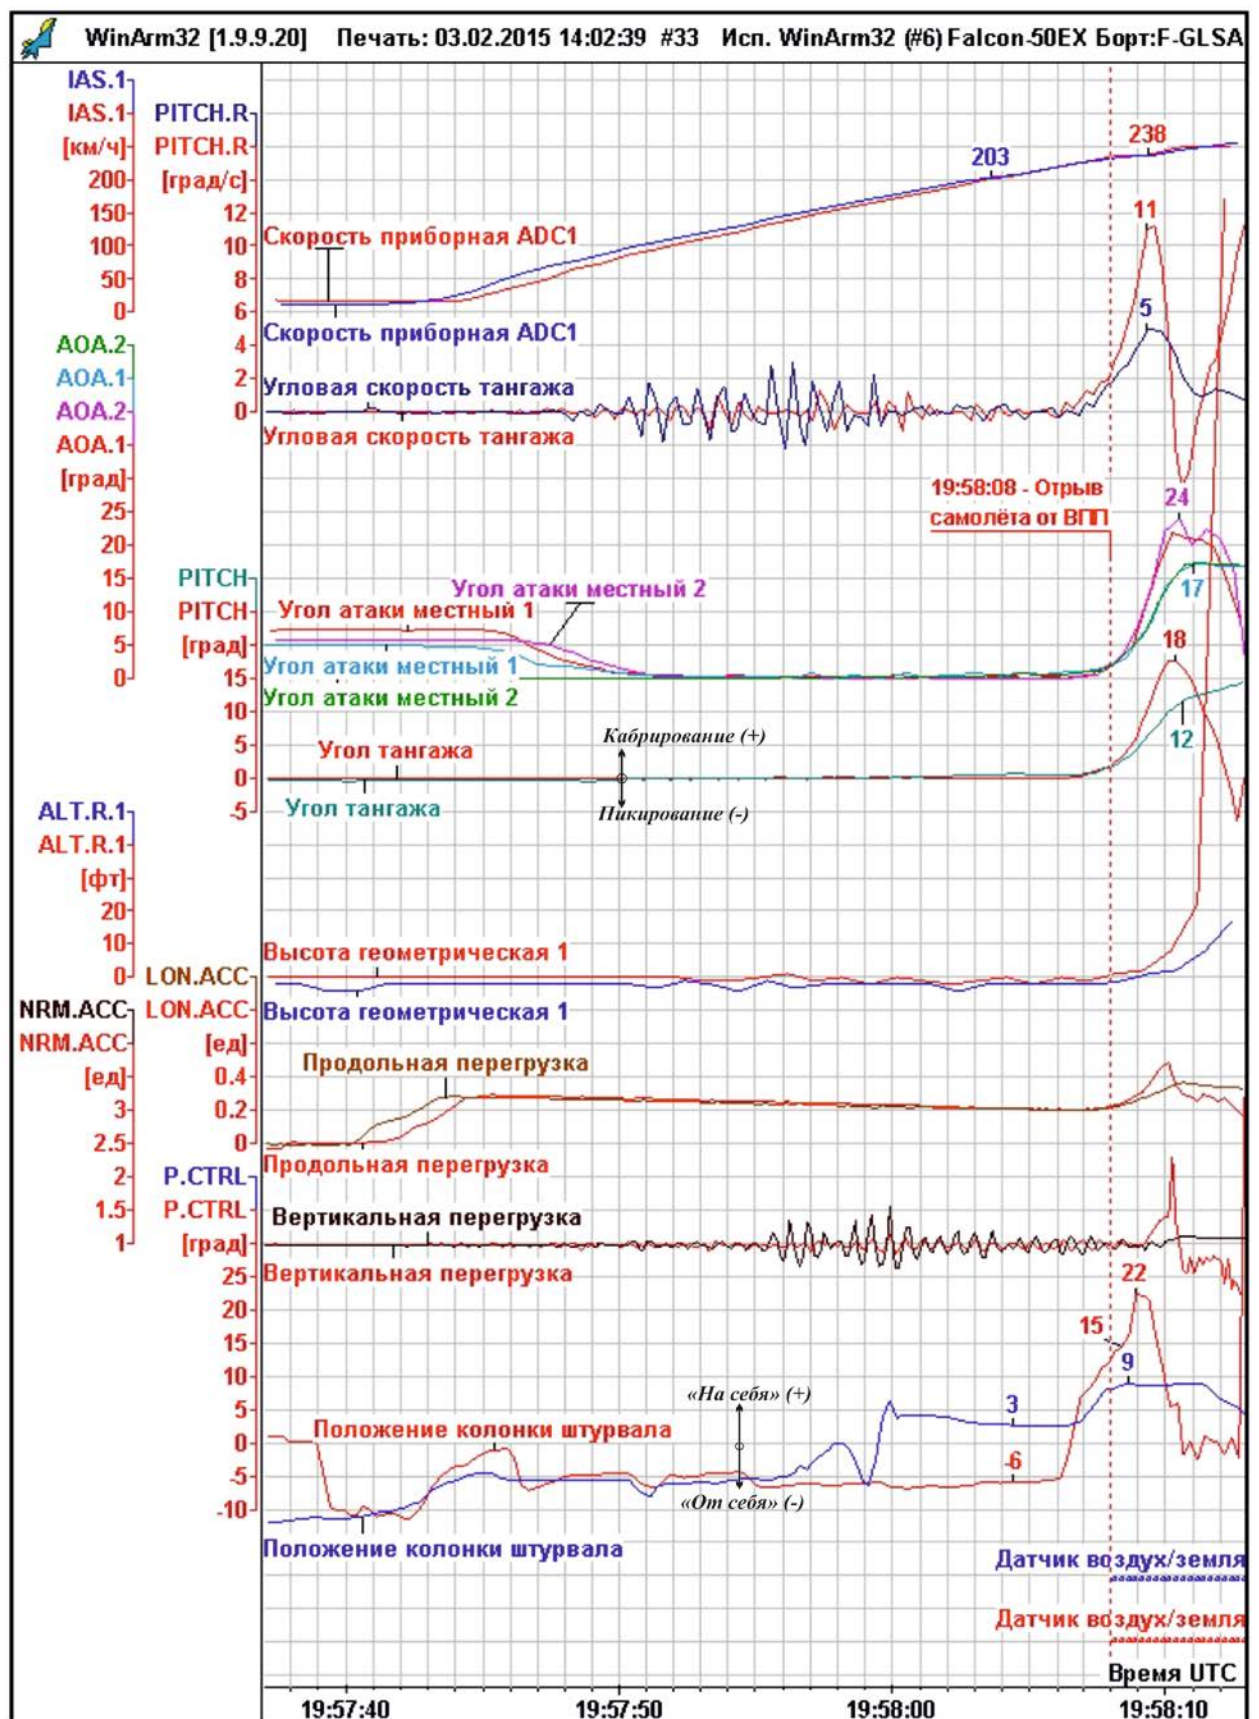
Figure 83. Comparison of flight parameters change during takeoff of Falcon 50EX F-GLSA at Vnukovo AP on 20.10.2014 with the respective parameters of the previous takeoff (shown in red are parameters of the flight on 20.10.2014)

The pitch rate before the liftoff was almost the same as in the previous flight (Figure 83). After that PIC's phrase and aircraft liftoff the FDR recorded an additional abrupt nose up control column deflection. These actions is an evidence that the flying FO must have reacted to the PIC's words. As a result of such pilot actions the local aircraft AOA increased to 22-24 degrees.

Then the control column was pushed from 22 degrees to 5 degrees within about 0.75 sec. This could have been caused by the will of the pilot to avoid exceeding the critical AOA.

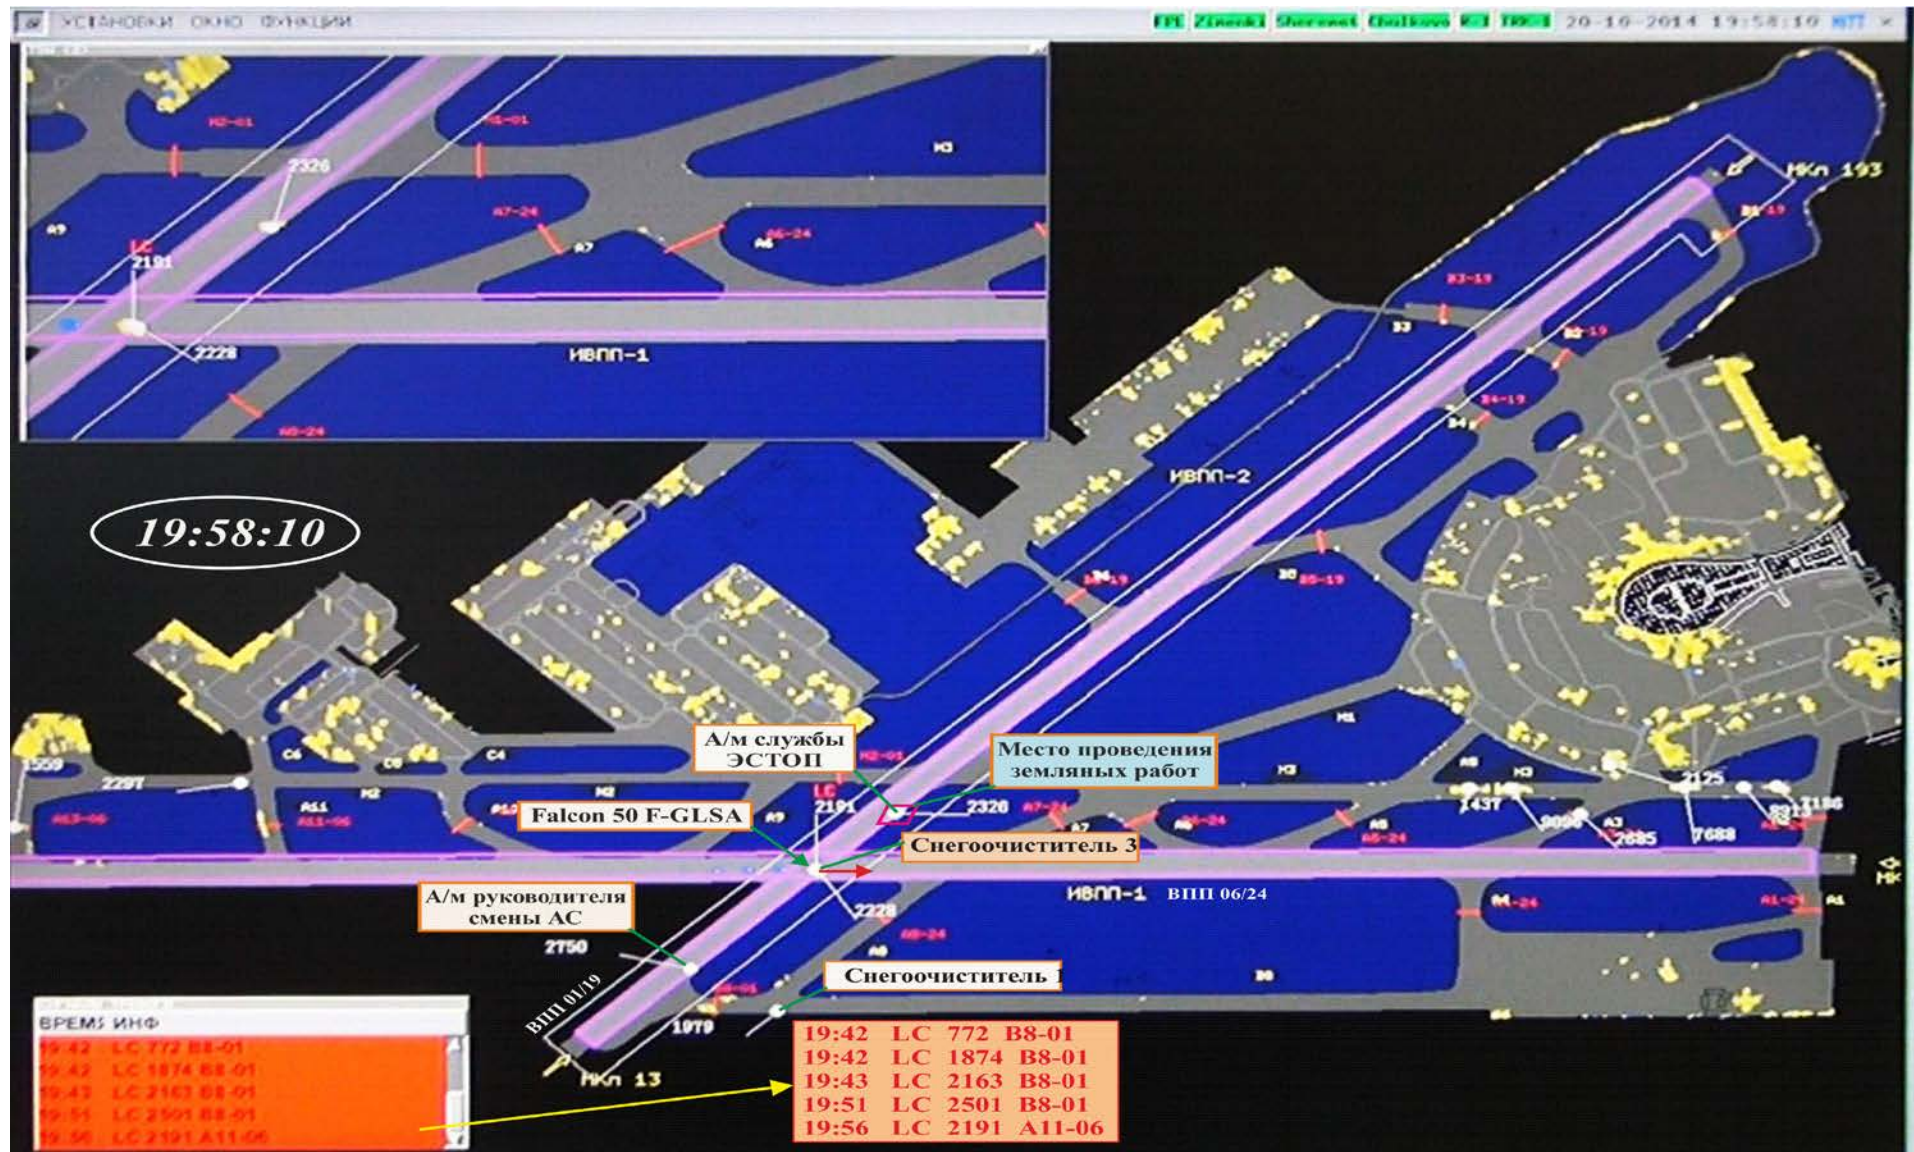
Figure 86. Location of objects at airdrome Vnukovo as viewed from the departure controller screen at 19:58:10 during the Falcon-50EX F-GLSA aircraft collision with snowplow 3

The collision occurred at 19:58:10 (Figure 77, Figure 78 and Figure 86) which is confirmed by the flight recorder data: noise as the aircraft structure was destroyed, as well as abrupt increase of vertical and lateral loads reaching as much as 2.3 g and 0.5 g respectively. The aircraft collided with snowplow 3, its right wing hitting the cab roof and snow evacuation nozzle while its RH landing gear hit the aft hood at a height of 1.8 m (Figure 84 and Figure 85).

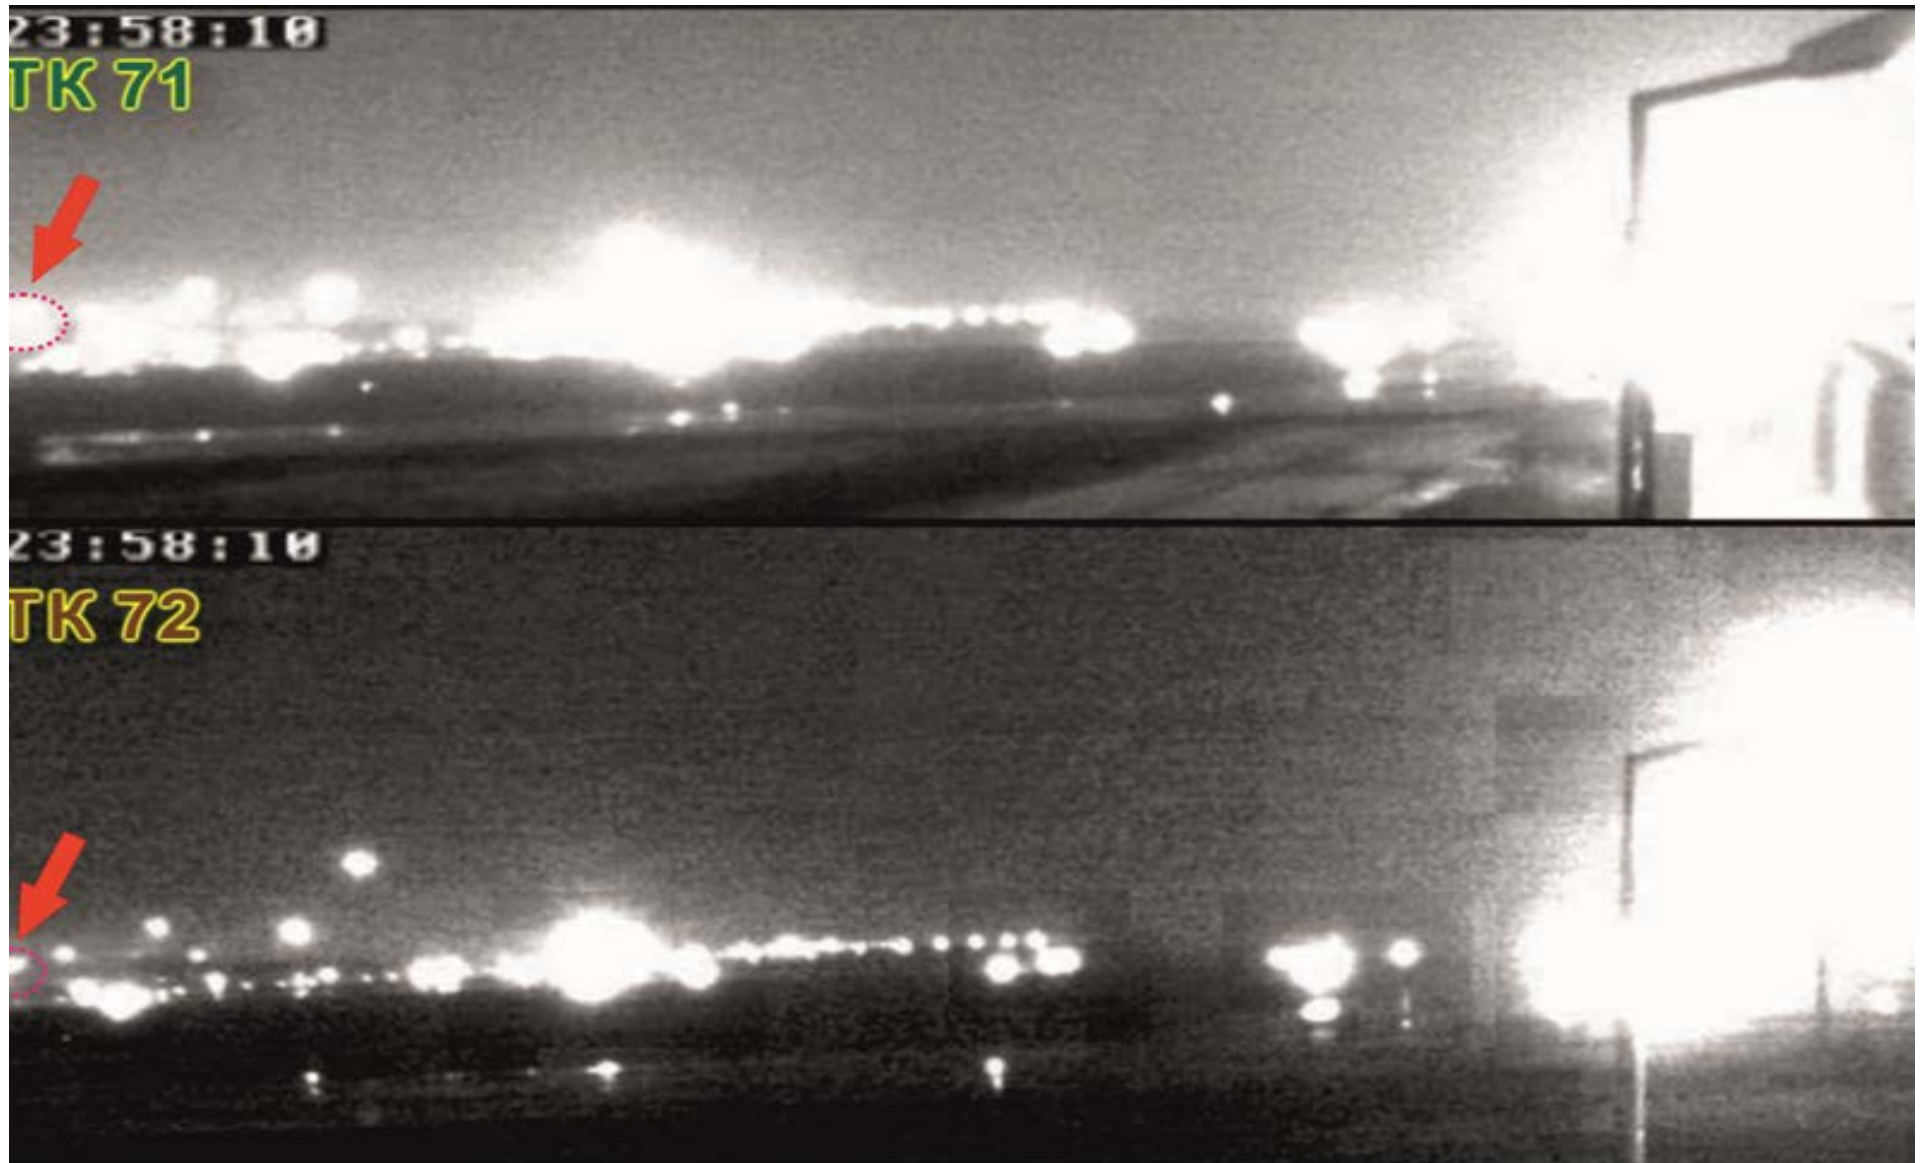
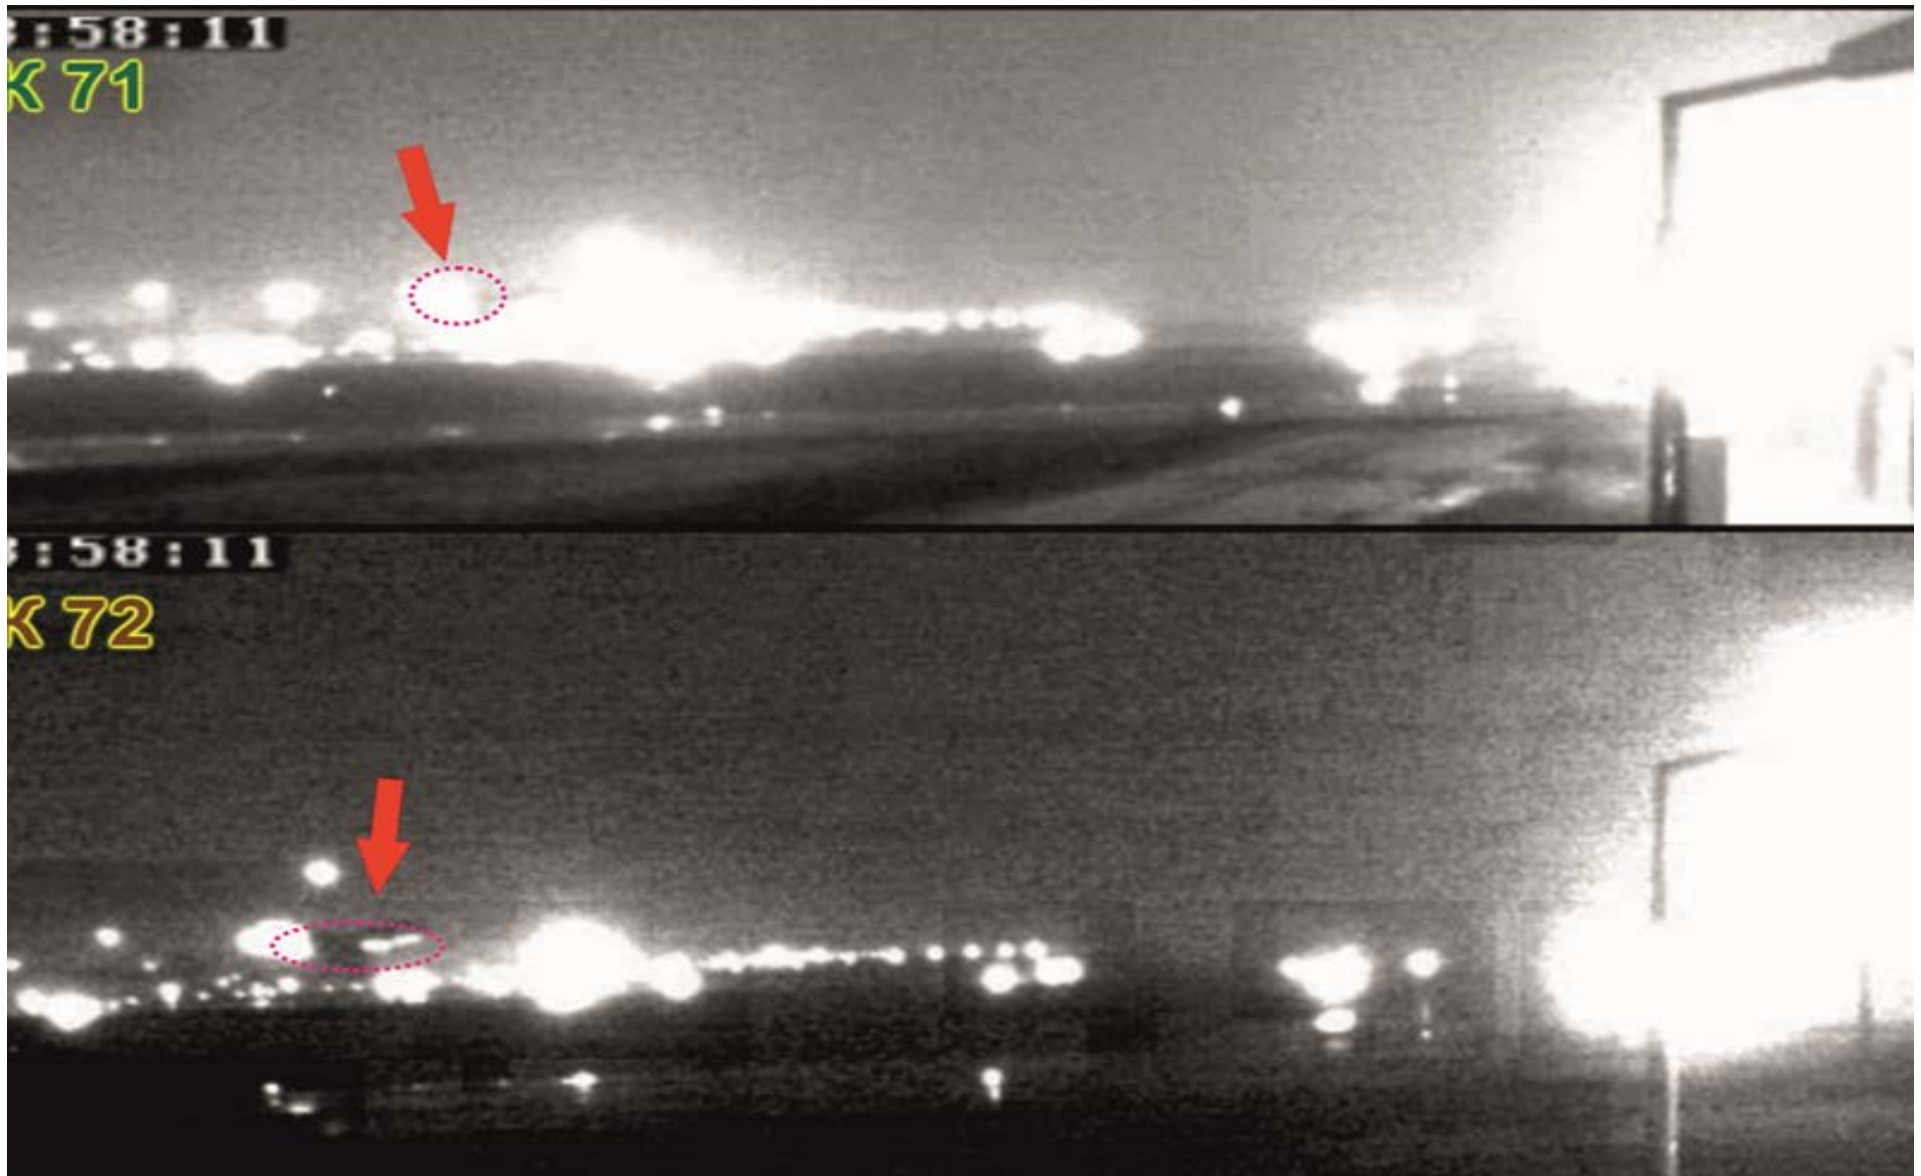
Figures 87 to 89 show the aircraft position recorded by airdrome surveillance cameras TK 071 and TK 072 at the moment of collision as well as 1 and 3 seconds afterwards.

After the collision, due to the damage of the RH wing, the aircraft experienced abrupt right bank. Full left input of the control column by the crew could not counteract the right bank and after about 250 m, inverted, the aircraft hit the ground, crashed and caught fire.

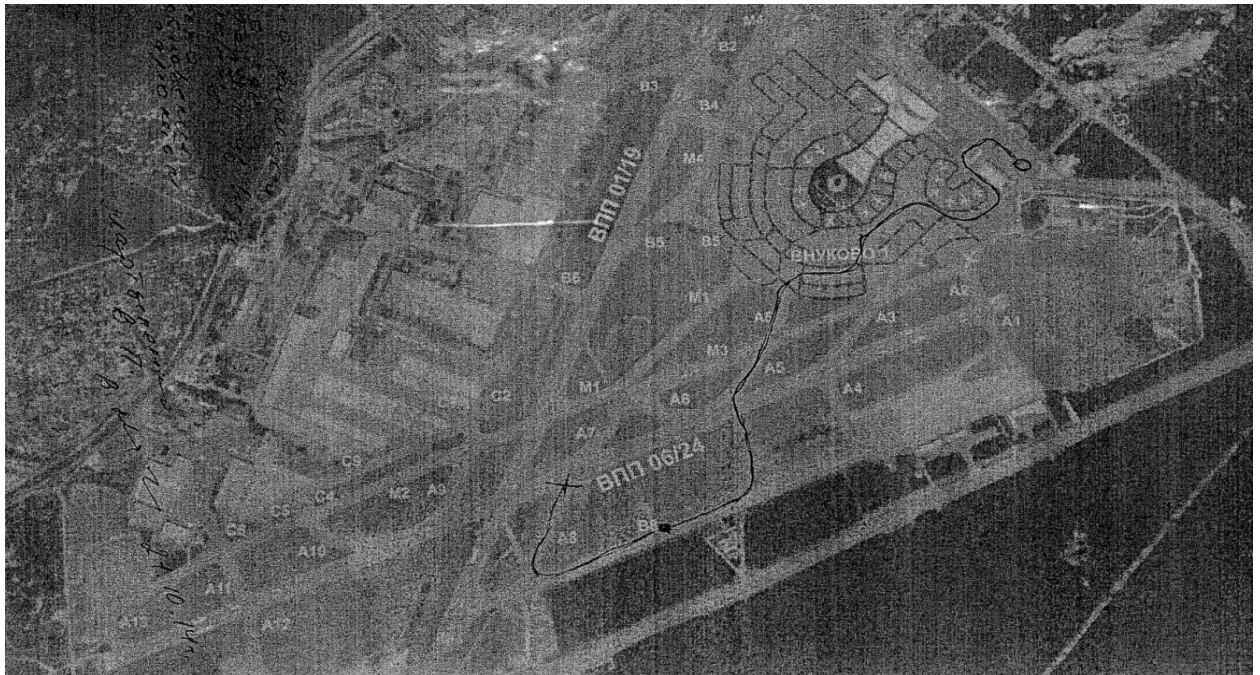
Figure 90. Vehicle path attached to snowplow 3 driver's interrogation protocol

Evidence of loss of situational awareness of snowplow 3 driver is the path of his vehicle along the airfield (Figure 90) that he attached to the interrogation protocol as of 21.10.2014. The

path drawing provided by snowplow 3 driver is not consistent with his actual movements as per the data from airfield surveillance radar (Figure 91).

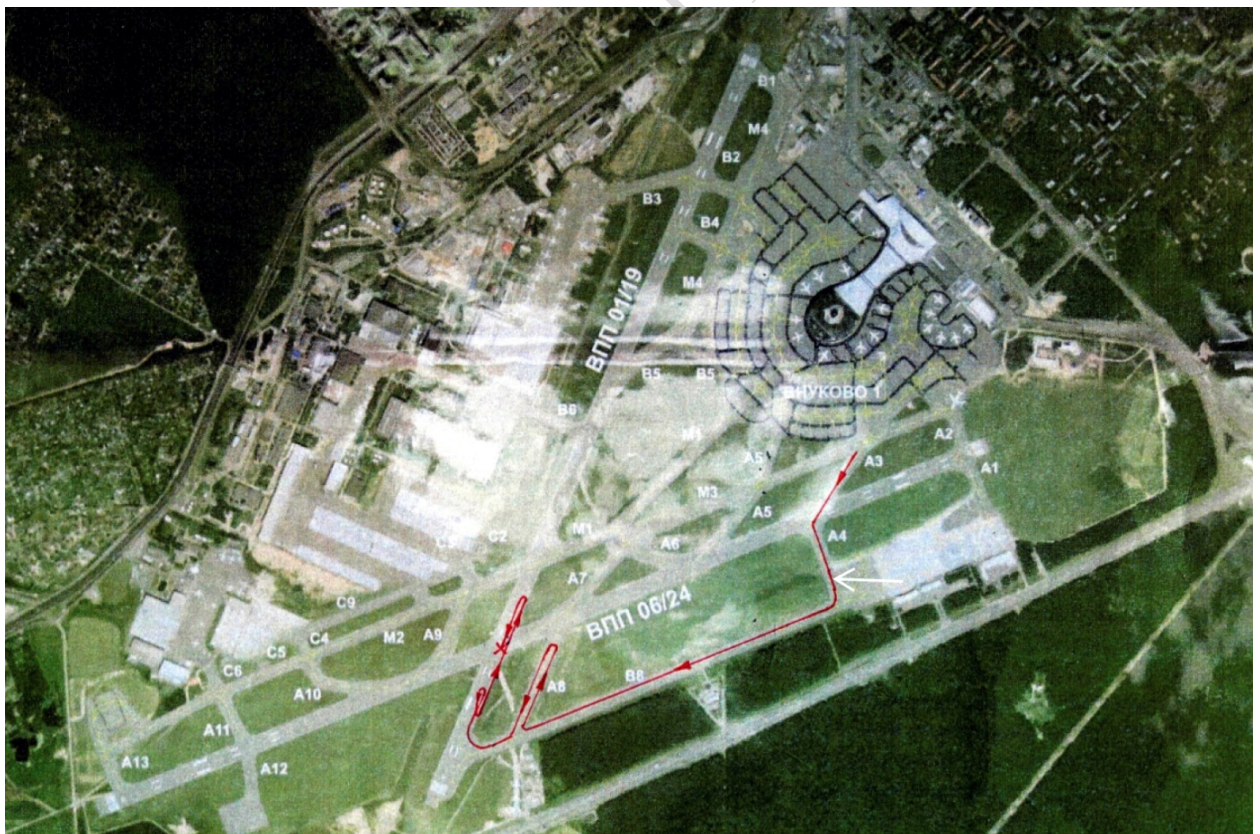
Figure 91. Snowplow 3 path as per the airfield surveillance radar data

The loss of situational awareness and further illogical movement of the snowplow might have been induced by alcohol influencing snowplow 3 driver. Just like in case with the airdrome

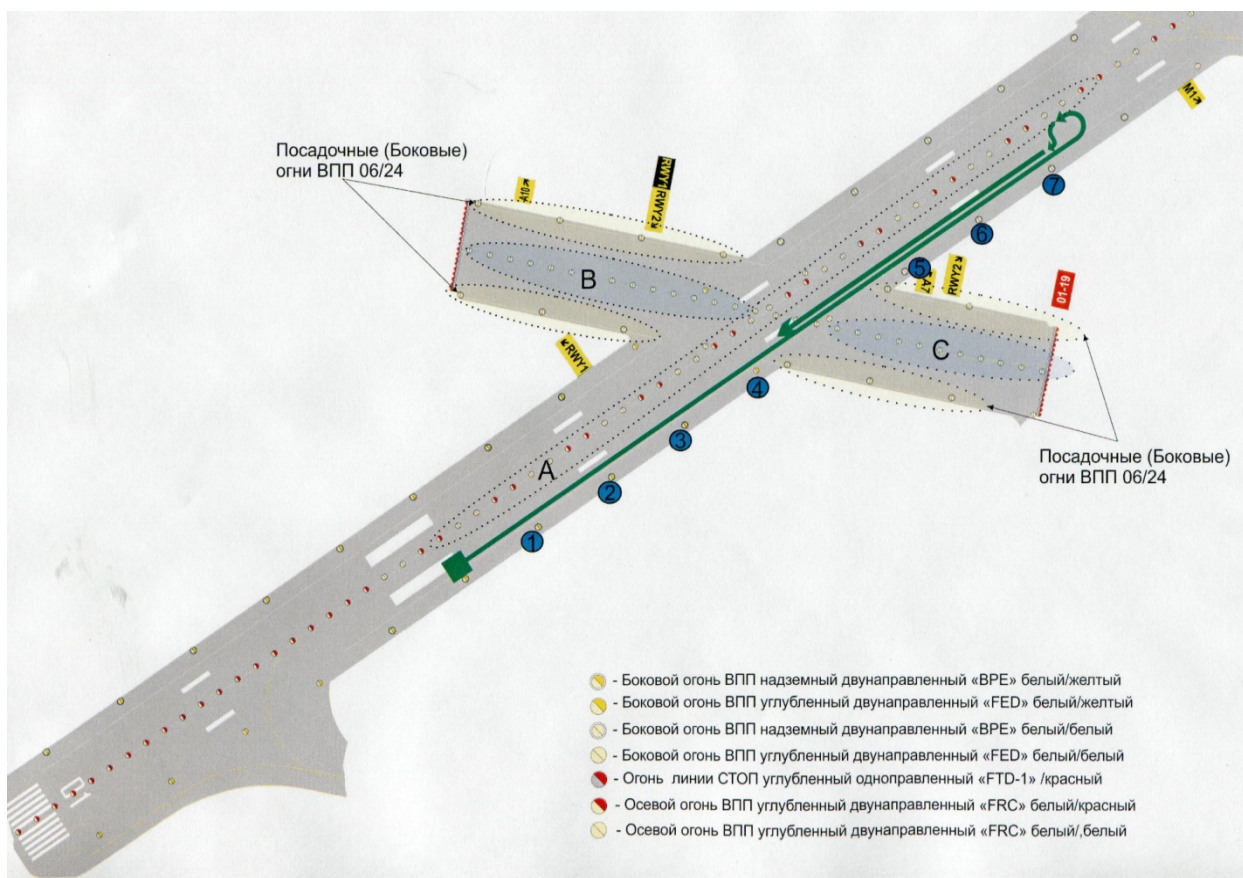
Figure 92. Snowplow 3 path with regard to runway lights

The investigation team also analyzed the actual path of snowplow 3 after the airdrome service shift supervisor lost control over it with regard to the location of runway lights and various airdrome signs (Figure 92) that could have helped the driver to regain situational awareness.

The green square marks the location where snowplow 3 started moving towards RWY 1. The green line represents its movement pattern from the start of his movement until the turn and then backwards.

Thus, the investigation team notes that there were a lot of lighting system elements on the way of the snowplow that could have assisted the driver in defining (provided he had pertinent knowledge and was in a sober condition) that he was on the runway and crossing another runway. The airdrome sign was also indicating that the snowplow was crossing RWY 1. Taking into consideration his significant experience of working at Vnukovo airdrome the snowplow driver could have been guided by the lights and signage, although vehicle drivers do not undergo any specific training on runway lights. The investigation team believes that such training can significantly increase drivers' situational awareness and become one of the defenses against runway incursions.

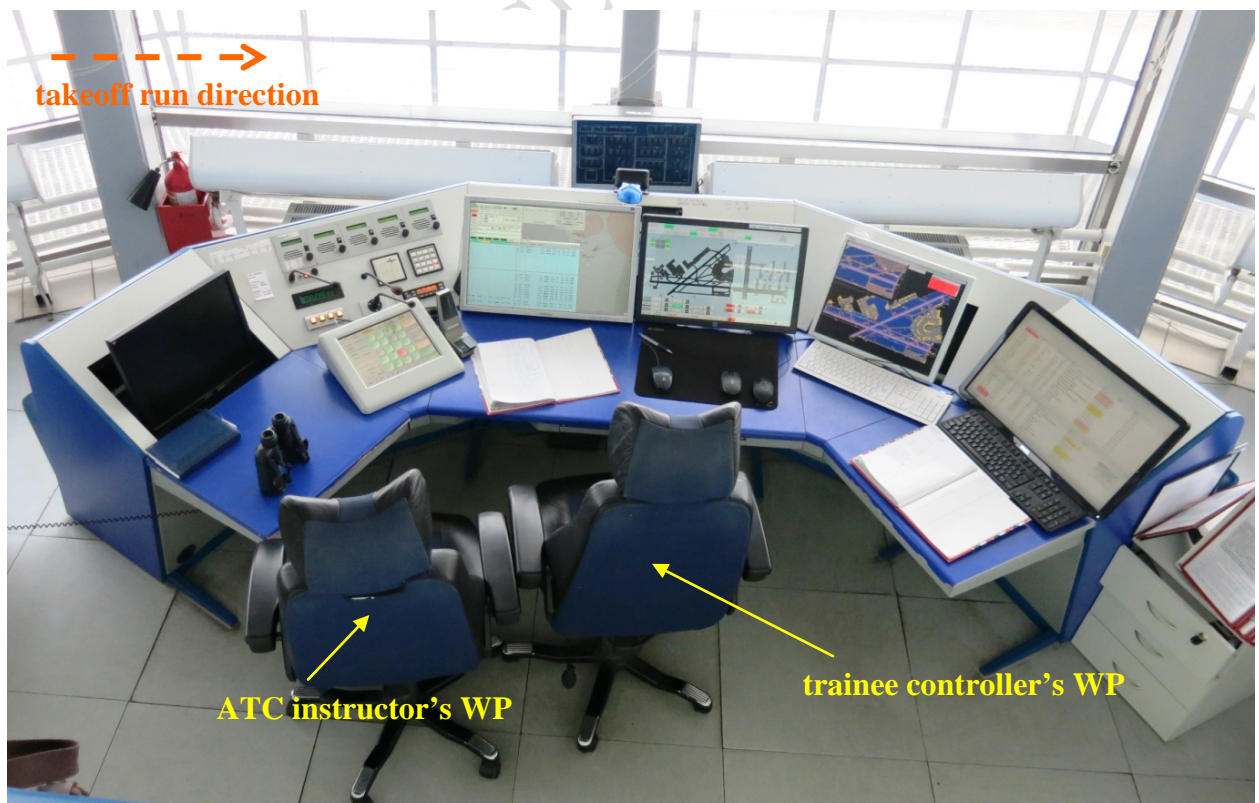
Figure 93. Positions of trainee controller and instructor controller at Ground Control at the time of the accident (judging by drawings attached to the interrogation records)

The position of the instructor controller and trainee controller at the ATM departure controller WP is shown in Figure 93.

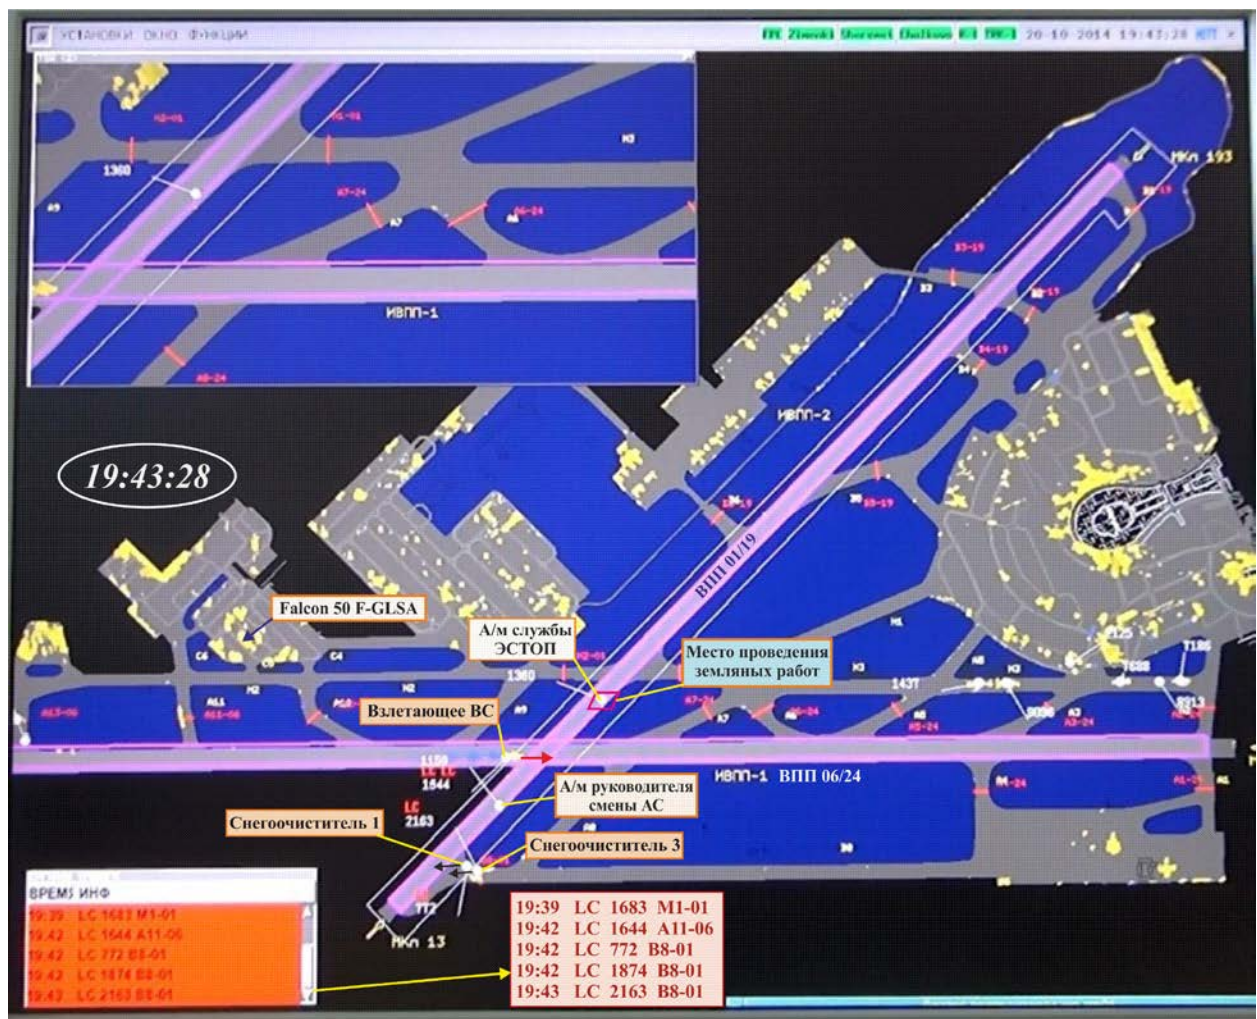
Figure 94. TRADIS indicator on departure controller's WP at 19:43:28  
(light red table shows information in the alert list)

As the vehicles crossed the B8-01 Reserved Line<sup>36</sup> and during the incursion of RWY 2 (that was not in use) mentioned above, the A3000 screen of the departure controller indicated, among others, the following alerts (Figure 94):

Controllers at the departure controller's WP did not react to the appearance of these alerts. Like in case with the ground controller, the documents regulating the departure controller's duties did not determine their actions when alert signals appear on the screen. Moreover, it is not possible to manage the TRADIS system (including acknowledgement of alert messages) from the Departure ATC position. As was described in Section 1.8.2.1, acknowledging alerts was only possible from the departure ATS working position. This is also true for the screen settings (the picture shown and the setting modes at departure ATC and departure ATS are identical, but it could be managed only from the departure ATS WP) that is after the sectors had been joined proper use could only be provided from the departure ATS WP which had not been considered in the working instruction of the departure controller when the decision to join the sectors had been taken.

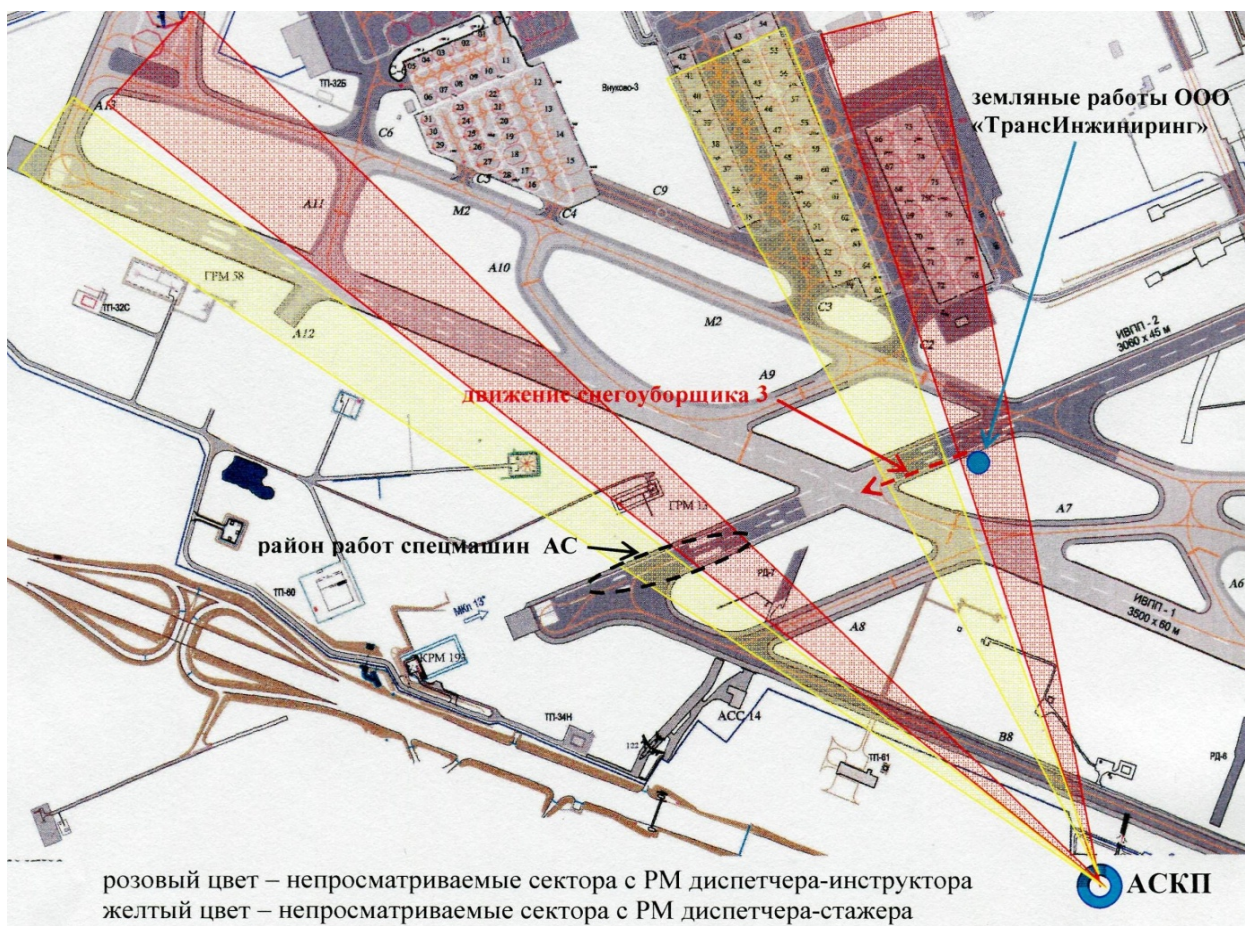
Figure 95. Sectors where visual observation is obstructed from departure ATC WP

It should be noted that visual observation is defined as the main method to control the departing aircraft for the departure controller. Figure 95 gives a schematic view of the sectors where visual observation could be obstructed from the working positions of the instructor controller and trainee controller.

It can be seen in the Figure that the area where the snowplow 3 was before entering the runway was in the obstructed visibility area from the departure controller's working position. As the control room is located 37 m above the ground the visibility range could have been further reduced due to complicated weather conditions at Vnukovo AP at the time of the accident (clouds with rough cloudbase: 30 m on threshold 24 and 70 m on threshold 06 of RWY 1, light drizzle and fog, night time). This situation is regulated by Para 5.2.2 of FAR-293: "A controller, visually monitoring the aircraft movement shall have complete visual range of the controller area from their working position. In case it is impossible to ensure complete visual observation of the control area from a certain working position there shall be technical means of monitoring or additional air control offices (sectors)." In the considered case the A3000 system ensured required monitoring of the complete control area of the departure controller. However, use of technical means of monitoring as addition to visual observations required additional training of controllers on the usage of the means, including attention allocation, which was not ensured in the case under consideration.

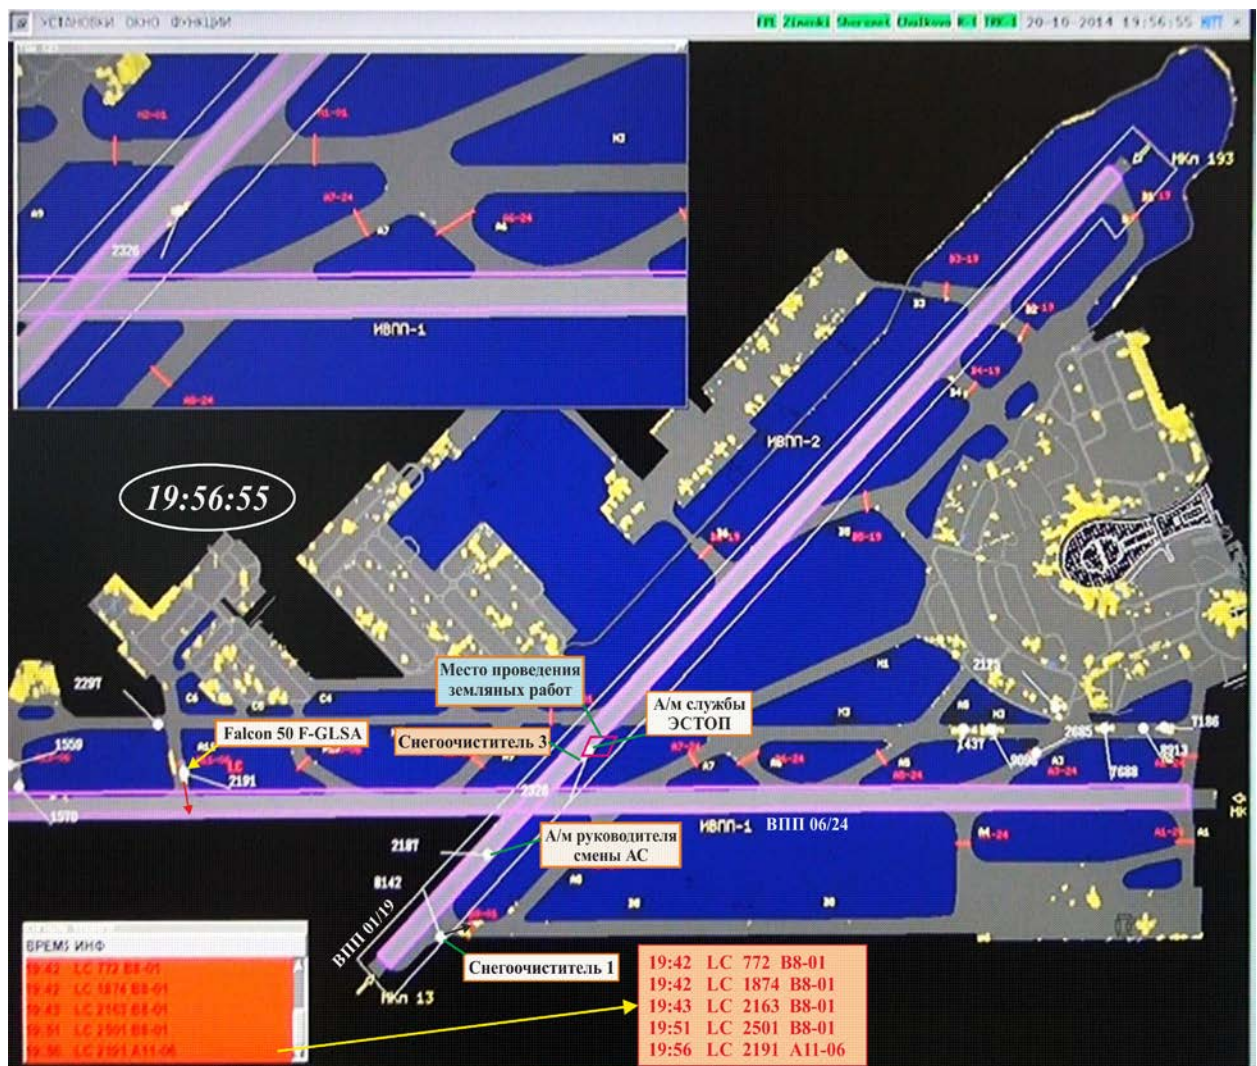
Figure 96. Location of objects at airdrome Vnukovo as viewed from the departure controller screen at 19:56:55

It is also clear from Figure 96 that after the aircraft crossed the Reserved Line between TWY A11 and the RWY, the controller's screen indicated the pertinent alert (track number 2191 belonged to Falcon 50EX F-GLSA aircraft). This alert was not acknowledged by the controller.

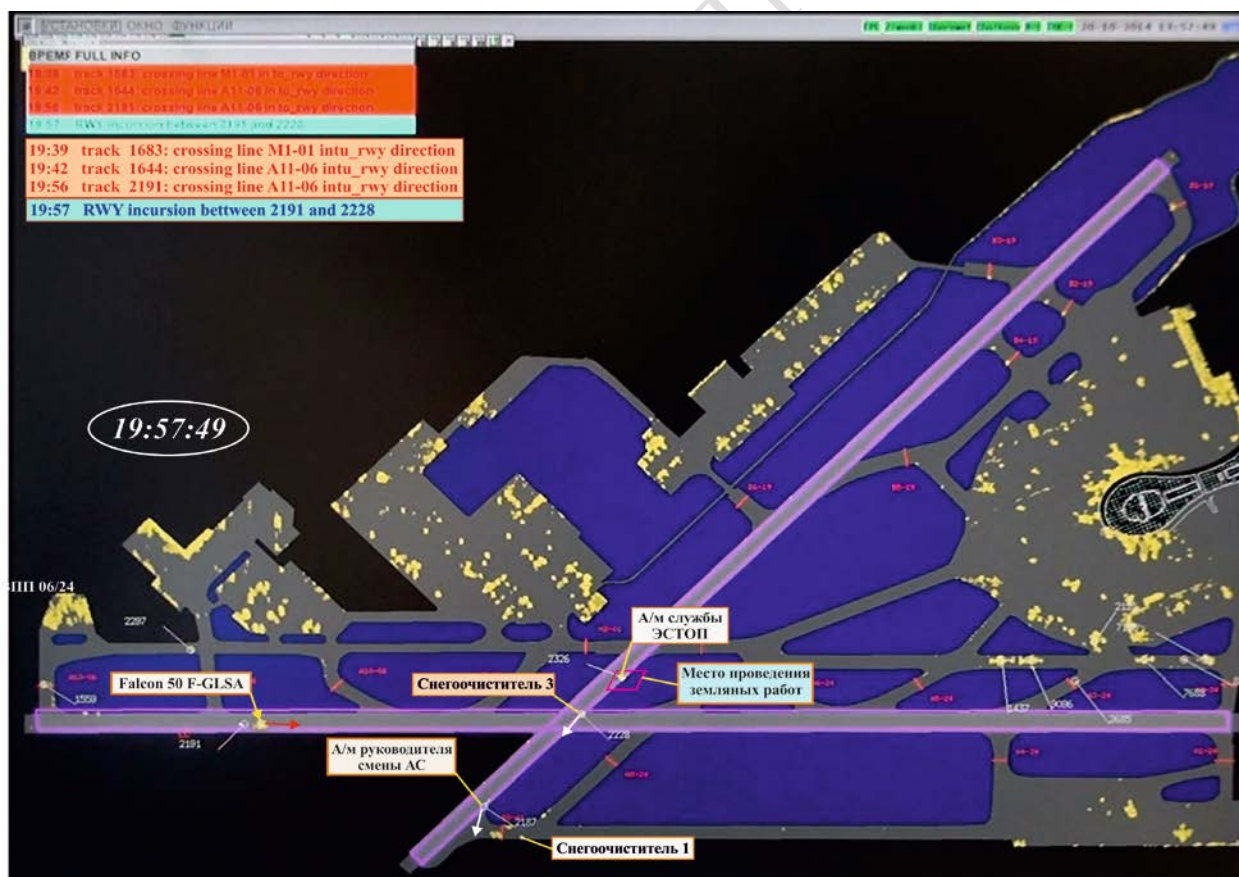
Figure 97 Location of objects at airdrome Vnukovo as viewed from the ATC shift supervisor's screen at 19:57:49

At 19:57:49, after the aircraft had started takeoff roll and the A3000 system had identified snowplow 3 as track number 2228, there was an alert message generated on the ATC shift supervisor's screen. The following indication was to appear on the screen: "19:57 runway incursion between 2191<sup>38</sup> and 2228<sup>39</sup>." The message first should have appeared on the light blue background and then on the amber one (Figure 97 and Figure 98) accompanied with an aural alert.
