*This document is an English translation of the Final Report on the fatal accident involving the Falcon 50EX aircraft registered F-GLSA that occurred on October 20, 2014 at Vnukovo Airport, Moscow.*

## **INTERSTATE AVIATION COMMITTEE**

### **AIR ACCIDENT INVESTIGATION COMMISSION**

#### **FINAL REPORT**

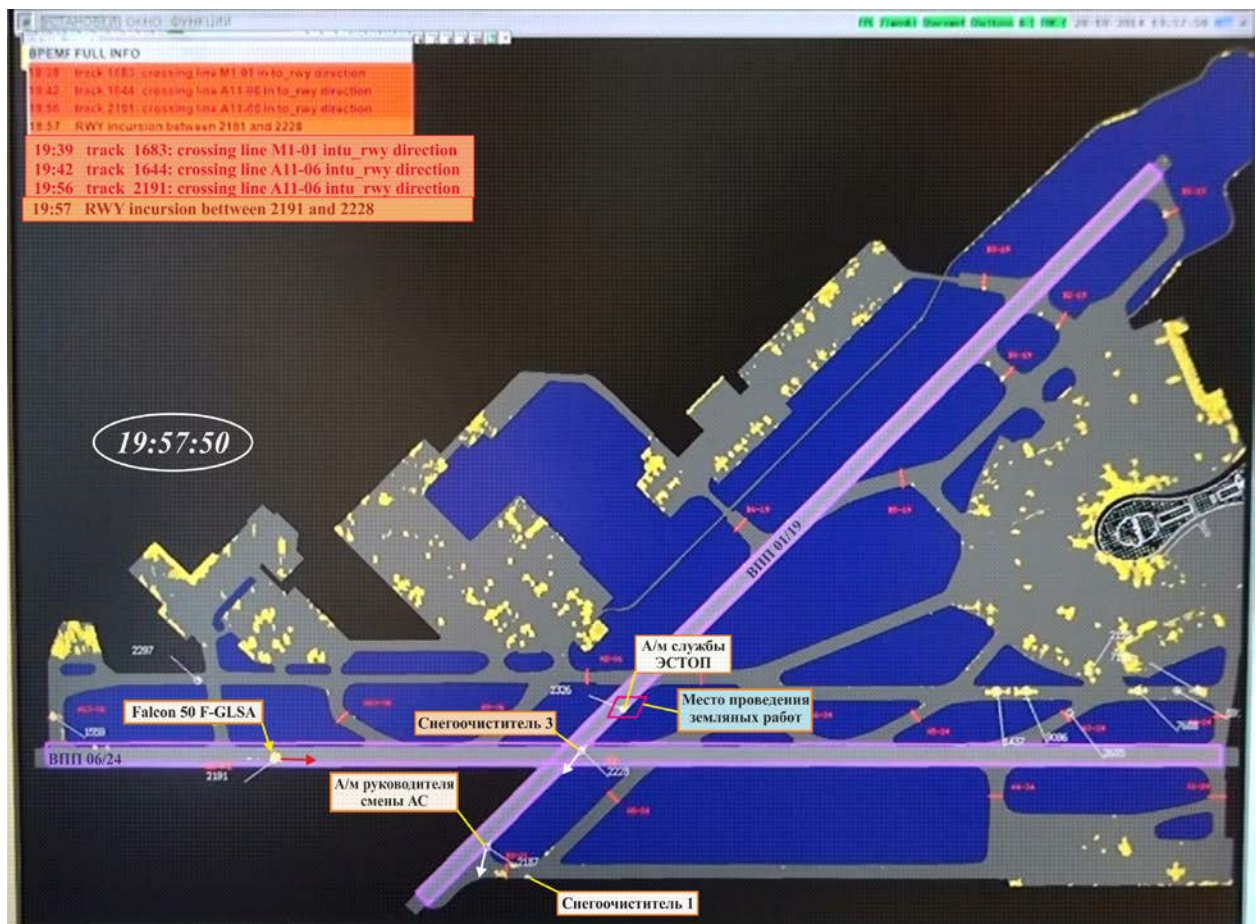
Figure 98. Location of objects at the Vnukovo airdrome as viewed from the ATC shift supervisor's screen at 19:57:50

At 19:57:49, after the aircraft had started takeoff roll and the A3000 system had identified snowplow 3 as track number 2228, there was an alert message generated on the ATC shift supervisor's screen. The following indication was to appear on the screen: "19:57 runway incursion between 2191<sup>38</sup> and 2228<sup>39</sup>." The message first should have appeared on the light blue background and then on the amber one (Figure 97 and Figure 98) accompanied with an aural alert.

The investigation team notes that the screen of A3000 system installed on the ATC shift supervisor's working position was also used to display weather information (such combination is not provided by the system operations manual, the connection was done upon oral order of the management of Vnukovo ATC Center, See Section 1.18.1). When weather information is displayed, the information of the A3000 system is not shown. As the selection of screen and ATM room video monitor modes was not documented, and there were no clear explanations of the ATC shift supervisor, it was impossible to determine what was on the screen during the aircraft takeoff roll.
