ACCIDENT

Aircraft Type and Registration:	Piper PA-31, N250AC	
No & Type of Engines:	2 Lycoming TIO-540-A2C piston engines	
Year of Manufacture:	1976 (Serial no: 31-7612040)	
Date & Time (UTC):	6 September 2017 at 1723 hrs	
Location:	Caernarfon Airport, Gwynedd	
Type of Flight:	Private	
Persons on Board:	Crew - 1	Passengers - None
Injuries:	Crew - 1 (Fatal)	Passengers - N/A
Nature of Damage:	Aircraft destroyed	
Commander's Licence:	Commercial Pilot's Licence	
Commander's Age:	62 years	
Commander's Flying Experience¹:	Over 4,000 hours (with experience on type) Last 90 days - unknown Last 28 days - unknown	
Information Source:	AAIB Field Investigation

Synopsis

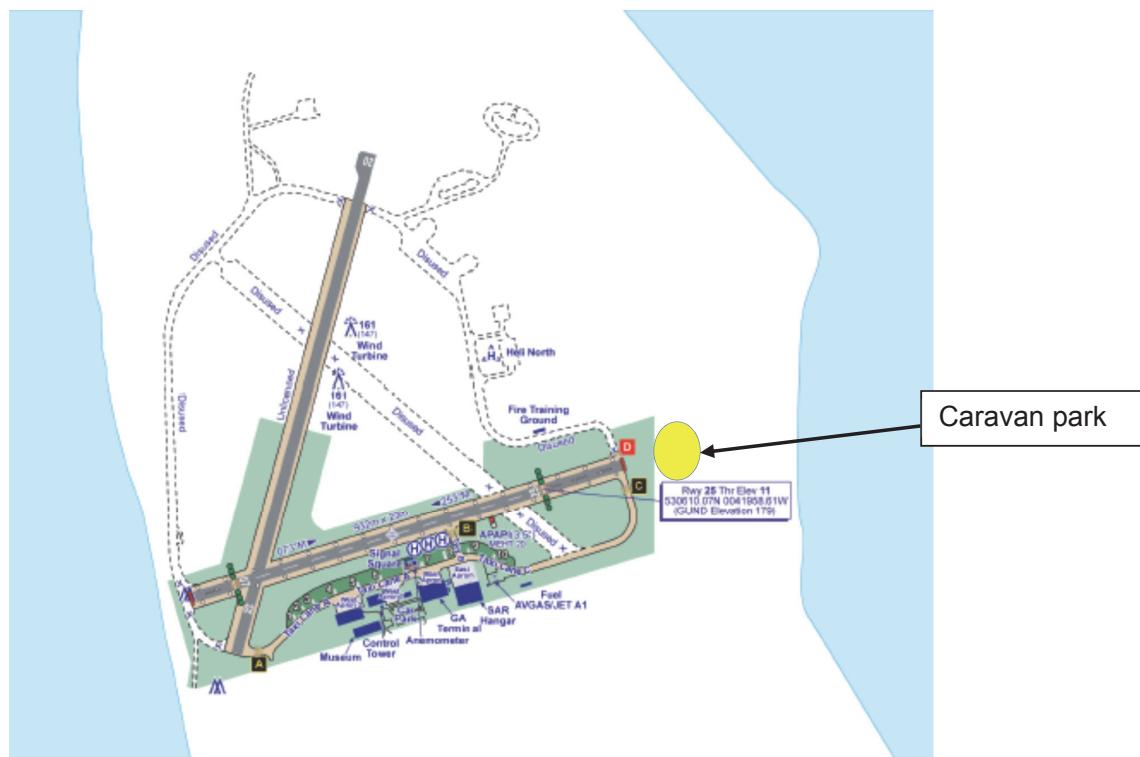
Figure 1
Caernarfon Airport and location of caravan park

Caernarfon's operational runway is 932 m long and orientated 070°/250° (Figure 1). The airport's published summer operating hours were from 0800 to 1700 hrs.

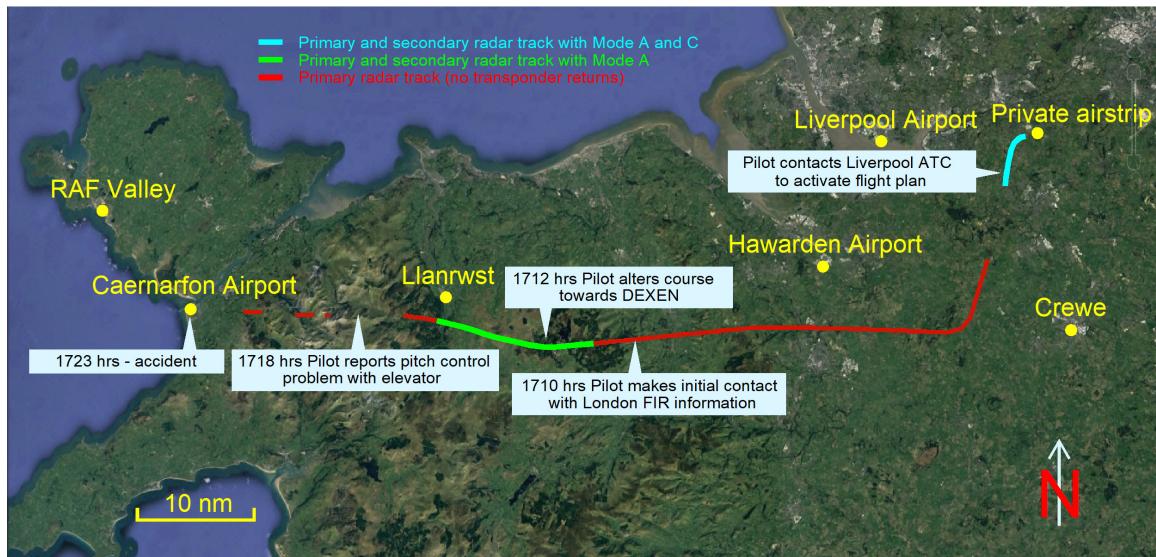
**Figure 2**

N250AC took off at 1653 hrs and the employee observed the landing gear retract normally at approximately 20 ft agl. Shortly after, the aircraft was recorded on primary and secondary radar at an altitude of about 550 ft amsl and squawking 7000⁴. The aircraft turned onto a southerly course and progressively climbed to about 1,100 ft amsl. The pilot then contacted Liverpool Approach and requested activation of his flight plan; shortly after the aircraft stopped transmitting Mode A and C transponder information (Figure 2).

Recorded radar information (primary and secondary Mode A and C⁹) was available from ground-based sites located at Manchester Airport and St Anne's (near Blackpool). The radar data provided an almost complete record of the accident flight, starting shortly after the aircraft had taken off and ending when the aircraft was about 4 nm east of Caernarfon Airport. Figure 2 provides a plot of the aircraft radar track.

Radar track of N250AC

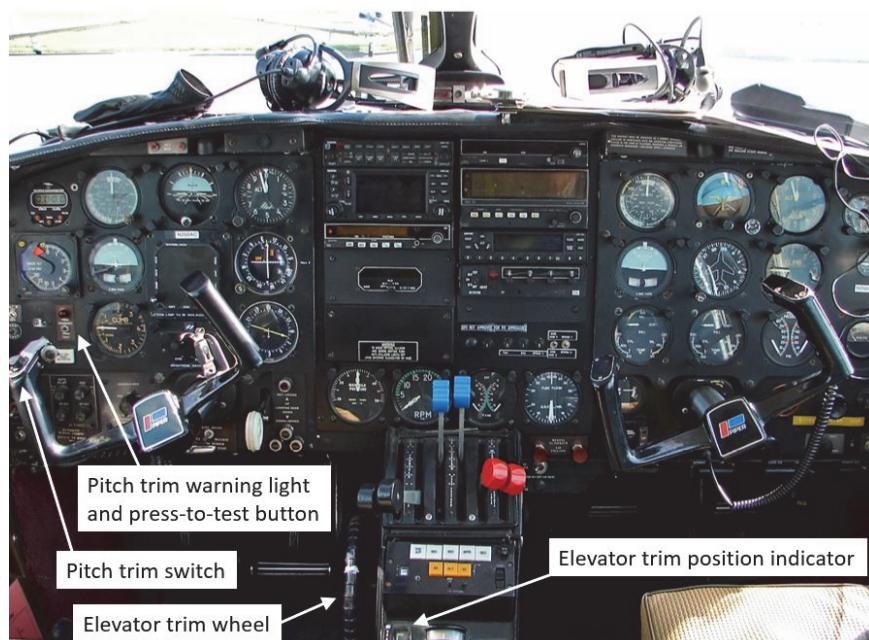
Figure 3

The aircraft's flying controls are conventional, unpowered and operated directly by the control yokes and rudder pedals via mechanical linkages. The elevator control circuit includes an electrically-powered pitch servo, actuated by the autopilot. Aileron, elevator and rudder trim are manually operated by trim wheels connected to cable-wrapped drums located in the cockpit centre pedestal (Figure 3). With rotation of a drum, a screw is moved fore or aft to allow the positioning of the trim tab. An electric sender unit is attached to each trim tab screw assembly to transmit an electrical signal to the trim position indicator on the centre pedestal, to provide a visual indication of the trim tab positions to the pilot.

N250AC cockpit, showing trim controls (image used with permission)
