Bureau Enquêtes-Accidents

REPORT

*on the accident on 12 November 1999
North of Pristina (Kosovo)
to the ATR 42-300 registered F-OHFV
operated by SI FLY*

F-FV99112A

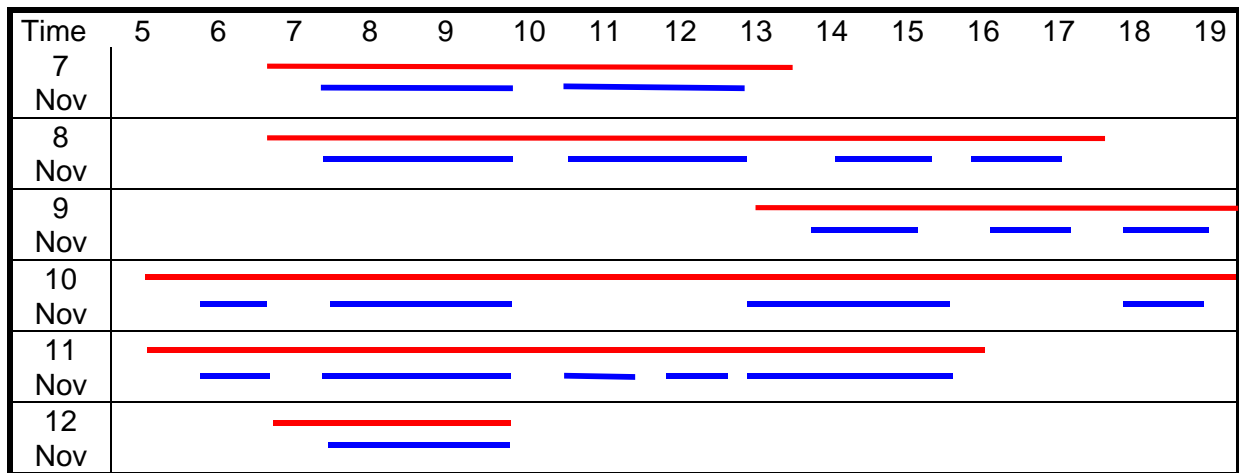
Figure 2 : Captain's activity in the week preceding the accident

Since the 1st of November, the Captain had flown fifty-two hours. He had had two non-flying days, on the 4th when he was available for the Director of flight operations, and the 6th when he had a rest day. Between the 7th and the day of the accident, he had flown thirty-two hours. The day before the accident, he had ferried from Ancona to Rome beginning his duty period at 5 h 45. His day continued with the Rome-Pristina-Tirana-Pristina-Rome line.

On the day of the accident, he went on duty at the Rome Ciampino airport, situated at around 20 minutes from his home. The arrival normal time before takeoff for a scheduled flight is 45 minutes.

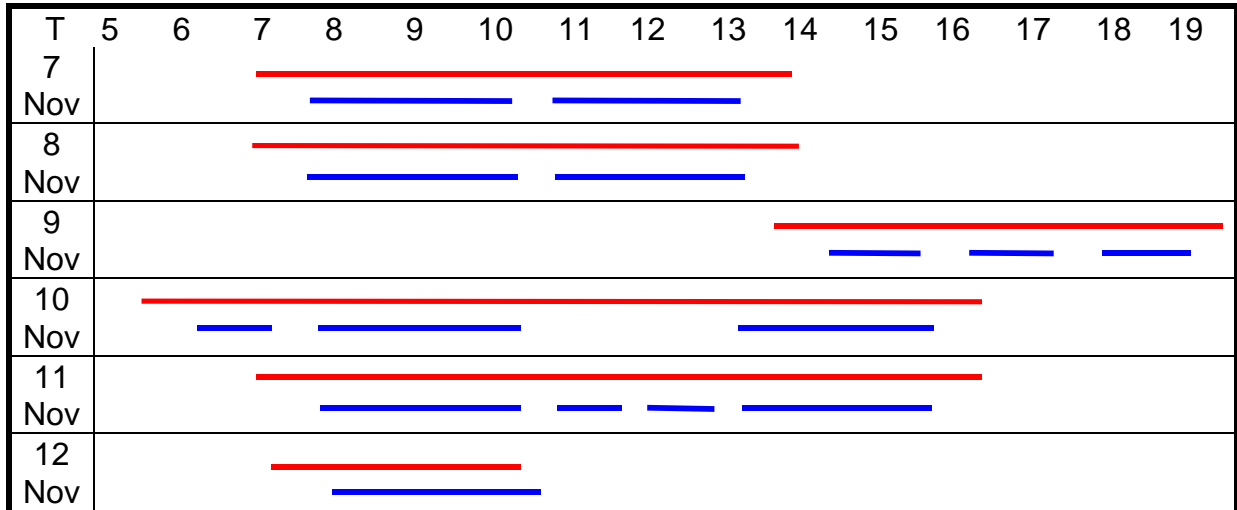
Figure 3 : Copilot's activity in the week preceding the accident

Since the beginning of November, he had flown forty-three hours. He had had two non-flying days, on the 4th when he was available for the Director of flight operations, and the 6th when he had a rest day. Between the 7th and the 12th, he had flown 27 h 30 min. The day before the accident, he had done the Rome-Pristina-Tirana-Pristina-Rome route with the same Captain.

On the day of the accident, he went on duty at Rome Ciampino airport, situated at around 15 kilometres from his home, for an eight o'clock takeoff.

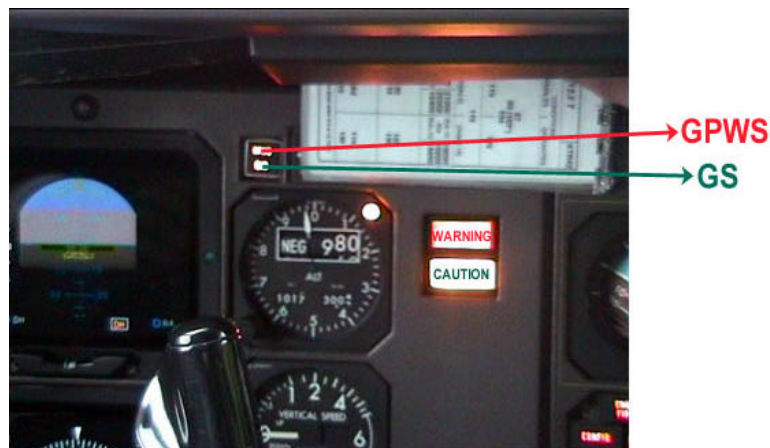
Figure 4 : GPWS and GS push buttons

GPWS : lights up red as long as one of modes 1, 2, 3, 4 is active. A spoken warning corresponding to the active mode is broadcast.

GS : lights up amber as long as mode 5 is active. A spoken warning corresponding to the active mode is broadcast.

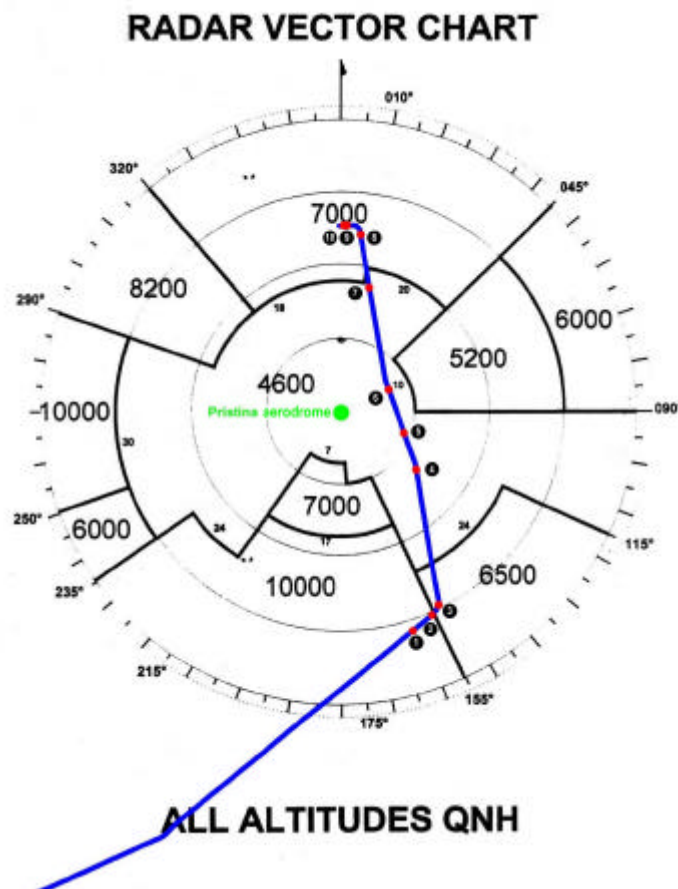
Figure 9 : Radar Data

At the time of the accident, a French Air Force AWACS was on a mission in the
region. Information relevant to the tracks of KSV 3275 and HCN 993 was provided
to the investigators. It showed an approximate speed of 250 kt for KSV 3275 and
of 400 kt for HCN 993. It allowed them to validate the track calculated from the pa-
rameters recorded on the aircraft's Flight Data Recorder (see 1.11.3) and to de-
termine the relative position of the two aircraft at the moment when HCV 993 be-
came number one for landing (see § 2.2).

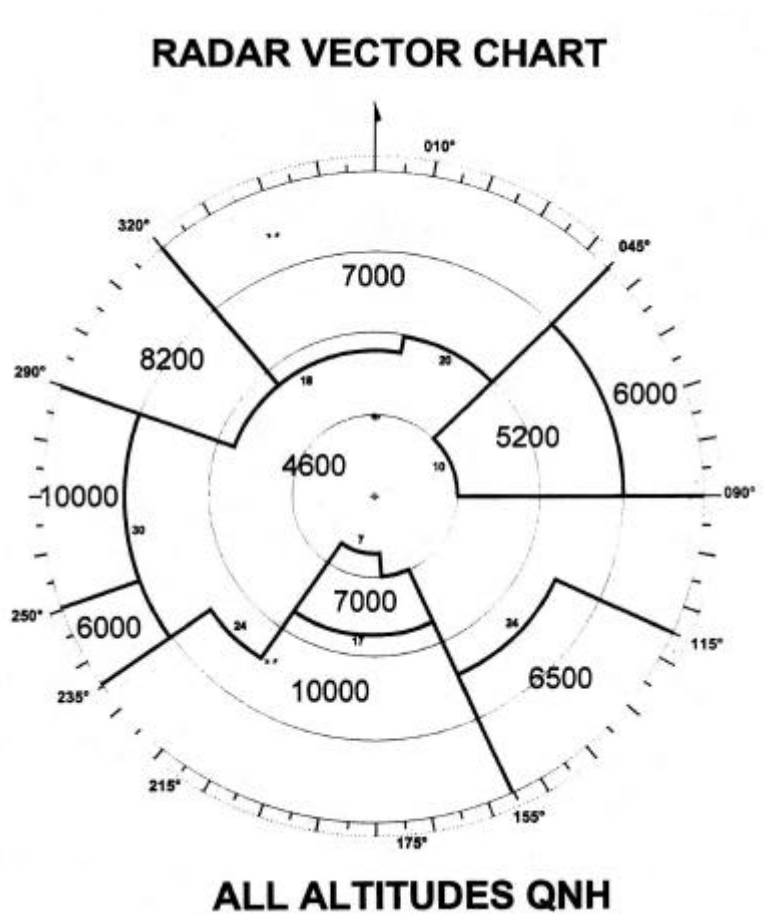
Figure 15 : Radar Vector Chart

Common practice at Pristina is to ask pilots their flight conditions and to offer radar vectoring to intercept the runway 17 ILS at 4,600 feet regardless of the flight conditions. Aircraft are vectored towards the north to go past the eastern edge of the CTR then to fix on the ILS by a left turn. The altitude instructions are given by the controller in accordance with the safety altitudes defined in the Radar Vector Chart (see fig.15).

Note : according to JSP 318A, pilots must notify the ATC of any change in flight conditions. This is not part of civil standards and practices.

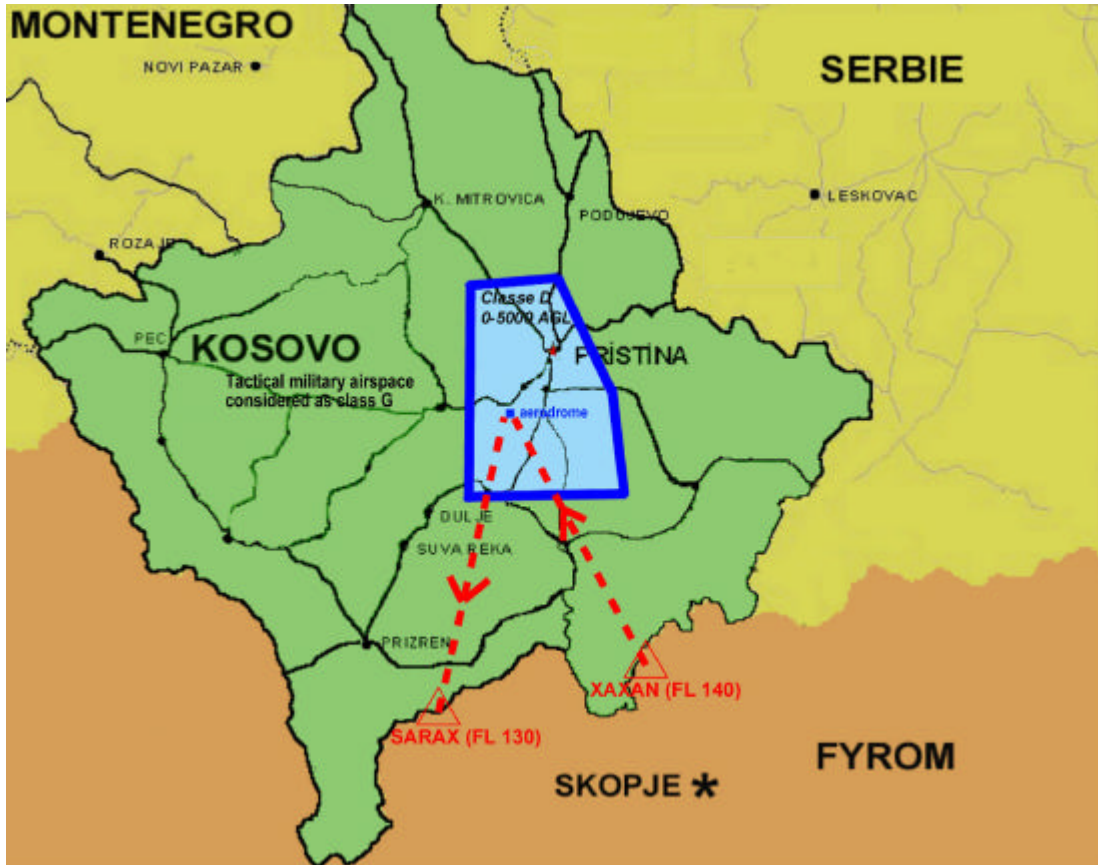
Figure 16 : Organisation of airspace in Kosovo

Only one arrival itinerary is possible. The Skopje control centre hands off aeroplanes going to Pristina via XAXAN waypoint at flight level 140. The forecast overhead time is transmitted by telephone to the Pristina approach controller, who takes over the flight from that moment on (see fig.16).

In addition, there are no documents indicating that aircraft arriving at Pristina must change flight rules and change to VFR. In practice, IFR flight plans remain active until landing.
