AIRCRAFT ACCIDENT REPORT 1/2020

Report on the accident to
Piper PA-46-310P Malibu, N264DB
22 nm north-north-west of Guernsey
on 21 January 2019

Air Accidents Investigation Branch

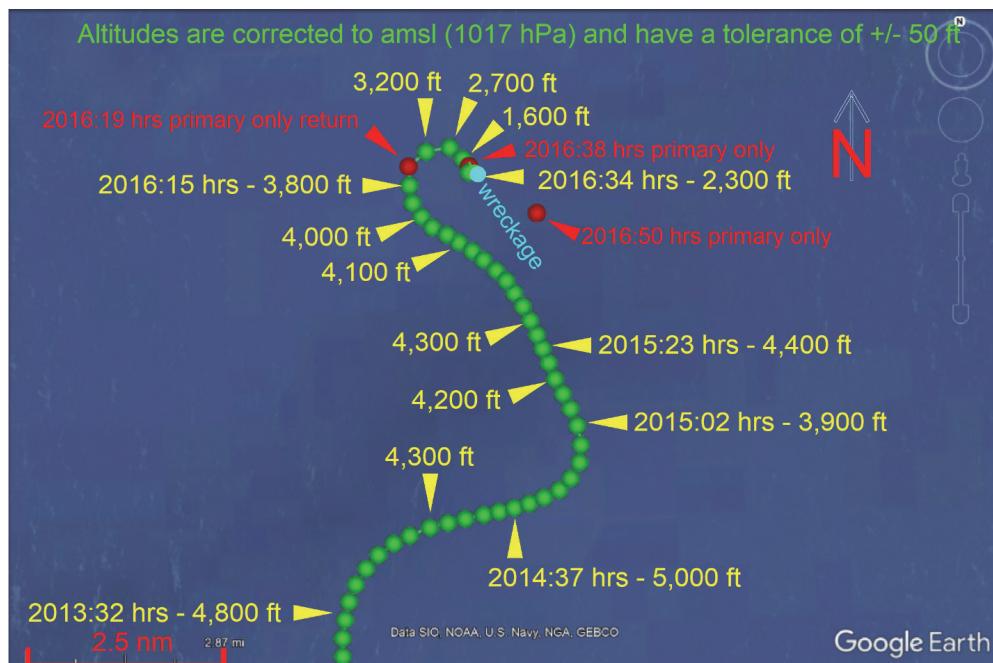
**Figure 12**

Radar track of final section of flight
(created from a combination of data from
Jersey (Les Platons) and Guernsey radars)

At 2012 hrs, when the aircraft was about 11 nm north of Guernsey, ATC gave permission for the pilot to descend below FL50, and this was the last communication with him. Shortly afterwards (Figure 12), a right, followed by left turn was flown, during which the bank angle reached about 56°, while the aircraft descended, climbed and then descended again at a vertical speed of about 5,000 fpm. This series of turns lasted about 90 seconds, and it was likely that they were flown to remain in, or regain VMC, but they resulted in a flightpath that was unstable and inconsistent with normal cruise flight or with use of the autopilot. The investigation concluded that the aircraft was being flown manually during this period, which was shortly before it entered the final descending turn to the right.

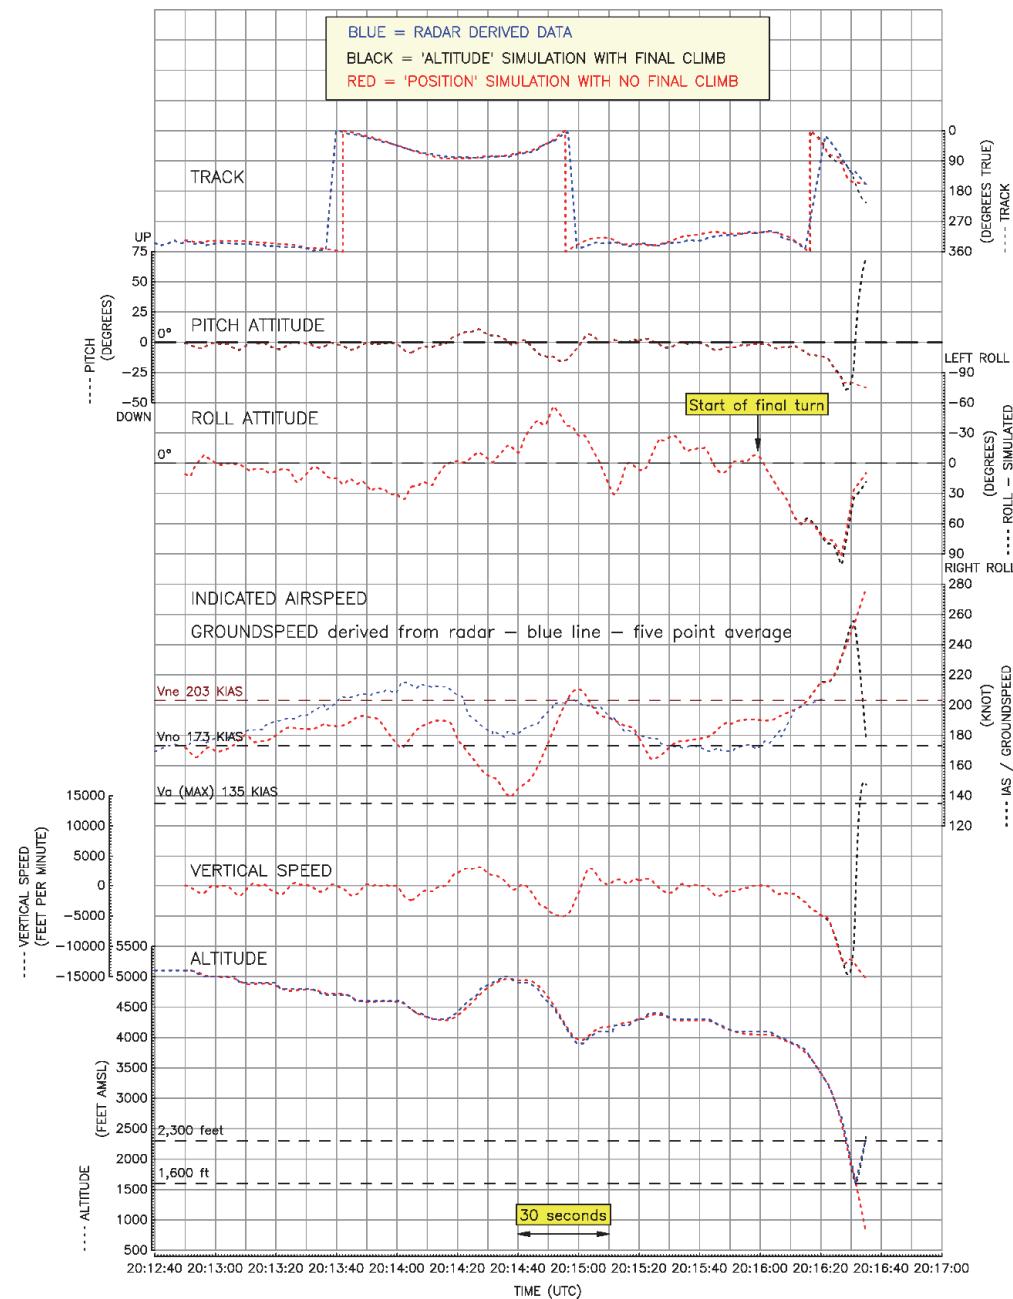
Figure 21

During the right and left turns which started at 2013:32 hrs (Figure 12), it was calculated that the aircraft's roll attitude reached maximums of about 36° right and 56° left. The pitch attitude reached about 10° nose up as the aircraft initially climbed at up to 3,000 fpm, and about 15° nose down as it descended at up to 5,000 fpm. The calculated airspeed also varied between about 150 KIAS and 200 KIAS during these manoeuvres.

The aircraft commenced the final turn from an altitude of 4,100 ft and a calculated airspeed of approximately 180 KIAS. As it entered the turn, the roll attitude progressively increased at an average rate of about 5° per second and the airspeed increased at about 1.4 kt per second. When the right bank reached about 30°, both simulations indicated that there was a slight pause of a few seconds before the roll angle began to increase again. When the aircraft was at 3,700 ft, the roll attitude had reached about 60°, the pitch attitude was

about 10° nose down, and the calculated airspeed was about 200 KIAS. There was another brief pause at this bank angle before it started to increase again. As the aircraft descended through 2,700 ft, the right bank had increased to about 90°, the pitch attitude was 30° nose down, and the estimated airspeed had increased to about 235 KIAS.

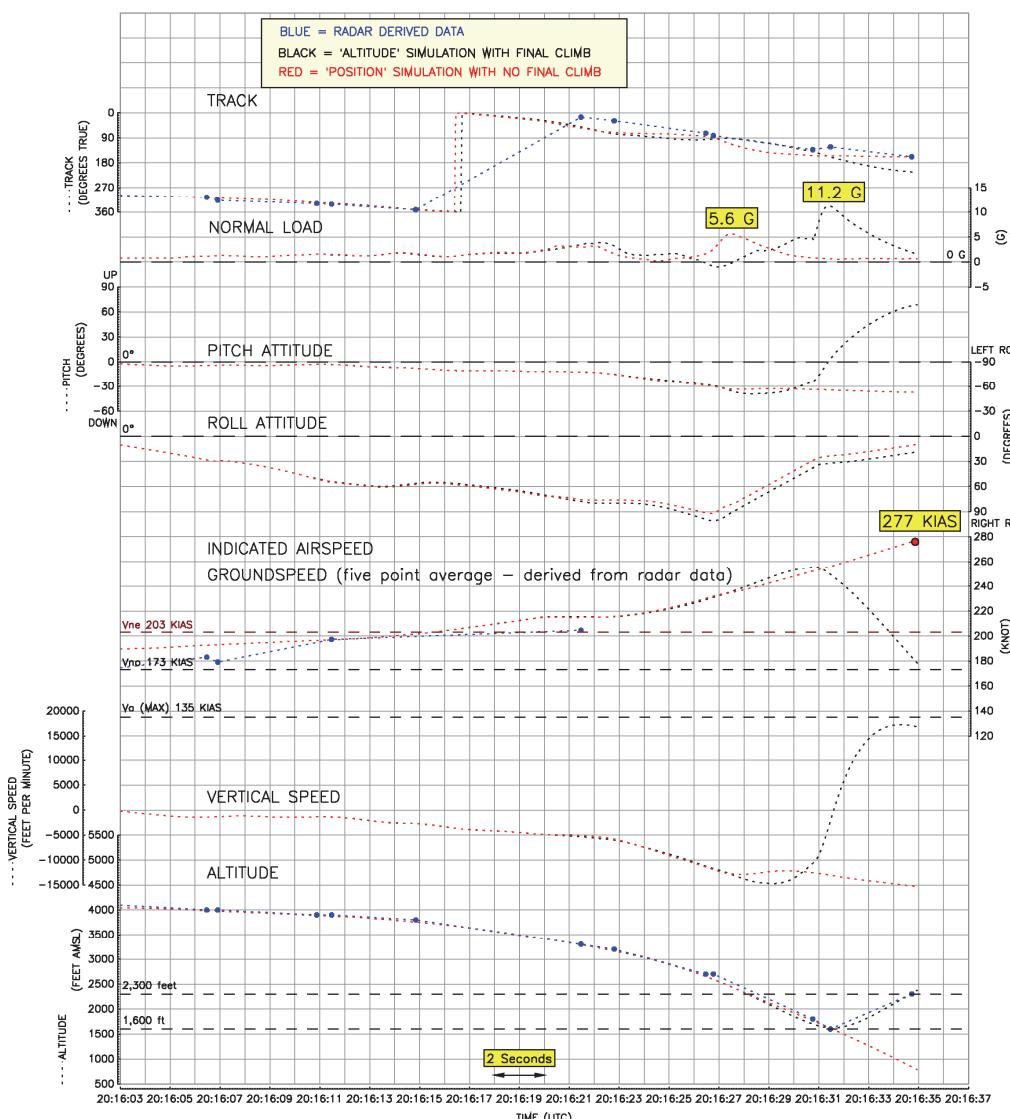
**Figure 22**

Estimated normal loads from simulations of final manoeuvre
(commencing at 2016:03 hrs)

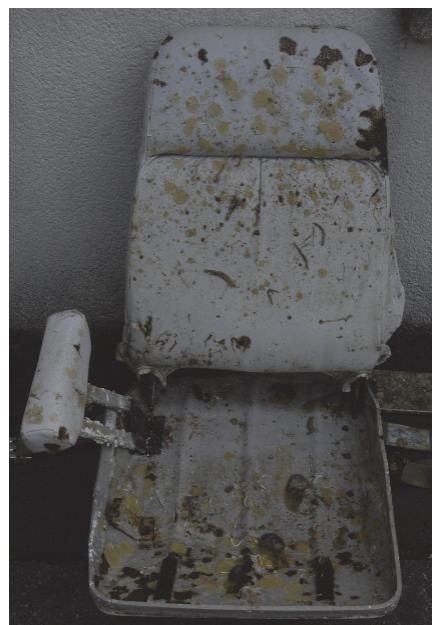
Figure B-2
Passenger seat from N264DB

On 26 September 2019, the crew of a trawler informed the French authorities that they had brought up what they believed to be an aircraft seat while conducting a trawl approximately 7 km to the west of the location of the main wreckage site. The seat was assessed by the AAIB as the left middle passenger seat from N264DB (Figure B-2).

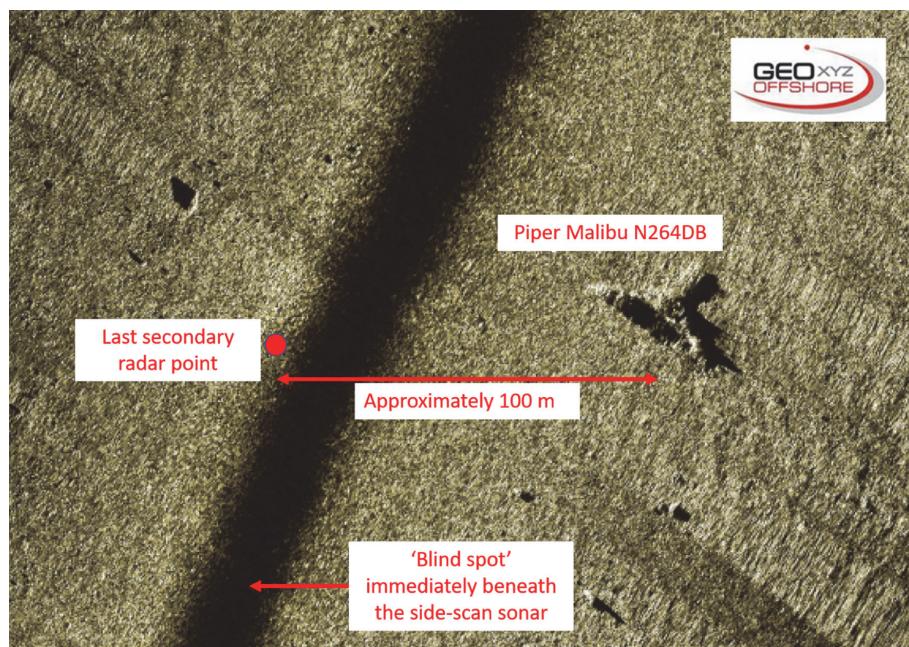
Figure B-5
Side-scan sonar image of N264DB

Both vessels began their side-scan survey of the seabed on the morning of 3 February 2019. Early in the search, the FPV Morven identified an object of interest at a depth of approximately 68 m and cleared the immediate area. The Geo Ocean III subsequently used its own side-scan sonar to observe the object (Figure B-5).

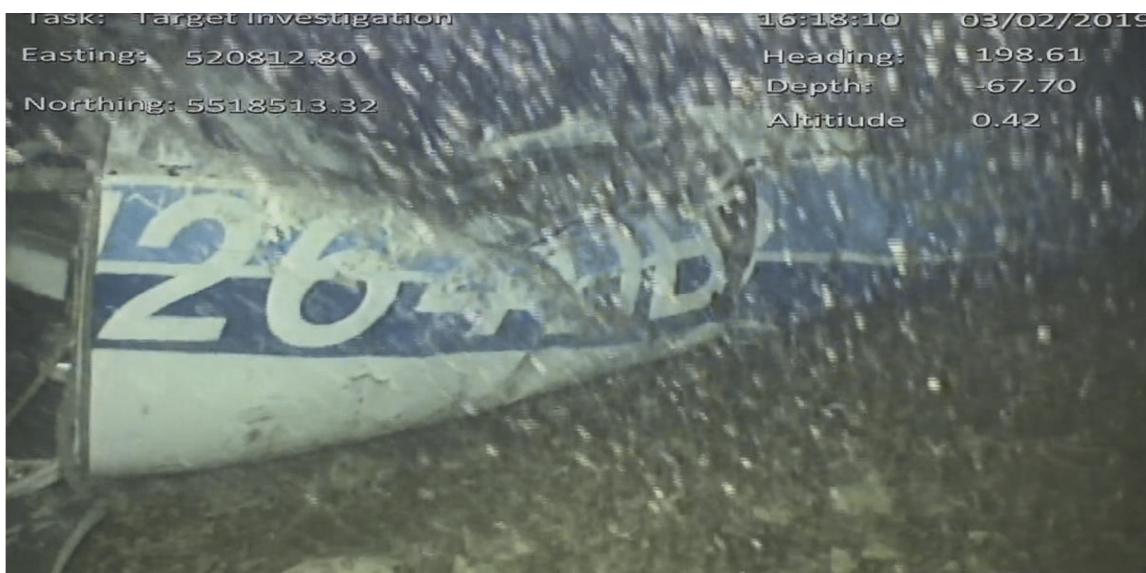
**Figure B-6**

The Geo Ocean III began a search of the seabed near the object of interest using its ROV, which was equipped with a video camera, and the object was identified as the wreckage of N264DB (Figure B-6).

Tail section of N264DB on seabed at a depth of 68 m
