Bureau of Air Safety Investigation

**MU-2 ACCIDENT INVESTIGATION**  
and  
**RESEARCH REPORT**

**VH-BBA near Leonora WA, 16 December 1988**  
**VH-MUA at Meekatharra WA, 26 January 1990**

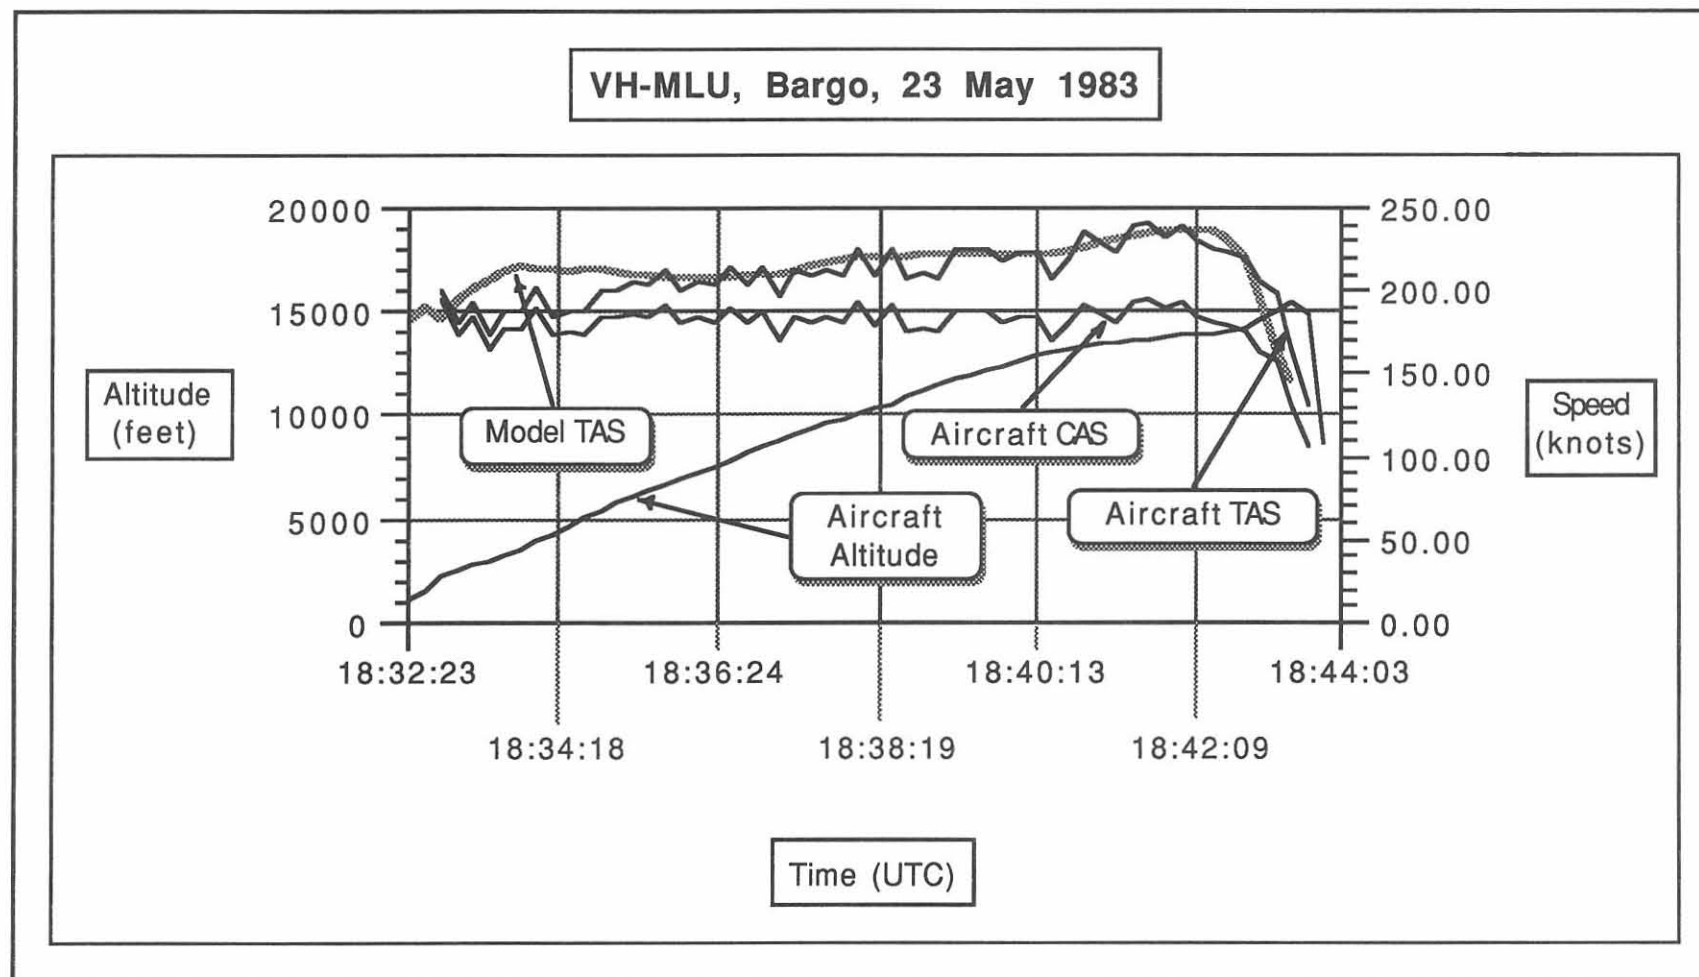
# CASE 1

VH-MLU: The model was able to approximate the climb profile to 12900 ft using MCP and small changes in attitude only. The resultant TAS profile appeared to be a smoothed version of the averaged radar data. An average icing factor of 40% was required to be applied to the model to simulate the reduced rate of climb between 12900 ft and 14250 ft. The final deceleration of the aircraft to the loss of control speed was simulated by a combination of a further increase in icing to 85%, and a large increase in attitude to produce a similar TAS and altitude profile to that of the aircraft. At the loss of control altitude of 15500 ft, the averaged aircraft TAS was 164 kts (131 kts CAS) compared with the model 158 kts TAS.

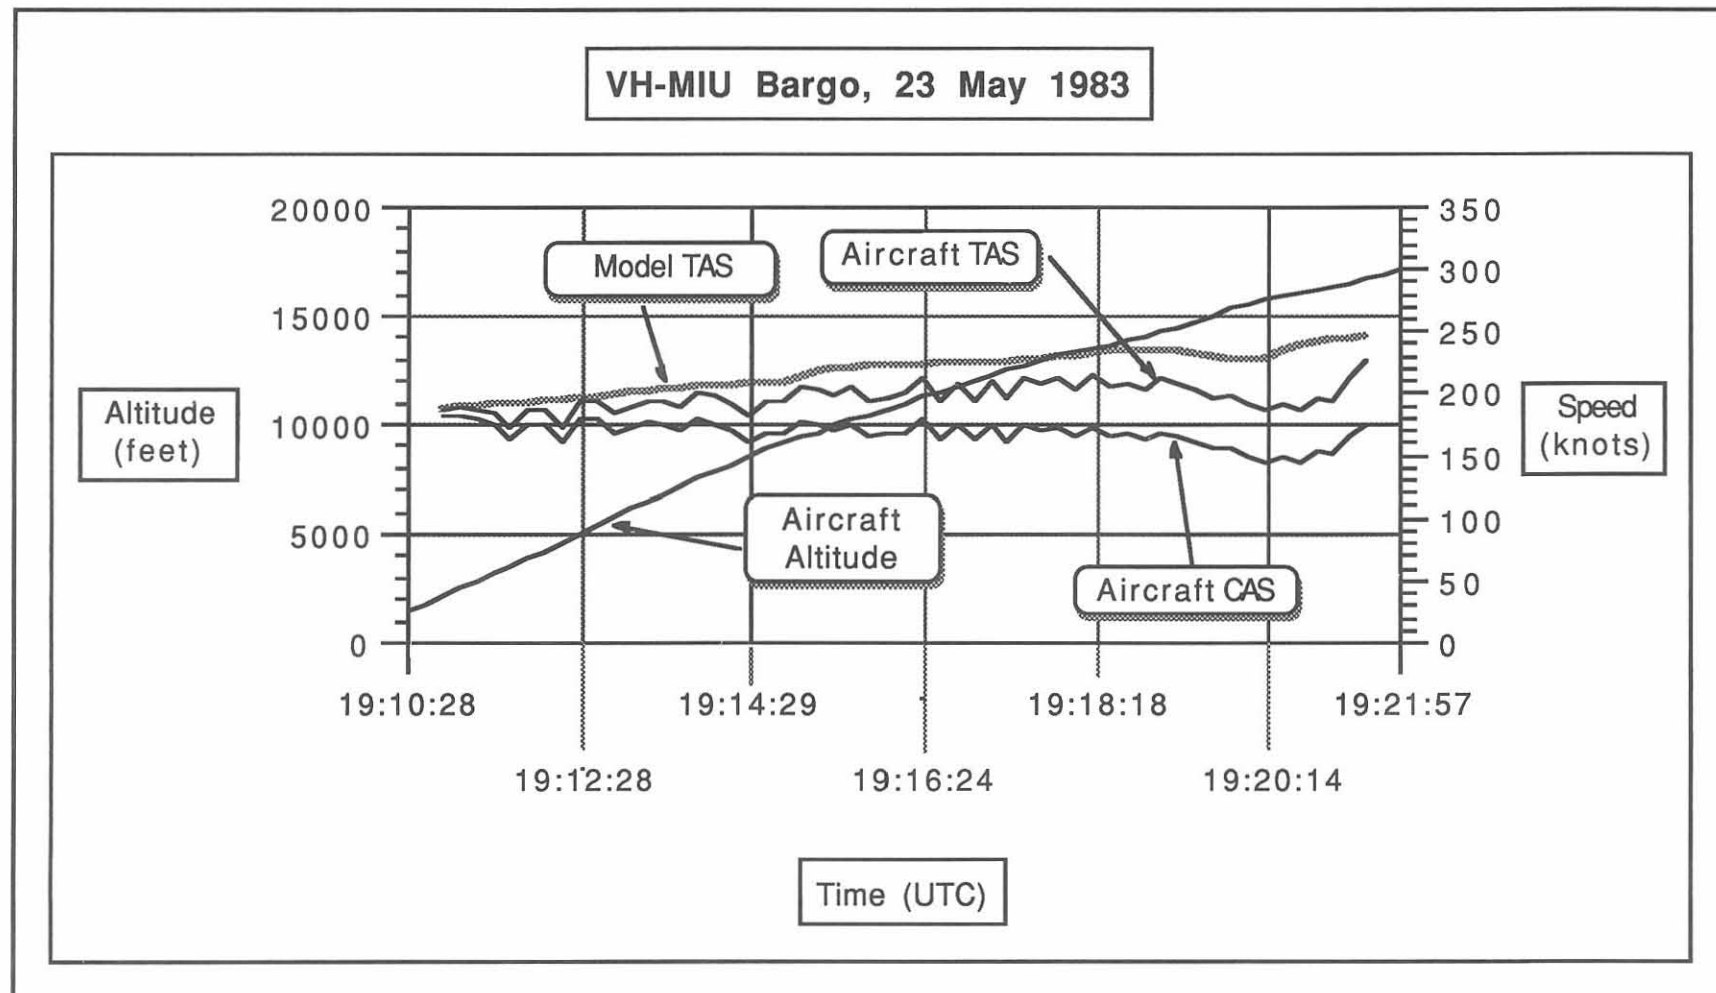
## CASE 2

VH-MIU: The climb for this aircraft was modelled by using MCP and changes in aircraft attitudes but without the addition of any icing factors. The model produced good agreement with the recorded data to 9 400 ft, and then diverged from the recorded data and climbed faster than the aircraft to the top of climb. No explanation was determined for this observation.

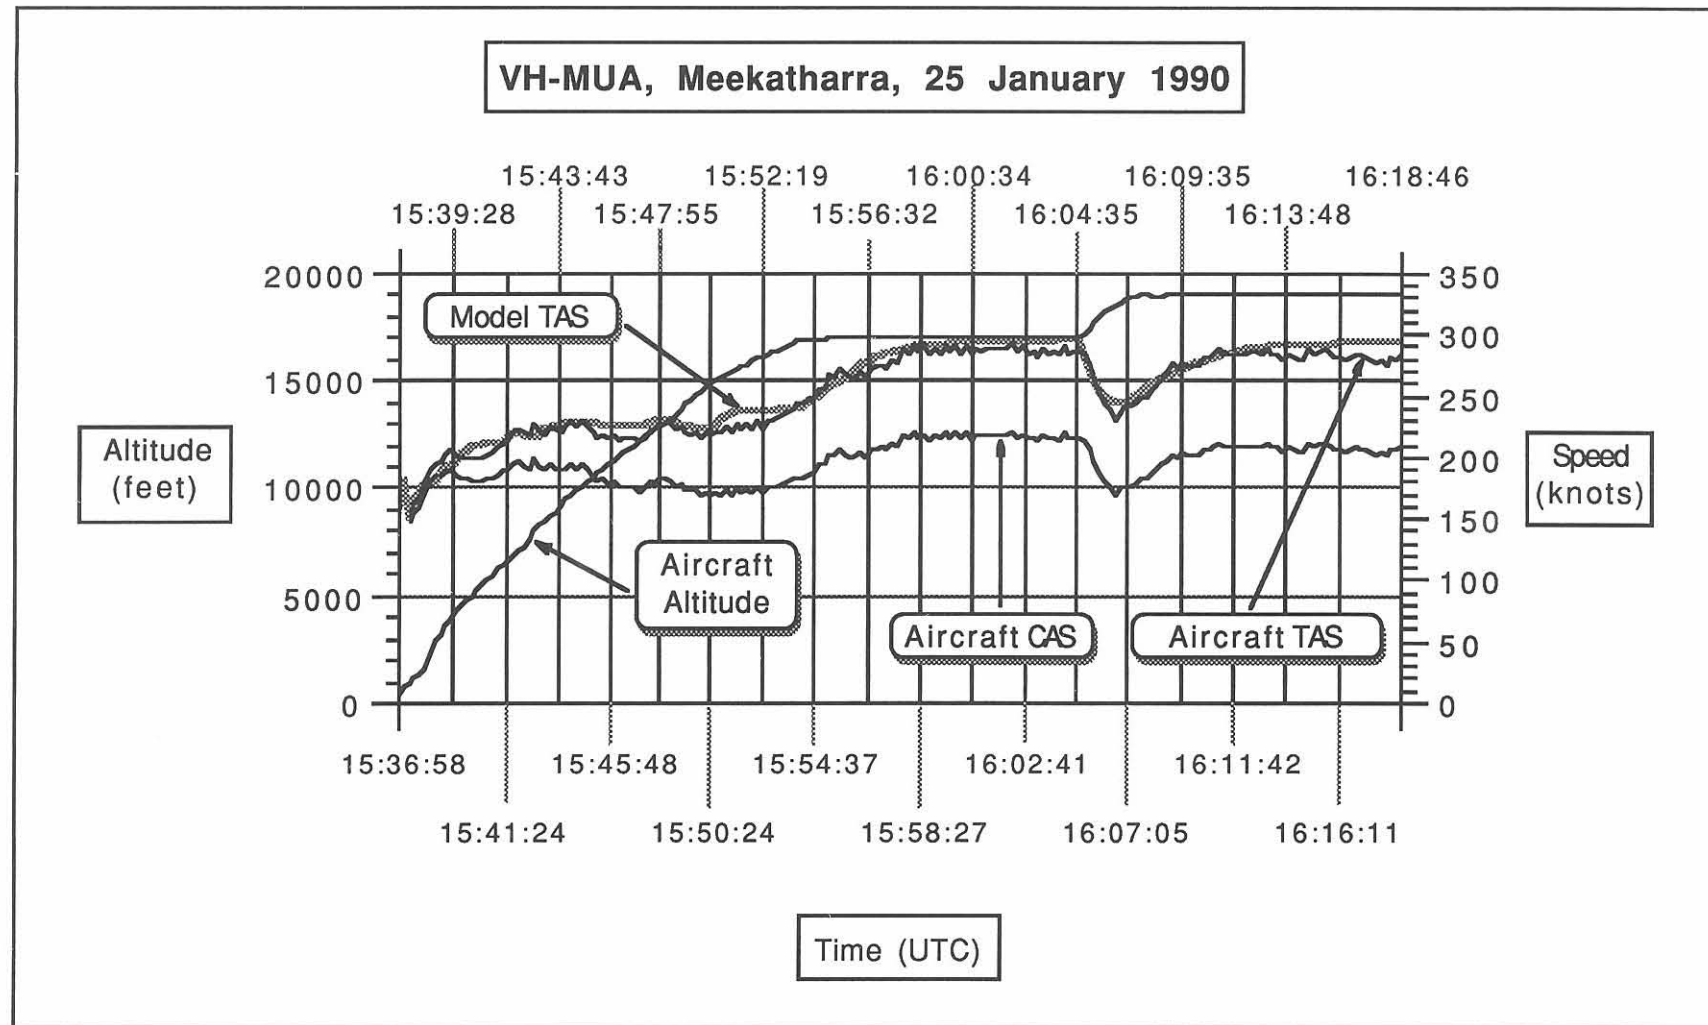
VH-MUA: The model was used to reproduce the radar flight profile for this aircraft from shortly after take-off until the end of the recorded radar data at 160 nm from Perth. Using MCP, the model produced a good likeness to the recorded data, except for the latter stages of the initial climb, where the model outclimbed the aircraft. By reducing the power at the top of both the initial and en route climbs, the model was able to reproduce the step in airspeed seen in the recorded data at the commencement of both cruise segments. No IFs were introduced during the flight comparisons and the simulations indicated that MCP was most probably used during the recorded cruise segments. No attempt was made to reproduce the speed variations seen towards the end of the recorded data due to the unknown nature of the variations and their frequency.

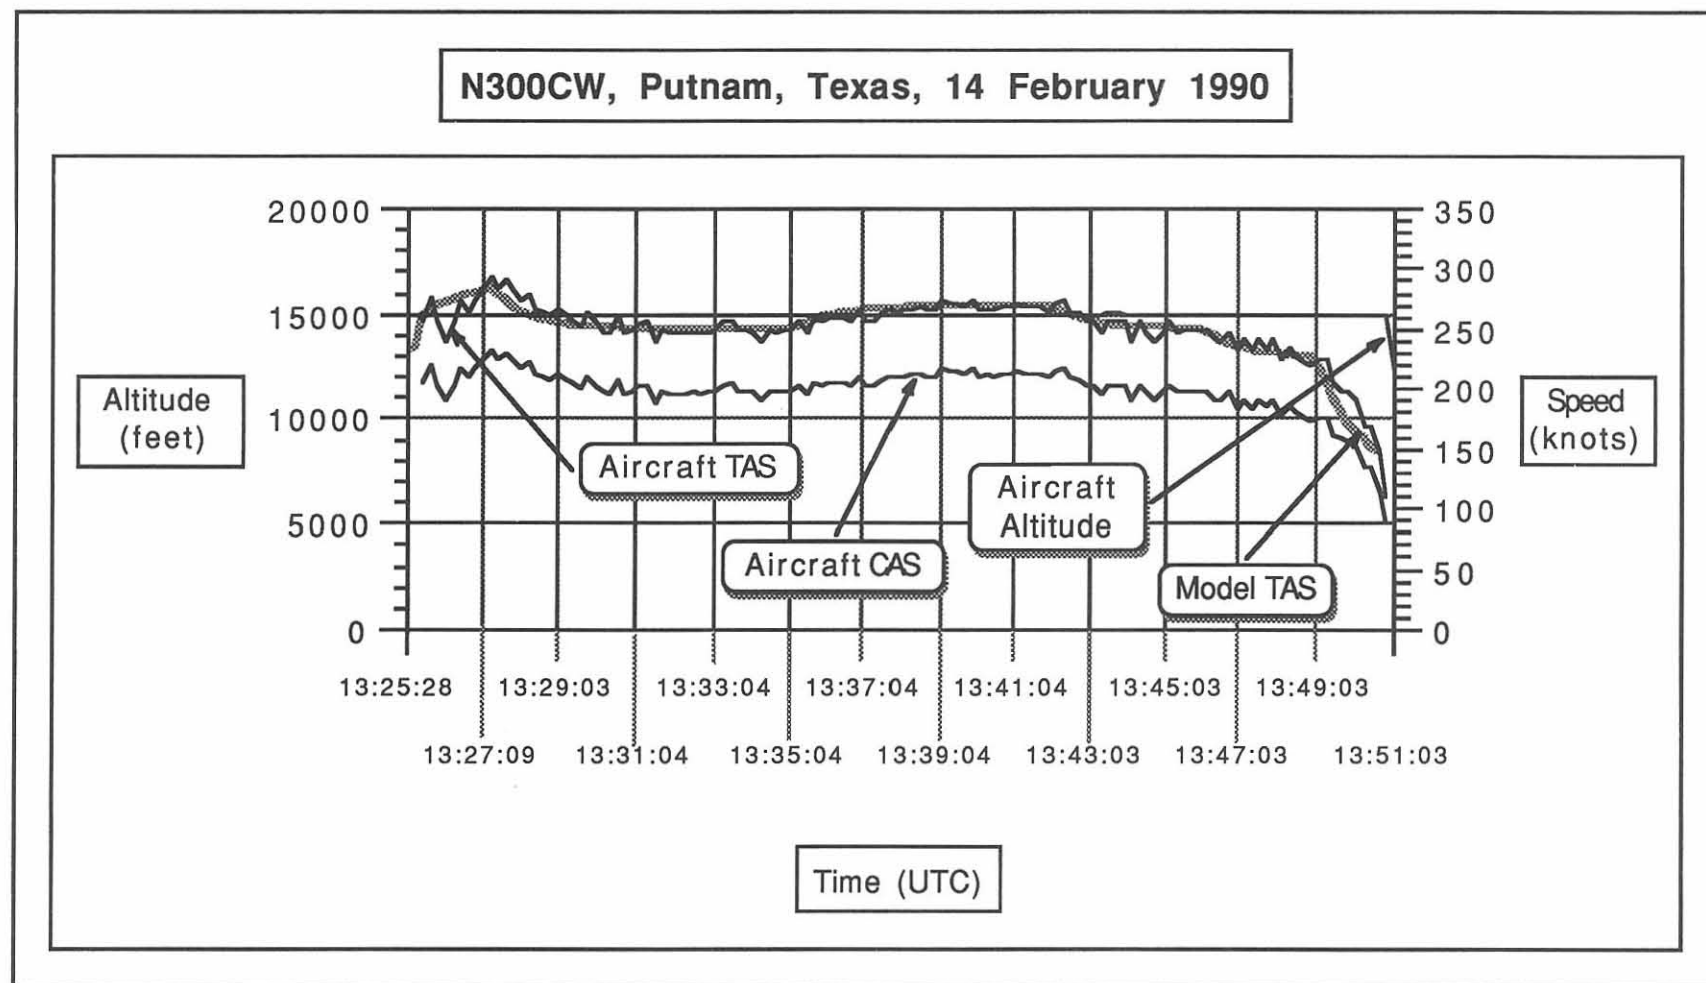
## CASE 4

N300CW: The model produced an excellent likeness to the recorded data provided by the NTSB investigation team. The accelerations and decelerations seen in the data were simulated assuming an accumulation and shedding of ice. Throughout the simulations, 100% power was used and IFs were progressively added to reproduce the actual flight. The recorded data showed that control was apparently lost at a TAS of 146 kts (116 kts CAS), and the model simulated the final deceleration to a TAS of 155 kts with an approximate icing factor of 1.85 (185%).

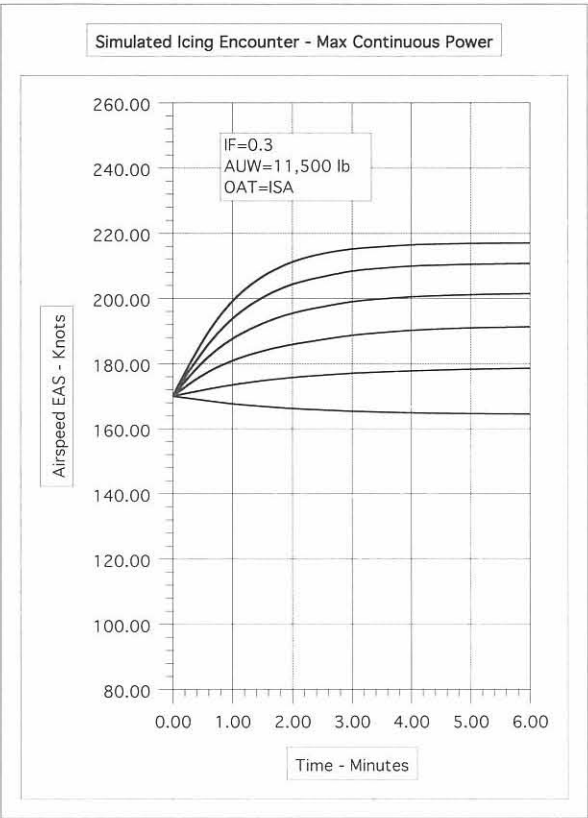
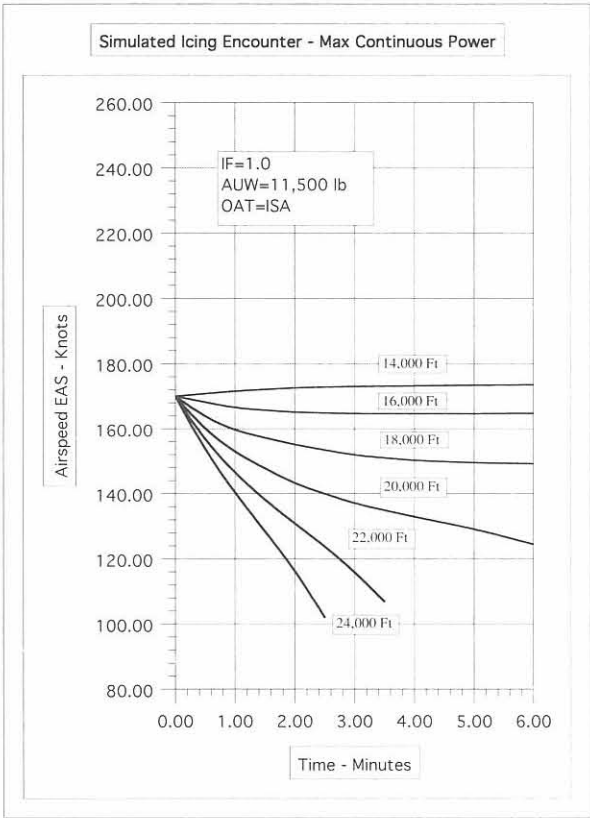
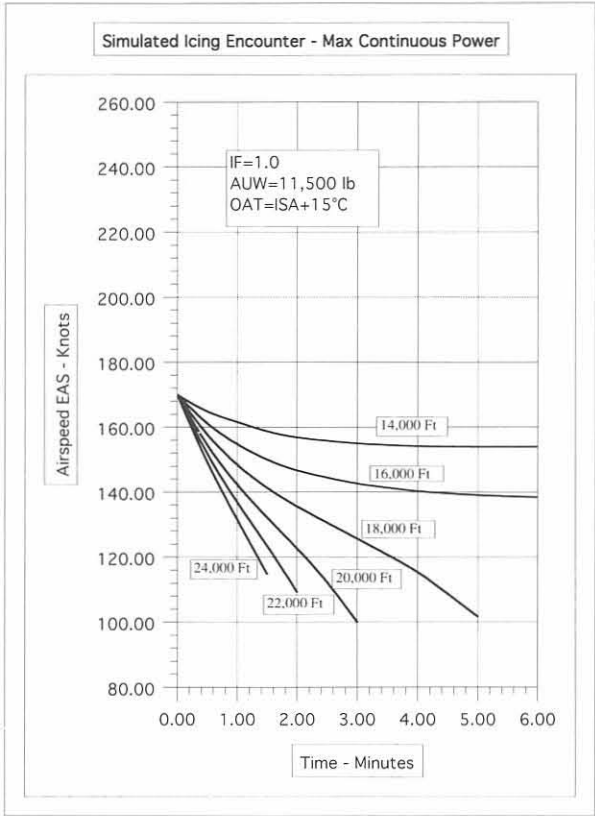
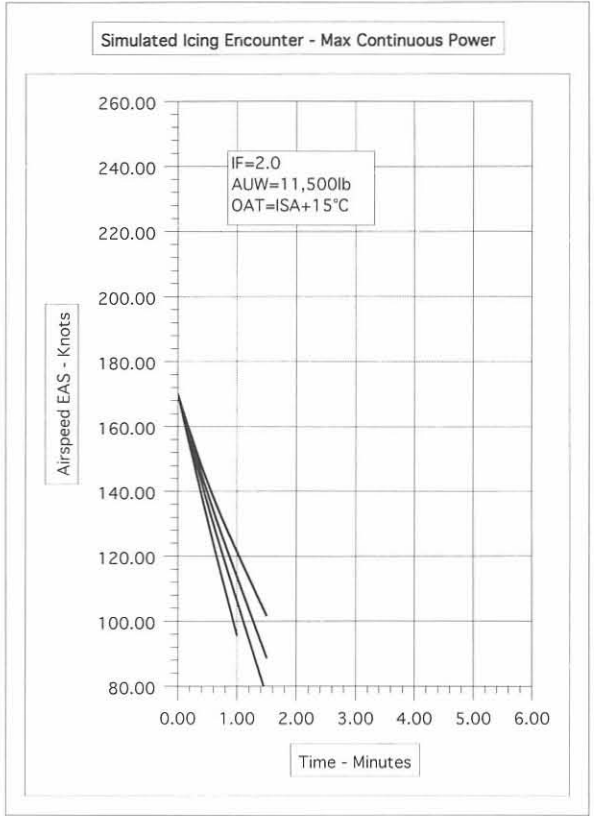
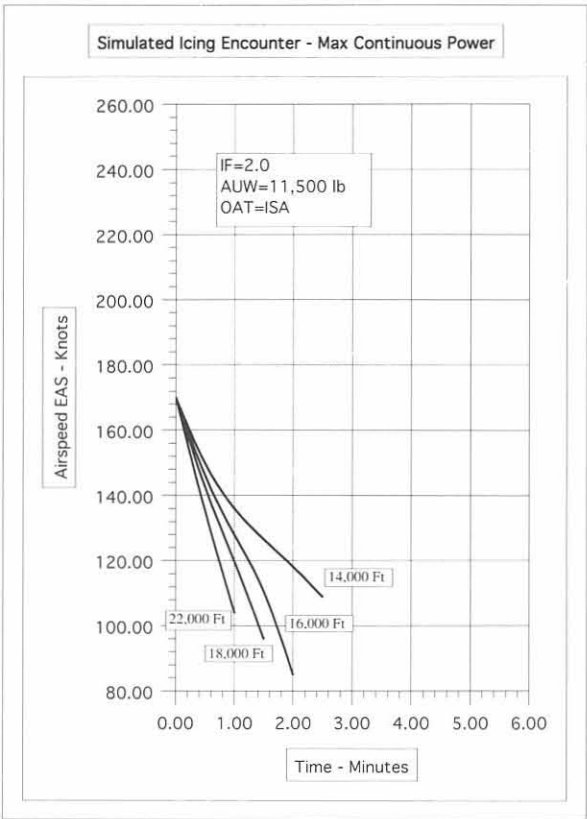
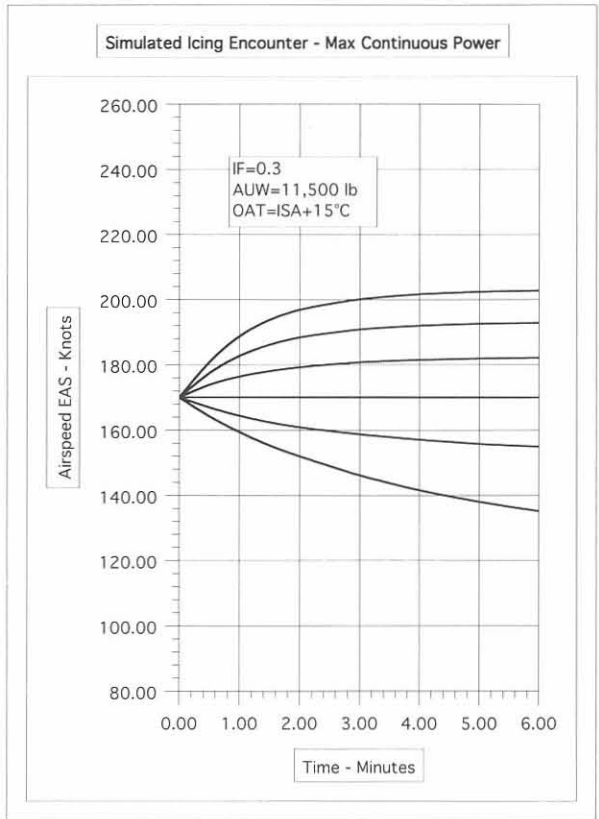
Simulation of the performance of the MU-2 in ice at high altitudes, particularly when the encounter is with moderate or severe ice, indicates a very high rate of speed loss. For example, at the altitude (21 000 ft) and temperature (ISA+12°C) at which VH-MUA was operating, the results indicate that decelerations of about 40 kts/min for moderate icing (IF=1.0), and about 90–100 kts/min in severe icing (IF=2.0), could be experienced. Such decelerations would require a very rapid response from the pilot if a stall was to be avoided, particularly if the autopilot was engaged in the altitude-hold mode. The graphs below show the results of the simulations.

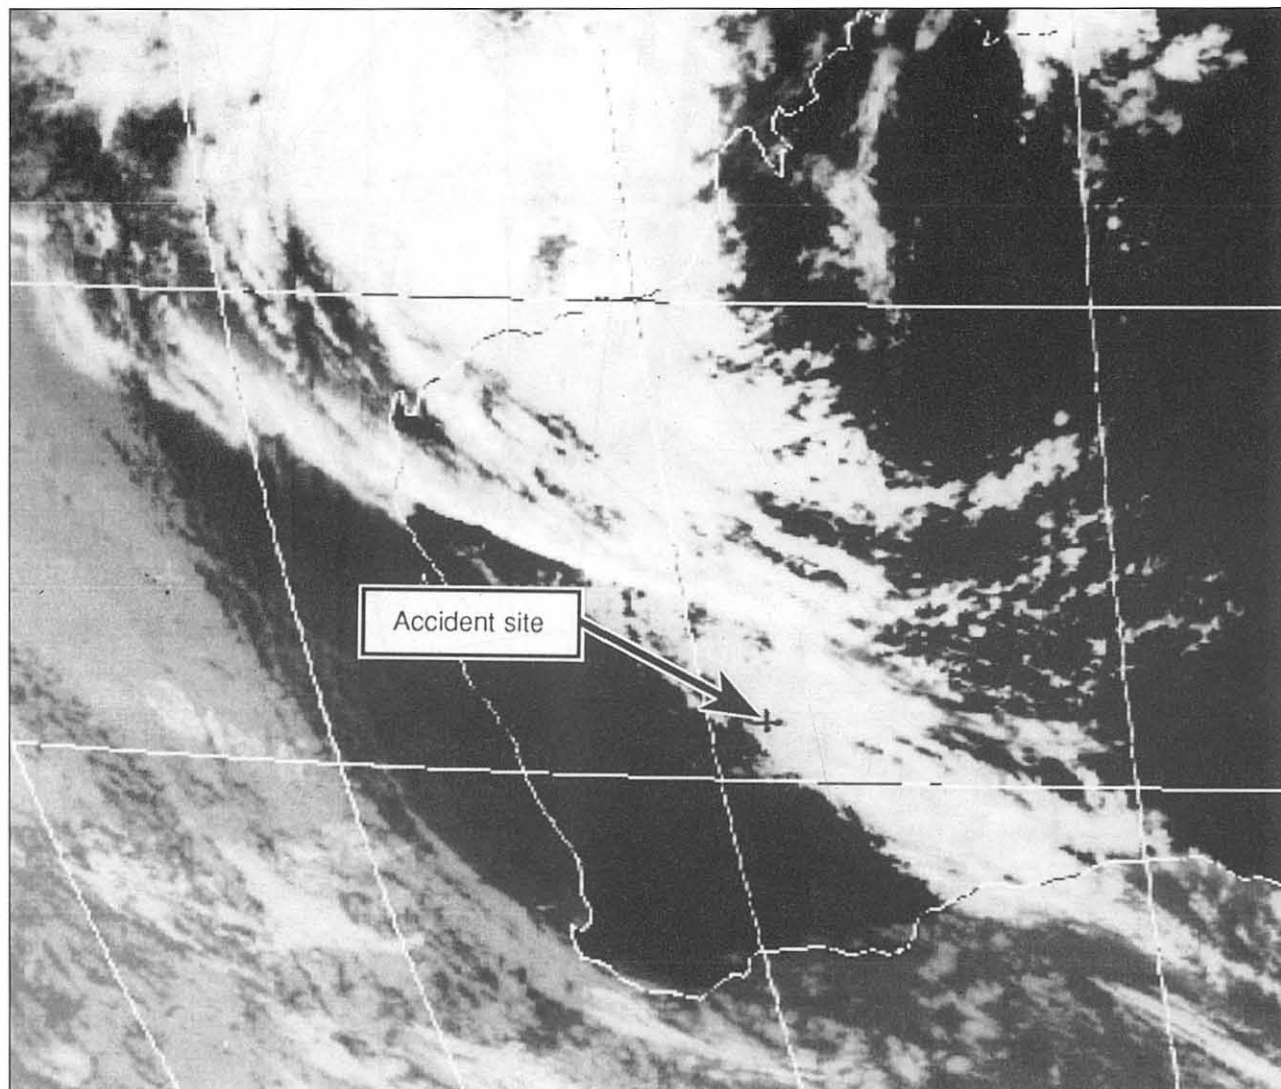
Weather situation 45 min after the Leonora accident involving VH-BBA

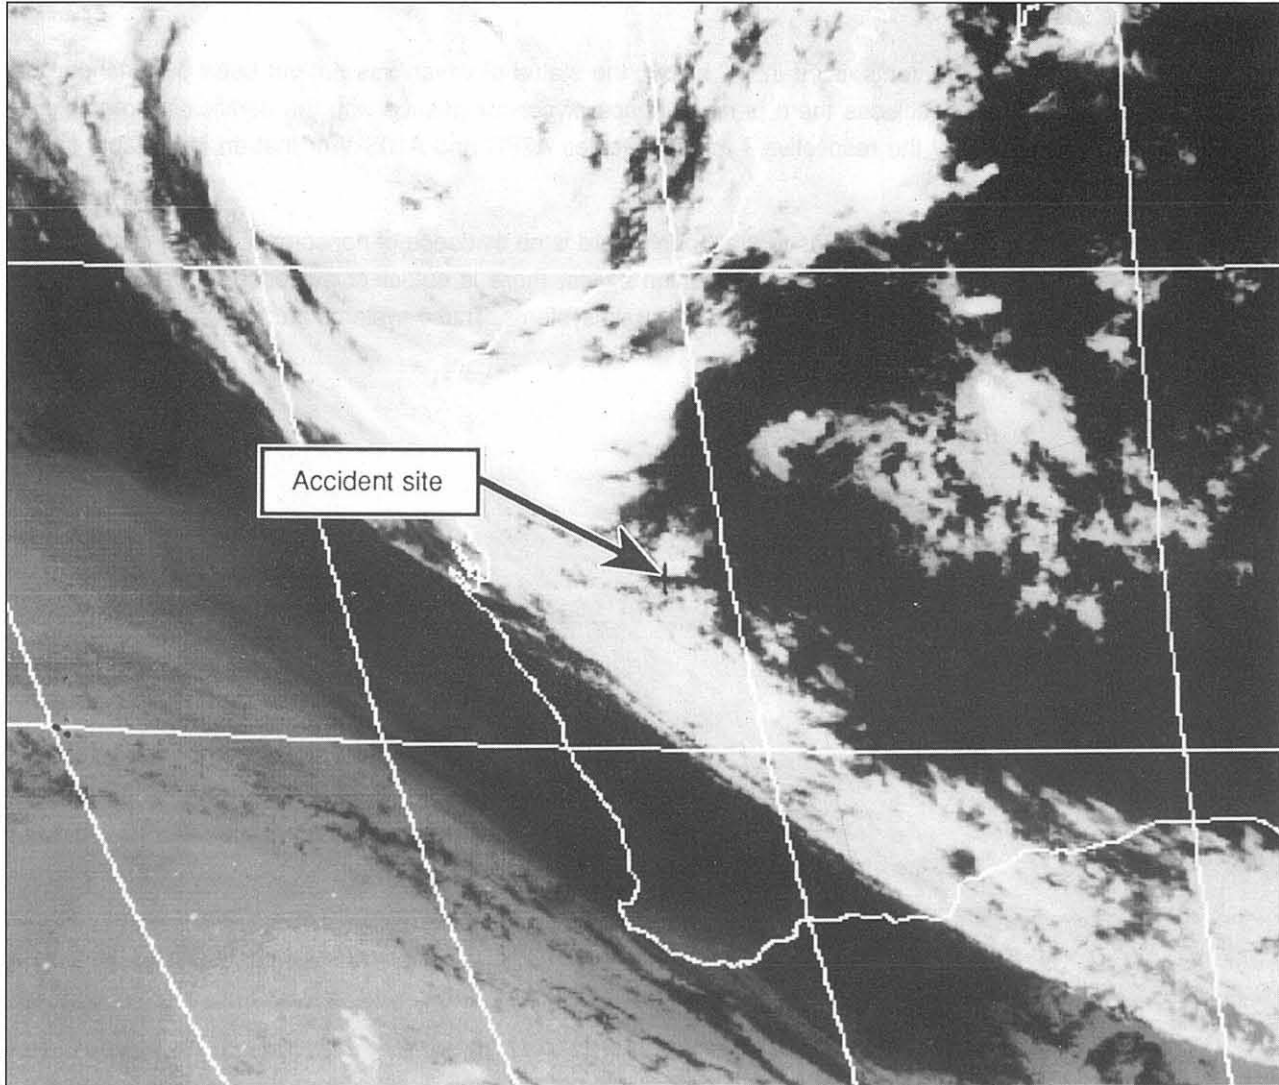
Weather situation 2 hrs 5 min before the Meekatharra accident involving VH-MUA

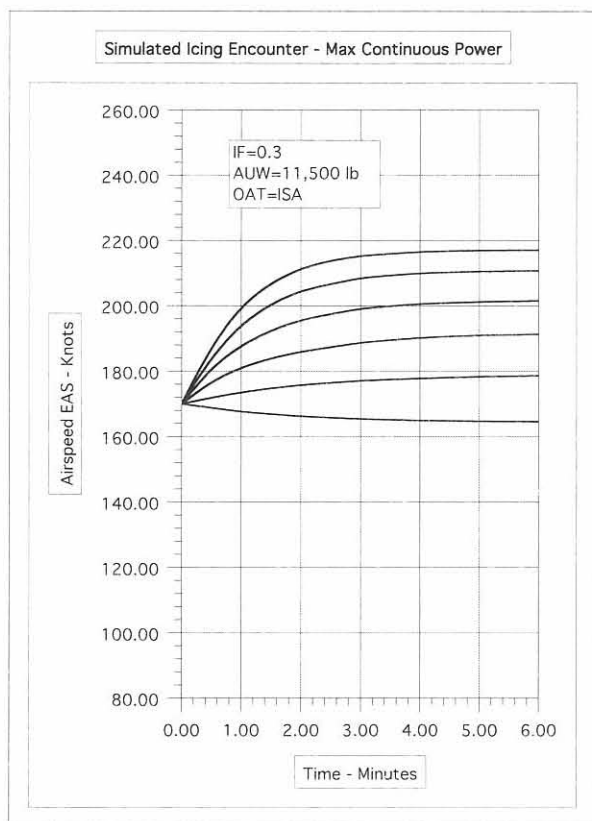
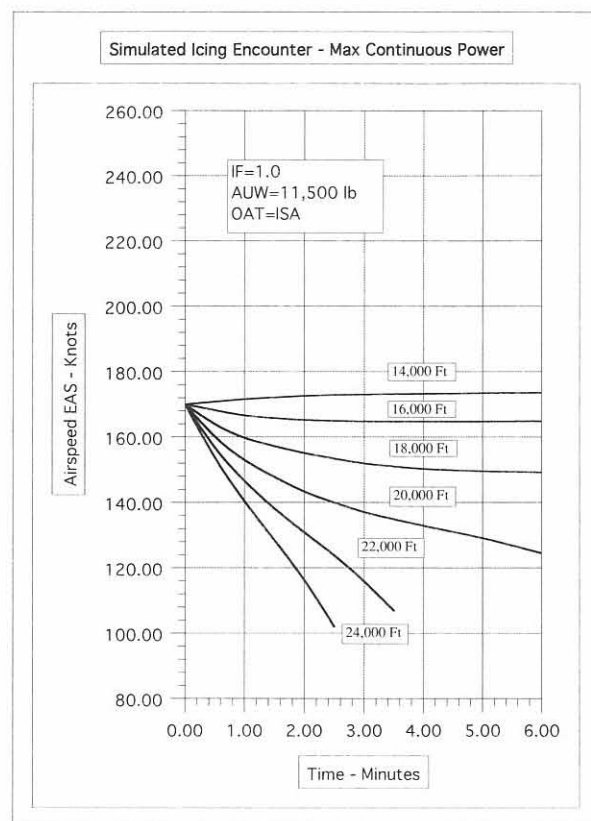
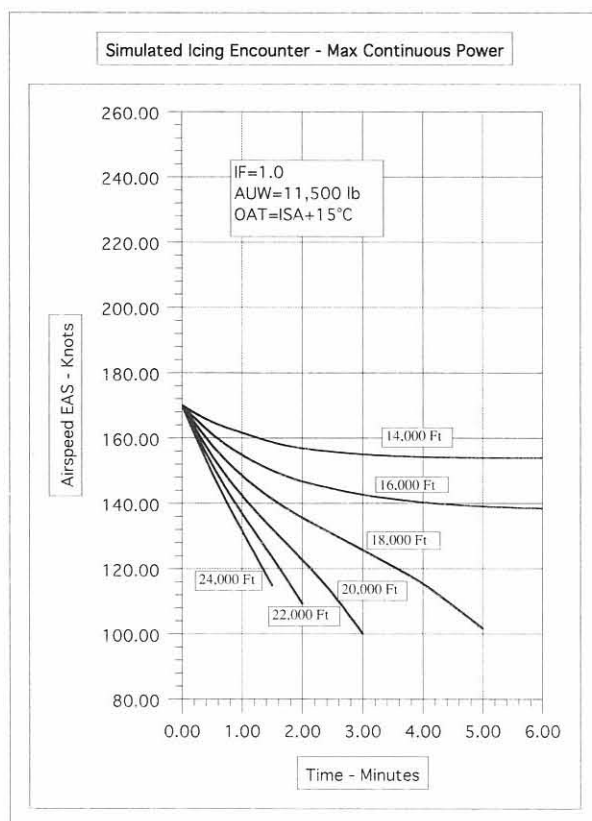
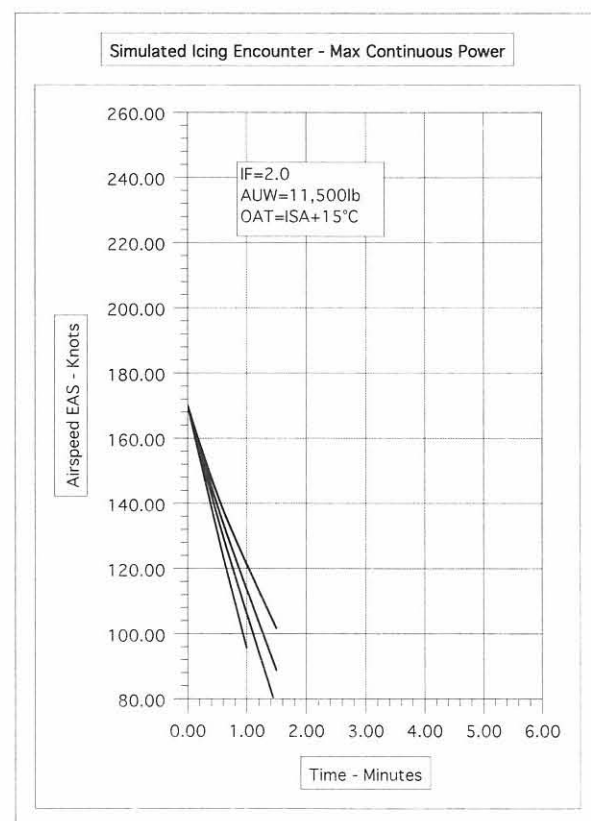
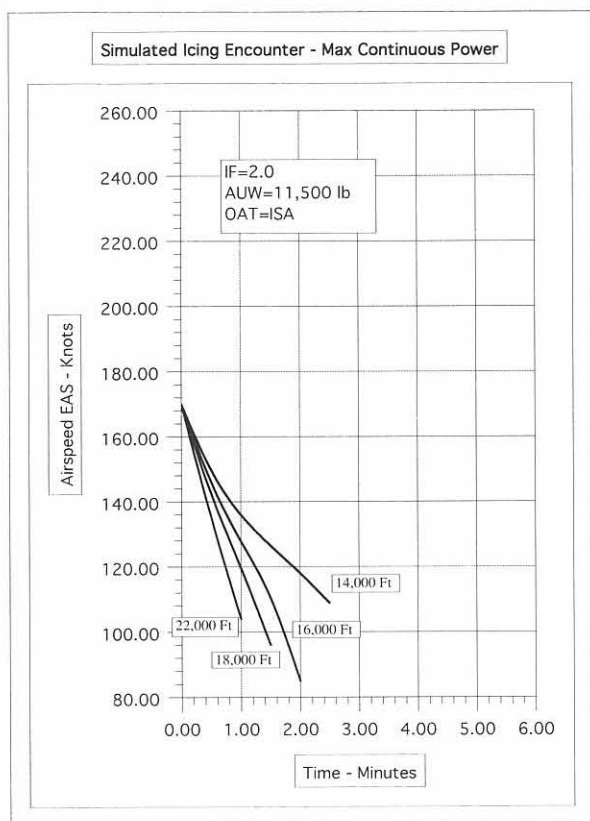
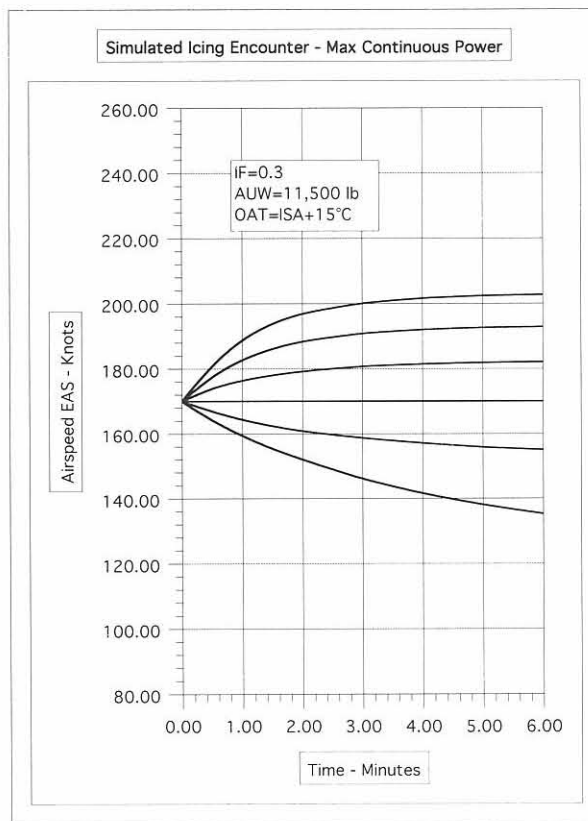
Figures 1a to 1f show the aircraft accelerating (or decelerating) from 170 kts at MCP. The results indicate that the aircraft can only maintain altitude and a reasonable flying speed at very light icing conditions below about 18 000 ft. Under moderate (IF=1.0) or severe icing (IF=2.0) the speed decays, sometimes at alarmingly high rates. For example, a severe encounter (IF=2.0) could cause the speed to decay to the stall speed in about 1 min or less for all altitudes above 14 000 ft.

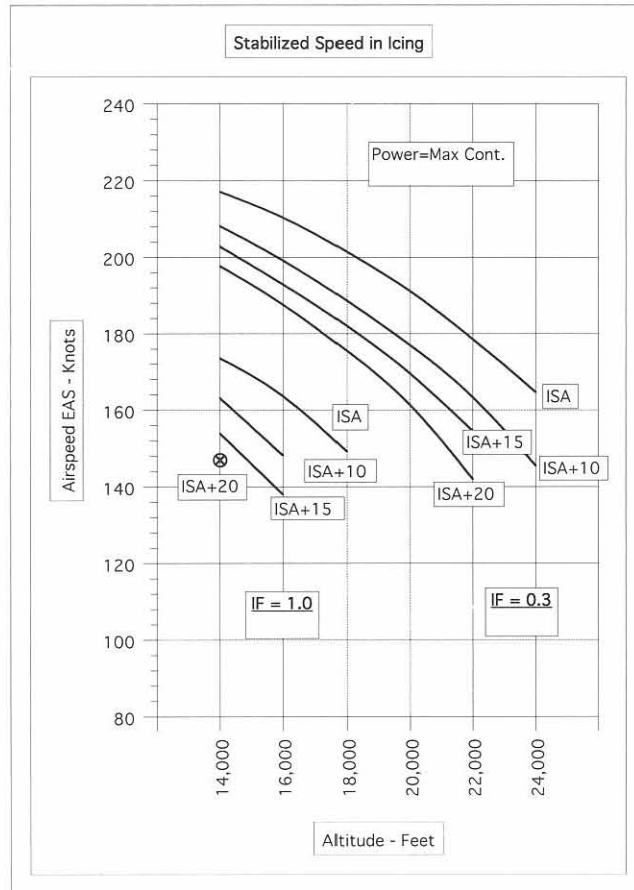
Figure 2

The speed at which the aircraft will stabilise in level flight and MCP is shown in figure 2. Note that no data is shown for IF=2.0. This is because the aircraft speed would not stabilise under any of the combinations of altitude and outside air temperature (OAT).

Even under moderate icing conditions (IF=1.0), a reasonable flying speed could only be maintained at temperatures close to ISA standard and relatively low altitudes of approximately 14 000 ft.

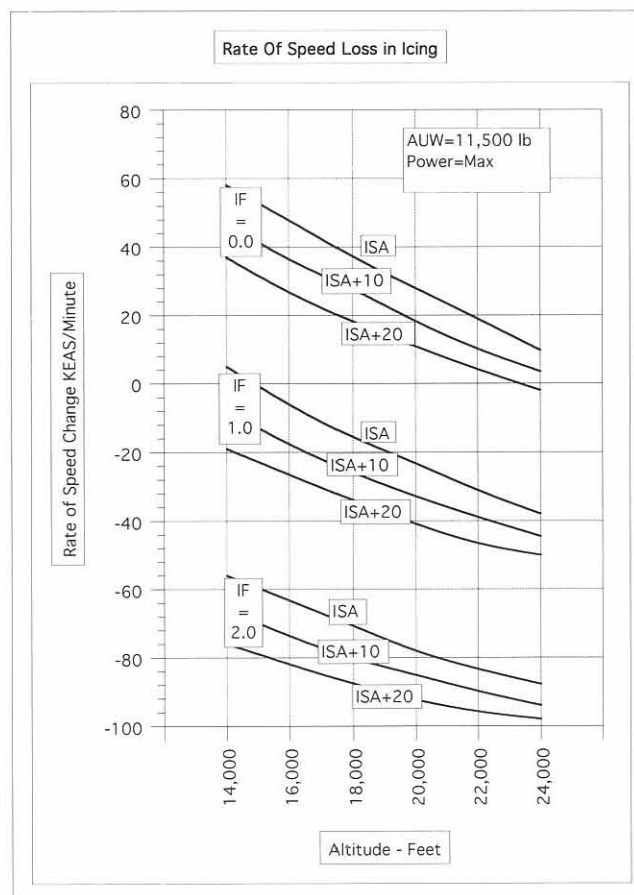
Figure 3

Finally, figure 3 shows the rate of speed loss as the aircraft accelerates or decelerates through 170 kts EAS. The aircraft weight is 5216 kg and MCP is selected. Temperatures range from ISA to ISA+20°C and icing factors of 0.0, 1.0 and 2.0 are used. The data indicates that the clean aircraft performs quite well at all conditions except high altitudes and high temperatures. However, when icing (either moderate or severe) occurred, the rate of speed loss was very high. For example, at the altitude and temperature VH-MUA was operating (21 000 ft and ISA+12.5°C), decelerations are of the order of 40 kts/min for moderate icing (IF=1.0) and about 90–100 kts/min for severe icing (IF=2.0).
