ACCIDENT INVESTIGATION REPORT
BUREAU OF AIR SAFETY INVESTIGATION

BASI REPORT B/901/1047

Beech King Air E90 VH-LFH
Wondai, Queensland
26 July 1990

Report B/901/1047

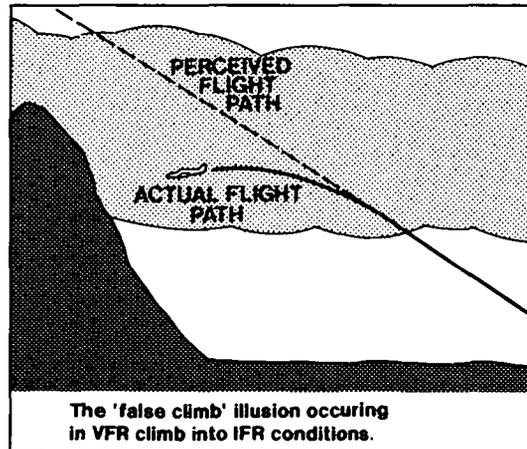
Figure 1

Many accidents are reported in which aircraft, flown by instrument-rated pilots strike the tops of hills in cloud or poor visibility, or crash into the ground after takeoff on dark nights (see Figure 1). The actual cause of these accidents is difficult to establish as they are usually fatal and the aircraft is extensively damaged. An inordinate number of such accidents occur within a few feet of safety and it seems reasonable to presume that many other aircraft, in similar circumstances, escape the same fate by a small margin and fly on without being aware of their proximity to a disaster.

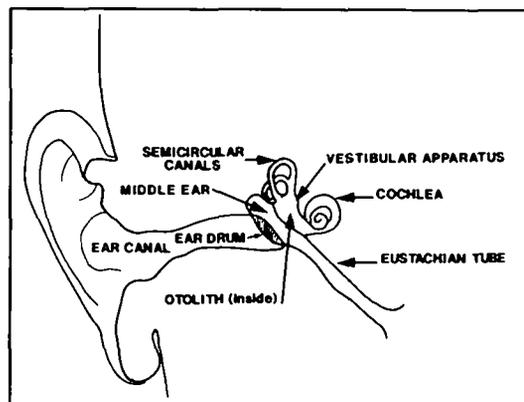
Figure 2

The main culprit in this illusion was found to be the otolith — an organ which forms part of the inner ear and vestibular apparatus, as illustrated in Figure 2. The otolith has its own special function — to sense and signal to the other organs, the position of the head relative to the vertical. In the absence of visual cues, this signal becomes a powerful influence on the balance and orientation of the body. Without the otolith, it would be impossible to maintain one's balance with the eyes closed.

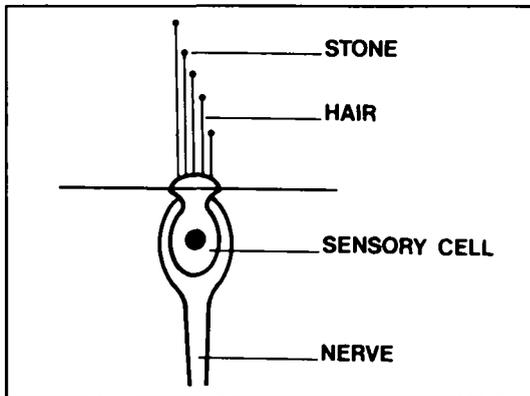
Figure 3

A detailed description of the structure and function of the otolith is outside the scope of this article but in relation to the 'false climb' illusion, it can be illustrated (see Figure 3) as a hair which stands vertically with a small stone at its tip. The base of the hair is inserted into a sensory cell which conveys information about the angle of the hair, to the brain.

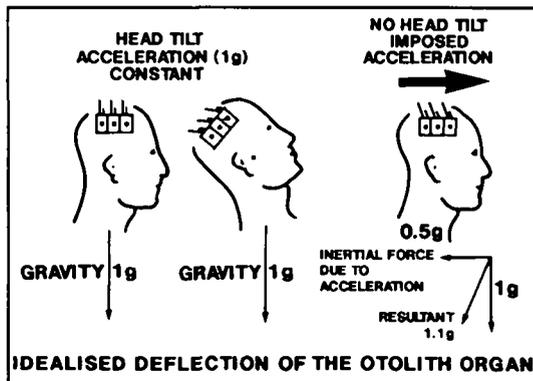
Figure 4

When the head is tilted backwards, as in Figure 4, the weight of the stone bends the hair and this message is relayed by the sensory cells to the brain, where it is interpreted as a backward tilt. If the head is held vertical and is accelerated forwards, the hair will bend in a similar fashion owing to the inertia of the stone. Thus, both tilt and acceleration produce the same response by the otolith. However, the brain is unable to differentiate between these responses. 'Acceleration' is read as 'tilt'.

If tilt and acceleration are experienced simultaneously, and in the same direction, the interpretation is that of a much steeper tilt. This is the explanation of the 'false climb' illusion. *When a pilot is subjected to climb and forward acceleration at the same time, and deprived of external visual cues, he experiences a strong sensation of a steeper than actual climb.* It is this illusion which tempts the pilot to lower the nose of the aircraft. This increases the forward acceleration component — and increases the illusion of climbing
