**Department of Transport**  
**Bureau of Air Safety Investigation**

INVESTIGATION REPORT  
9301743

**Piper PA31-350 Chieftain VH-NDU**  
**Young, NSW**  
**11 June 1993**

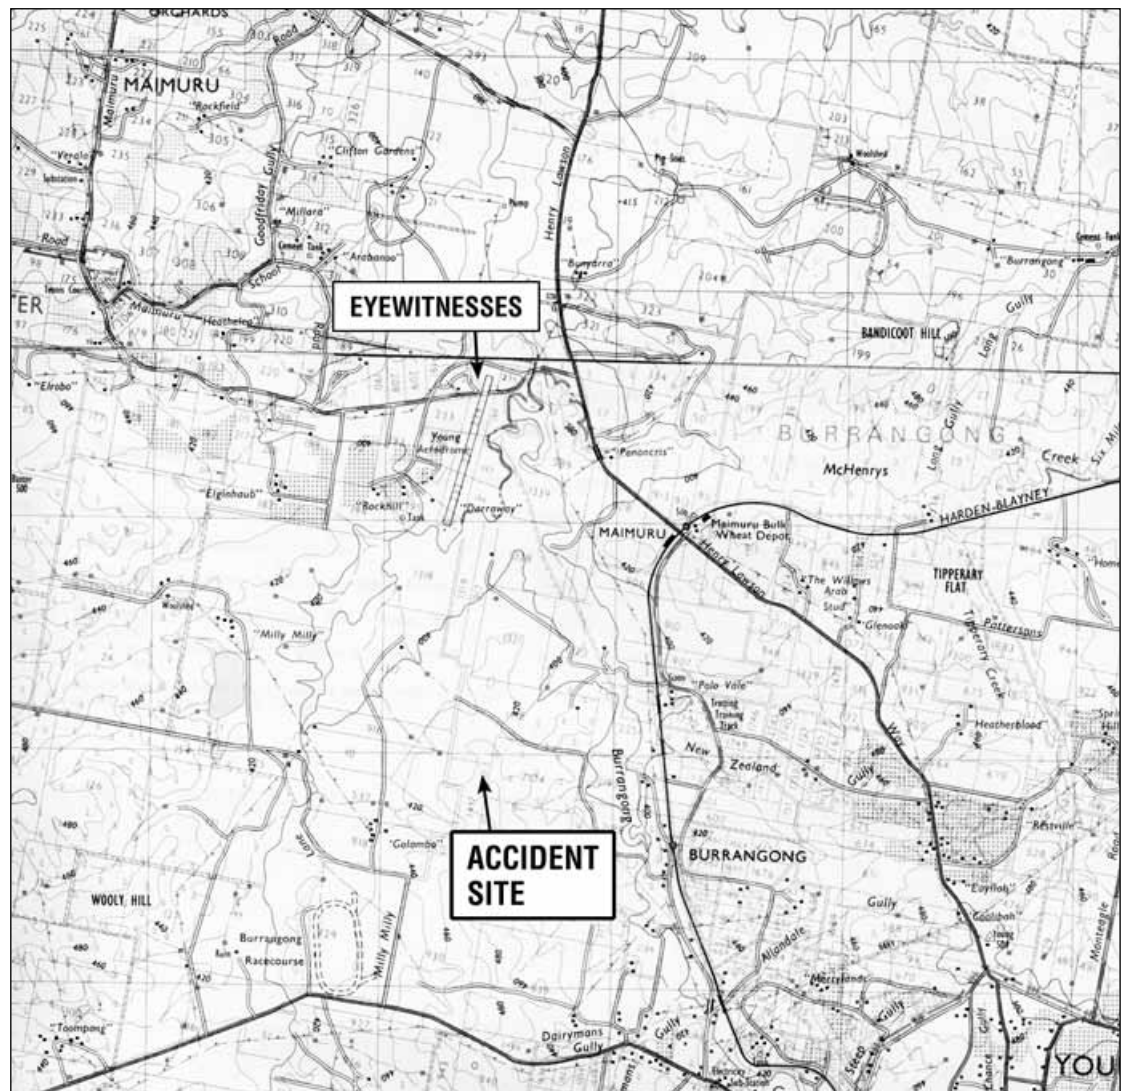
**Figure 2** Locality map showing accident site in relation to Young Aerodrome

aircraft (VH-NDU) was significantly lower than another aircraft approaching from the east (VH-XML). Shortly after VH-NDU turned onto an apparent base leg the navigation lights were lost to sight. Almost immediately a fireball was observed, consistent with the final position of the aircraft (see figure 2).

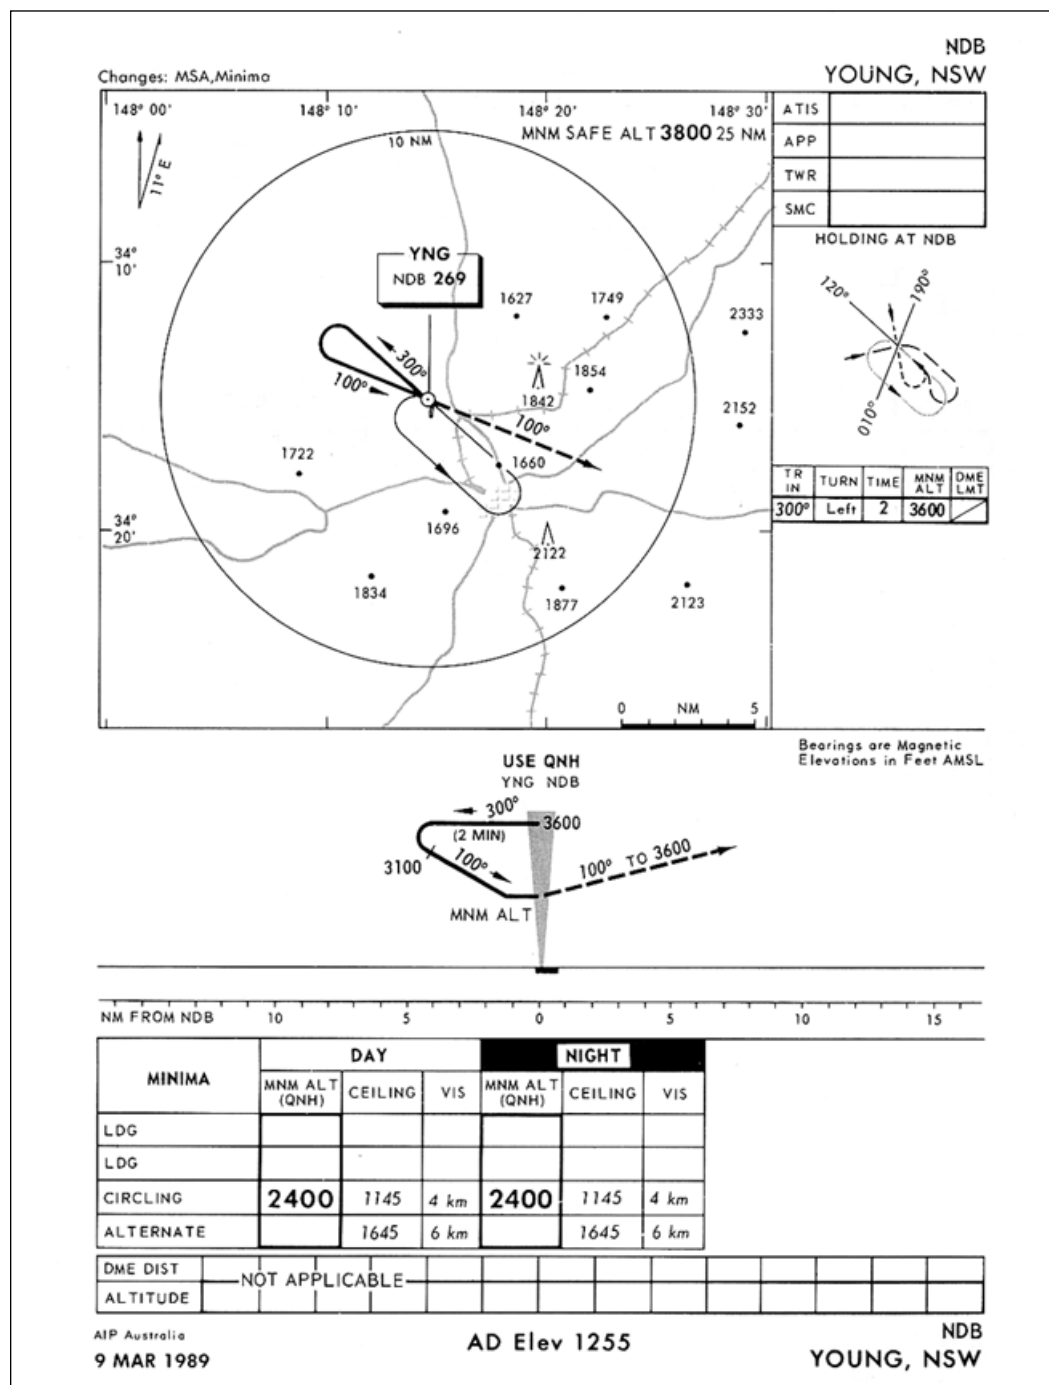
**Figure 3** Young NDB Approach Chart

The significant difference between the two types of instrument approach charts is that new criteria charts have landing minima determined by aircraft performance category. The design of ‘old criteria’ NDB approach charts, including Young (see figure 3), provided an obstacle clearance of at least 400 ft within the circling area at the circling minima, the circling area being the area within a 3 NM radius of the aerodrome reference point.

With the exception of the 1,255 ft aerodrome elevation, the approach chart did not indicate the height of terrain or obstacles within the circling area. The landing chart (see figure 4) indicated a low intensity, steady red, obstruction light at an elevation of 1,504 ft, about 1,950 m from the ARP,

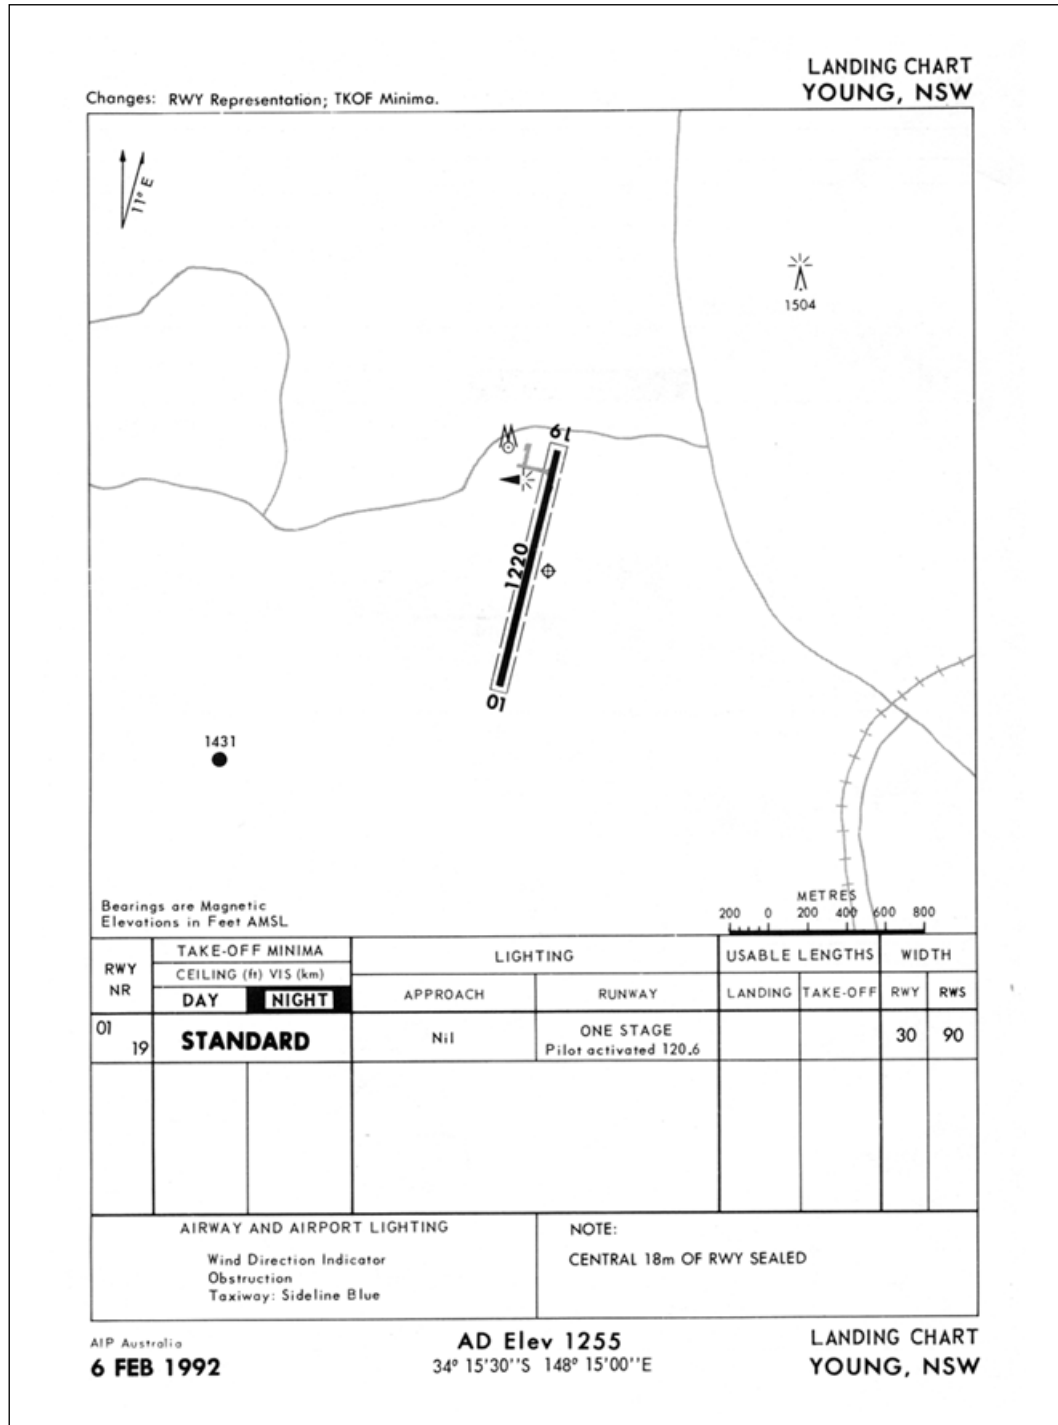
Figure 4 Young Landing Chart

bearing 033°. An unlit spot elevation of 1,431 ft, was also indicated at a distance of about 1,945 m from the ARP, bearing 230°. The IAL chart legend states that a spot elevation does not necessarily indicate the highest terrain in the immediate area. This is repeated with a caution in AIP/DAP 1-1. The terrain struck by the aircraft was not marked on the NDB approach chart, and lay outside the boundary of the landing chart.

The aerodrome lies in a valley surrounded by low hills. Within the 3 NM radius aerodrome circling area the only illuminated obstacle is a hill, at an elevation of 1,504 ft, about 1,950 m from the ARP, bearing 033° (see figure 4). The steady red obstacle light is reported to have been illuminated and functioning normally. No visual approach slope guidance systems are installed.

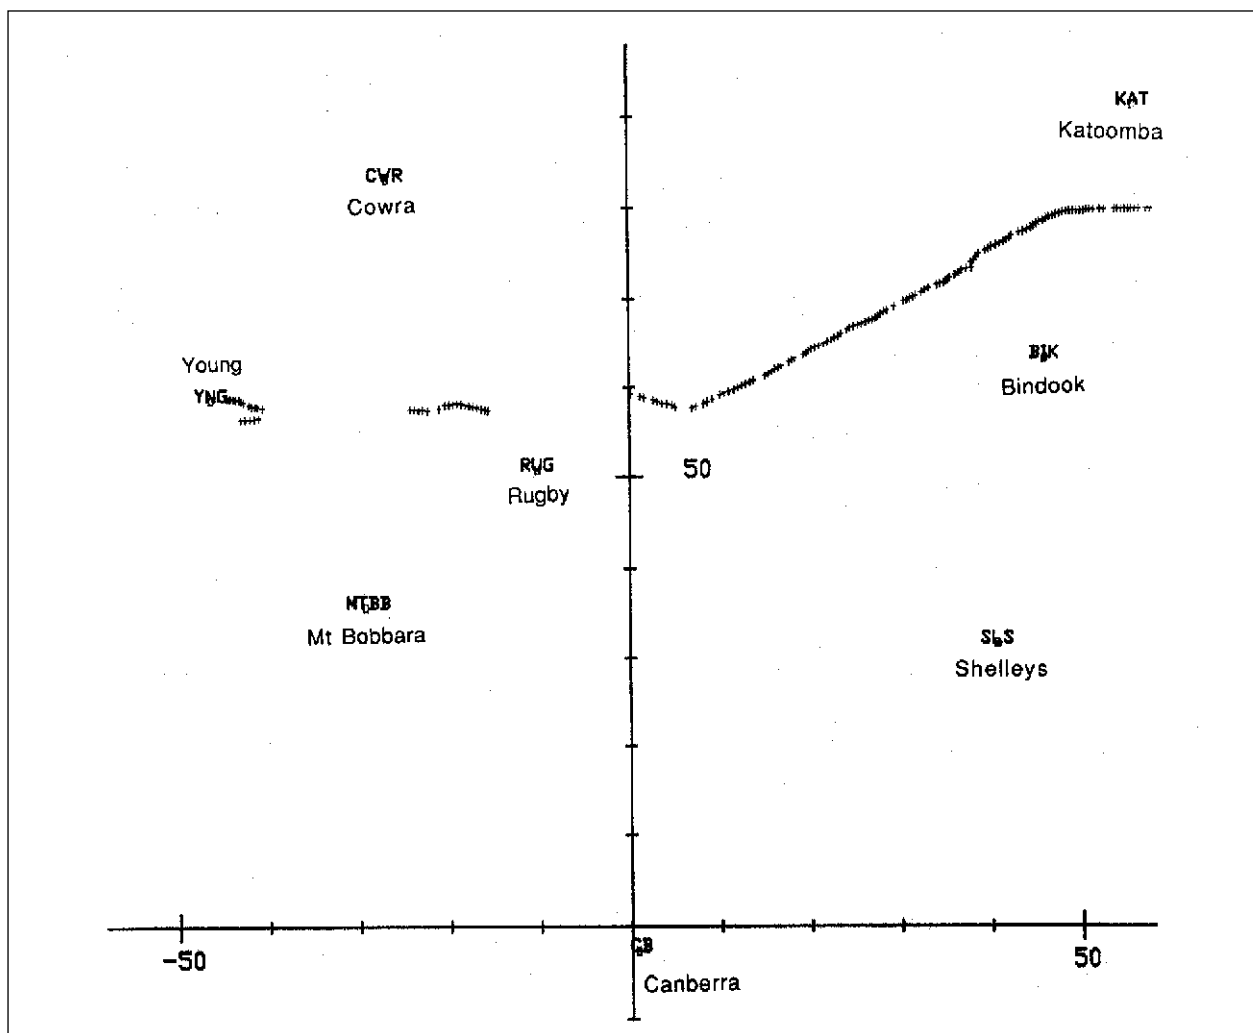
**Figure 12** Diagram of plotted radar track of VH-NDU

Radar data covering the flight of VH-NDU were recorded at Sydney and Melbourne airports. The Sydney recording included secondary data from the Sydney TAR and the Sydney RSR. The Melbourne recording included primary and secondary data from the Canberra RSR and secondary data from the Mount Bobbara RSR, located 29 NM south-east of Young. A diagram of the recorded radar track of VH-NDU is shown in figure 12.

- d. At 1819 the aircraft passed 13.5 NM to the south-east of Riley. At 1824 the aircraft changed track to the right and tracked approximately towards Young. From this time the primary returns from VH-NDU were received intermittently.

- e. Radar coverage plots for Canberra RSR show that terrain shielding occurs in the Young area at low altitudes. This was consistent with radar data recorded during the test flight which indicated that an aircraft needed to be at an altitude of at least 3,400 ft for primary returns to be received by Canberra RSR.

- f. The last radar data received from VH-NDU were eight primary returns which were recorded between 1905:40 and 1907:35. They showed VH-NDU approaching Young on a track of about 270°, consistent with the entry to a NDB approach.
- g. Only primary radar data was received from VH-XML and the last recorded return was from a position 12 NM south-east of Young.
- h. The transponder of VH-XMA was left selected ON. As a result, secondary radar data was received by Mount Bobbara and showed the aircraft's track inbound from Cowra. The recorded manoeuvres and altitudes were consistent with those described by the pilot of that aircraft. The last recorded return from VH-XMA was consistent with the aircraft tracking on a left base leg for runway 01 at a pressure altitude of 1,900 ft.

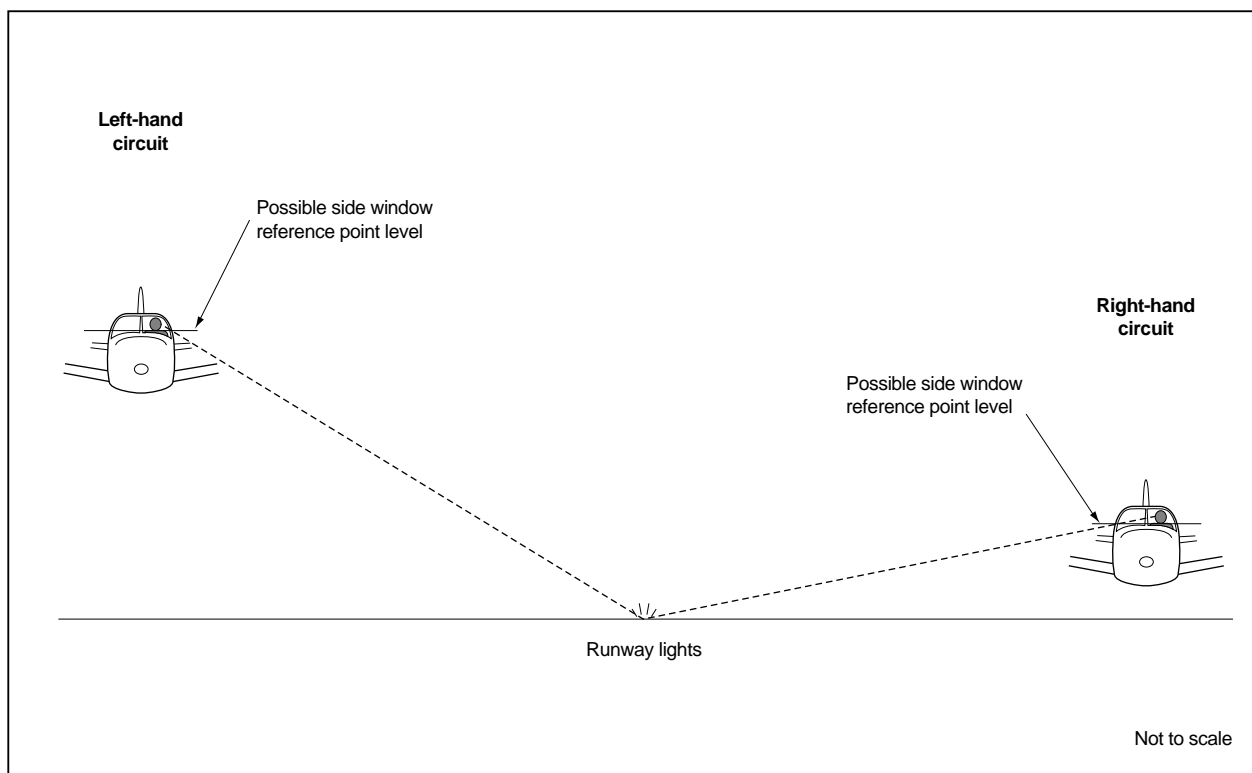
It was also considered that under certain circumstances, a pilot flying a right circuit may get the impression that the aircraft is higher than normal. This illusion could occur to a pilot who has developed the habit of visually judging circuit height and position by relating the position of the runway lights to some feature of the aircraft, such as a particular position in a side window. Such a rule of thumb which worked satisfactorily for the more typical left circuits could lead a pilot to descend lower to achieve the same picture when making right circuits (See figure 13). Like most habits, such a practice could be carried out unconsciously. In this case it would be an example of negative transfer, where a pilot transfers a habit from a situation

**Figure 13** A diagram showing the difference between viewing runway lights from the downwind leg of left and right circuits when positioned in the left cockpit seat.

where it works successfully, to a new situation where it is inappropriate. This phenomenon would not occur on final approach, when the runway appears normally in the front windscreen.

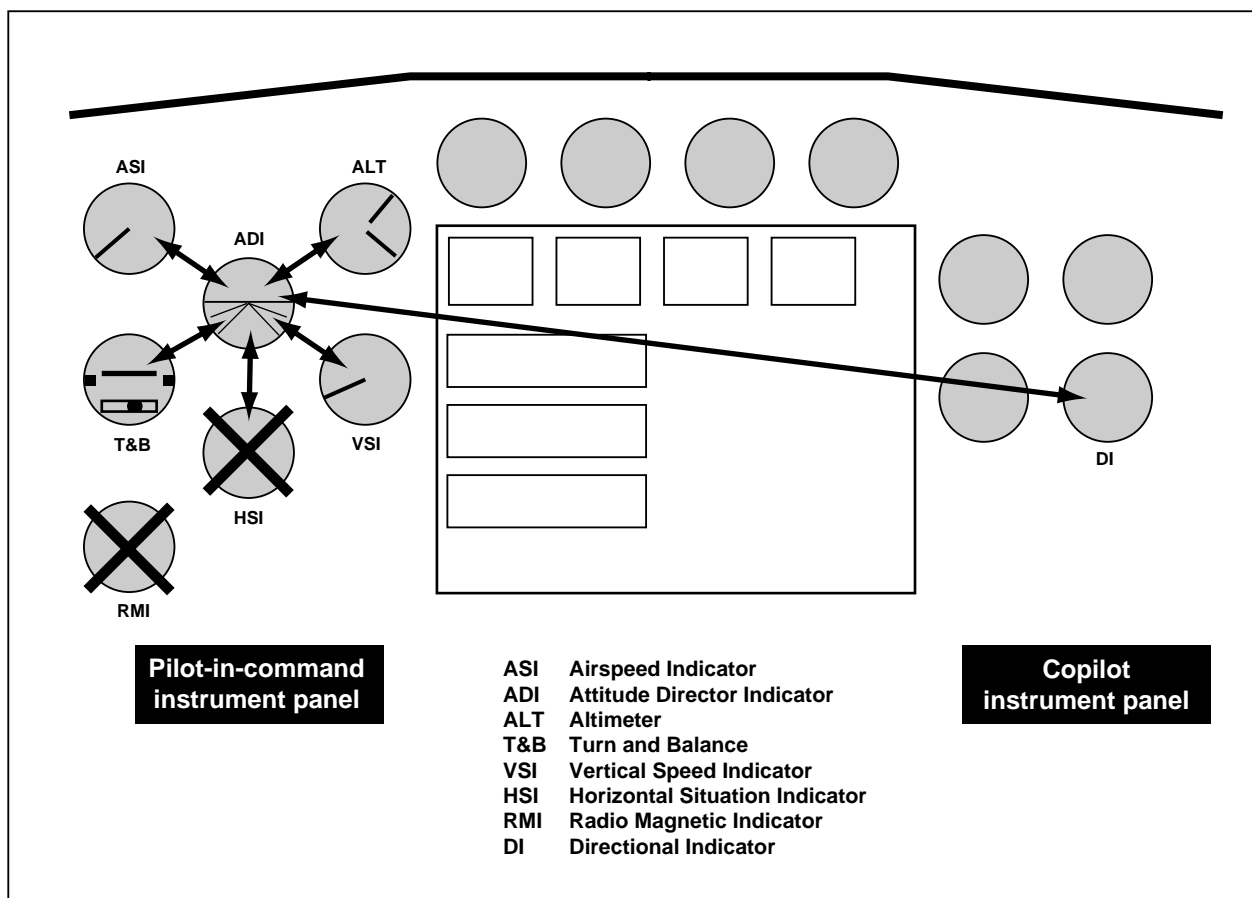
During the final stage of the test flight the left instrument panel directional indicator was covered to simulate an unserviceable indicator. Due to the limitations of the magnetic compass, resulting from turning and acceleration errors, readily useable directional information was only available from the right heading indicator. The handling pilot in the left seat reported an increase in workload, and a decline in general flight accuracy, resulting from disruption to his normal pattern of instrument cross checking (see figure 15, p.50).

The visual cues available to the flight crew were inadequate as a sole reference to judge terrain clearance accurately during the circling approach at night. The position of the crash site and the aircraft track indicated that the crew were aware of their lateral position in relation to the runway, but were not aware of their true vertical position. Descent below the minimum circling altitude required the maintenance of sufficient visual reference to facilitate terrain avoidance. The visual cues available to the crew on the night were insufficient to provide for this. Those cues which were available could have been misinterpreted, as a result of:

- the position of the aircraft in the circuit;
- the cockpit seating position of the pilot-in-command;
- negative habit transfer;
- focal trap effect .

**Figure 15** Diagram of the pilot-in-command's flight instrument scan pattern superimposed on a representation of the cockpit instrument panels in VH-NDU.
