Air Accidents Investigation Branch

**Report on the accident to Fokker F27-500, G-BNCY
at Guernsey Airport, Channel Islands
on 7 December 1997**

Aircraft Accident Report No: 4/99

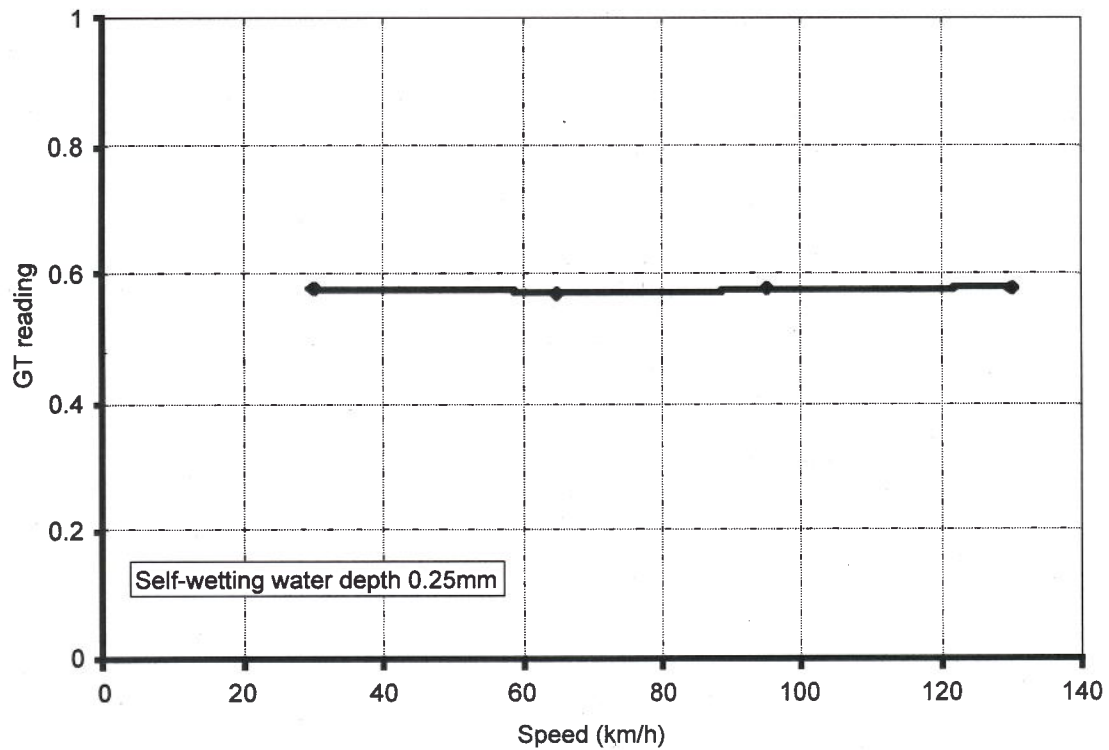
Figure 4 Speed/friction curve runway 09/27

The speed friction/curve for runway 09/27 is presented in Figure 4. A single 500m run 6m from the centreline was made at each of the speeds 30, 65, 95, and 130km/h. The curve remains essentially flat, but at a fairly low level. This indicates that the surface is providing good water clearance beneath the GT measuring tyre, but that the aggregate is polished and has a low microtexture.
