Foreword

This document is based on the data collected on the circumstances of the accident, which then has been analysed for the investigation. The focus of the investigation of the tragic accident to GF-072 has been to establish what happened, to analyse how and why the occurrence took place, and from this analysis to determine what the occurrence reveals about the safety health of the aviation system. Such information is used to arrive at conclusions and make safety recommendations aimed at reducing or eliminating the probability of a repetition of the same type of occurrence, and where appropriate, to increase the overall safety of the aviation system.

Executive Summary

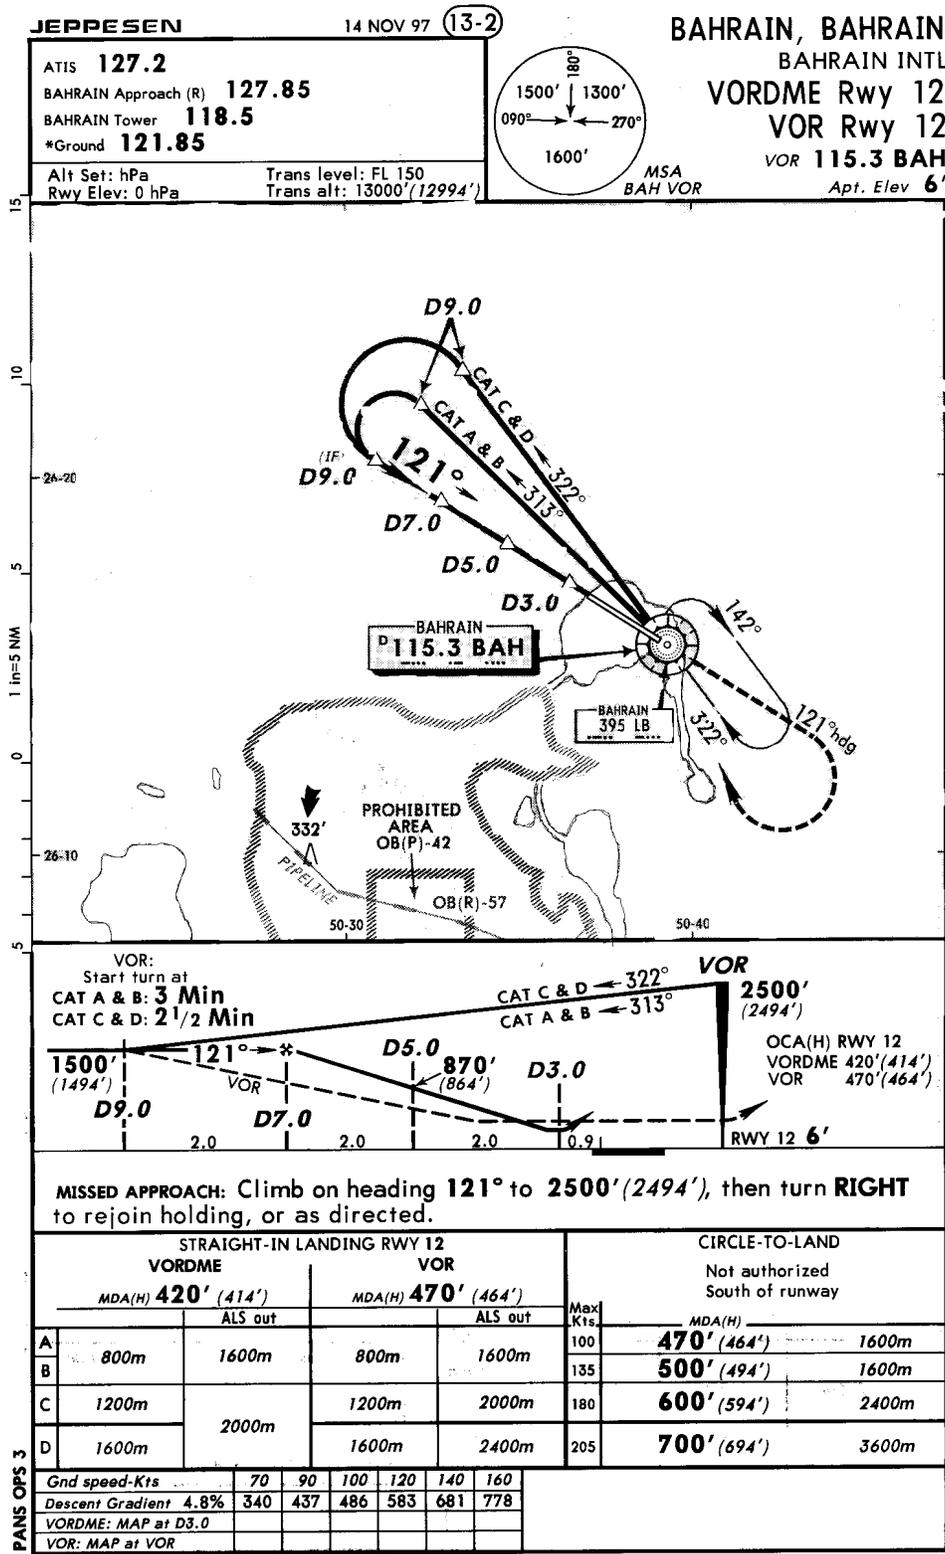
Figure 1: Instrument Approach Chart of Bahrain Runway 12 VOR/DME Procedure

With reference to Figure 1 on page 6, the Instrument Approach Chart of Bahrain Runway 12 VOR/DME Procedure, the final approach fix (FAF) is at seven DME (i.e. about 5 nm from the runway threshold). The standard procedure is to establish the aircraft on the approach path (VOR-radial 301 degrees), and configure the aircraft for the approach prior to reaching the FAF. The "approach configurations" constitute: landing gear 'down', flaps to 'full', altitude 'as required at FAF' [in this case 1500 ft (1494 ft AGL)], and speed V_{APP} . ($V_{APP} = V_{LS} + 1/3$ headwind component
