AVIATION SAFETY INVESTIGATION REPORT  
BO/200105769

**Raytheon Beech 200C,  
VH-FMN**

**Mount Gambier, SA  
10 December 2001**

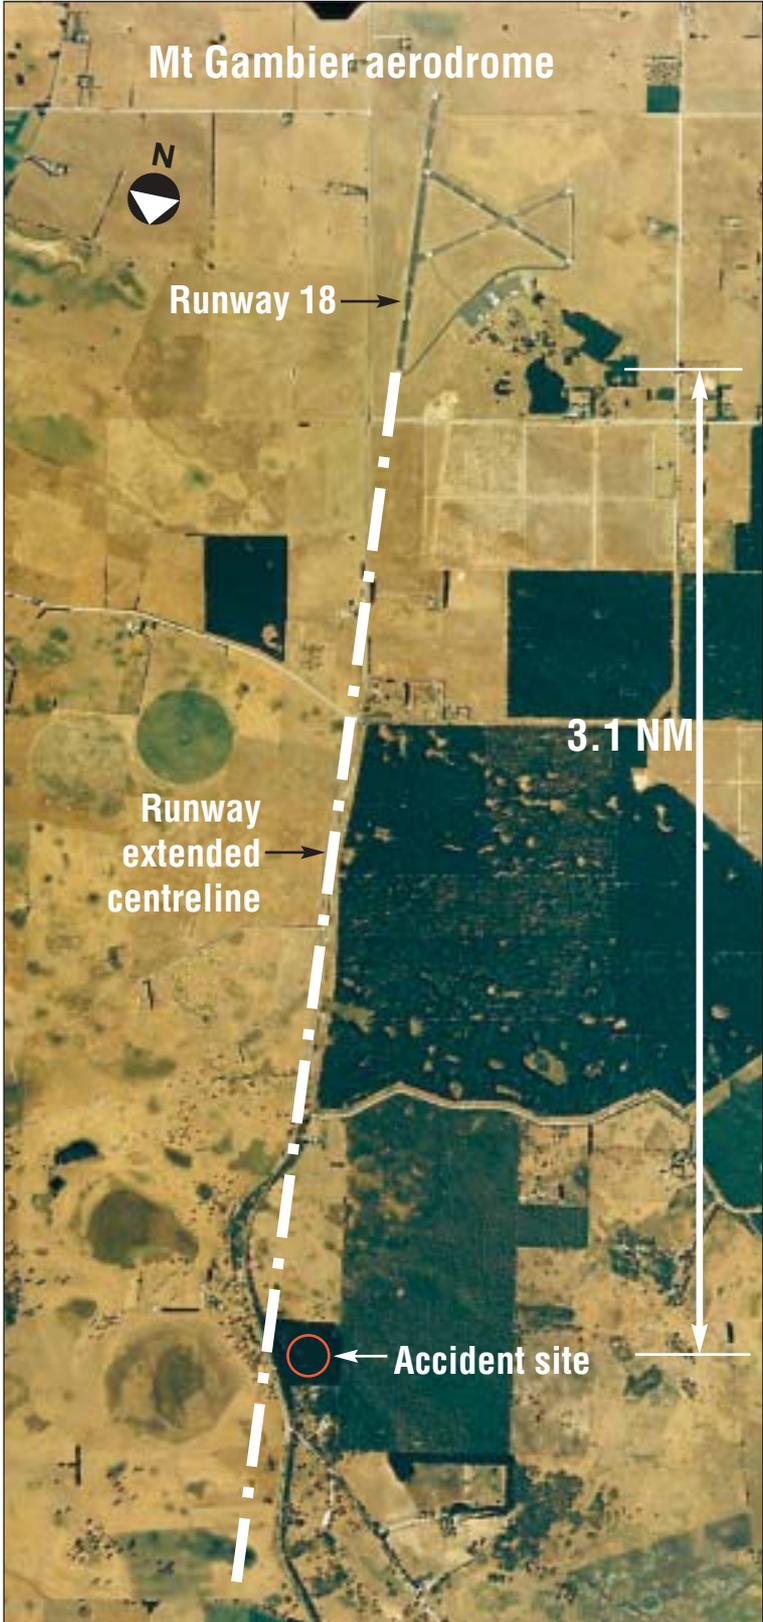
Figure 1:  
Location of accident site

The location of the accident site is depicted at fig. 1.

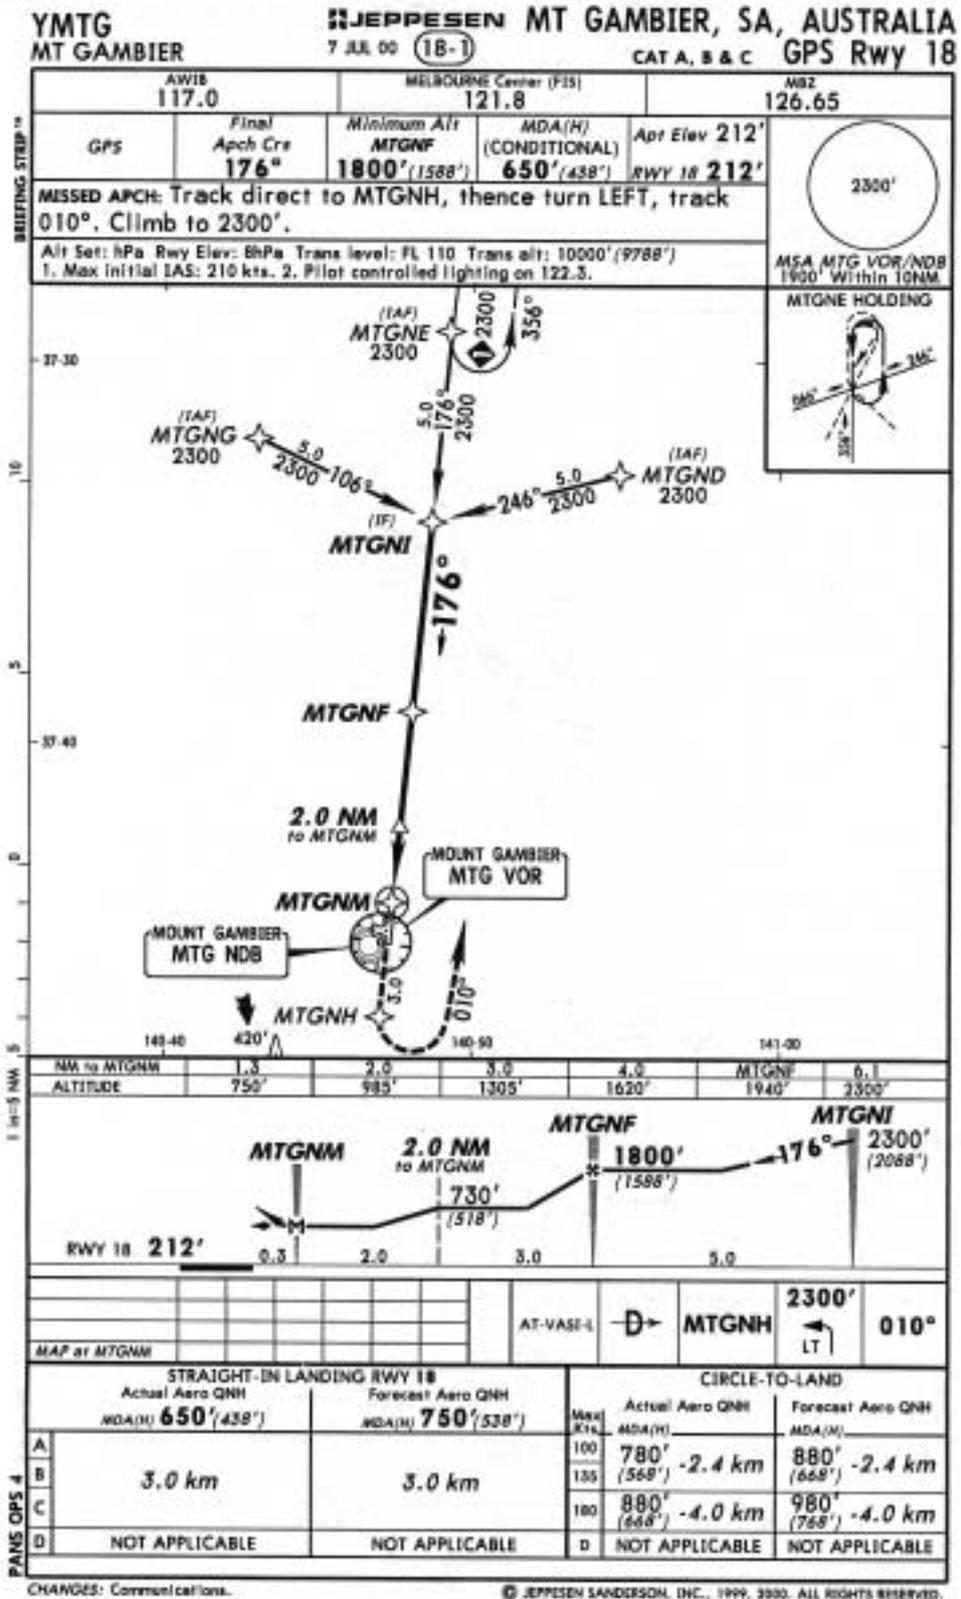
FIGURE 7:  
Jeppesen Mount Gambier GPS RWY 18 Approach

The pilot was reported to have used Jeppesen Sanderson, Inc. (Jeppesen) instrument approach charts. The Jeppesen Mount Gambier GPS RWY 18 Approach, current at the time of the occurrence, is depicted at fig.7. CASA had approved the use of GPS as a non-precision approach navigation aid, in Australian domestic airspace, under the Instrument Flight Rules. The operator reported that FMN was not certified to conduct GPS non-precision approaches, and company pilots were not trained to, and therefore not permitted to, conduct GPS non-precision approaches.

Witnesses located under the GPS RWY 18 Approach path, and to the south of the GPS waypoint MTGNF (5.3 NM north of the threshold RWY 18), reported that they heard the occurrence aircraft some distance to the west of them, and that it did not overfly their location. Witnesses located to the south and west of MTGNF, reported that the occurrence aircraft overflew their location.

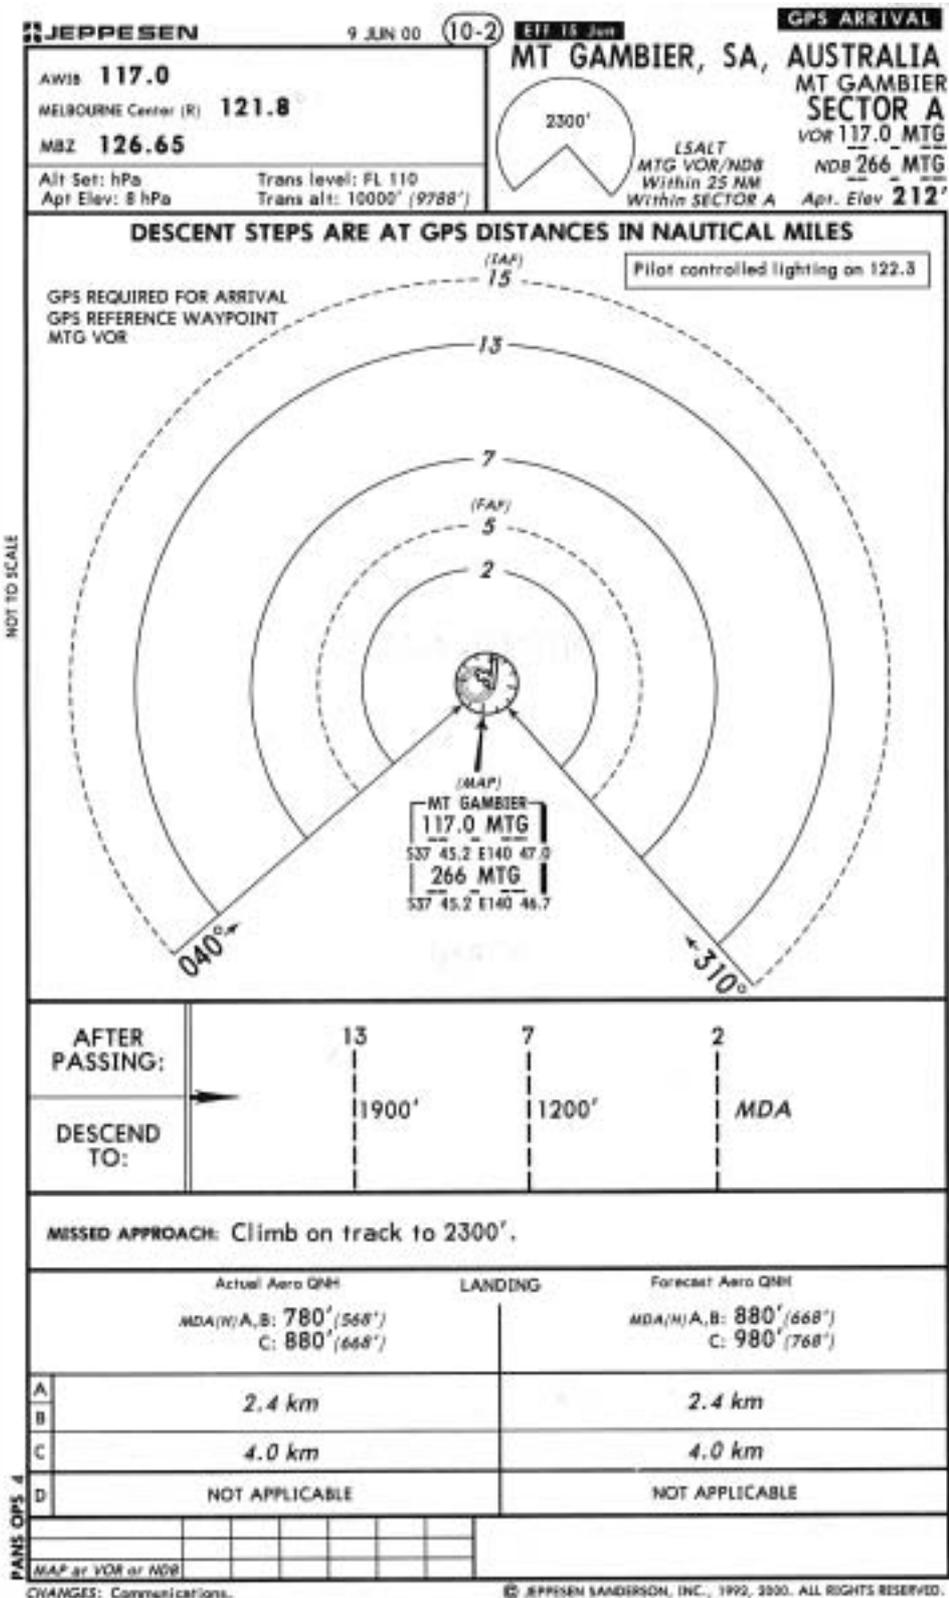
FIGURE 8:  
Jeppesen Mount Gambier GPS Arrival procedure

The Jeppesen Mount Gambier GPS Arrival procedure, current at the time of the occurrence, is depicted at fig. 8. A GPS Arrival procedure provides descent guidance from either a controlled airspace step or an enroute or sector lowest safe altitude in uncontrolled airspace, to the visual circling area of an aerodrome. Azimuth guidance is required from the radio navigation aid specified in the procedure. Azimuth guidance for the Mount Gambier GPS Arrival procedure was provided with reference to the Mount Gambier VOR.

The minimum altitudes specified for the Mount Gambier GPS Arrival procedure, as shown at fig. 8, were 1,900 ft above mean sea level (AMSL) from 13 NM to 7 NM and 1,200 ft from 7 NM to 2 NM. The minimum descent altitude (MDA) for the procedure, at less than 2 NM, was 780 ft<sup>9</sup>. At MDA, the procedure specified a flight visibility requirement of 2.4 km. The missed approach point was the VOR. Descent below MDA is discussed at paragraph 1.16.4.2. The initial approach fix was at 15 NM and the final approach fix was at 5 NM, with reference to the Mount Gambier VOR.

<sup>9</sup> FMN was a Category B aircraft. The MDA for the approach was 780 ft, which was 100 ft lower than the 880 ft depicted on the chart. That was permitted in accordance with the provisions of the Aeronautical Information Publication because an actual aerodrome QNH was available to the pilot.

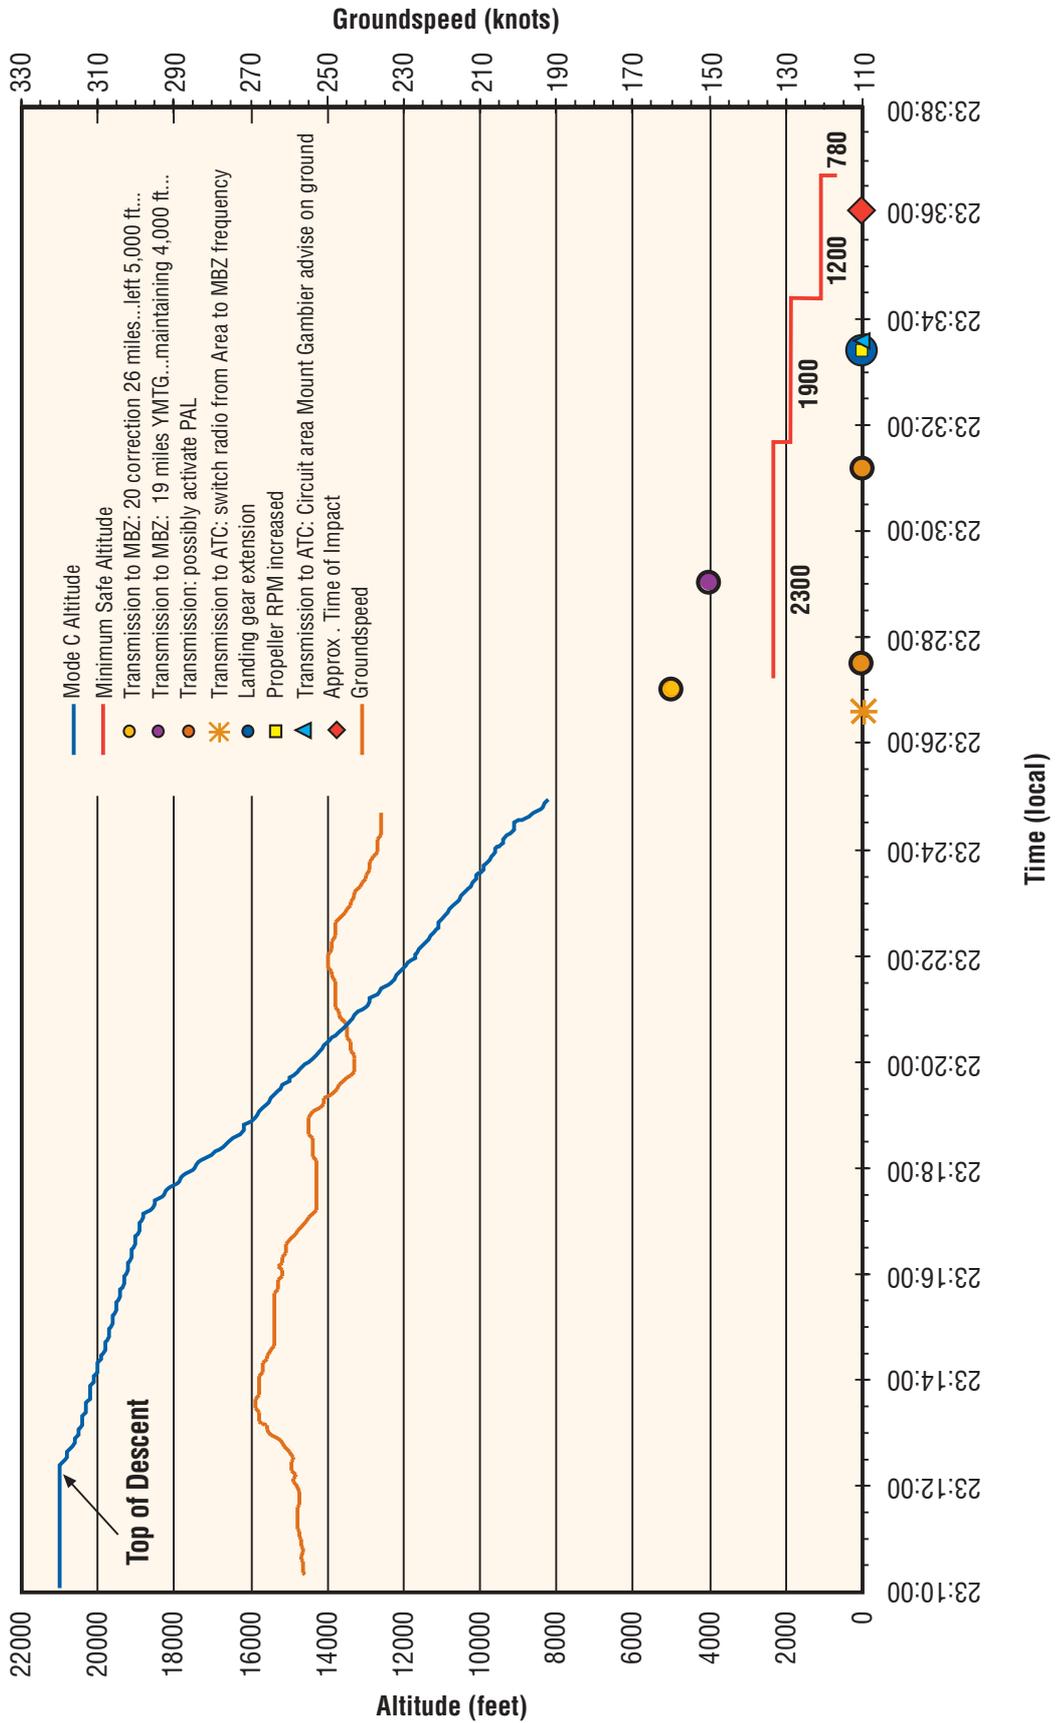
**FIGURE 9:**  
**Aircraft descent profile<sup>10</sup>**

ATS recorded radar data at fig. 9, indicated that the aircraft commenced descent to Mount Gambier, from cruise altitude, at about 2312 and was about 89 NM from Mount Gambier at that time. The initial rate of descent was about 440 ft per minute for about 5 minutes, until about 67 NM from Mount Gambier, indicating a descent profile of about 6 NM per 1,000 ft. The aircraft then descended at a rate of 1,350 ft per minute for about 8 minutes, until radar contact was lost at an altitude of about 8,200 ft AMSL and 34 NM from Mount Gambier. That indicated a descent profile of about 3 NM per 1,000 ft. Aircraft groundspeed during the descent varied between 237 and 269 kts.

<sup>10</sup> Altitudes shown in Figs. 9 and 10 are in feet above mean sea level (AMSL). Mount Gambier aerodrome is 212 ft AMSL.

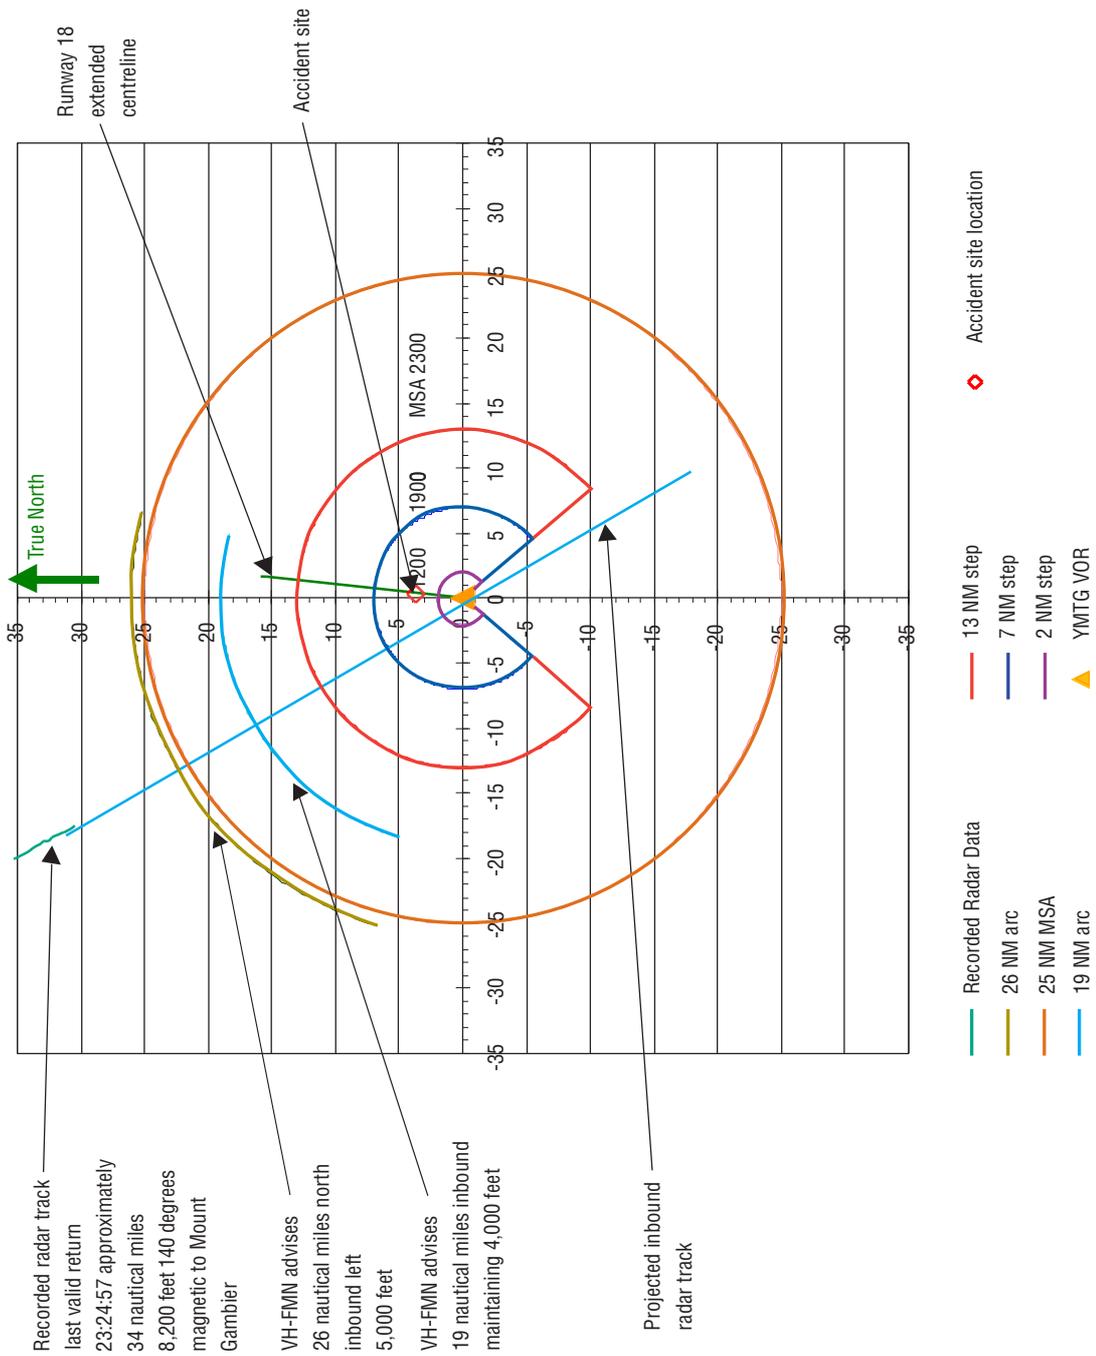
**FIGURE 10:**  
**Plan view depicting pilot position reports and radar data<sup>11</sup>**

A plan view depicting pilot position reports and radar data is at fig.10.

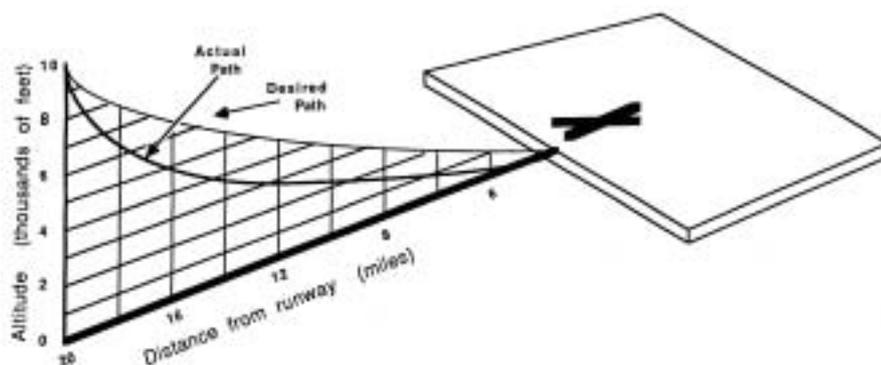
**FIGURE 11:**  
Comparison of the approach path flown by pilots during a night visual approach with the desired altitudes<sup>14</sup>

The latter stages of the occurrence flight were flown over dark, unlit terrain towards lights, in conditions of low cloud, rain showers and the lack of a defined horizon. Flying a visual approach in those conditions has been associated with less reliable pilot control of approach path angle due to the lack of visual cues. On occasions, pilots have experienced difficulty judging rates of descent and closure rates, resulting in them overestimating approach path angle and flying a shallow approach, sometimes resulting in ground impact short of the lit area. The same conditions can also produce high approaches, however low approaches have been shown to be more likely. In those instances of low approaches, a comparison of the approach path flown by pilots during a night visual approach, with the desired altitudes, is depicted at fig. 11.
