SL Report 2007/23

**REPORT ON THE AIRCRAFT ACCIDENT AT BODØ AIRPORT ON 4
DECEMBER 2003 INVOLVING DORNIER DO 228-202 LN-HTA, OPERATED
BY KATO AIRLINE AS**

June 2007

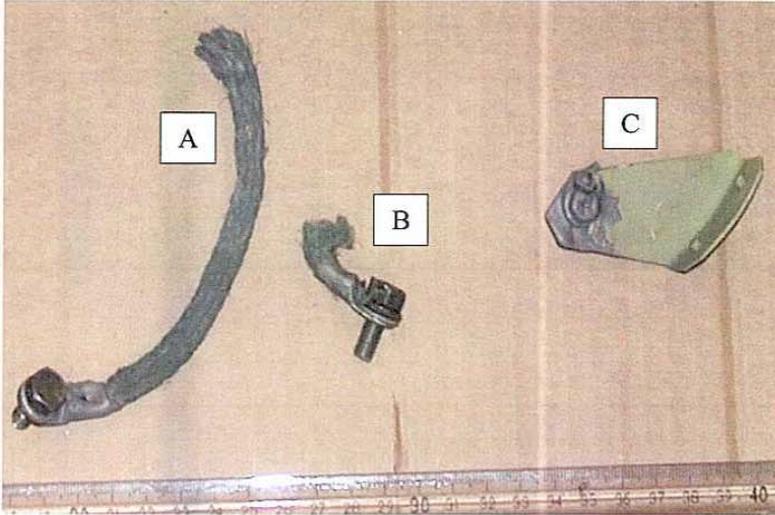
FOLAT, kjemi og materialteknologi, mottok deler av jordingskabler etter lynnedslag. Det var ønskelig å fastslå hvorvidt kablene hadde røket som følge av lynnedslaget, eller om kablene hadde vært utsatt for mekanisk slitasje. Det ble utført fraktografi i SEM samt metallografiske undersøkelser.

Figur 1 Oversiktsbilde av jordingskabler mottatt for undersøkelse, merket A, B og C.

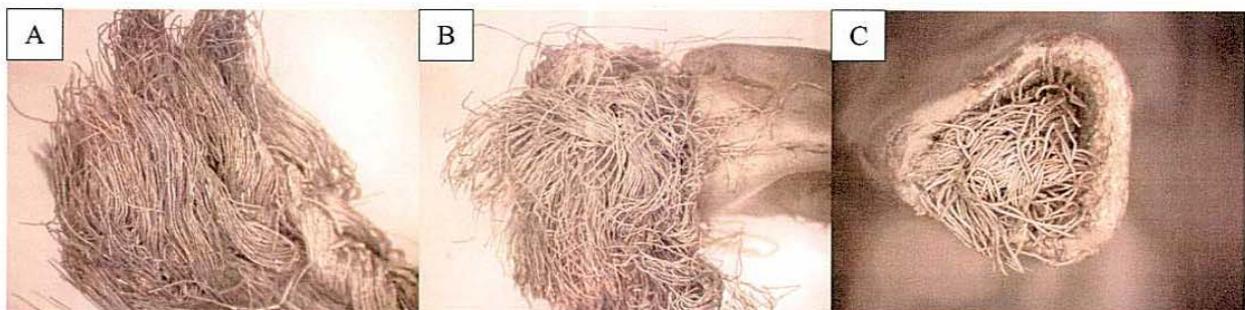
Noen karakteristiske bilder av bruddflatene på de ulike kablene ref. Figur 1 og Figur 2 er vist hhv. i Figur 3, Figur 4 og Figur 5. Gjennomgående kunne trådene deles inn i fire hovedgrupper: tråder med dimpler i bruddoverflaten, tråder med glatt overflate med liten/ingen innsnevring mot bruddflaten, tråder med innsnevring uten åpenbare dimpler, og tråder med smelteperler. Det var kun mulig å observere åpenbar smelting av noen få tråder på kabel A, se bilde b og d i Figur 4.

Figur 2 Bilder tatt i stereomikroskop av de ulike kablene vist i Figur 1 (merket tilsvarende).

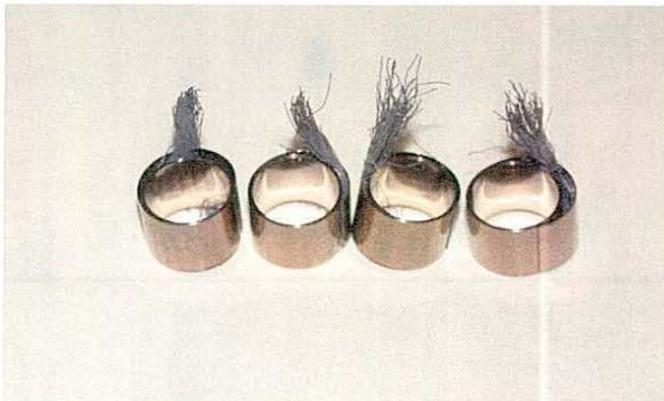
Kabelen merket A i Figur 1 ble valgt for å forsøke å gi et anslag på hvordan fordelingen mellom de ulike brudd typene var. Kabelen ble flettet opp, og fire prøver ble tatt ut, vist i Figur 6. Totalt 75 tråder ble undersøkt og delt inn i fire grupper: Dimpler: bruddflater med dimpler, Sm.Perle: bruddflater med smelteperler, U m/innsn.: Uidentifisert bruddflate med innsnevring og U u/innsn.: Uidentifisert uten innsnevring.

Figur 6 Oversiktsbilde av prøver tatt ut fra kabel merket A i Figur 1 for vurdering av bruddflater.

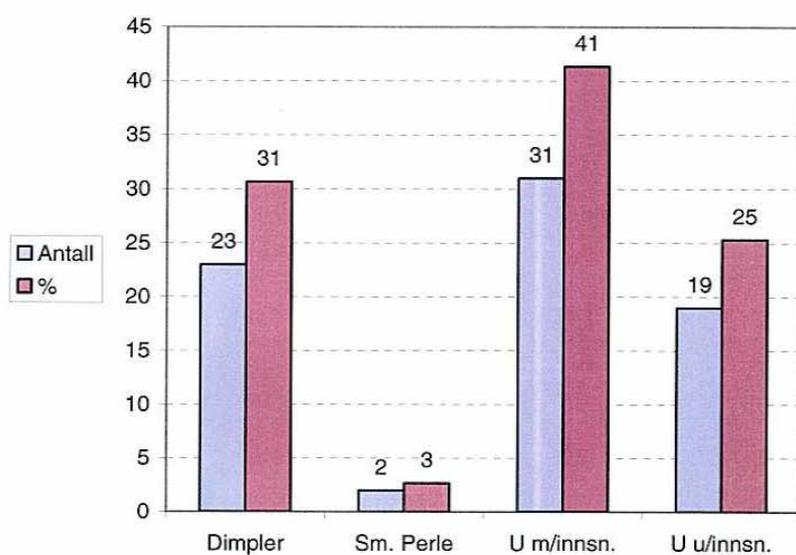
Figur 7 Grafisk presentasjon av fordeling (antall og prosentvis) av ulike bruddtyper. Totalt ble 75 tråder undersøkt.

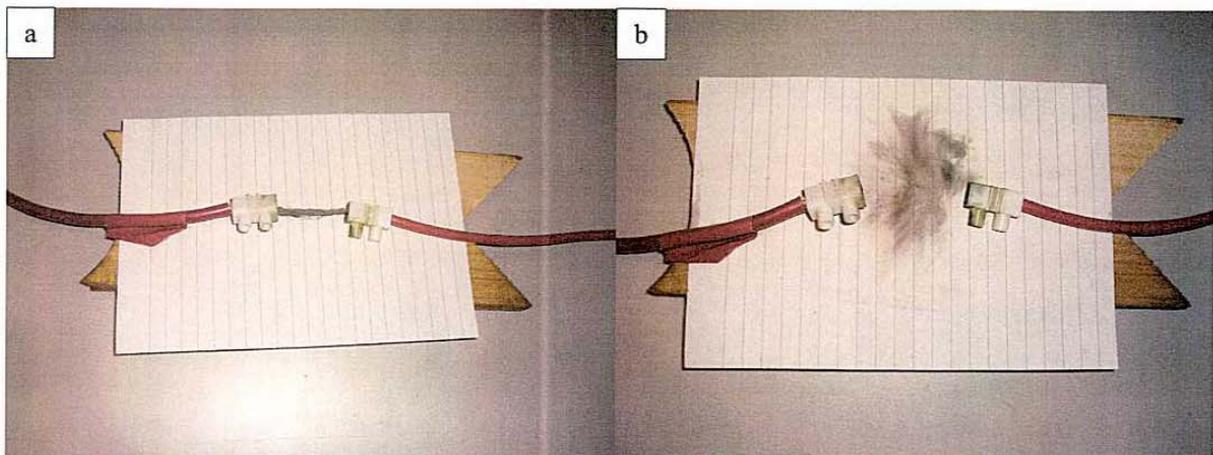
Lynavleder A (se Figur 1) ble flettet opp, og bunter med tråder ble utsatt for belastninger mellom 1500 og 2000 V. Forsøkene avdekket to forløp: i enkelte tilfeller ble lederen svidd av og delt i to, i de fleste tilfellene ble lederen pulverisert som vist i Figur 12b.

Figur 12 Oversiktsbilde av tråd før og etter belastning ved 2000V.

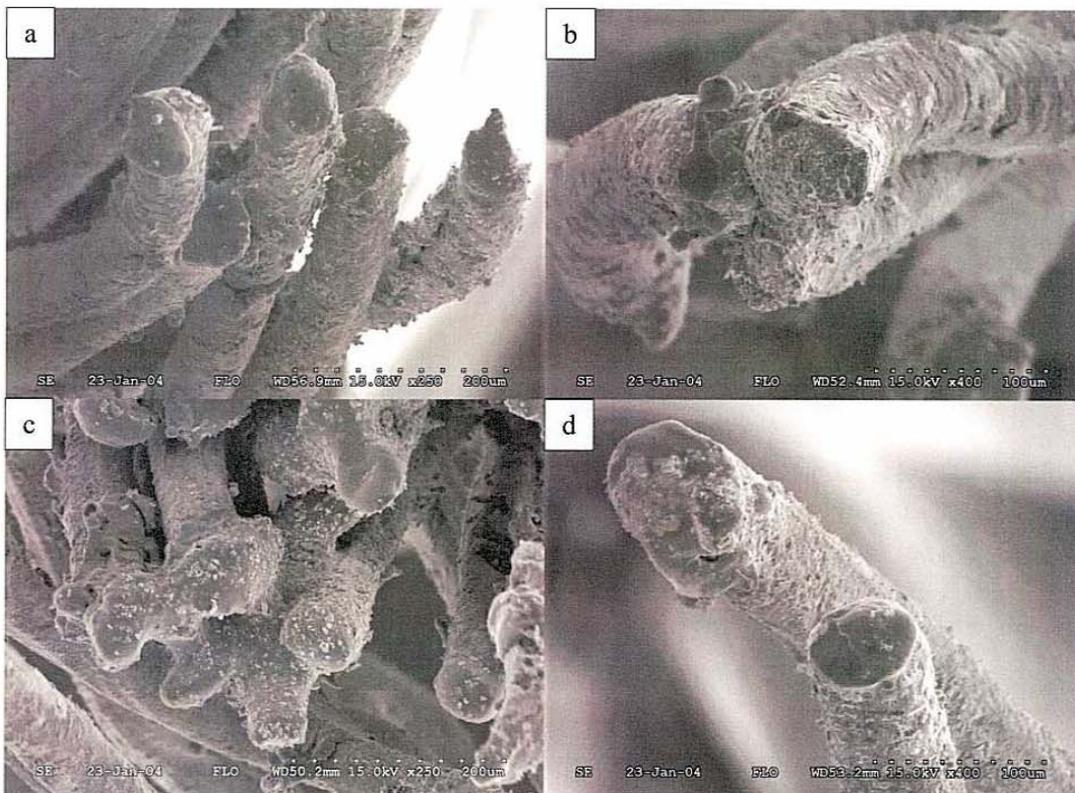
Bruddflaten på to prøver der trådene ble svidd av ble undersøkt i SEM for sammenlikning med resultatene fra lederne undersøkt tidligere. Representative bilder av trådene er vist i Figur 13. Resultatene viser en noe større tendens til sammensmelting sammenliknet med observasjonene ovenfor, det kunne heller ikke observeres bruddflater med dimpler.

Figur 13a-d Representative bilder i SEM av tråder etter avbrenningsforsøk, belastning 2000V.
