## **FINAL REPORT**

**AIC 07-1002**

**P2-ALU**

**EMB-110P1 Bandeirante**

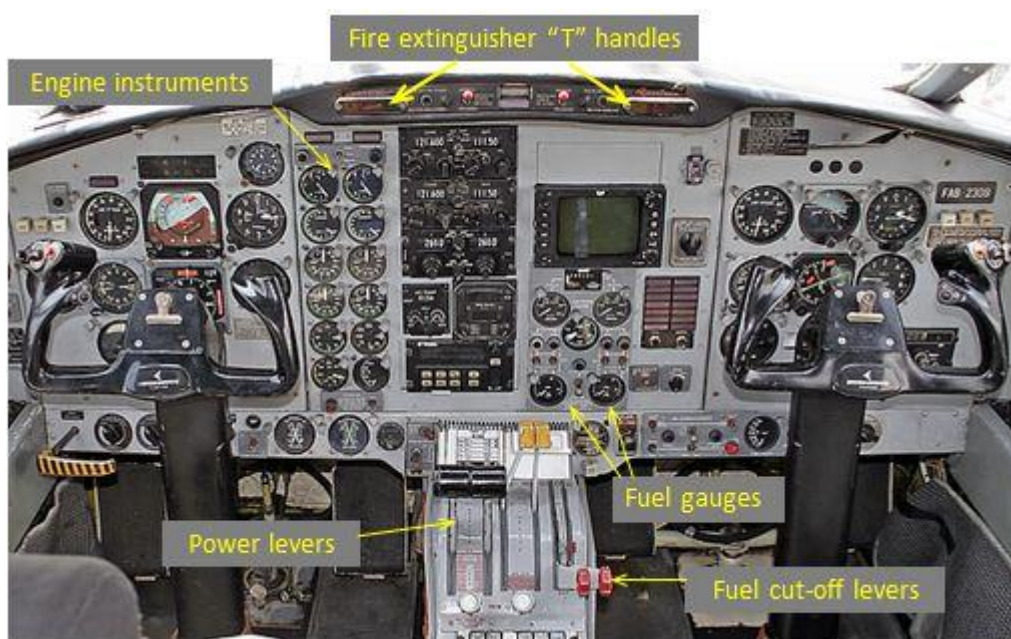
**Figure 19: Typical EMB-110 Bandeirante cockpit**

The Fire Extinguisher “T” Handle for the right engine had been activated. The safety “witness” lockwire was broken, confirming activation. The left “T” handle “witness” lockwire was unbroken/secure.

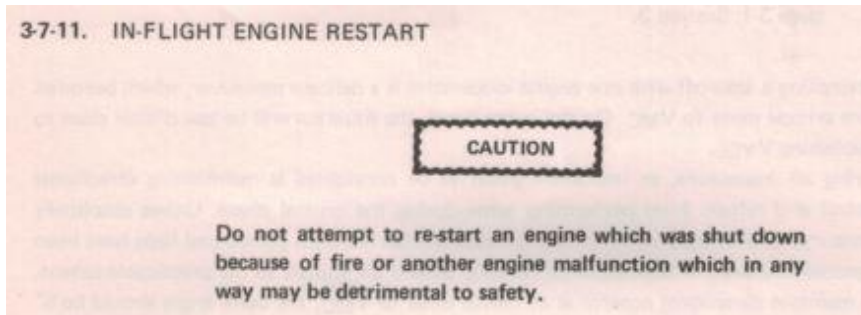
**Figure 23: EMB-110 P1 *Emergency Procedures* Section 3.7.11**

The Embraer EMB-110 P1 Fire Detection and Extinguishing system description does not detail a physical or electrical impediment that could prevent the crew from trying to relight an engine in flight. However, the aircraft's Emergency Procedures Section 3.7.11 cautions against relighting an engine that has been shut down because of in-flight fire.

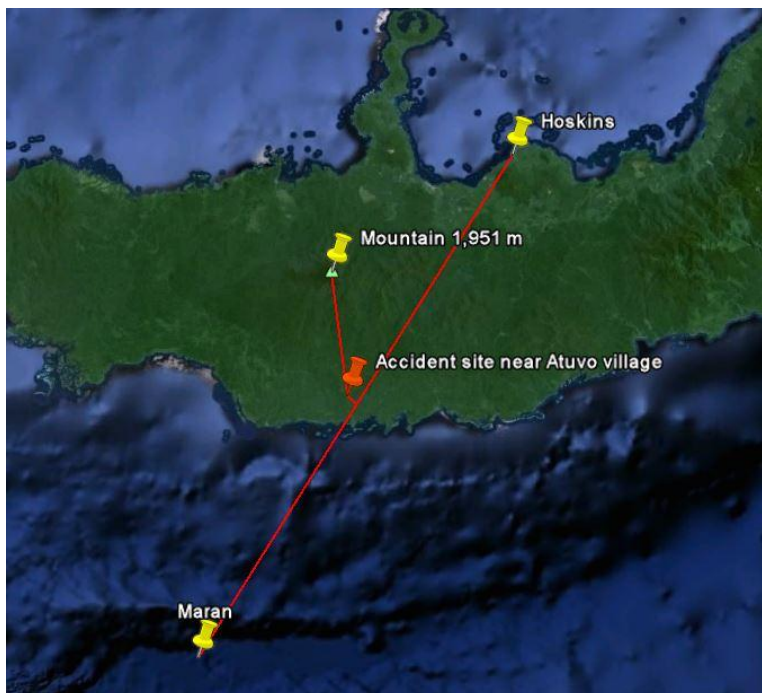
**Figure 24: Map of accident site in relation to mountains**

The terrain on West New Britain along the aircraft's track had ridges varying in height to about 1,500 m, with one peak 32 km west abeam the flight planned track 1,951 m high. That mountain was 42 km northwest of the accident site.
