ATSB TRANSPORT SAFETY INVESTIGATION REPORT  
Aviation Occurrence Report 200501977  
Final

Collision with Terrain  
11 km NW Lockhart River Aerodrome  
7 May 2005  
VH-TFU  
SA227-DC (Metro 23)

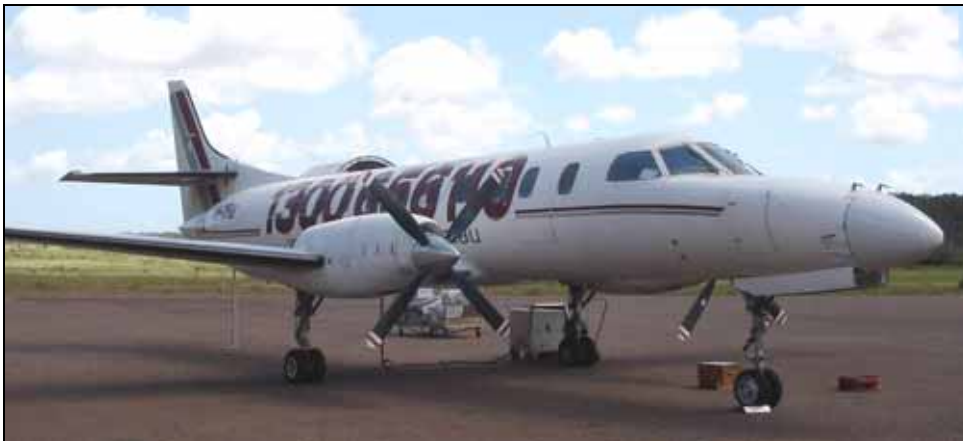
**Figure 1: VH-TFU at Bamaga aerodrome on a previous flight**

On 7 May 2005, a Fairchild Aircraft Inc. SA227-DC Metro 23 aircraft, registered VH-TFU (Figure 1), with two pilots and 13 passengers, was being operated by Transair<sup>4</sup> on an instrument flight rules (IFR) regular public transport (RPT) service from Bamaga<sup>5</sup> to Cairns, with an intermediate stop at Lockhart River, Queensland. This service was operated as Aero-Tropics Air Services<sup>6</sup> flight HC675.

At 1143:39 Eastern Standard Time<sup>7</sup>, the aircraft impacted terrain about 11 km north-west of the Lockhart River aerodrome. At the time of the accident, the crew was conducting an area navigation global navigation satellite system (RNAV (GNSS)) non-precision approach<sup>8</sup> to runway 12. It was very likely<sup>2</sup> that they were using Jeppesen Sanderson Inc. (Jeppesen) instrument approach charts (Figure 2). The aircraft was destroyed by the impact forces and an intense, fuel-fed, post-impact fire. There were no survivors.

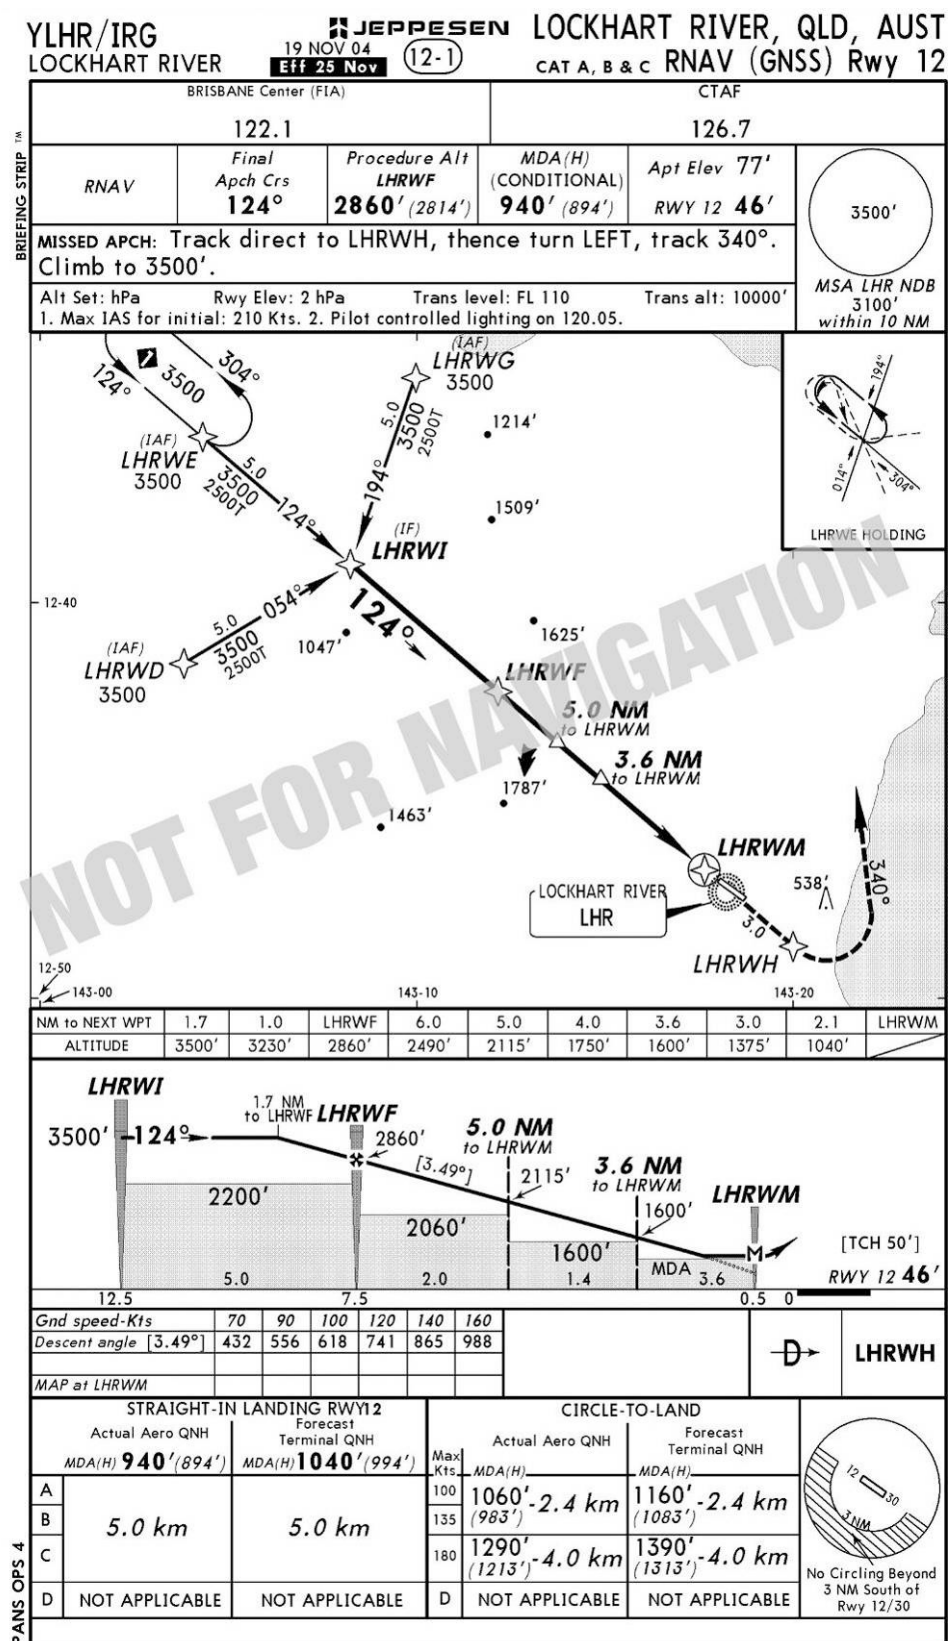
Figure 2: Lockhart River Runway 12 RNAV (GNSS) approach chart

The accident site was located on the published Lockhart River Runway 12 RNAV (GNSS) final approach track (Figure 4). The initial impact point with trees was at an elevation of 1,210 ft AMSL. At that point on the approach, the segment minimum safe altitude was 2,060 ft AMSL (Figure 5).

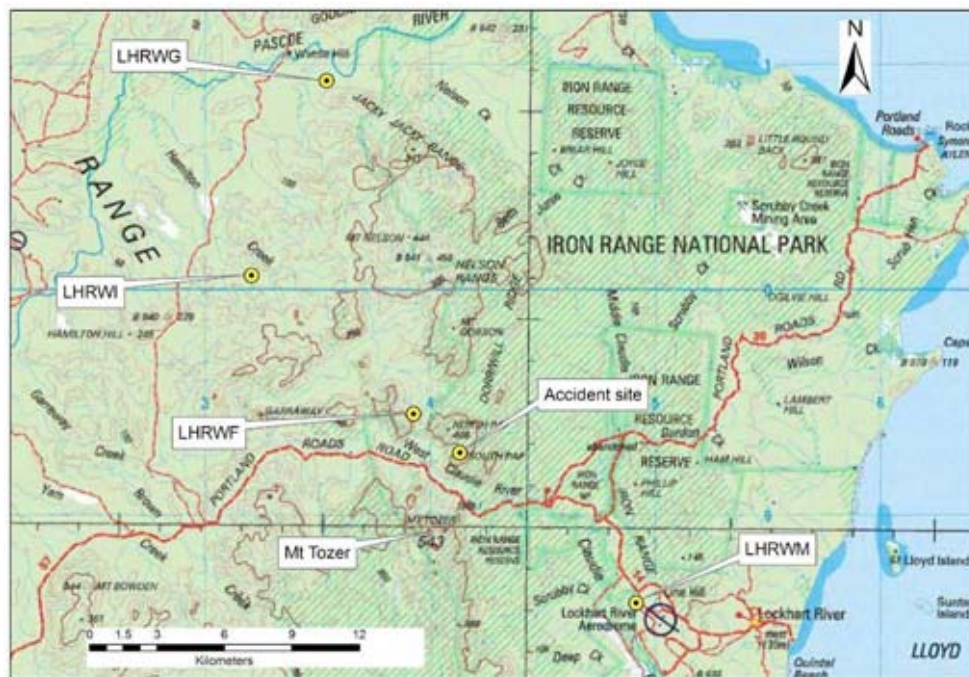
**Figure 6: Topographic map of Lockhart River area with accident site and RNAV(GNSS) approach waypoints**

At 1158, when the crew had not reported having landed at the Lockhart River aerodrome, ATC declared an uncertainty phase. When attempts to contact the crew were unsuccessful, a search for the aircraft was commenced. AusSAR<sup>18</sup> reported that there were no signals from an emergency locator transmitter received in the Lockhart River area at or about the time of the accident. At 1625, the burnt wreckage of the aircraft was located in the Iron Range National Park on the north-western slope of South Pap, a heavily timbered ridge, approximately 11 km north-west of the Lockhart River aerodrome (Figure 6).

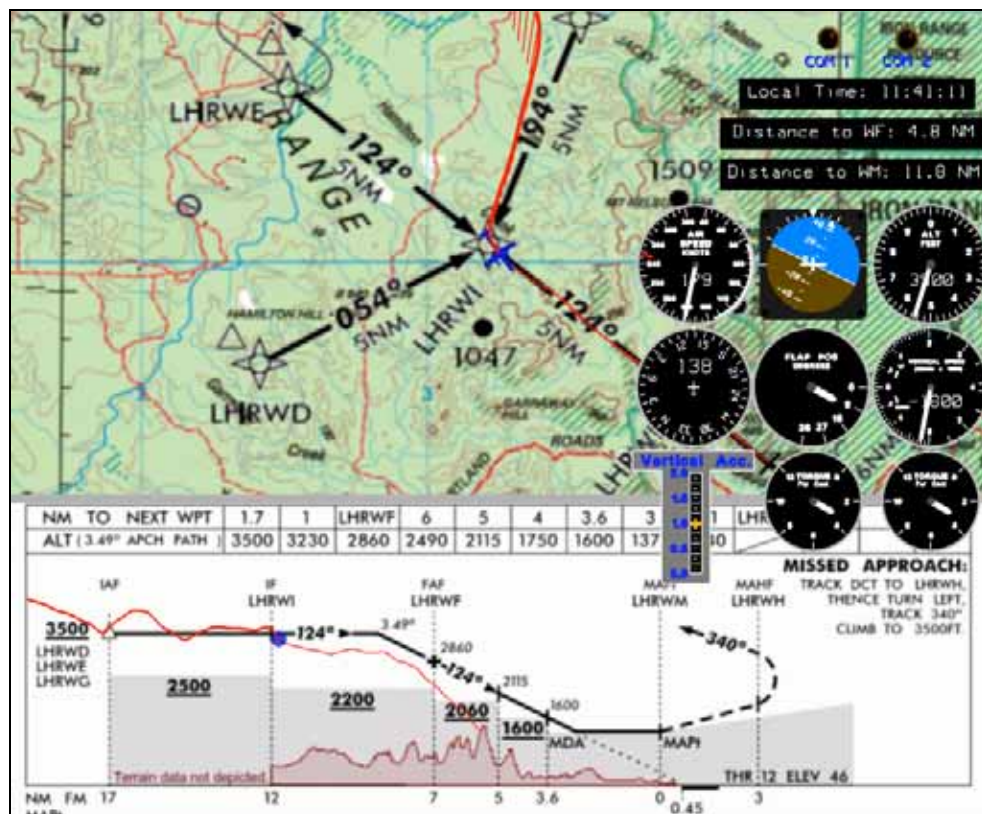
Figure 17: Screen image of FDR animation

Section 1.1 and Appendix A provide details of the information obtained from the FDR. An approach track and altitude profile, derived from the FDR data, are shown in Figure 4. An animation of the incident was prepared using Insight Animation™ software and is part of this report. A file containing the animation in Insight View™ format (.isv) is available for download from the ATSB website.<sup>79</sup> A still screen capture of the FDR animation is shown at Figure 17.

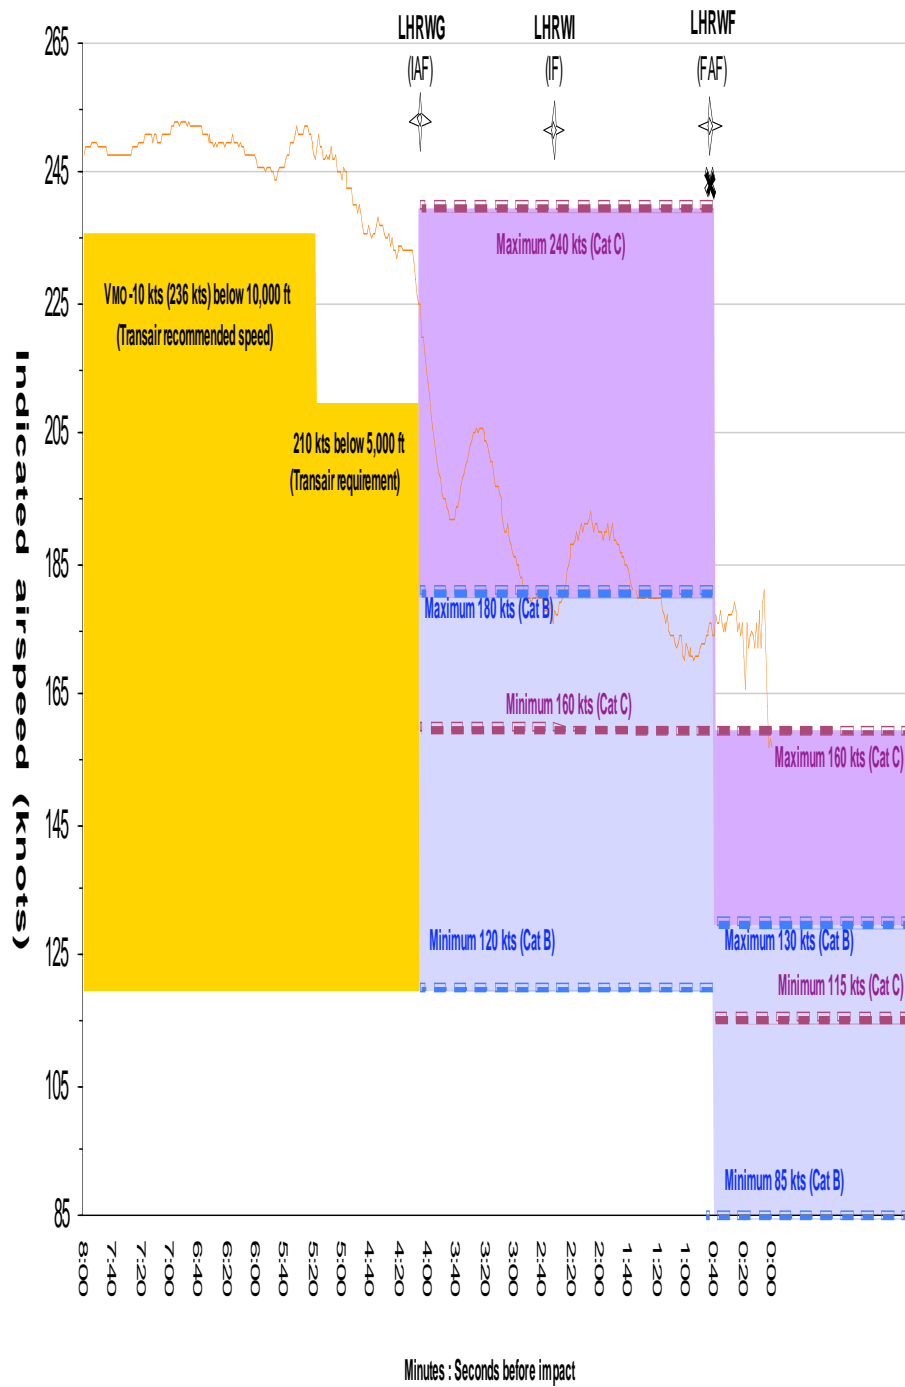
Figure 18: Approach speed profile<sup>81</sup>

The speed profile from the accident flight recovered from the FDR was compared with the maximum operating speeds defined in the *Transair Operations Manual* and the approach speeds specified in the *Aeronautical Information Publication* for aircraft performance Categories B and C (Figure 18).<sup>80</sup>

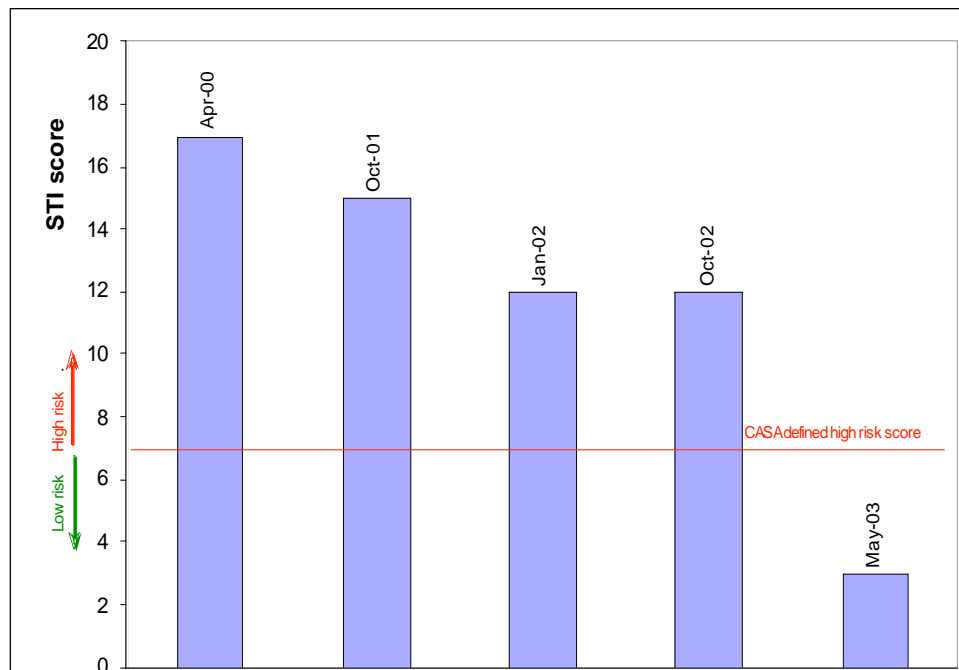
**Figure 29: Transair's safety trend indicator (STI) scores**

CASA inspectors completed five STIs on Transair between March 2000 and May 2003. Four of the STIs were completed after Transair commenced RPT operations. The summary results for the STIs, and a comparison with the 'high risk score' level, are presented in Figure 29. Further details on each of the STIs are presented in Appendix H.

There was no record on CASA files of special audits or spot checks being carried out on Transair operations after December 1999. CASA inspectors from the Brisbane airline office reported that they did not consider Transair to be a high risk operator.

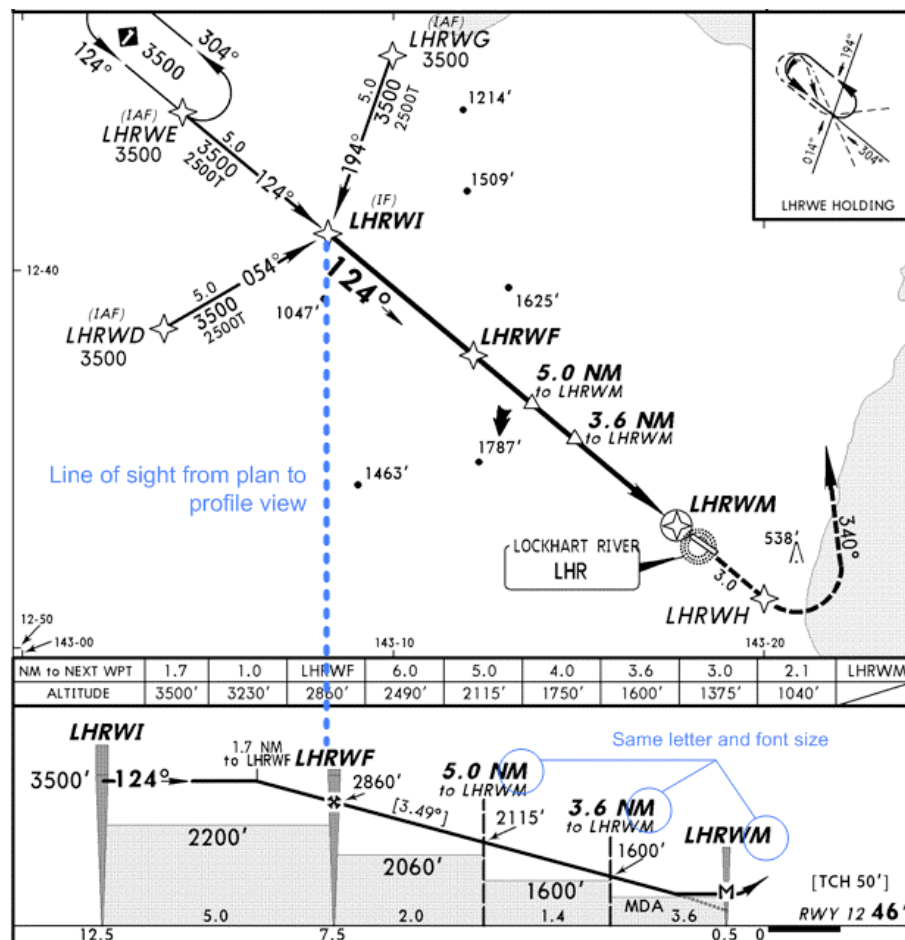
**Figure 35: Jeppesen chart line of sight between diagrams**

Unlike the Airservices charts, the Jeppesen charts did not display the first segment of the approach in the profile diagram from the initial approach fix (waypoints LHRWG/E/D) to the intermediate fix (waypoint LHRWI) (Figure 35). Instead, the profile diagram commenced from the intermediate fix. Jeppesen reported that this was to maximise the space available to display the details of the profile view. The plan-view provided details of all segments, starting from the initial approach fix.

For the Lockhart River runway 12 approach, the plan and profile-views superficially followed a similar spacing, but with one less segment on the profile diagram. As such, on the Lockhart River Runway 12 RNAV (GNSS) approach chart, the second waypoint (LHRWI) on the plan diagram was coincidentally aligned with the second waypoint (LHRWF) in the profile diagram (Figure 35).

On Jeppesen charts, the beginning of the intermediate altitude limiting steps (in between waypoints) was printed with the first line using the same font type and size, using capital letters for the nautical mile indications, and in the same

positions, as the waypoint names (Figure 35).<sup>160</sup> The final letter on the first line was 'M', as was the final letter for the missed approach waypoint before the runway. Furthermore, as explained in Section 1.19.4, pilots needed to focus on the last letter of a waypoint (as the first four letters were the same for all waypoints) to identify their position.

The Lockhart River Runway 12 RNAV (GNSS) approach chart was produced by Jeppesen only in black and white printing. On the plan-view diagram, the ocean was shaded grey and the terrain was white with high terrain depicted using spot heights (Figure 35), but no contour lines or terrain elevation shading. The ICAO Annex 4 *Aeronautical Charts*<sup>161</sup> stated 'Appropriate spot elevations are those provided by the procedures specialist.' The spot heights depicted that were closest to the approach were Mount Tozer to the South, (1,787 ft, highlighted by an arrow as the highest terrain on the chart) and Mount Dobson to the north (1,625 ft). North Pap and South Pap were not depicted. Therefore, there was no indication on the chart of the existence of terrain under the approach path.

The Jeppesen Lockhart River Runway 12 RNAV (GNSS) approach chart used by the pilots could facilitate position confusion if a pilot was visually scanning between the plan-view and profile-view diagrams. This was due to the absence of the approach segment from the initial approach fix to the intermediate fix being depicted on the profile diagram, and the coincidental alignment between the intermediate fix on the plan-view and the final approach fix on the profile diagram (see Figure 35 on page 152). This problem also existed on other Jeppesen RNAV (GNSS) approach charts.

After passing LHRWF, the crew needed to monitor their position in relation to the missed approach point (LHRWM) and the two intermediate altitude limiting steps ('5.0 NM' and '3.6 NM'), all of which had an 'M' at the end of the position or waypoint identifier (see Figure 35 on page 152). During high workload situations such as during an instrument approach, pilots needed to divide their attention between numerous visual tasks, only one of which involved the approach chart. As a result, it could be expected that the crew would be referencing the information on the chart using momentary glances. As the pilots needed to focus on the final letter of each waypoint identifier, and because the 'M' was the same font size and type in each position, this could lead to misidentification.

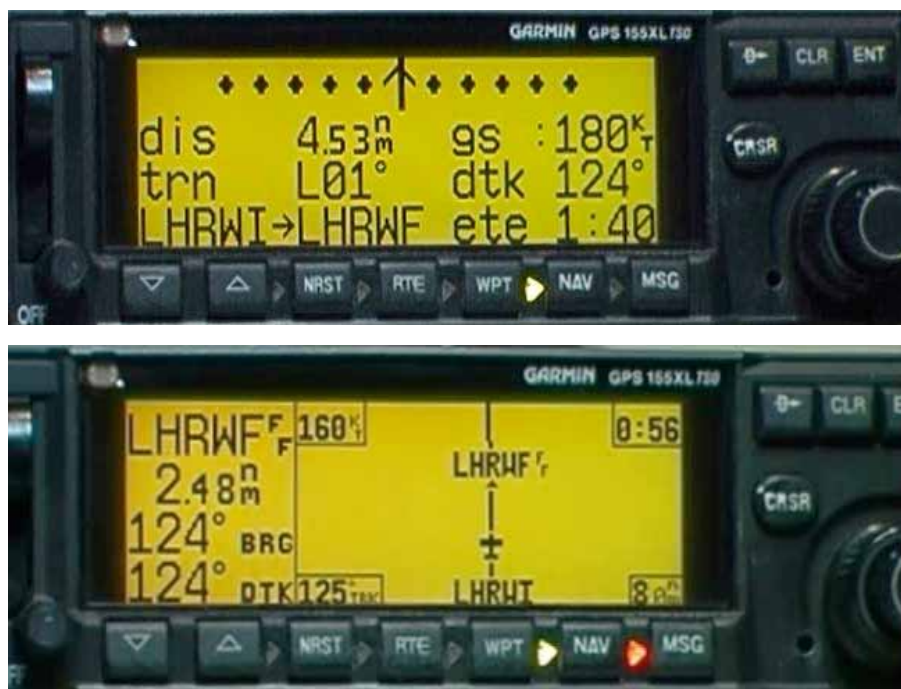
**Figure 38: Garmin 155XL NAV summary page (top) and MAP page (bottom)**

The Garmin 155XL GPS receiver fitted to VH-TFU had two display modes that the crew could have used: 'MAP' and 'NAV' summary. The MAP page, which included a moving map, showed a pictorial representation of the aircraft in relation to the waypoints, as well as limited numerical information. The NAV summary page only showed numerical information and the previous and next waypoints, along with a lateral deviation from track display as a course deviation indicator (CDI). Lateral tracking accuracy was also shown on the pilot in command's horizontal situation indicator (HSI). Numerical information displayed included track, and seconds and distance to the next way point (see Figure 38).

The moving map was available in the receiver, but the extent of the approach that could be shown on the screen was extremely limited due to the small vertical screen size in conjunction with the automatic scaling of the display which changed the scale from 20 NM to 1 NM as the aircraft approached each waypoint. The *Transair Operations Manual* did not specify which page should be used during an

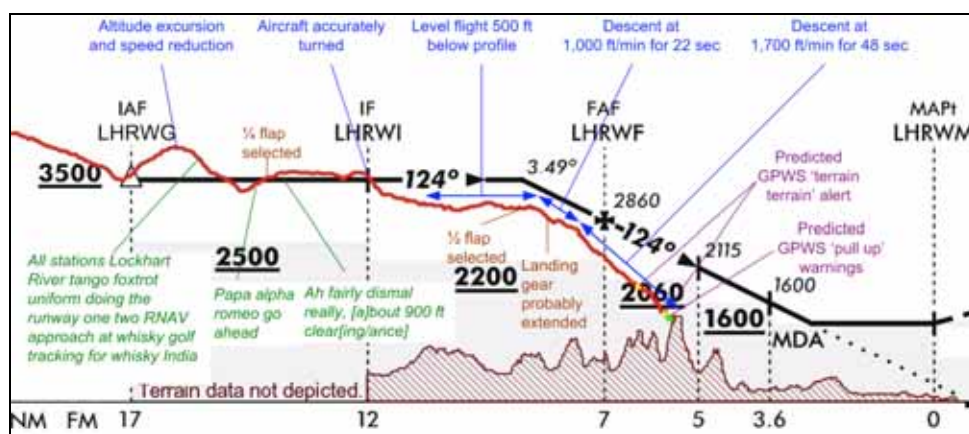
**Figure 40: Vertical approach profile.**

The FDR data also showed that as the aircraft passed abeam waypoint LHRWG (the initial approach fix, or IAF), the crew descended the aircraft to 3,500 ft above mean sea level (AMSL), which was the initial recommended approach altitude (see Figure 40). An altitude excursion to about 4,000 ft occurred after the aircraft passed the initial approach fix. The investigation was unable to determine the reason for this excursion, but it may have been an intentional manoeuvre to decelerate the aircraft.

At 1.4 NM before waypoint LHRWF (the final approach fix, or FAF), the crew recommenced the descent at 1,000 ft/min for about 22 seconds. The crew then reduced engine power from about 36 per cent to about 30 per cent, which further increased the rate of descent to an average of 1,700 ft/min over the final 48 seconds before the aircraft collided with trees at 1,210 ft AMSL. During this final descent, at about 28 seconds before the impact with terrain, the crew descended below the segment minimum safe altitude of 2,060 ft.

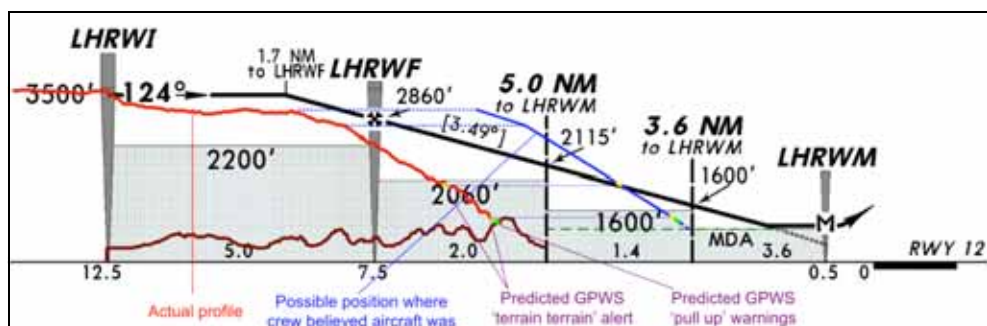
**Figure 41: Profile that the crew may have believed they were following overlaid on a Jeppesen profile diagram. (Note: diagram not to scale.)**

Rather than confusing one waypoint with another, the crew may have confused the altitude limiting steps. The FDR data indicated that, at the descent rate recorded, the aircraft would have reached between 900 and 1,000 ft at about the altitude limiting step '5.0 NM to LHRWM' (5 NM to the missed approach waypoint) on the Jeppesen chart (see Figure 2 on page 2). This would have placed the aircraft at about the minimum descent altitude (MDA, or 1,040 ft) at the '5.0 NM to LHRWM' position. Therefore, the crew may have confused the '5.0 NM to LHRWM' position with either the '3.6 NM to LHRWM' position or the LHRWM waypoint. The blue profile shown on Figure 41 corresponds to what the crew would have believed the flight path to be according to such a scenario. The red profile corresponds to the actual flight path of the aircraft.

Alternatively, the distance from the LHRWF to the LHRWM was 7 NM, whereas on most approaches the distance between the final approach fix and the missed approach point was 5 NM. If the crew thought they were 2 NM closer to the missed approach point prior to reaching LHRWF, then the initiated rate of descent would have also placed the aircraft at the minimum descent altitude at about the '5.0 NM to LHRWM' position (or where the crew thought was about 3 NM to the missed approach point). This scenario would also correspond to the blue profile on Figure 41.

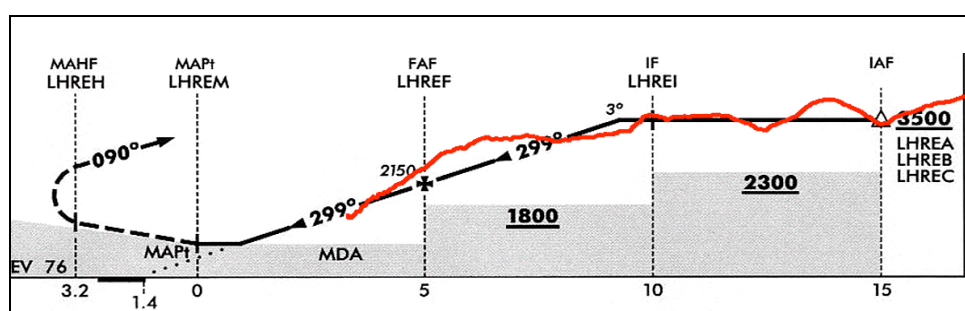
**Figure 42: Vertical profile of VH-TFU overlaid on a Lockhart River Runway 30 RNAV (GNSS) approach profile diagram**

However, this scenario would not be consistent with the aircraft levelling out at about 3,000 ft. In addition, the crew had broadcast that they were conducting a runway 12 approach via the 'whiskey golf' waypoint. The equivalent point on the runway 30 approach was 'echo charlie'. The GPS unit would also have been showing 7 NM instead of 5 NM after passing the intermediate fix (LHREI).

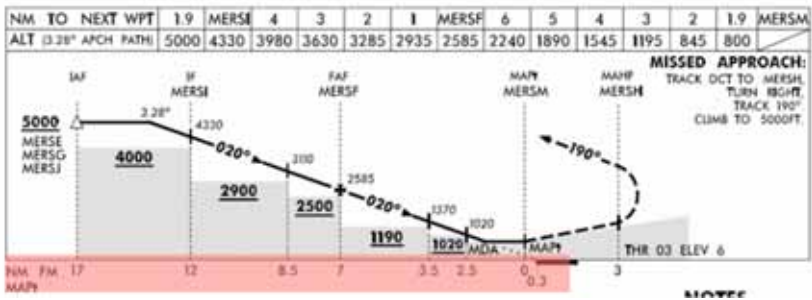
All Australian DAP RNAV (GNSS) instrument approach charts produced by Airservices Australia have distance to the MAPt reference from the Initial Approach Fix (IAF) to the MAPt below the profile view of the procedure (see Fig 1 below). The distances shown below the profile are in a similar format to existing conventional procedures.

Fig 1 – Merimbula, Rwy 03 RNAV (GNSS) approach plate profile – Distance-to-go highlighted below the profile

Approach procedures in areas of high terrain can be more complex. The example shown, Merimbula 03 RNAV (GNSS) procedure, has one 'non-ideal' segment length, the final approach segment of 7nm. By inspection and well inside the capabilities of pilots to calculate, the distance is 17nm (5+5+7) from the initial approach fix to the MAPt (clearly shown below the profile view on the chart – see Fig 1).
