**ATSB TRANSPORT SAFETY REPORT**

Aviation Occurrence Investigation AO-2007-037

**Controlled flight into terrain - 24 km S Tully, Qld**

**Pacific Aerospace Corporation Cresco 08-600**

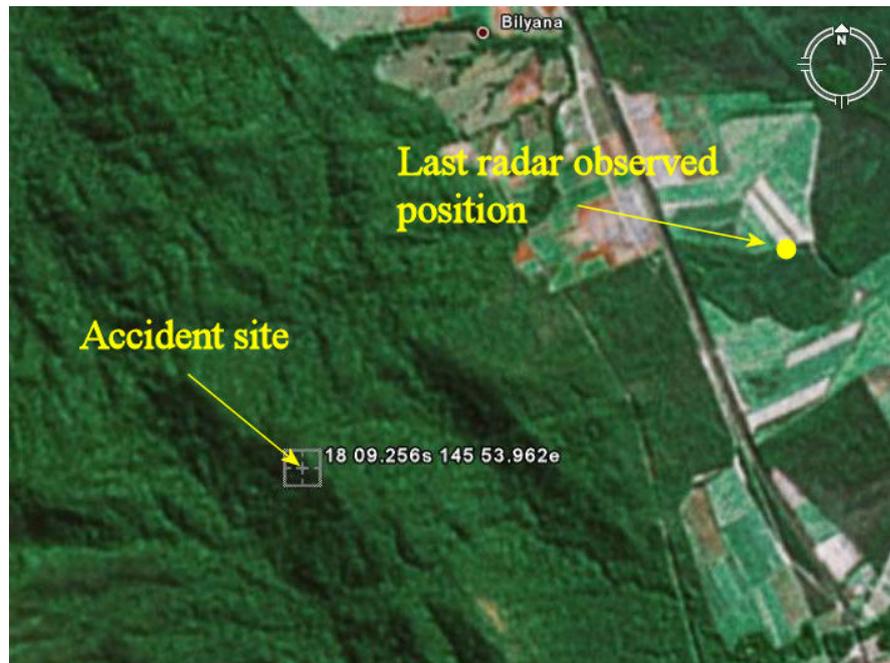
**Figure 1: Satellite image of accident location**

It was not until the next day that the pilot and aircraft were reported missing. Australian Search and Rescue<sup>2</sup> (AusSAR) was notified and a search, based on the last air traffic control radar observed position of an unidentified aircraft from a replay of recorded radar data together with witness reports from the area, was initiated. Searchers located the aircraft wreckage on the morning of 18 August. The aircraft had impacted mountainous terrain in a state forest 24 km south of Tully (Figure 1). The pilot was fatally injured and the aircraft was destroyed.

The next radar return had been recorded at 1511:21, 21.7 km (11.7 NM) south of Tully. The aircraft appeared to have been in a climbing left turn before descending and taking up a south-westerly heading. The aircraft once again disappeared from radar and the last observed radar return at 1512:26 was later calculated to be 3.3 km (1.8 NM) from the accident site (Figure 1), with a groundspeed of between 100 and 120 kts.

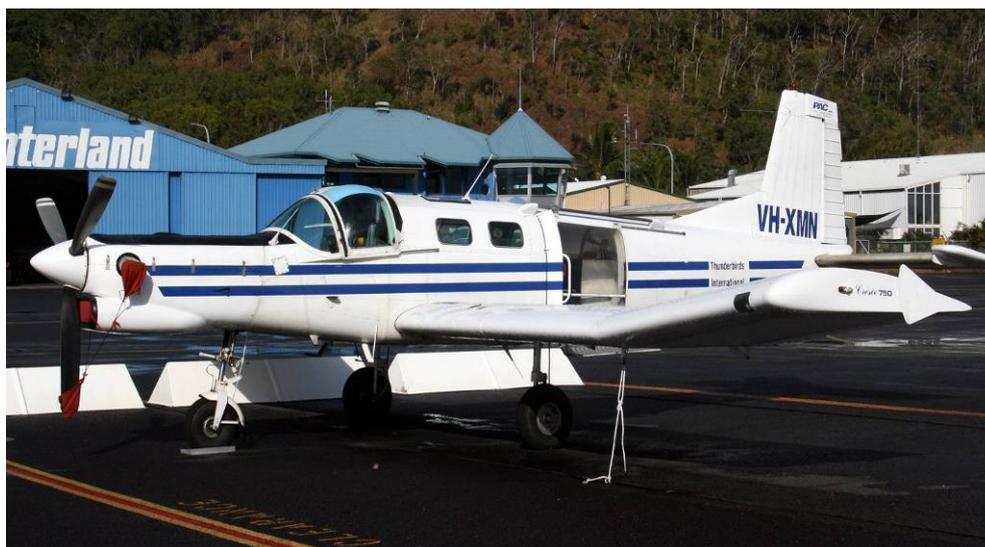
**Figure 2: VH-XMN**

The aircraft, serial number 036, was manufactured in New Zealand in 2002 and was first registered in Australia in July 2004. The aircraft was of a low wing, fixed tricycle undercarriage design (Figure 2). It was powered by a single Pratt and Whitney Canada PT6A-34 750 horsepower turboprop engine and was fitted with a constant-speed, reversible, three-bladed Hartzell propeller. The total time in service for both the airframe and engine prior to the accident flight was 2,617 hours.

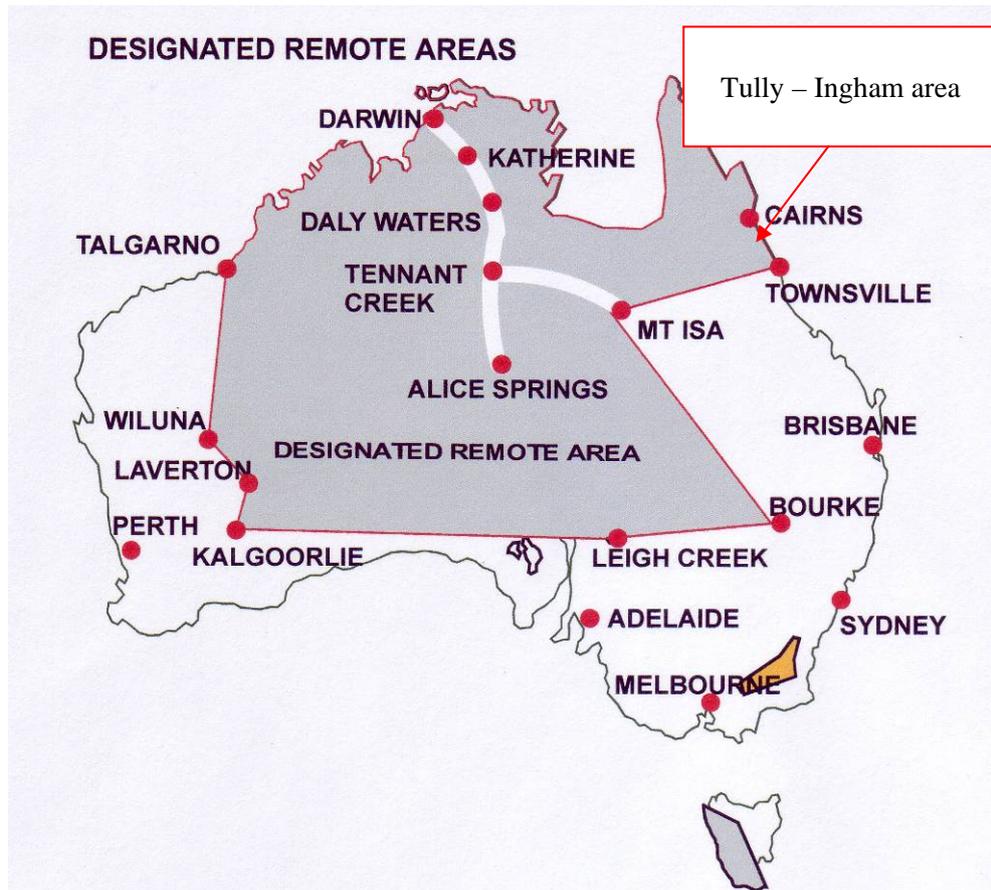
Figure 3: Designated Remote Areas<sup>8</sup>

The pilot did not submit a flight plan for the flight and the AIP<sup>6</sup> did not require him to do so. There was also no record of the pilot having provided any other flight notification such as a SARTIME<sup>7</sup> or Flight Note (Appendix A). The AIP required pilots of VFR flights operating within a Designated Remote Area (DRA) to submit one of those two forms of notification. A flight from Ingham to Tully was within a DRA (Figure 3).
