**ATSB TRANSPORT SAFETY REPORT**  
Occurrence Investigation Report AO-2007-029  
Final

**In-flight breakup – Clonbinane, Vic.**

**31 July 2007**

**VH-YJB**

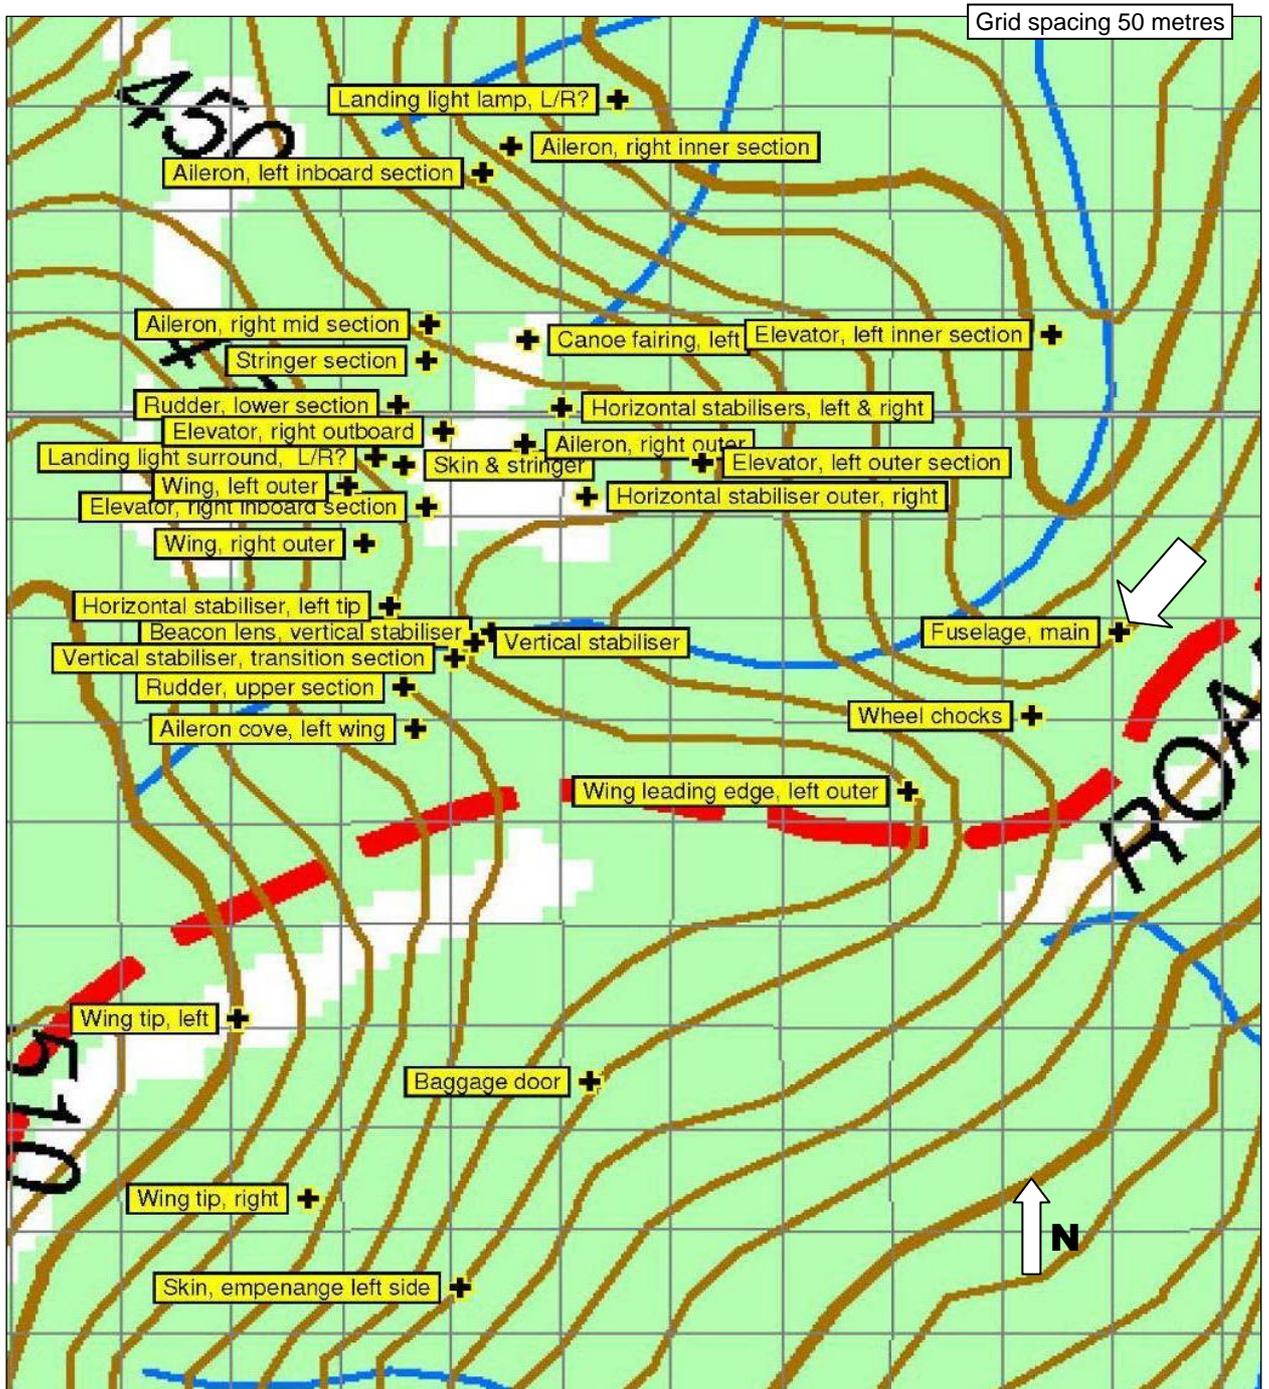
Figure 1: Wreckage distribution (main fuselage arrowed)

All of the aircraft wreckage was recovered from the accident site after each item was identified and its position recorded (Figure 1). All structural components that had separated from the main fuselage of the aircraft (see Table 1) were relocated to a hangar at Tyabb Aerodrome, Vic. where they were arranged in a layout fashion that represented the original aircraft structure. To facilitate the study of the wing failures, the inboard fracture surfaces and adjacent material (approximately 30 cm) were removed from the inboard section of both wings and transported to Tyabb with the other items.

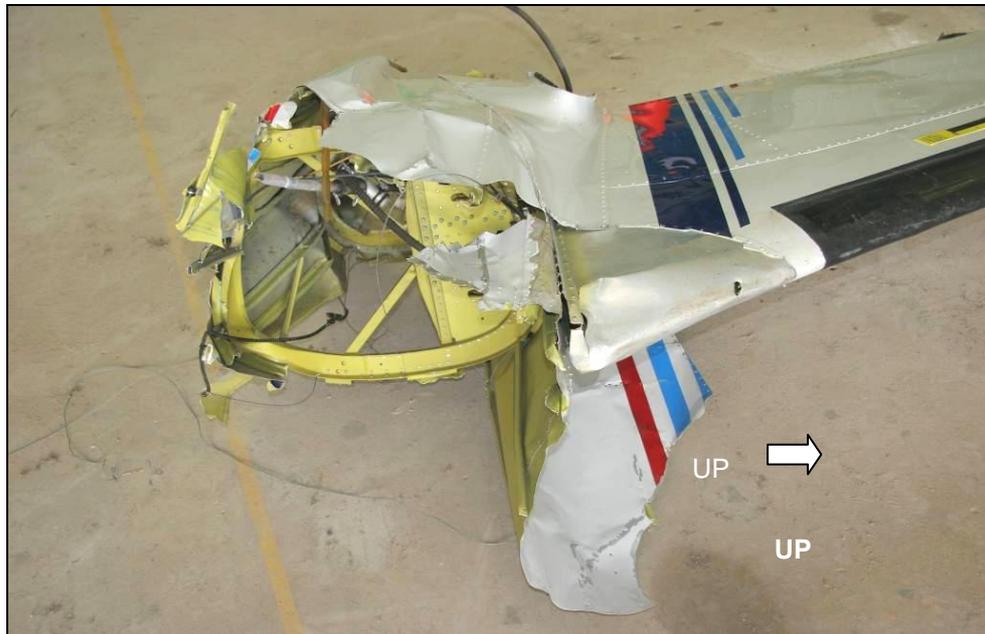
The aircraft empennage had separated from the main fuselage along a transverse diagonal plane, extending from around station 292 at the top of the fuselage, to station 312 at the fuselage base (refer to Figures 4 and 20). The separated empennage had itself broken into two principal sections – the forward-most section carrying the vertical stabiliser and sub-structure (Figure 21); the rear section comprising both horizontal stabilisers, carry-through structure, control surface rigging and tail-cone (Figure 22). Separation between the two empennage sections had occurred predominantly along the bulkhead at fuselage station 335 (Figures 23 and 24).

**Figure 21: Forward empennage with vertical stabiliser – corresponding view to Figure 20. Bulkhead visible is at fuselage station 312.83**

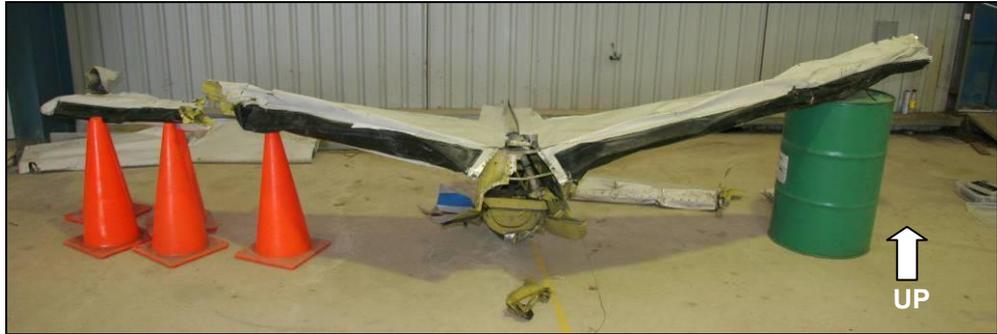
**Figure 22:** Rear empennage section including horizontal stabilisers and tail cone

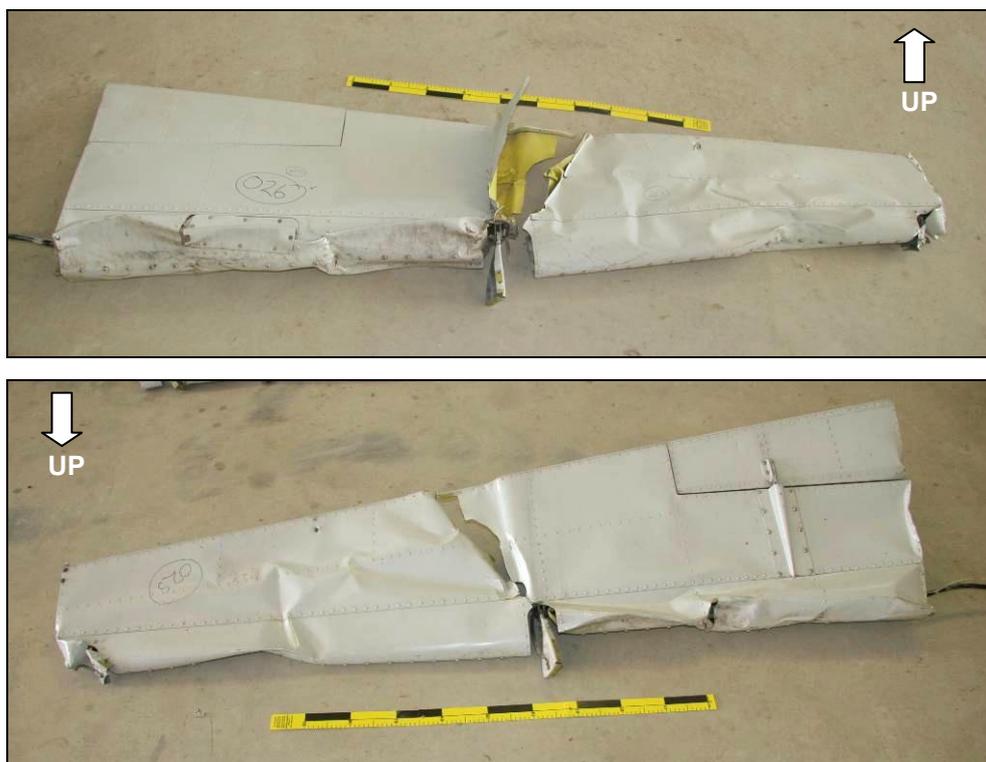
**Figures 25 & 26: Left elevator control surface**

Without exception, all surfaces had fractured into two or three sections, with failure typically occurring transversely through the region adjacent to the centrally-located hinge point (Figures 25 – 28). All such fractures were typical of a tearing failure mode, with the buckling and creasing of the surface skin towards the trailing edges suggesting the contribution of backward-bending forces.

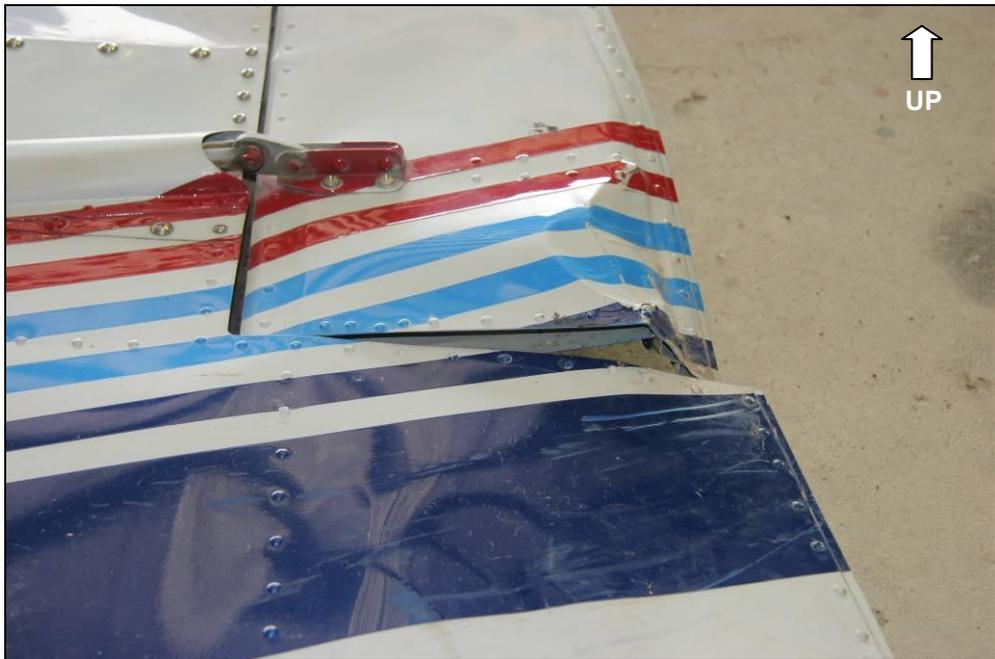
**Figure 34: Rudder trim-tab position, as-recovered**

Both elevators and the rudder carried individual trim-tabs set along the trailing edges. All tabs were comparatively undamaged and had remained in-situ on their respective surfaces during the breakup event. The left elevator tab (pitch trim) presented in a near-neutral position with respect to the primary surface, whereas the right elevator tab presented slightly tab-up (aircraft nose down trim effect). Some indentation and impact damage to the tab pushrod and surrounding structure of the right elevator may have accounted for the elevator tab position discrepancy. The rudder trim-tab (yaw trim) was also intact, positioned slightly to the left of centre (aircraft nose right trimming effect). The aircraft was not equipped with an aileron (roll) trim facility.

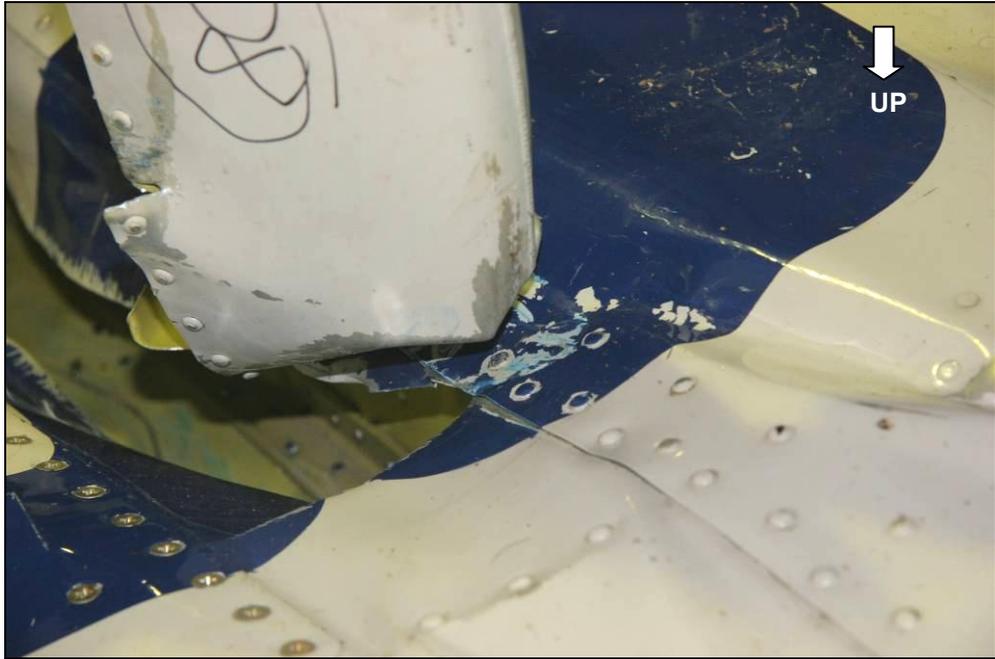
**Figure 42: Left horizontal stabiliser tip held to indicate possible source of semi-elliptical paint mark and angular skin puncture**

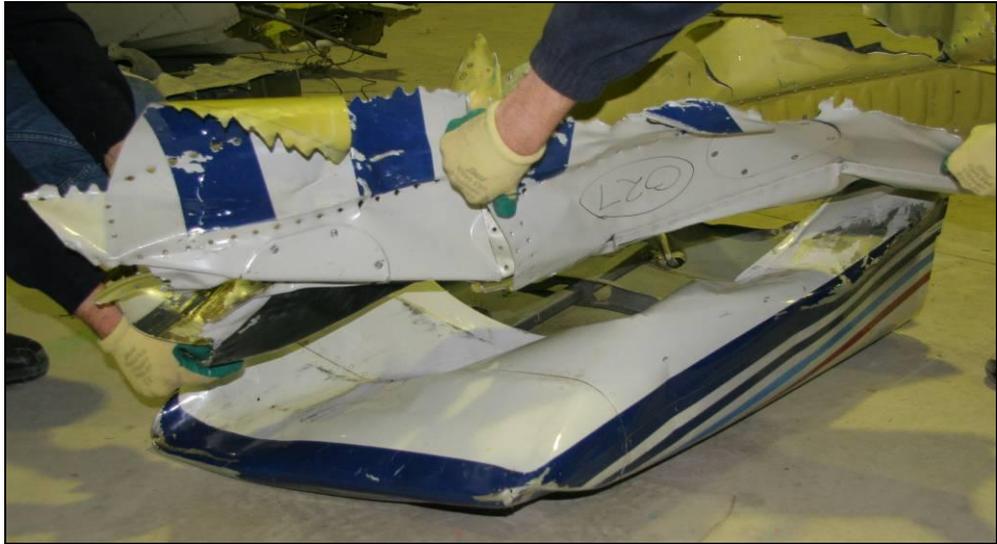
The rear nacelle fairing (canoe fairing, item 021) from the left engine / landing gear assembly had sustained a forceful impact with structure along a line extending diagonally across the wheel-well region on the underside of the fairing. Dark smears, similar to those visible along the underside of the right wing, were associated with the impact line.

**Figure 45: Left wing inner leading edge section (item 027) held to illustrate conformance with the nacelle impact damage**

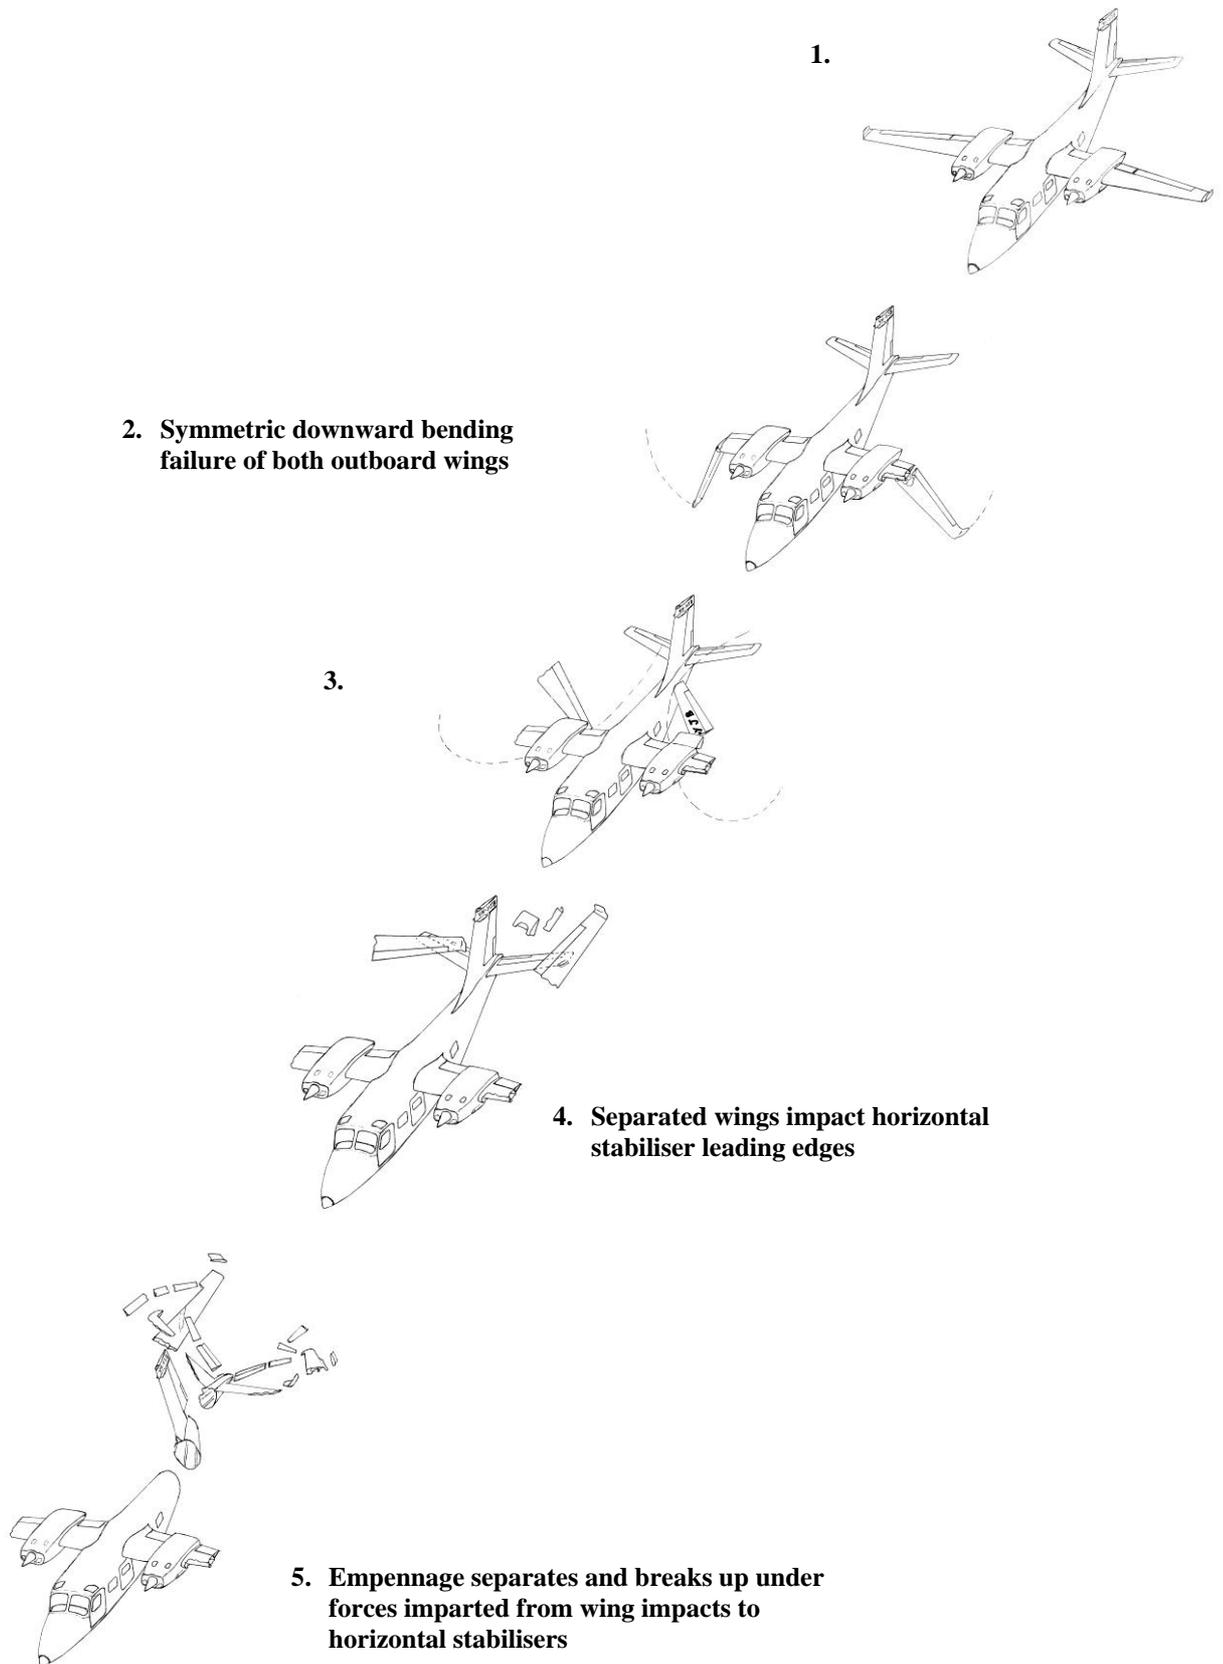
**Figure 46: Illustrated impression of the probable aircraft breakup sequence**
