**ATSB TRANSPORT SAFETY REPORT**

Aviation Occurrence Investigation AO-2006-001

**Loss of control – 9 km SE Raglan, Qld**

**Piper Aircraft Corporation PA-31-350**

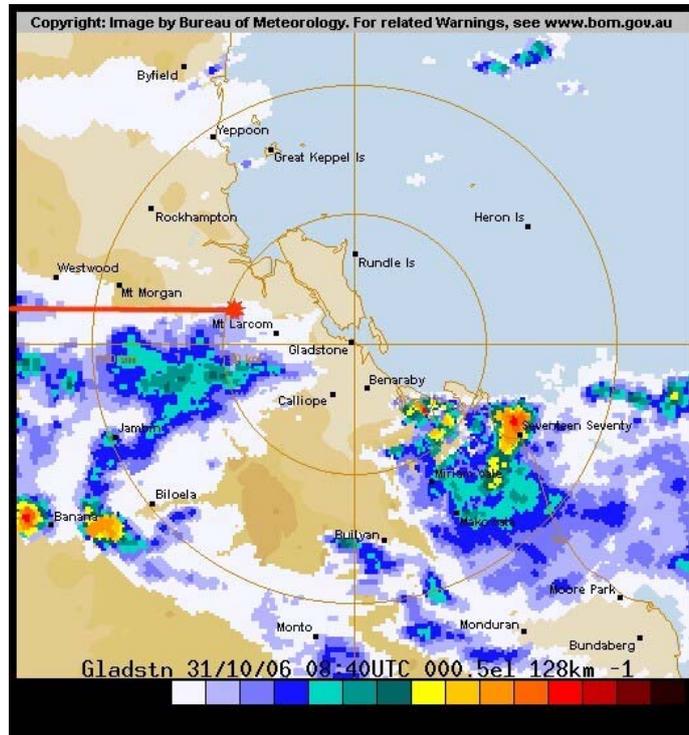
**Figure 4: Bureau of Meteorology Gladstone Weather Radar image, 128 km radius, recorded on 31 October 2006 at 1840. The approximate track of the aircraft, and the accident location, are shown in red**

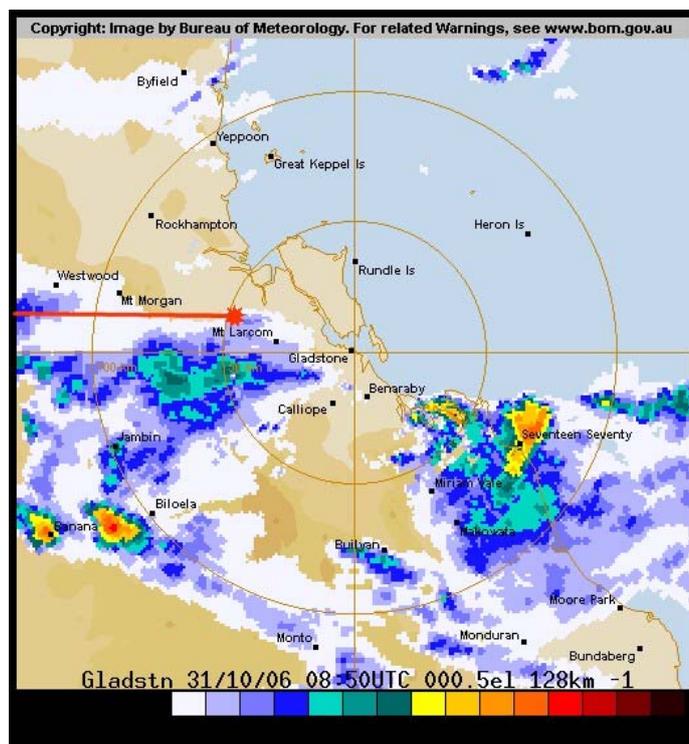
**Figure 5: Bureau of Meteorology Gladstone Weather Radar image, 128 km radius, recorded on 31 October 2006 at 1850. The approximate track of the aircraft, and the accident location, are shown in red**

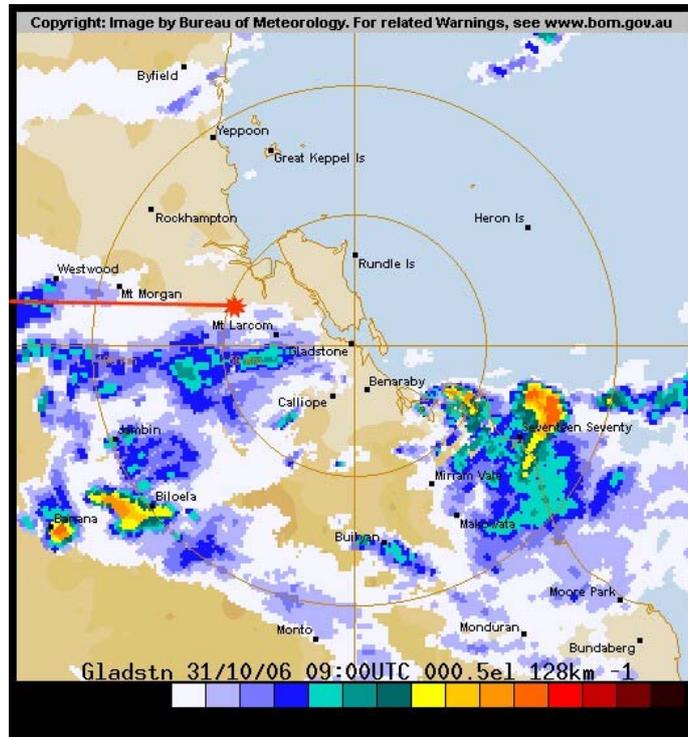
**Figure 6: Bureau of Meteorology Gladstone Weather Radar image, 128 km radius, recorded on 31 October 2006 at 1900. The approximate track of the aircraft, and the accident location, are shown in red**
