Air Accidents Investigation Branch

**Report on the accident to
Beech 200C Super King Air, VQ-TIU
at 1 nm south-east of North Caicos Airport
Turks and Caicos Islands, British West Indies
on 6 February 2007**

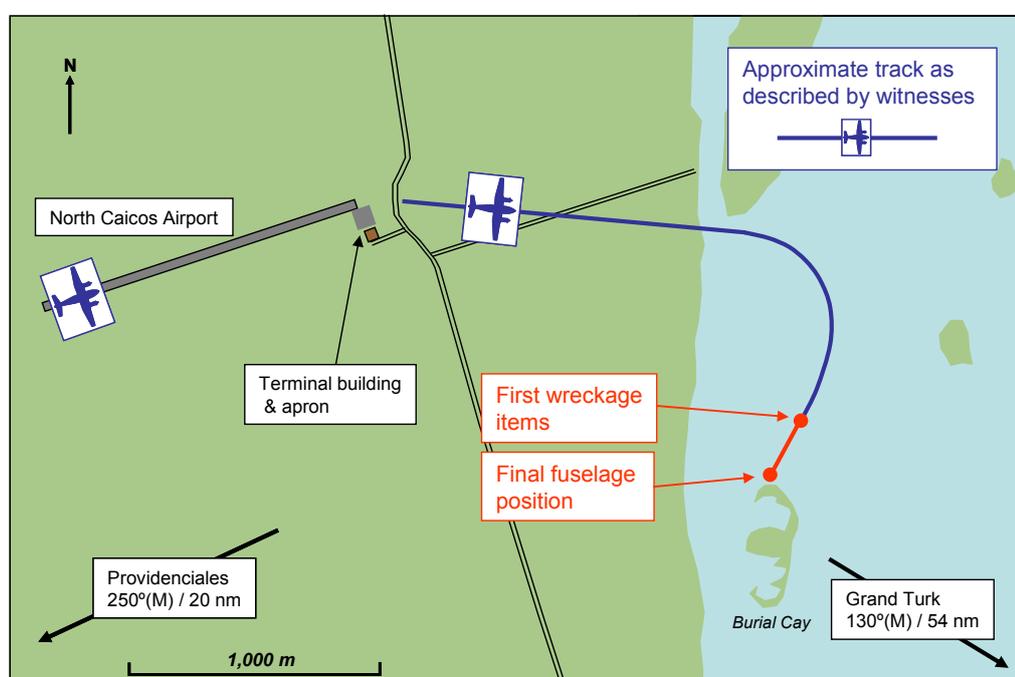
Figure 1

The witnesses collectively described the aircraft climbing ahead until just after crossing the coast, after which it started a right turn. The initial track they described may have been up to 20° to the right of the runway heading. The approximate flight path as described by witnesses is shown at Figure 1, together with the accident site location.

Those witnesses who saw the aircraft turn right described it rolling to a larger than normal bank angle (variously described as being banked between 45° and 70° to the right). As the aircraft banked it began to descend, and the witnesses realised that the aircraft was no longer following a normal profile. It descended at a relatively high speed, remaining in a banked, right wing low attitude.

Aircraft flight path as described by witnesses, with location of impact and wreckage trail

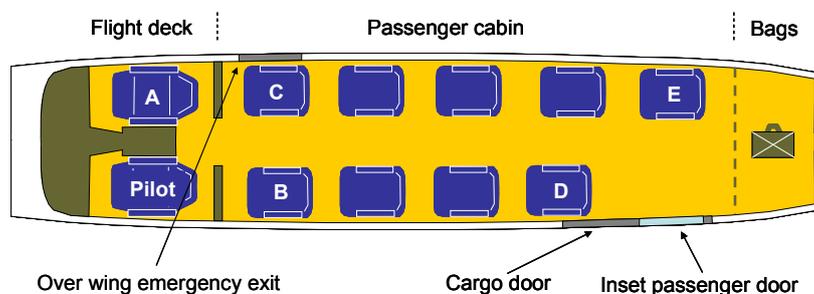
Figure 2

General aircraft layout and seating positions

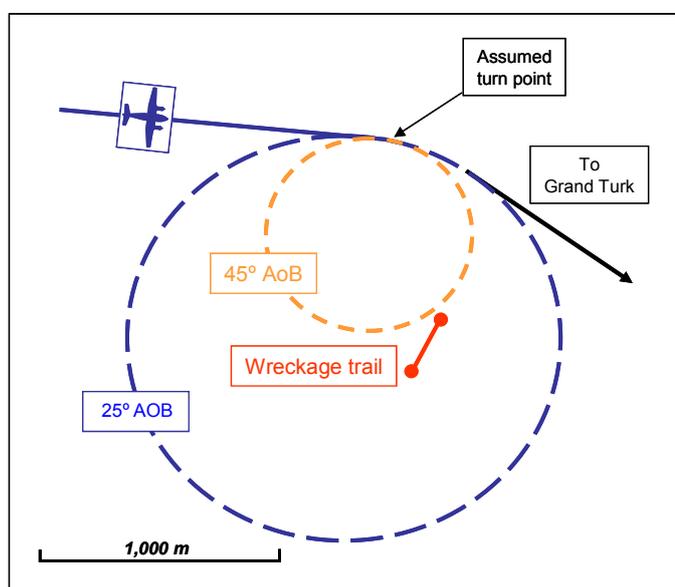
The turn towards Grand Turk should have involved a track change of about 30° , allowing for the initial track being somewhat to the right of the Runway 08 centreline. Figure 3 shows the approximate turn point and a turning diameter for an aircraft flying in nil wind at 125 kt with a steady 25° angle of bank (AOB). This would be about the maximum AOB for normal operations. For comparison purposes, a turn diameter is shown for 45° AOB. For an aircraft maintaining level flight, this would require a constant load factor of 1.4g.

Aircraft turn performance

As Figure 3 (page 13) shows, only a moderate angle of bank was required to take up a track towards its destination, Grand Turk, yet a much greater angle of bank must have been reached for the aircraft to achieve the turn that it did, and this is confirmed by witness accounts.

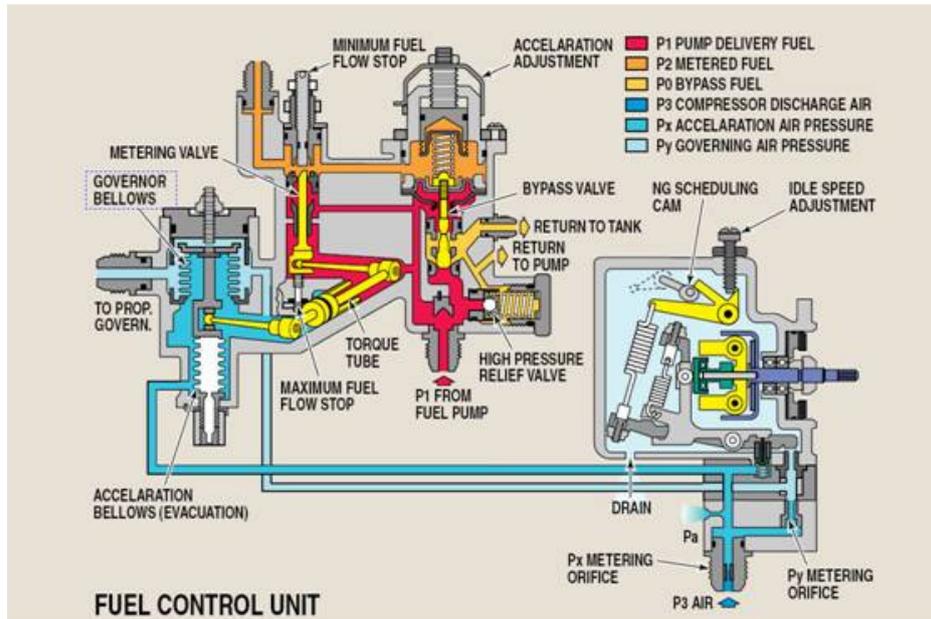
Figure 7

The second failure concerned the bellows assembly within the right engine FCU, a schematic illustration of which is presented at Figure 7. It can be seen that the assembly comprises the governor bellows and the acceleration bellows, the latter being evacuated. The tandem arrangement of the combined bellows assembly acts on a torque tube that in turn alters the position of the fuel metering valve and hence the fuel flow. The governor bellows initiates acceleration, deceleration and controls the gas generator rpm (N_g) steady state, with bellows movement being achieved by modified compressor discharge air, P_Y . The evacuated acceleration bellows expands or contracts in response to changes in another compressor discharge pressure derivative, P_X . An increase or decrease in P_Y will respectively increase or decrease the N_g , as it acts solely on the governor bellows. The evacuated acceleration bellows are attached to the FCU housing, whilst the rest of the bellows assembly is allowed to move up and down depending on P_X and P_Y . The acceleration bellows thus control the acceleration and deceleration rates in response to P_X variations following changes in N_g .

Schematic diagram of Fuel Control Unit

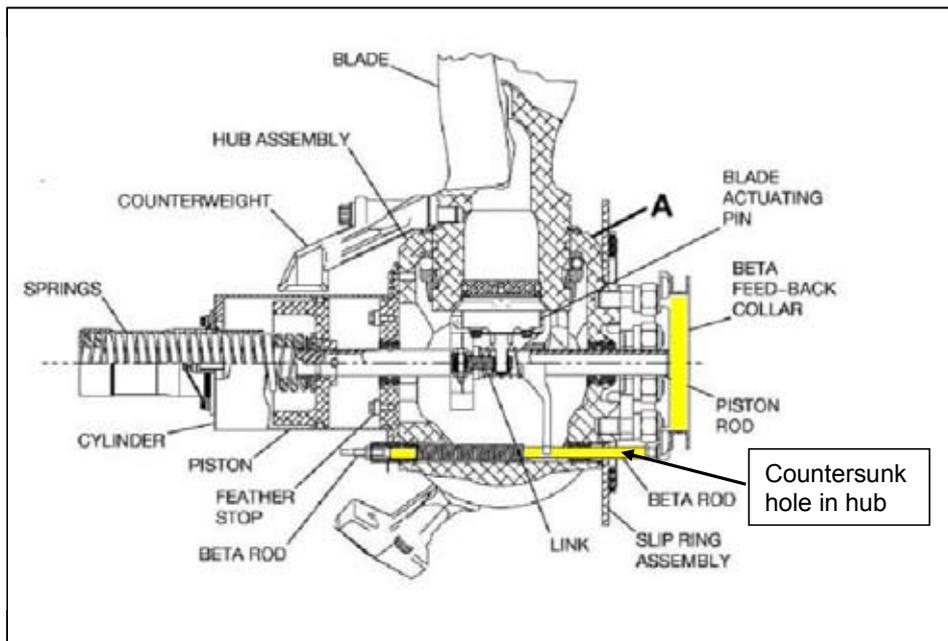
Figure 11

A schematic diagram of the propeller hub is shown in Figure 11. Propeller pitch angle is a function of the position of the piston in the cylinder, which in turn is determined by propeller governor oil pressure behind the piston, operating in opposition to the force generated by the counterweights and feathering springs. Thus, in the diagram, the piston, which is shown in a representative position in the middle of the governed range, moves to the right for feather, to the left for flight idle and further left for reverse pitch. The beta feedback collar does not move significantly to the right of the position shown on the diagram, but moves progressively to the left with decreasing pitch angles below flight idle, such that the lock-nuts on the beta rods, close to their attachments to the collar, enter the countersunk holes in the hub that contain the beta rod bushings.

Section through propeller hub, showing beta rods and feed back collar (highlighted)

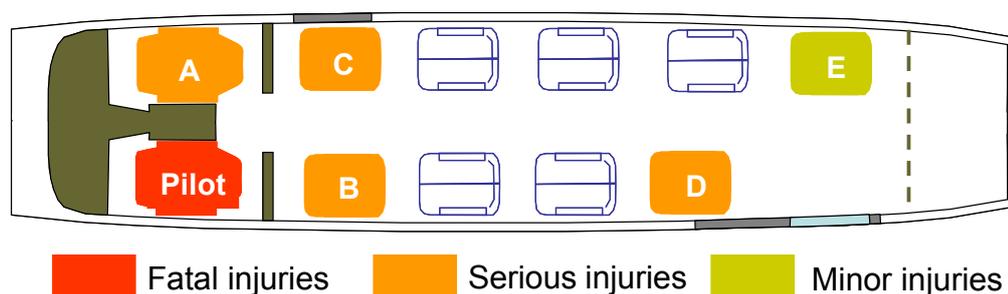
Figure 13

All five passengers were injured in the accident, with the most serious injuries occurring to those in the forward cabin, as shown at Figure 13. The two occupants at the rear of the cabin sustained the least injuries and were treated locally in the TCI. The remaining three passengers were flown to Miami, USA, for treatment.

Occupant injuries by seat position

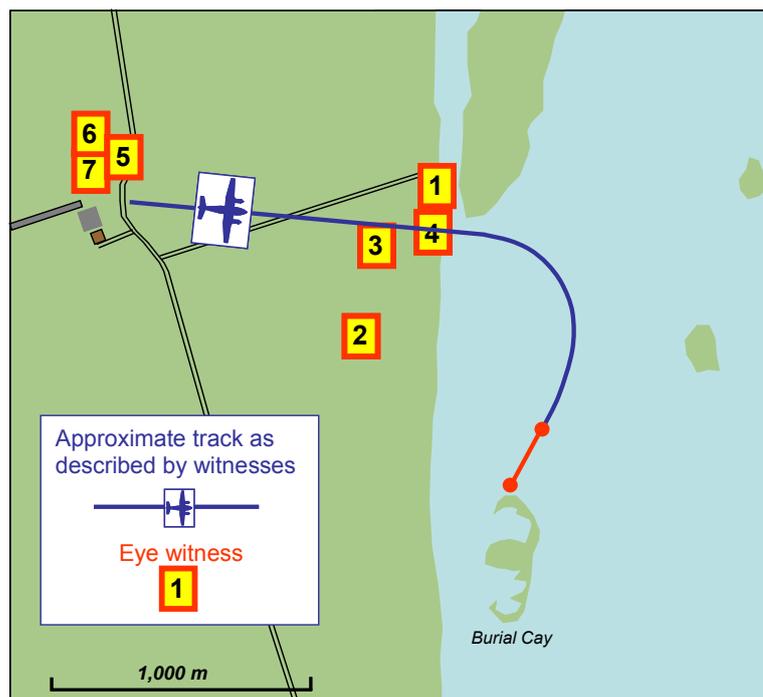
Figure 16

There were seven known eyewitnesses who saw the aircraft in flight. Of these, five saw it turn and descend and one reported seeing the impact. Two further witnesses saw the initial part of the climb only. Those who saw the majority of the final descent described it as occurring over a period of just seconds. The witness locations are shown at Figure 16.

Witness locations
