CIAIAC

Final report A-019/2008

Accident involving
a PILATUS PC6-B2H4
Turbo-Porter aircraft,
registration EC-JXH,
in Lillo (Toledo),
on 30 May 2008

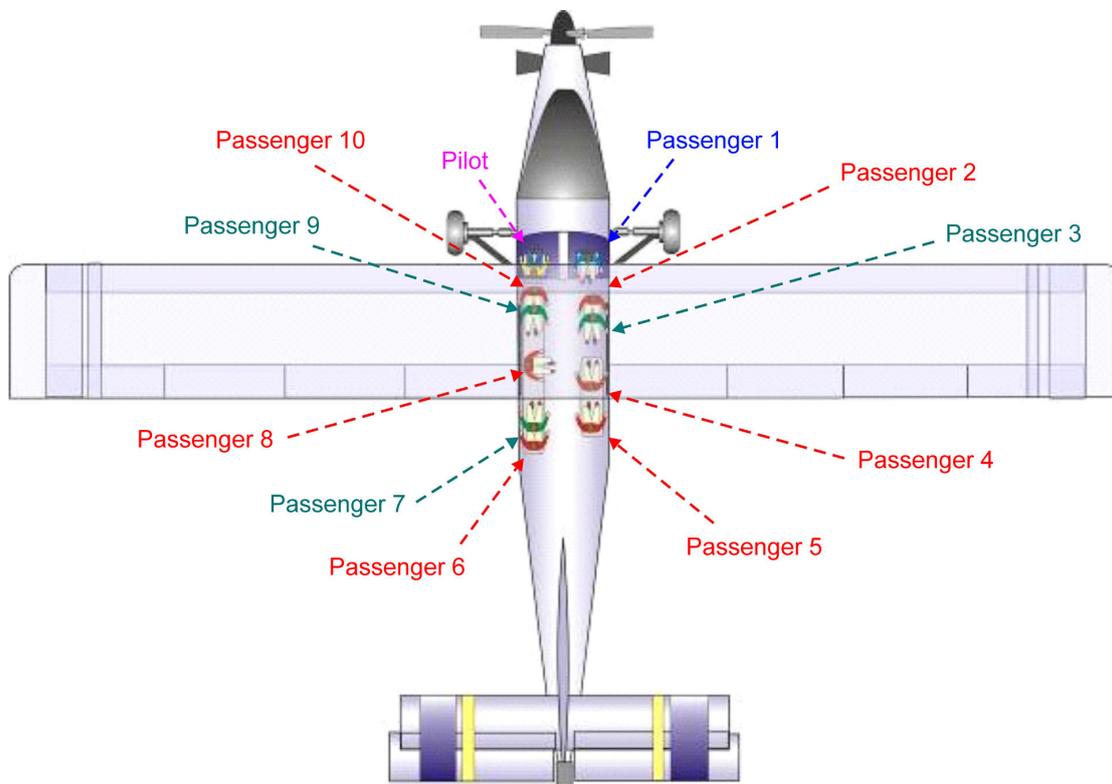
Figure 6. Positions of the occupants

Figure 6 shows the seating arrangement in the airplane, as reported by the occupants. The passengers are numbered clockwise, starting with the one seated next to the pilot (passenger 1). There was a small bench on the right side of the airplane where passengers 4 and 5 were seated. Passengers 2 and 3 were on the floor. There was a longer bench on the left side where the other five passengers were seated.

Two different cases were considered for the calculation. In the first, and as shown in the below figure, passengers 4 and 8 were assumed to have the same arm (4.57 m) for the momentum calculation. The same assumption was used for passengers 5, 6 and 7 (5.28 m).

In any event, for the weight and number of passengers on the airplane, small variations in their locations could cause the center of gravity to shift outside the flight envelope.

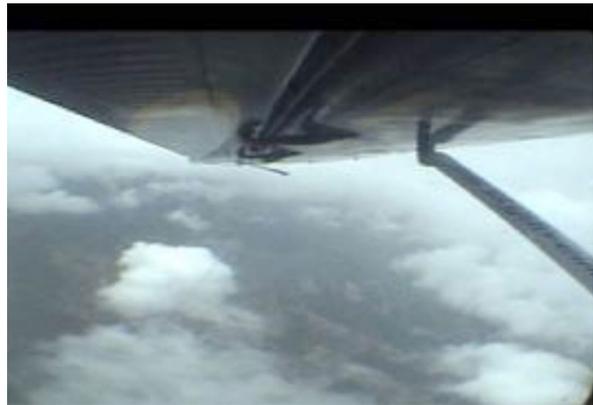
Figure 9. View from inside

One of the parachutists was recording during the climb on a camera mounted on his helmet (figure 9). Later, during the fall, the camera turned on inadvertently when he hit his head as he was ejected from the airplane, so part of the fall was recorded. The footage shows the atmospheric situation described above, with abundant clouds (figures 10 and 11).

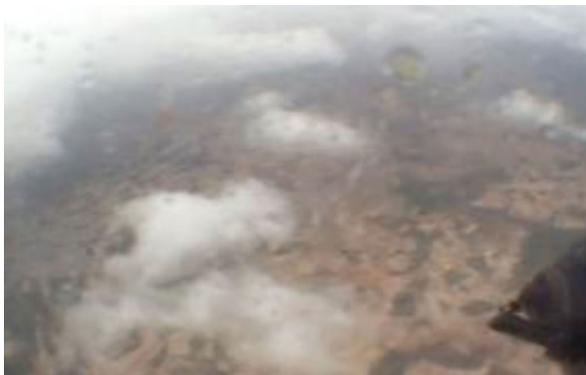
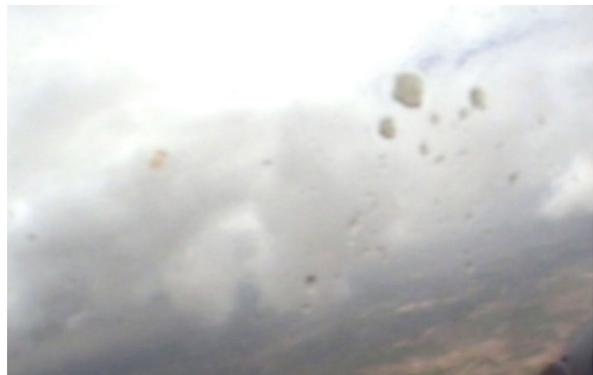
Figure 10. Photograph during fall

Figure 11. Photograph during fall
