**AVIATION INVESTIGATION REPORT
A11H0002**

CONTROLLED FLIGHT INTO TERRAIN

**BRADLEY AIR SERVICES LIMITED (FIRST AIR)
BOEING 737-210C, C-GNWN
RESOLUTE BAY, NUNAVUT
20 AUGUST 2011**

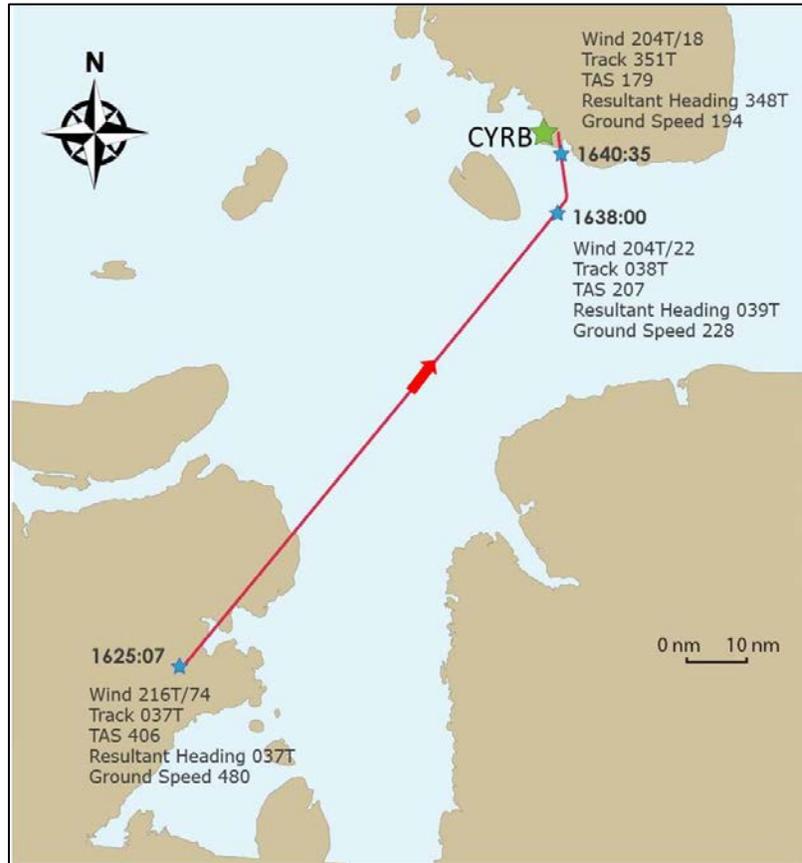
A wind triangle may be used to make calculations of unknown variables if sufficient other variables are known (Figure 3 and Table 8).

Figure 3. Locations for heading calculations

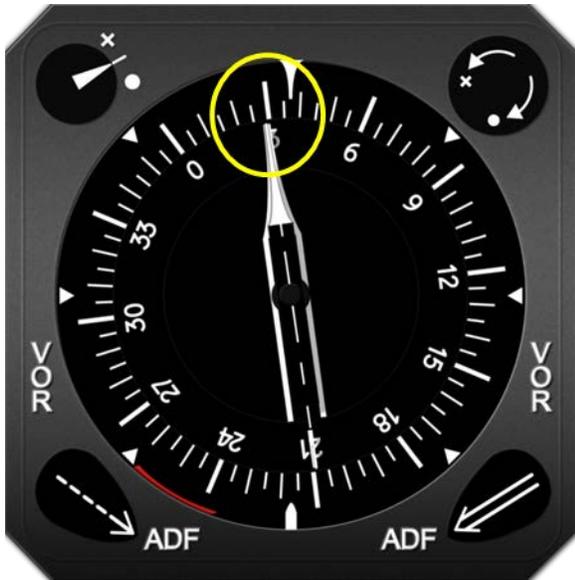
Radar and wind data show that the aircraft was tracking 037°T to MUSAT with no wind drift. The correct post-procedure radio-magnetic indicator (RMI) indications, assuming no NDB/ADF (automatic direction finding) error influence, should have been ADF bearing pointer head at 029°T, with the resultant true heading 037°, under the lubber line (Figure 12).

Figure 12. 1625:07: Exemplar of first officer (FO) radio-magnetic indicator (RMI) (no. 2 compass), showing expected true indications with no heading error

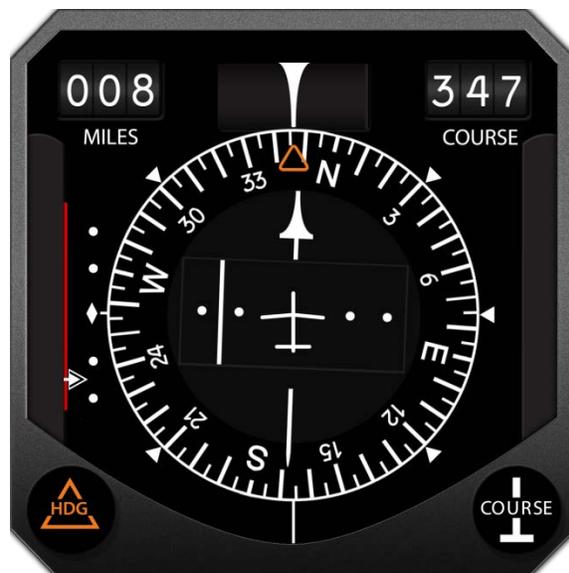
Figure 17. Exemplar of captain's HSI (no. 2 compass) indications at 1639:10, had there been no heading error

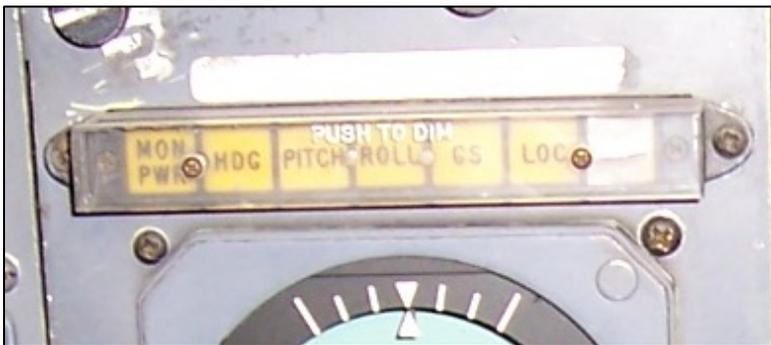
An instrument warning system is installed which compares the captain's and FO's compass headings, pitch and roll attitude indications, and localizer and glideslope deviation outputs from the no. 1 and no. 2 VHF NAV units. An instrument comparator annunciator (Photo 6) is located above each pilot's instrument display.

Photo 6. C-GNWN captain's instrument comparator

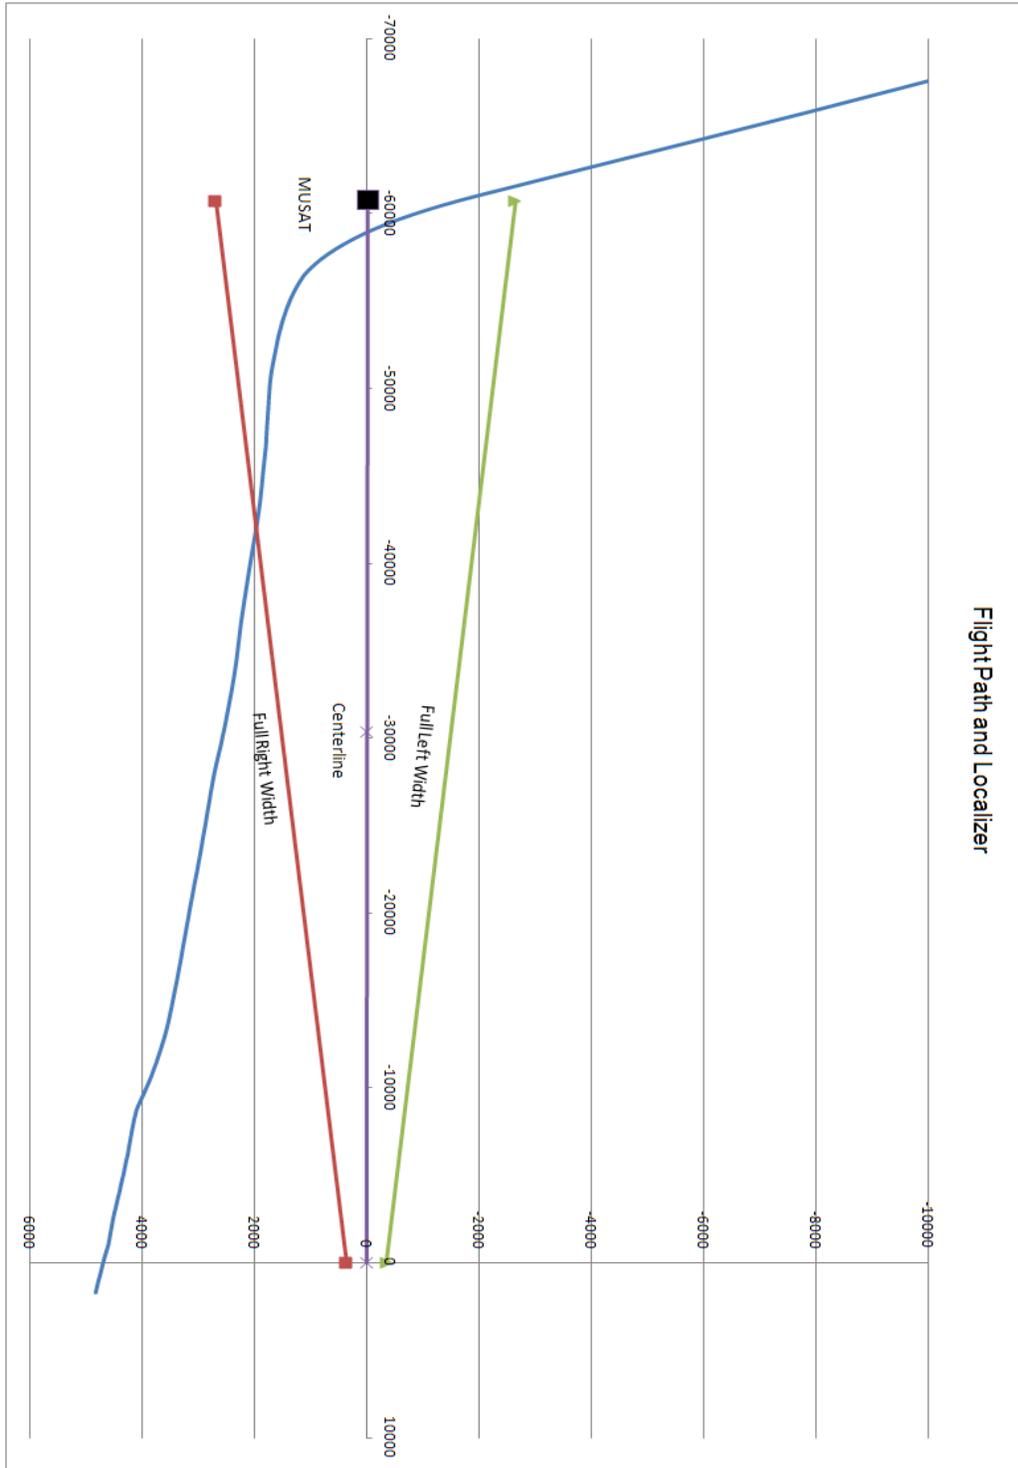
Appendix P – Flight path and localizer

NOTE: Given that the aircraft left the localizer beam, the results obtained from the glideslope calculation are mathematical, were used for illustrative purposes only, and may not be what the aircraft instruments would have shown (as the aircraft may not have been within receiving range of the antenna's signal).

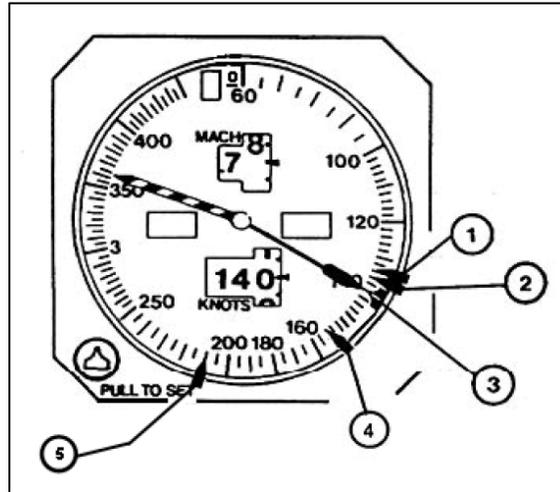
Figure 26. B737 airspeed indicator (with legend, reproduced immediately below diagram) ¹⁹¹

Recommended airspeed marker (bug) settings are described in Figure 26. According to the AOM: 189

After the aircraft has been configured for landing with the gear down and landing flap. [sic] All airspeed callouts will be referenced to the airspeed internal Bug ("The Bug") E.g. "Bug + 5 or Bug -5".
