ACCIDENT INVESTIGATION FINAL REPORT

AN-26B, SP-FDP

Tallinn, Estonia

25. August 2010

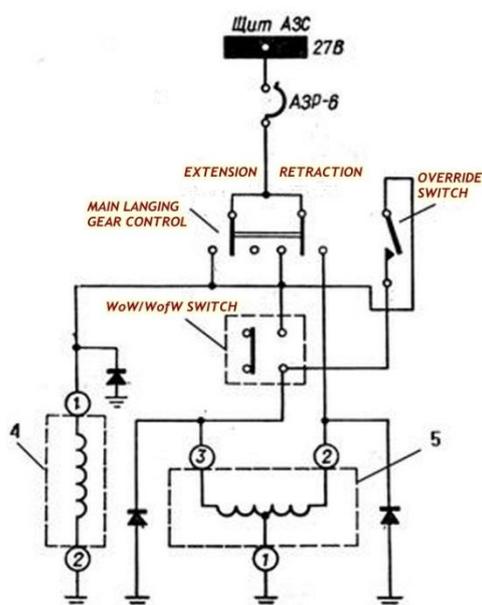
The An-26B is a transport airplane designed to carry cargoes (either stacked on standard pallets or without pallets) and wheeled vehicles along short and medium range routes. The airplane is equipped with two main propulsion turboprop engines with the propellers and one auxiliary turbojet engine. The main engines are accommodated in nacelles on the wing center section.
