**UNITED STATES AIR FORCE**  
**AIRCRAFT ACCIDENT INVESTIGATION**  
**BOARD REPORT**

**KC-135R, T/N 63-8877**

**LOCATION: 6 MILES SOUTH OF CHALDOVAR,**  
**KYRGYZ REPUBLIC**

**DATE OF ACCIDENT: 3 MAY 2013**

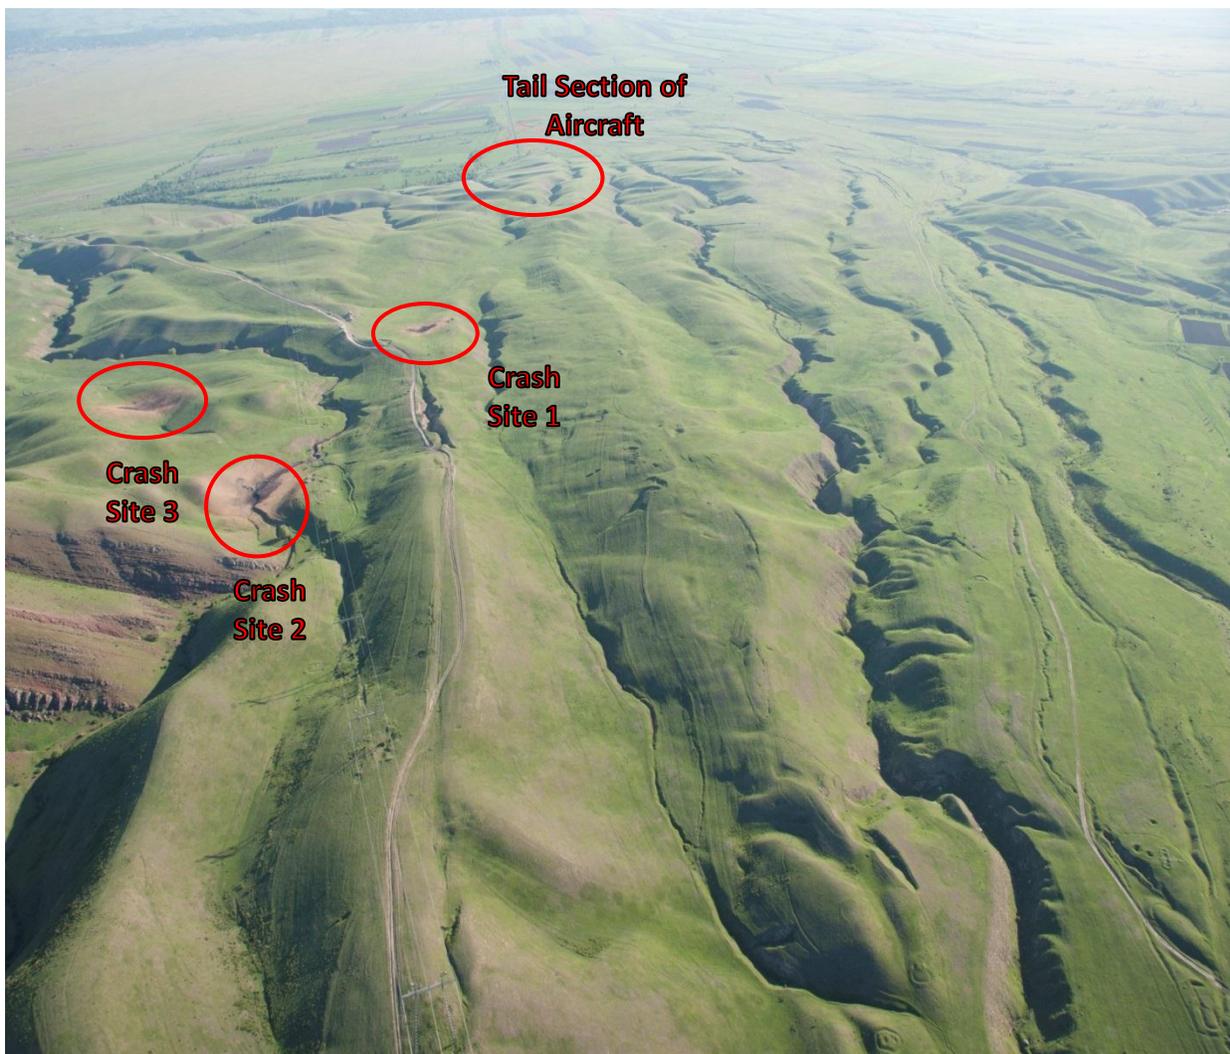
Figure 2. Aerial View of Crash Site (Tab Z-8)

The last point captured on the flight data recorder (FDR) was a nose down attitude of 82 degrees at 21,760 feet (Tab EE-12, EE-18). Around 10,000 feet, the MA exploded into three main sections and fell to the earth, impacting the terrain approximately 1.5 miles southwest of where the tail section of the MA was found (Tabs V-24.2, W-4, Z-8). The three main sections included the cockpit section, the center fuselage section, and the aft section (Tab Z-4).

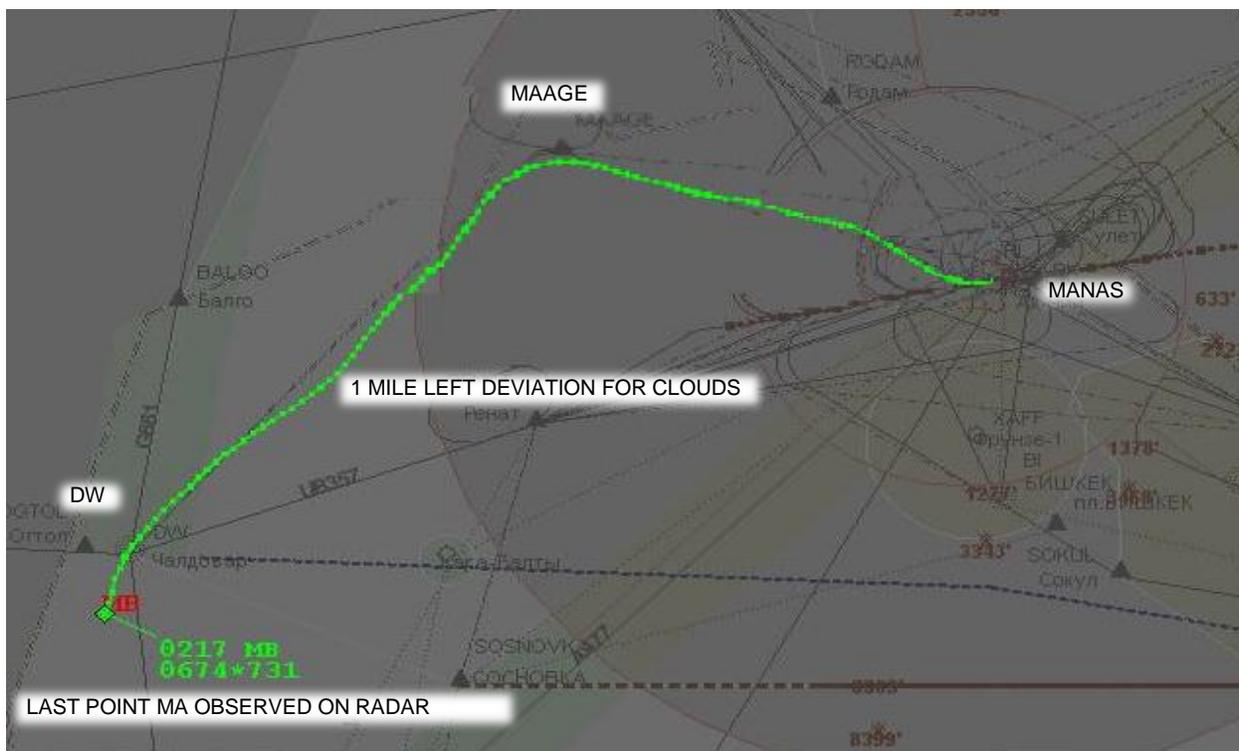
Figure 4. RADAR Plot of MA's Flight Path (Tab Z-3)

(Tab N-4 to N-8). The MC departed at 1437L, 18 minutes prior to the scheduled departure time of 1455L (Tab U-15). Immediately after takeoff, the MP and MCP experienced an unexpected rapid heading change known as a crab in which the MA's nose was pointed at an angle opposite of what would be expected due to the takeoff winds (Tabs N-10, N-13, EE-7, EE-10). The MC did not verbalize any further control difficulties for the next six minutes of flight (Tab N-8 to N-10). However, the nose of the MA hunted left and right about one degree in both directions during the same six minutes (Tab EE-10). The weather RADAR system operated normally for a brief time (about two minutes into the flight) before failing again two minutes later (Tab N-9 to N-10). The MC flew their planned route of flight, except for a one-mile deviation left of course en-route to waypoint DW to avoid cloud buildups (See Figure 4) (Tab N-10 to N-11). The MCP visually identified the building clouds near waypoint DW (Tab N-10 to N-11). At 1446L, the MP reported "clear of the weather" (Tab N-11).

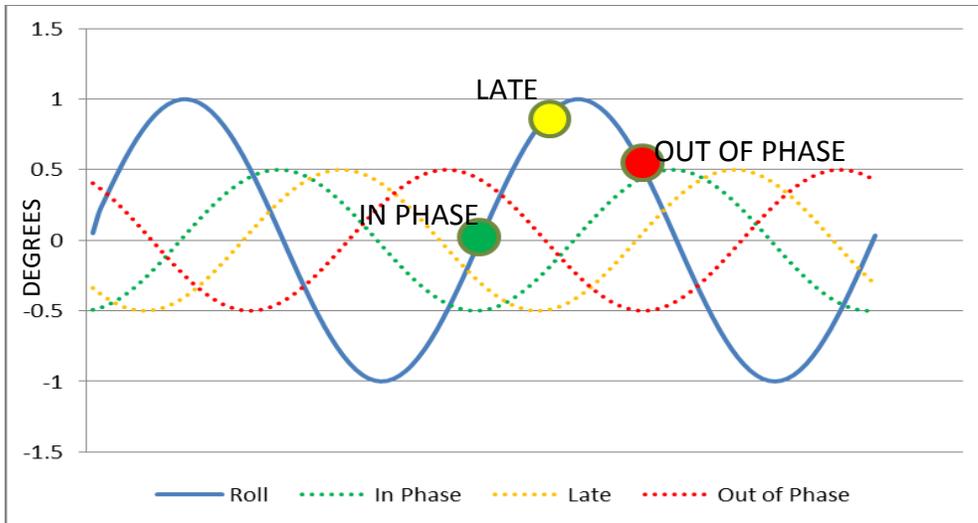
Figure 8. Lateral Input Timing Assessment (Tabs Z-10, EE-9)

Proper dutch roll damping technique is to apply corrective control wheel deflections as the aircraft rolls through wings-level (Tab AA-28 to AA-30). The damping technique described in the Technical Order (T.O.) 1C-135(K)R(II)-1, *KC-135R/T Inflight Data*, Change 12, dated 1 April 2012 (Inflight Manual) is to “stop the rising wing at the desired bank angle with aileron. As the wing stops, center the control wheel and prepare to stop the other wing from rising” (Tab BB-171). Figure 8 below illustrates a properly timed input (green dot), a late input (yellow dot), and an out-of-phase input (red dot). The out-of-phase input occurs after roll has changed direction, and in turn accelerates roll in the opposite direction instead of dampening the roll (Tab BB-171).

Most of the lateral control inputs accomplished by the MCP resemble the example in Figure 8 regarding the in-phase properly timed inputs. As a trend, the roll oscillations of the MA did not get larger with in-phase inputs. The amplitudes of the inputs appear to be greater than that of the roll. When engaged, the autopilot applied late corrections and in turn generated a larger, steeper roll in the opposite direction (Tab EE-9). Once the MP takes control of the MA, the lateral control inputs can no longer be reliably measured due to the FDR constraints and rudder input (Tab EE-4 to EE-5, EE-9).

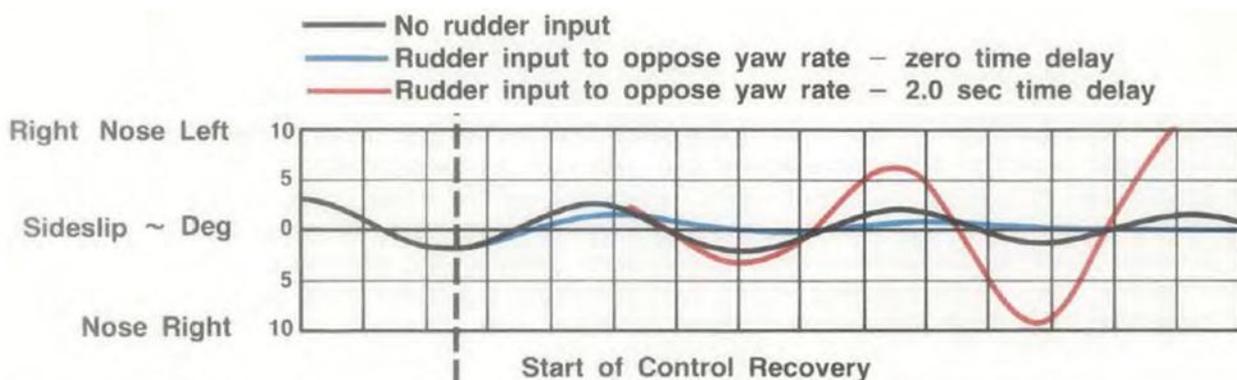
Figure 12. KC-135 Aerodynamic Characteristics Dutch Roll Response (Tab AA-28)

The MP's rudder response in Figure 11 is analogous to the expected response shown in red in Figure 12. The rudder input is nearly zero between 08:47:00Z and 08:47:34Z, and the sideslip oscillates steadily around plus or minus three degrees. From 08:47:34Z until the end of the flight, rudder inputs correspond with increasing sideslip on each cycle. Figure 12 below depicts the same divergent sideslip tendency when rudder input is applied two seconds late (Tabs AA-28, EE-11). The amplitudes of the building sideslip are indicative of undesirable rudder inputs, as shown below in Figure 12 (Tab AA-28).

If the pilot reacts to an abrupt roll onset with a large rudder input in the opposite direction, the pilot can induce large amplitude oscillations. These large amplitude oscillations can generate loads that exceed the limit loads and possibly the ultimate loads, which could result in structural damage (Tab AA-14). Boeing airplanes are capable of sustaining a single control input, but do not account for input reversal or oscillatory inputs (Tab AA-8). The Inflight Manual contains a warning that states, "The sudden reversal of rudder direction at high rudder deflections, due to improper rudder application or abrupt release, can result in overstressing the vertical fin. This condition could be brought about during recovery attempts from a flight condition induced by a lateral control malfunction" (Tab BB-172). Figure 11 depicts an abrupt application and release of the rudder, as well as a rudder reversal in the final 10 seconds (Tab EE-11).

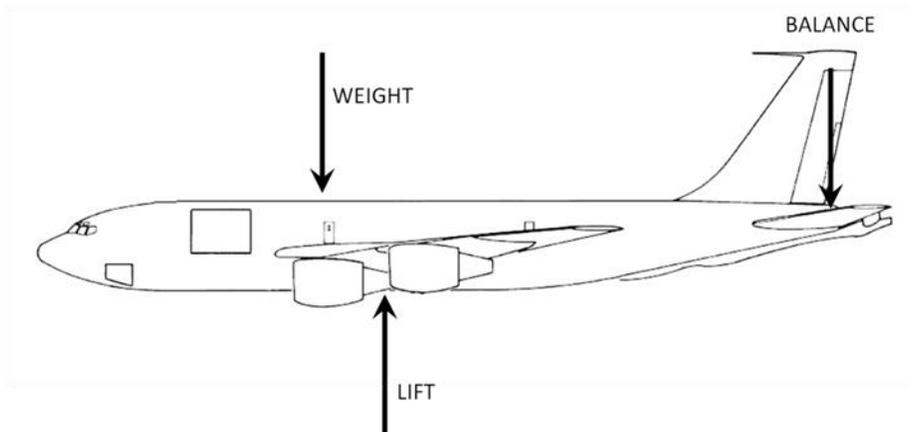
Figure 17. Balancing Stabilizer Load (Tab Z-9).

The structure that failed in Section 48 of the fuselage did so under extreme load. These loads could not be applied unless the vertical stabilizer was firmly attached to the fuselage forward of section 48 prior to the overload (Tab J-29). Following the loss of the stabilizers, the MA would rapidly pitch down. At this point, the MA experienced structural overload beyond design conditions of virtually all components (Tab J-28). This is consistent with the design of conventional swept wing aircraft which dictate a strong nose down pitching moment, normally balanced by the downward force of the horizontal stabilizer (See Figure 17) (Tab J-27 to J-28).

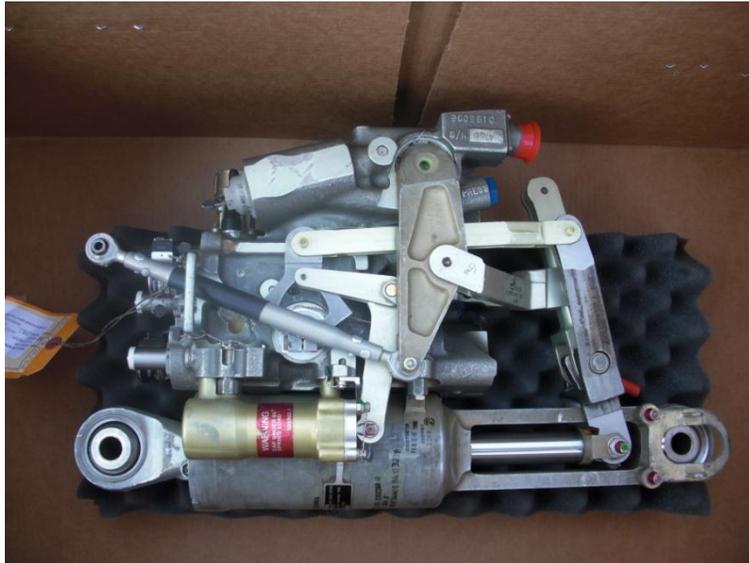
Figure 18. Non-Mishap PCU (Tab Z-10)

Under normal conditions the rudder is hydraulically positioned through full travel by the PCU (See Figure 18) (Tab BB-45). In addition to the pilots, the FCAS provides automatic rudder control inputs to assist with yaw control of the airplane. The FCAS system consists of an EFAS and SYD. The SYD provides full-time, automatic rudder inputs in response to a broad range of adverse yaw conditions including dutch roll, uncoordinated turns, asymmetric thrust, and other disturbances such as gust or turbulence (Tab BB-144). The SYD deflects the rudder through a secondary rudder actuator inside the PCU. There is no motion in the rudder pedals when the SYD is operating the rudder (Tab BB-67). FCAS components are connected and controlled by an electro-hydraulic sensing, warning and actuation network. The FCAS computer contains both electronic components and circuitry for the EFAS and SYD (Tab BB-144). The MA's SYD and EFAS servo valves were still operational after the mishap (Tab J-125). Several aircraft parts were sent off for analysis. However, the remaining electrical components, including the FCAS computer, were destroyed during the mishap and thus not tested (Tab Q-12 to Q-13, Q-19 to Q-21).

The PCU main actuator shaft was broken in the vertical plane after the rudder hinges overloaded and subsequently failed (Tab J-35 to J-36). Failure of PCU linkages also occurred including a broken tablock H-assembly (Tab J-125). The outer fork of the main clevis of the lock lever was bent toward the actuator at the bearing rivet (See Figure 19) (Tab DD-12).

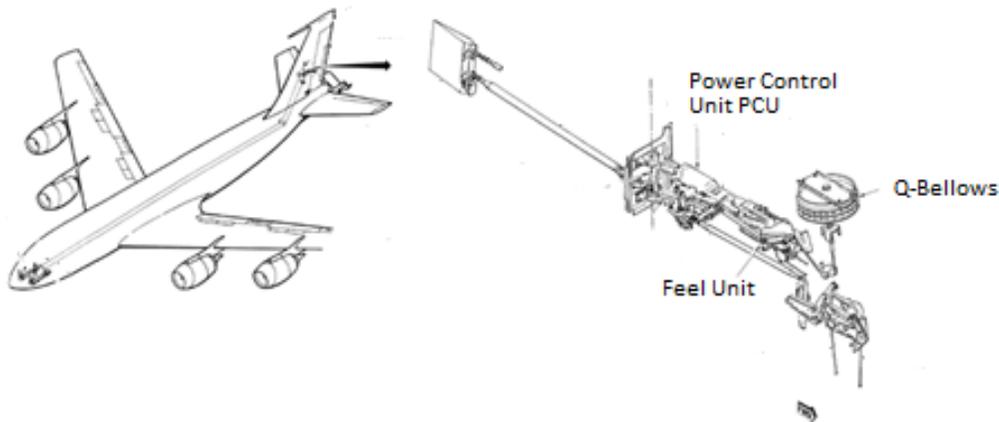
Figure 20. Rudder Control Equipment (Tab BB-47)

The feel unit and Q-bellows provide artificial rudder feel for the pilot during hydraulic power-on mode of rudder operation. The feel unit also receives rudder power trim inputs from the control stand and transmits these trim inputs to the rudder power control unit (PCU) (See Figure 20) (Tab BB-44 to BB-45). The amount of feel at the pedal is a function of and proportional to the amount of pedal deflection and aircraft speed. The feel unit and Q-bellows provide feel in the hydraulic power on mode only. The rudder feel forces felt by the pilot in the manual mode of rudder operation (hydraulic power-off) are due to system friction and aerodynamic forces reacting on the rudder tab (Tab BB-45 to BB-46). Wear in the rudder feel unit was found during post-mishap inspection and teardown of the rudder and rudder trim components (Tab DD-13).

Wear in the rudder feel unit could correlate to an input to the rudder PCU to displace the rudder either left or right from the neutral position. Due to increased Q-bellow input at higher airspeeds, the rudder would be displaced further from the neutral position. Additionally, the Q-bellow force will be constant and not induce an oscillating rudder (Tab DD-13). Analysis of FDR data from the MA's previous flight on 2 May 2013 from RAF Mildenhall to the Transit Center at Manas showed the MA's control wheel position appeared to be oriented to the left indicating a tendency for the MA to roll to right (Tab EE-6). Although the MA had a tendency to roll to the right, the flight on 2 May 2013 was uneventful (Tabs V-20.7, EE-6). FDR data indicates the MA experienced this same tendency to roll to the right on the day of the mishap (Tab EE-5). There is no evidence to suggest the wear in the rudder feel unit caused the MA's rudder to oscillate during the mishap flight.
