ACCIDENT

Aircraft Type and Registration:	Raytheon 390, Premier I, G-OOMC	
No & Type of Engines:	2 Williams International FJ44-2A turbofan engines	
Year of Manufacture:	2005 (Serial no: RB-146)	
Date & Time (UTC):	12 March 2015 at 1148 hrs	
Location:	Blackpool Airport, Lancashire	
Type of Flight:	Commercial Air Transport (Passenger)	
Persons on Board:	Crew - 2	Passengers - 2
Injuries:	Crew - None	Passengers - None
Nature of Damage:	Damaged beyond economic repair	
Commander's Licence:	Airline Transport Pilot's Licence	
Commander's Age:	34 years	
Commander's Flying Experience:	3,455 hours (of which 408 were on type) Last 90 days - 85 hours Last 28 days - 29 hours	
Information Source:	AAIB Field Investigation

Synopsis

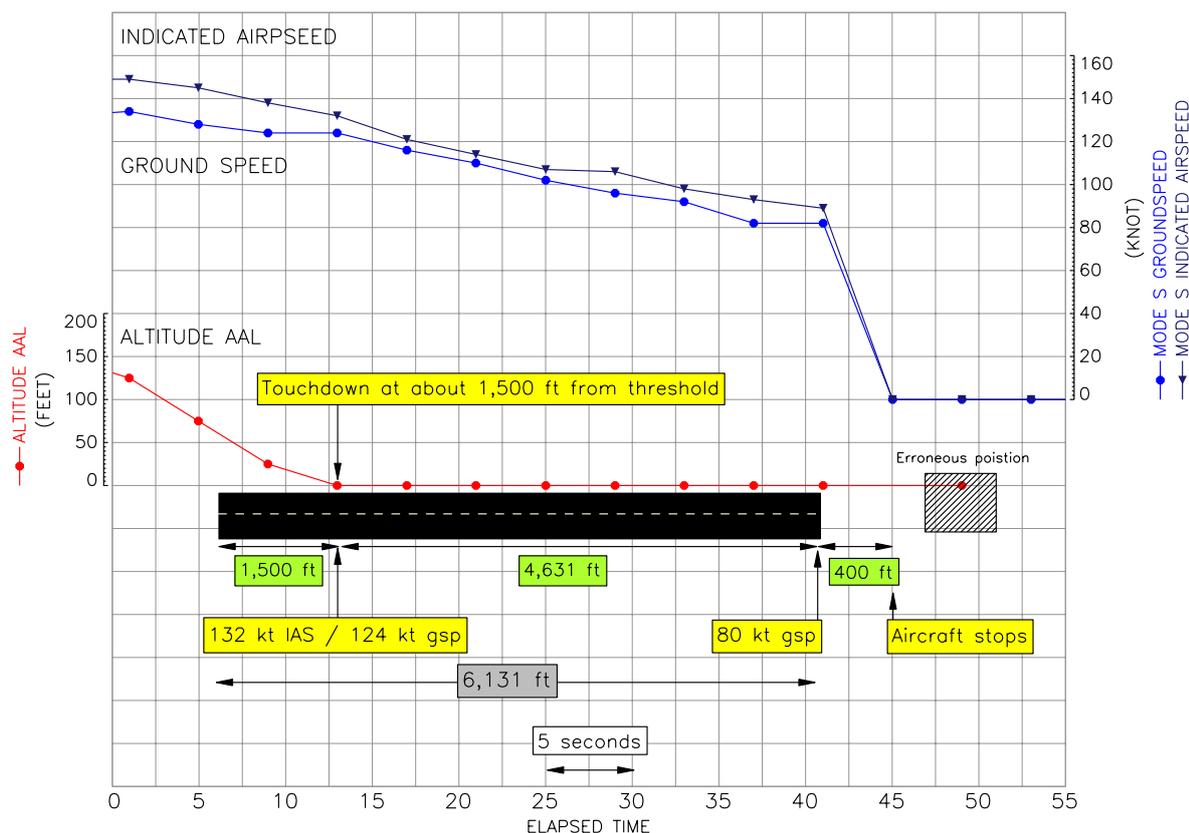
Figure 2
Salient final approach and landing data

The aircraft touched down about 1,500 ft from the start of the paved surface at an airspeed of 132 kt and a groundspeed of 124 kt. When the commander applied the toe (power) brakes he felt no significant retardation. During the landing roll no attempt was made to apply the emergency brakes, as required in the event of a power brake failure. The co-pilot asked if he should try to operate the lift dump, but it failed to function, due to the lack of hydraulic pressure. At some point, while the aircraft was on the runway, the co-pilot transmitted a MAYDAY call to ATC. When an overrun appeared likely, the commander shut down the engines. The aircraft subsequently overran the end of the runway at a groundspeed of about 80 kt. The commander later commented that he was in a "state of panic" during the landing roll and was unsure whether or not he had applied the emergency brake.

Radar information was available from three radar heads. The radar at St Annes, located less than 1 nm to the south-east of Blackpool Airport, provided a complete record of the approach and landing, with Mode S groundspeed and airspeed data available.

The salient recorded data for the approach and landing are presented in Figure 2.
