FINAL REPORT

ACCIDENT OF M/S. AIRCRAFT SALES AND SERVICES BEEHCRAFT-1900D AIRCRAFT, REG. NO. AP-BII ON 18TH MARCH, 2016 AT JIAP, KARACHI

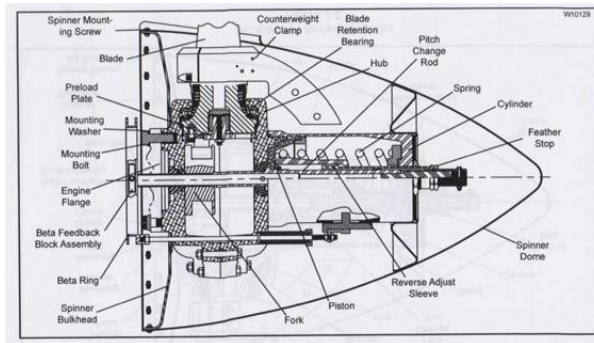
Propeller pitch change mechanism schematic

- 2.3.2 The oil pressure attempts to move the pitch towards lower blade angle (fine pitch). The pressurized oil is supplied by the internal pump of propeller Governor. The Governor uses its speed sensing mechanism to sense the desired selected RPM and directs oil to the propeller pitch change mechanism or drains it out to keep it at desired RPM (according to Propeller Control position) with varying power lever position and aircraft flight conditions.

- 2.3.3 If governor oil pressure is lost during operation, the propeller will increase pitch and feather. Feathering occurs because the summation of the propeller forces causes the oil to drain out of the propeller until the feather stop position is reached.
