Kodiak-100 N642RM Draft Report Courtesy Translation

INTERSTATE AVIATION COMMITTEE

FINAL REPORT

Type of occurrence	Accident
Type of aircraft	Airplane, Kodiak-100
Registration	N642RM
Owner	Apelsin-T, LLC
Aviation Administration of place of occurrence	Rosaviatsia ITO AT for North-West Regions
Aviation Administration of the aircraft registration	FAA (USA)
Place of occurrence	1400 m southward of Pskov aerodrome ARP Coordinates: N 57°46,263', E 28°23,578'
Date and Time	06.07.2015, 13:18 UTC, 16:18 local time, day

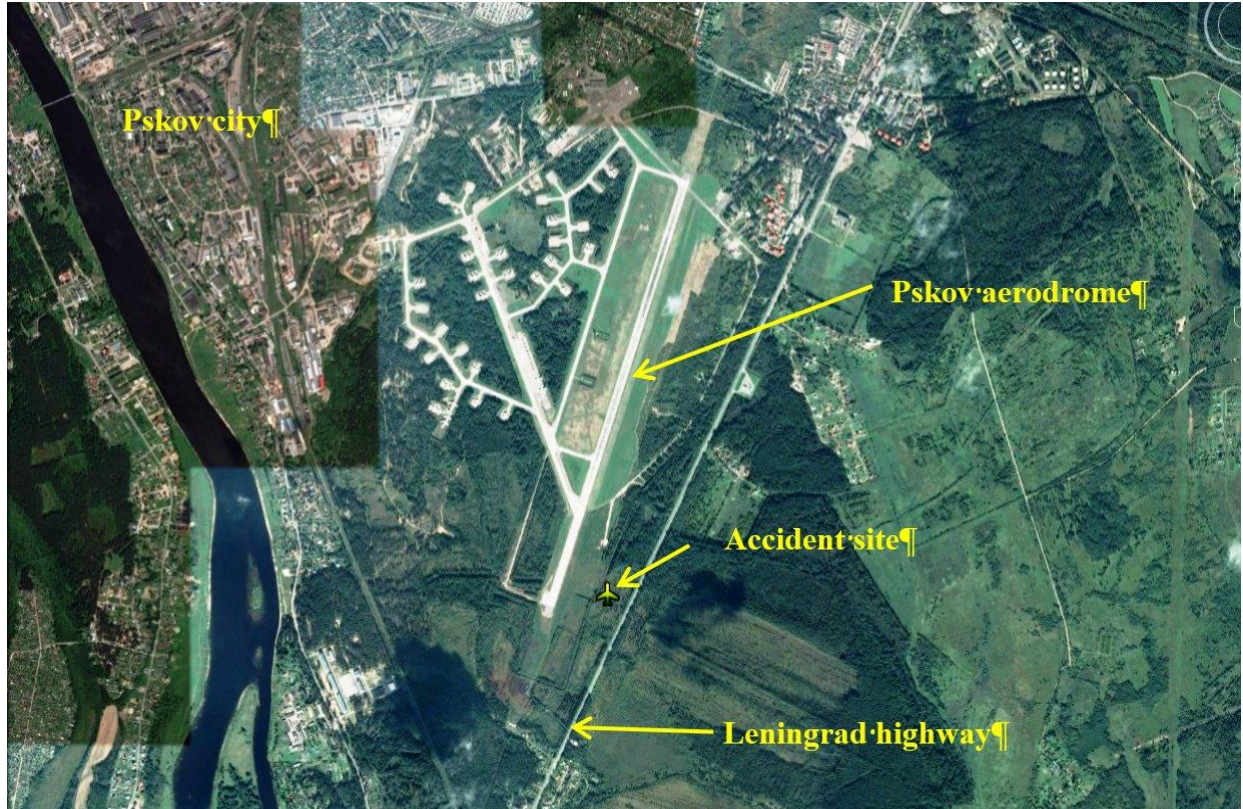
Figure 4. The accident site (picture was done from the space)

The accident site is located 1400 m to the south of Pskov AD ARP (see Figure 4).

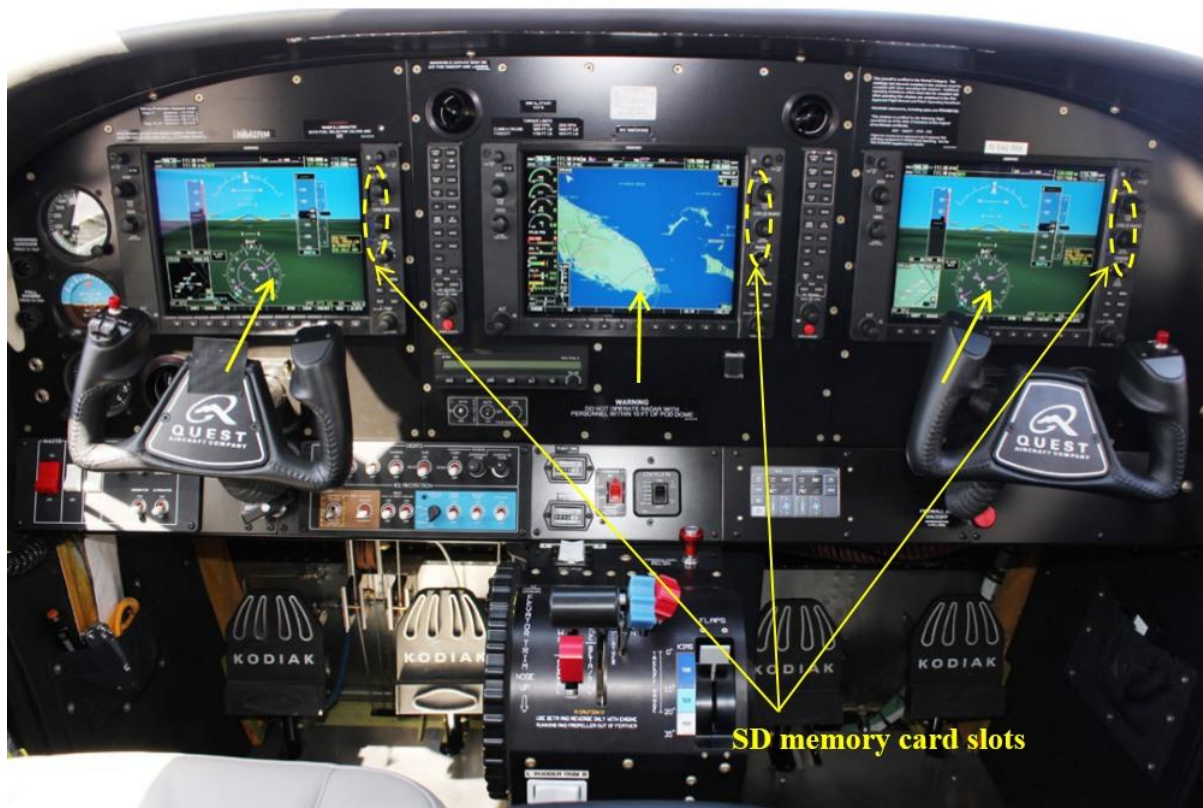
Figure 13. Kodiak-100 N642RM aircraft cockpit. FDIS displays are pointed by arrows

Three FDIS displays Garmin G-1000 were installed in Kodiak-100 N642RM cockpit (see Figure 13). Left and right displays were PFDs, the central one was MFD.

The Investigation team was provided with three(3) SD data cards, which had been inserted into FDIS Garmin G-1000 displays before the accident flight, and on next day after the accident, were recovered from the aircraft by FO. According to FO explanations, he had inserted five (5) SD data cards in total into all slots excluding the LH display top slot.

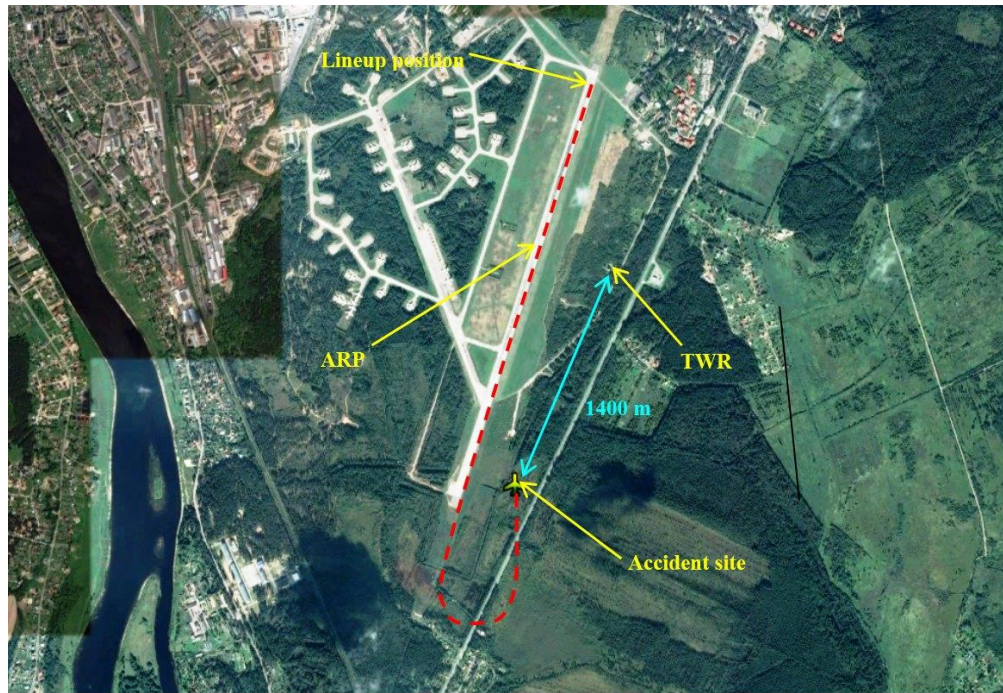
Figure 18. The aircraft calculated path after the takeoff

It was our common decision to land to the sparse forest, as we understood that we would not reach the runway. Having control on the speed and height of gliding, we descended to about 30 meters. The speed was 80 knots (148 km/h). I put flaps down to 35 degrees; cut the fuel off and de-energized the airplane. When saw the tops of trees (which were far between) about seven or eight meters high, we levelled the plane off to reduce a forward speed. The plane was controllable up to the with-trees-collision."

At Figure 18, the aircraft calculated path after the takeoff is shown.
