FINAL REPORT

CLASSIFICATION	Accident
Operator	AEROWEST
Manufacturer	W.S.K – MIELEC
Aircraft	Antonov AN-2
Registration country	ROMANIA
Registration	YR-PEG
Location	Coordinates: Latitude: 44° 54' 1.31" N Longitude: 027° 51' 8.87" E
Date and time	01.08.2015/ 08:05 LT

No. : A 20 - 04
Date : 27.03.2020

FINAL REPORT**AIRCRAFT LOSS OF CONTROL DURING TAKE-OFF**

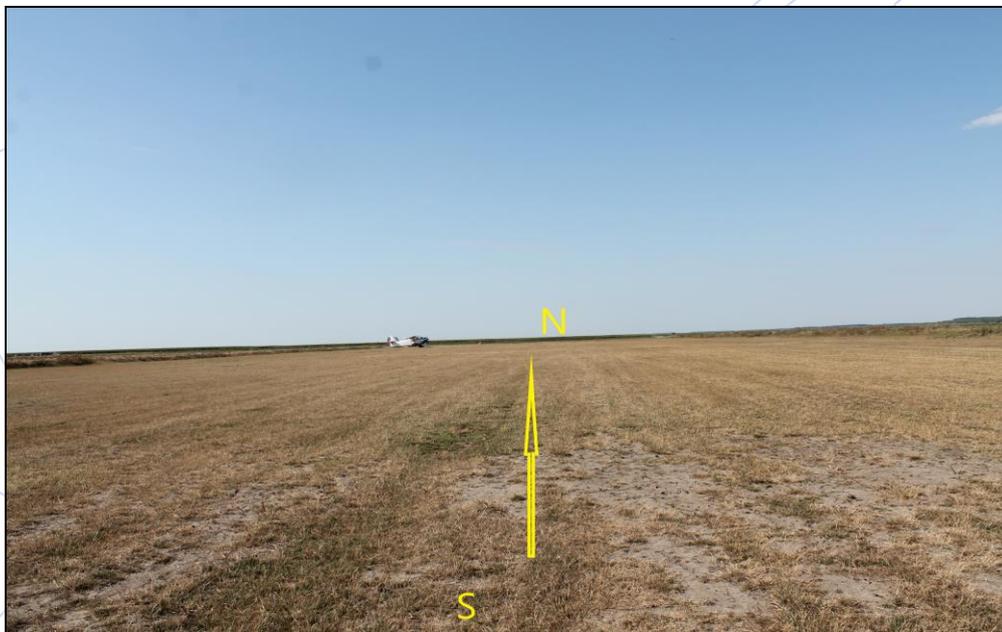
Fig. 3 Flight field

aircraft can be performed. It was arranged on a grassy surface, in the vicinity of a farm, in the area of Stăncuța village, Brăila County.

The runway was positioned on direction: North/South (007°/187°).

Runway available length: 520 m

Elevation: approximately 39 m
