This document is an English translation of the Final Report on the fatal accident involving the L-410UVP-E20 aircraft registered RA-67047 that occurred on November 15, 2017 at Nelkan landing site, Khabarovsk Krai, RF. The translation was done as accurate as a translation may be to facilitate the understanding of the Final Report for non-Russian speaking people. The use of this translation for any purpose other than for the prevention of future accidents could lead to erroneous interpretations. In case of any inconsistency or misunderstanding, the original text in Russian shall be used as the work of reference.

INTERSTATE AVIATION COMMITTEE

**FINAL REPORT
RESULTS OF INVESTIGATION
OF ACCIDENT**

Type of accident	Accident
Type of aircraft	L-410UVP-E20, airplane
Registration	RA-67047
Owner	State Transport Leasing Company, Public Company
Operator	Khabarovsk Airlines, RSUE
Aviation Administration	Rosaviatsia Far East ITO
Place of accident	Nelkan landing site, Khabarovsk Krai, RF Coordinates: N 57°37'25.5" E 136°09'11.4"
Date and time of accident	15.11.2017, 13:09 local time (03:09 UTC), daytime

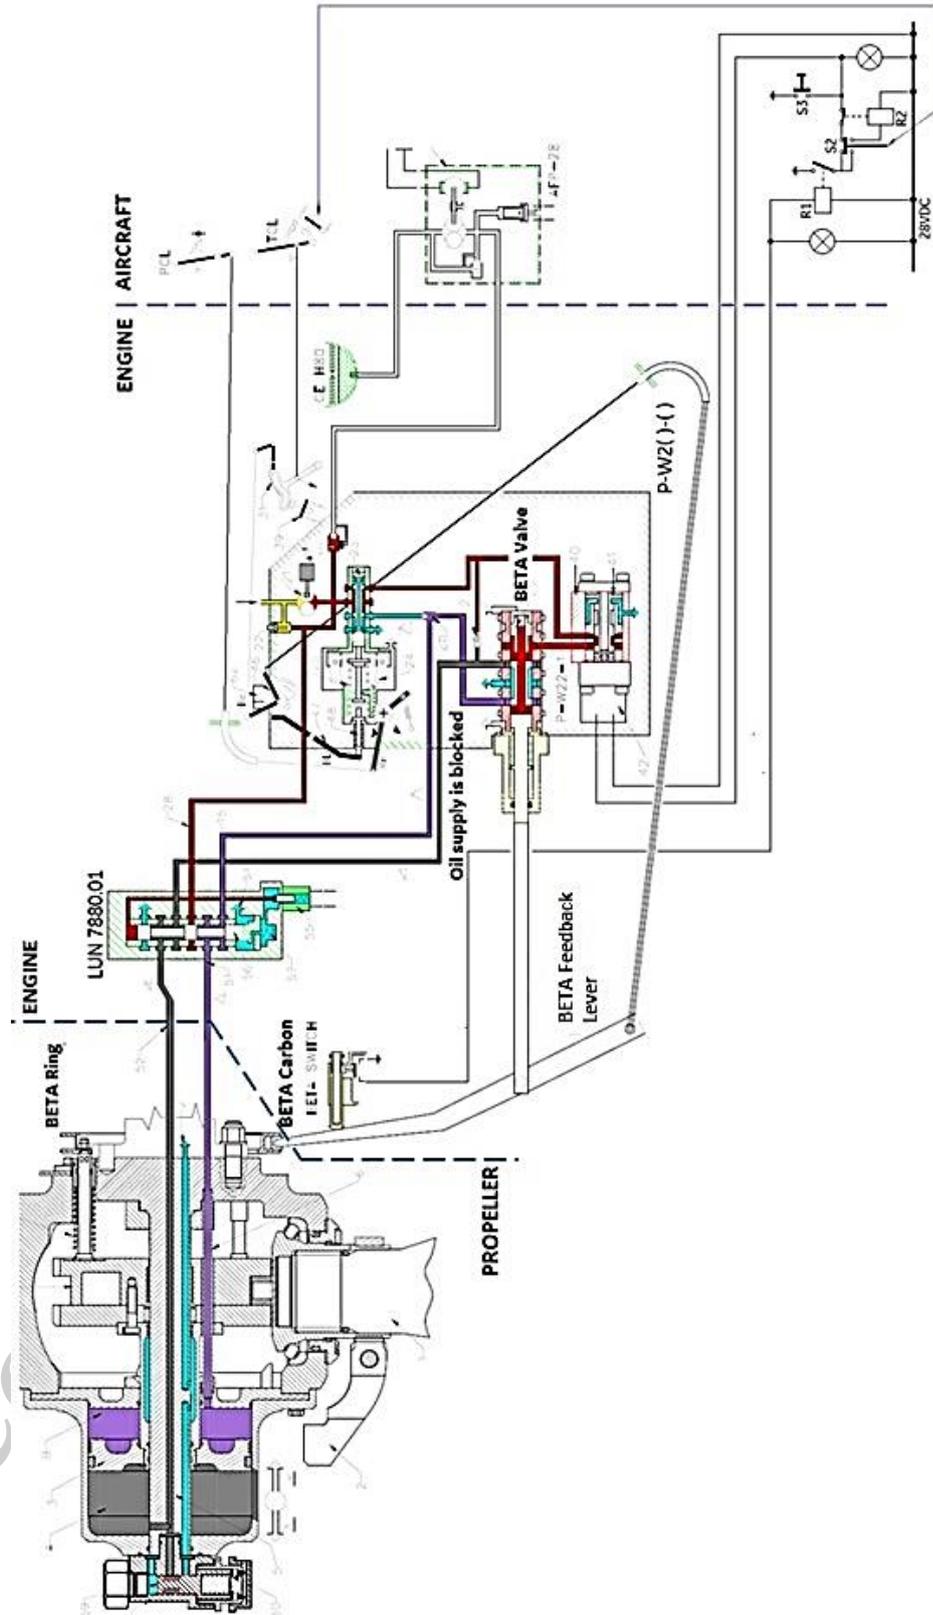
Fig. 4. Propeller system description

According to the propeller control system description (see Fig. 4), the propeller governor provides pressurized oil to the propeller servo piston to increase or decrease the propeller blades pitch to maintain preselected propeller speed which is set by the PCL. The rotating pivoted flyweight governor mechanically controls the pilot valve which regulates oil to the propeller servo piston and thus changes (decreases or increases) the propeller blades pitch. The rotating flyweight governor exerts centrifugal force which acts against the speeder spring which is mechanically controlled by the PCL.

In flight, when the pilot moves PCLs into higher propeller speed RPM, the increasing oil pressure turns the propeller blades into the lower blade angle direction. When min flight angle $+13.5^\circ$ is reached (with TCLs set to forward thrust close to the flight idle position), the BETA valve has to stop further blades' pitch decrease by stopping the oil supply to the propeller pitch change mechanism (servo piston).

The BETA Valve is a primary device to set the minimum propeller flight blade angle. The BETA Valve is controlled by the BETA Feedback Lever (a part of BETA control/Feedback system). This BETA Feedback lever is connected with propeller BETA Carbon Block at one end, with the BETA Valve in the center and with BETA Control Mechanical Linkage on the other end (see Fig. 4). The BETA Control Mechanical Linkage enables to manually control propeller blades pitch in BETA/Reverse mode.

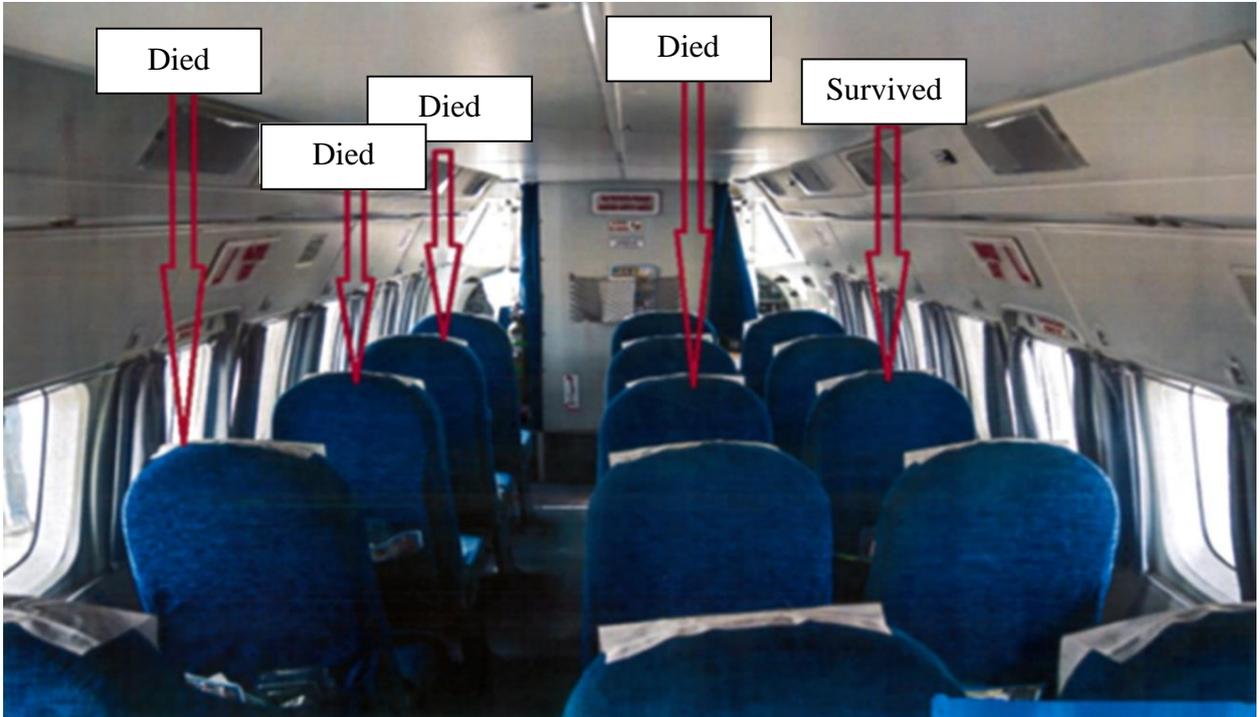
Fig. 7. Passengers' location in the cabin

During the accident, there were PIC, FO and 5 passengers aboard. PIC and FO were at their working stations and were secured with the safety belts. The passengers were sitting in the cabin (see Fig. 7) and were also secured with the safety belts.

When the A/C collided with the ground, PIC and FO remained in their seats. All the passengers remained in their seats after the collision.

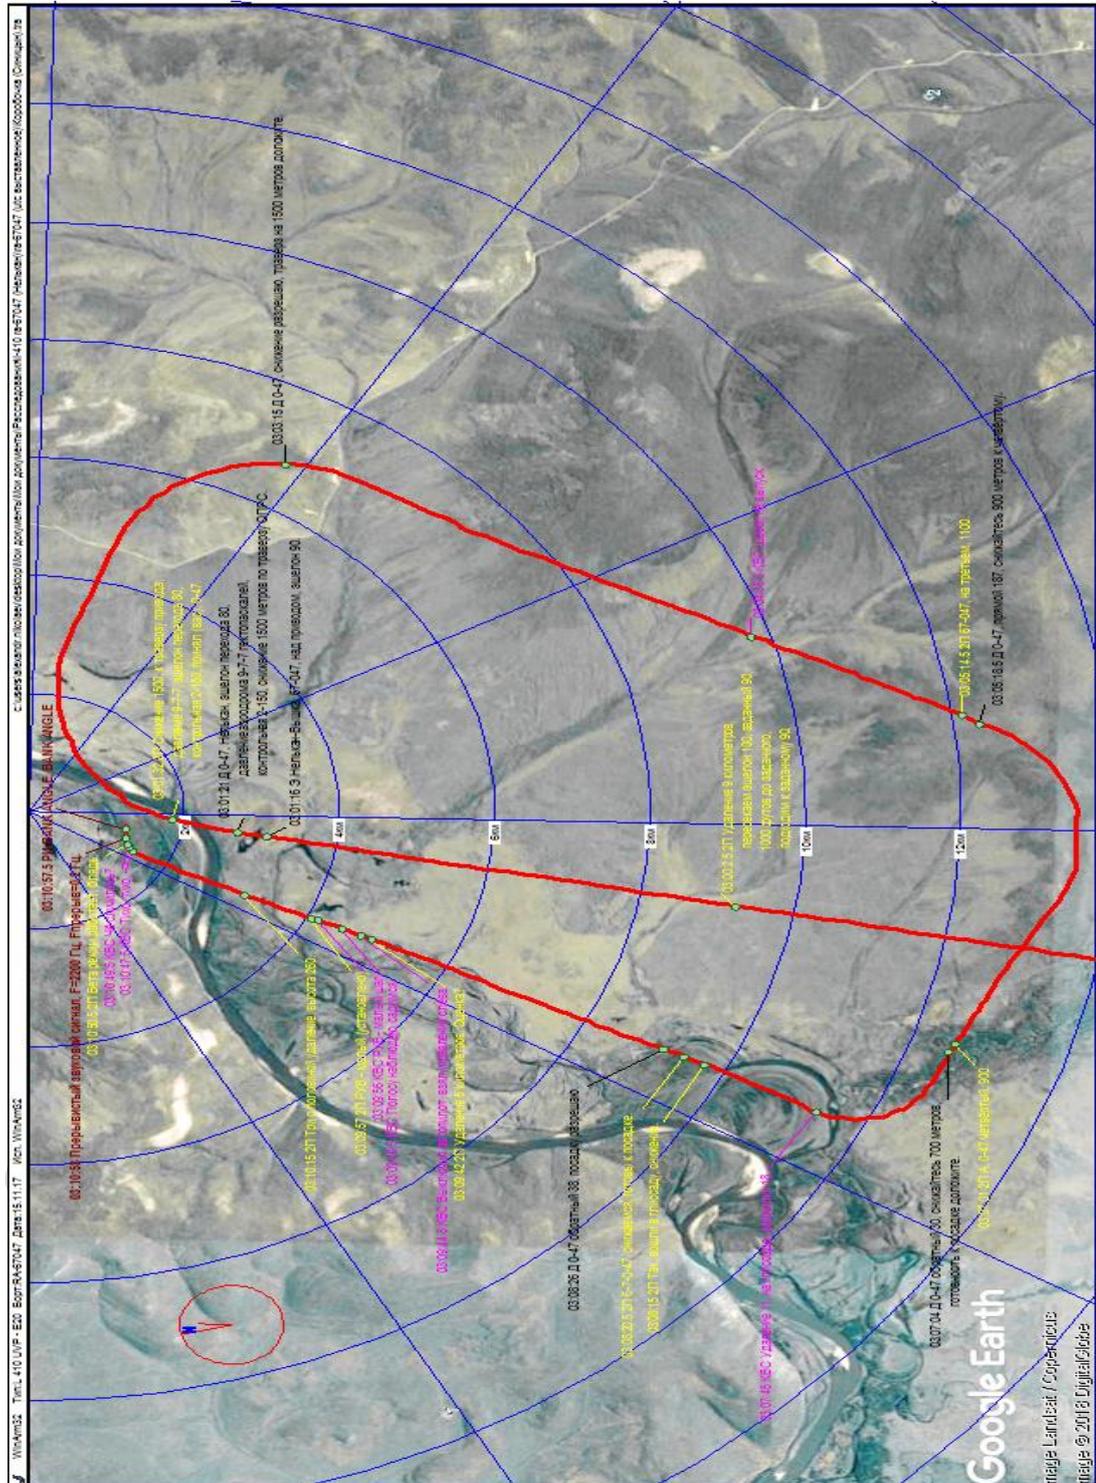
Fig. 10. Trajectory of L410UVP-E20 RA-67047 aircraft approach

At 02:35 the crew communicated with the Nelkan Tower controller and received the approach and landing conditions and the landing site actual weather. The approach to landing was conducted to RWY 04 (MHLAND 41°) with the standalone NDB (see Fig. 10) by the RH landing pattern (see Fig. 5 and 6).

For this kind of approach, the weather operating minima are 360 x 3000 m. The actual weather were appropriate for conducting of the approach.

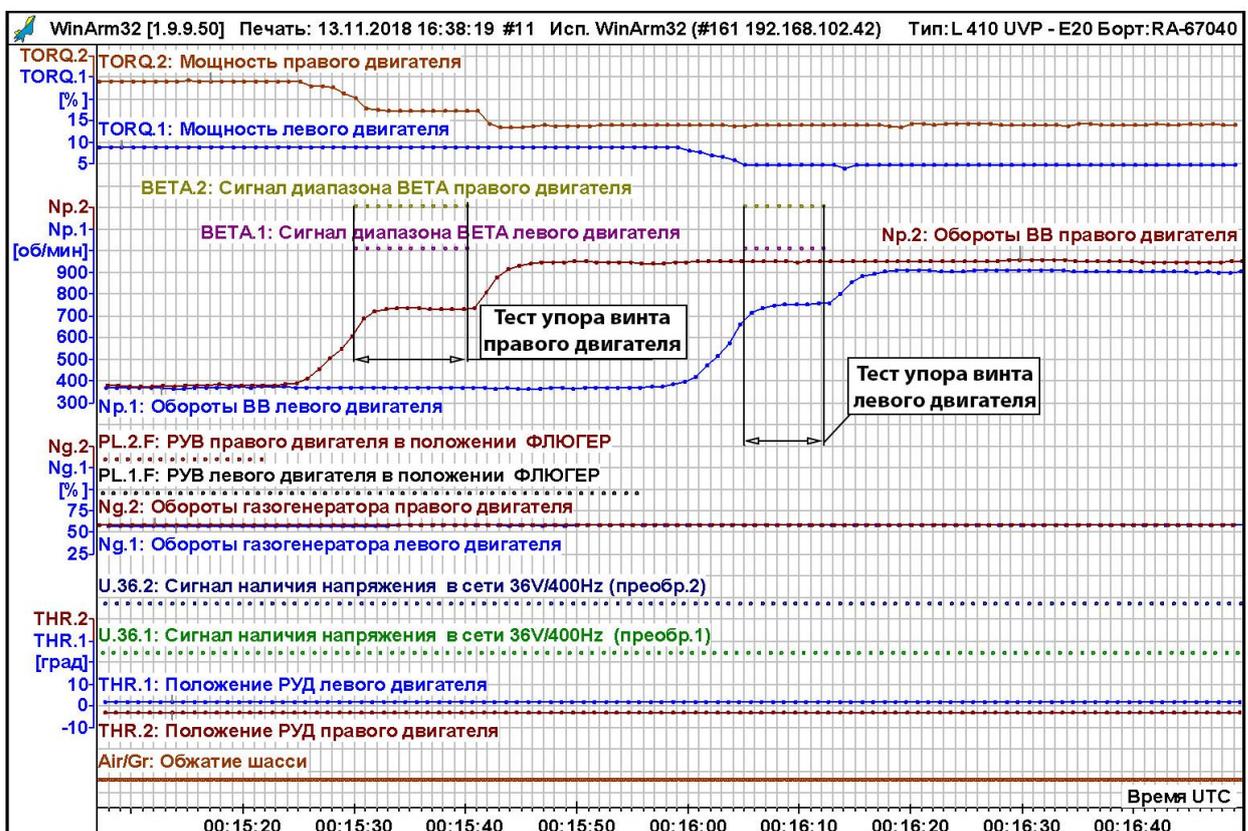
Fig. 12. An example of Propeller Pitch Lock Test for LH and RH engines check.

See below the Propeller Pitch Lock system Test at the FDR readout graph at Fig. 12:

Note: A BETA status annunciation is generated (and the single event is recorded by FDR) during conducting of the Propeller Pitch Lock Test at L410UVP E20 airplanes after their modification following the accident (see Fig. 12). As for the airplane in question no recording of the said single events was provided,
