# Engine shutdown and collision with terrain involving Beech Aircraft Corporation B200 VH-MVL

Moomba Airport, South Australia | 13 December 2016

**ATSB Transport Safety Report**  
Aviation Occurrence Investigation  
AO-2016-170  
Final – 6 July 2017

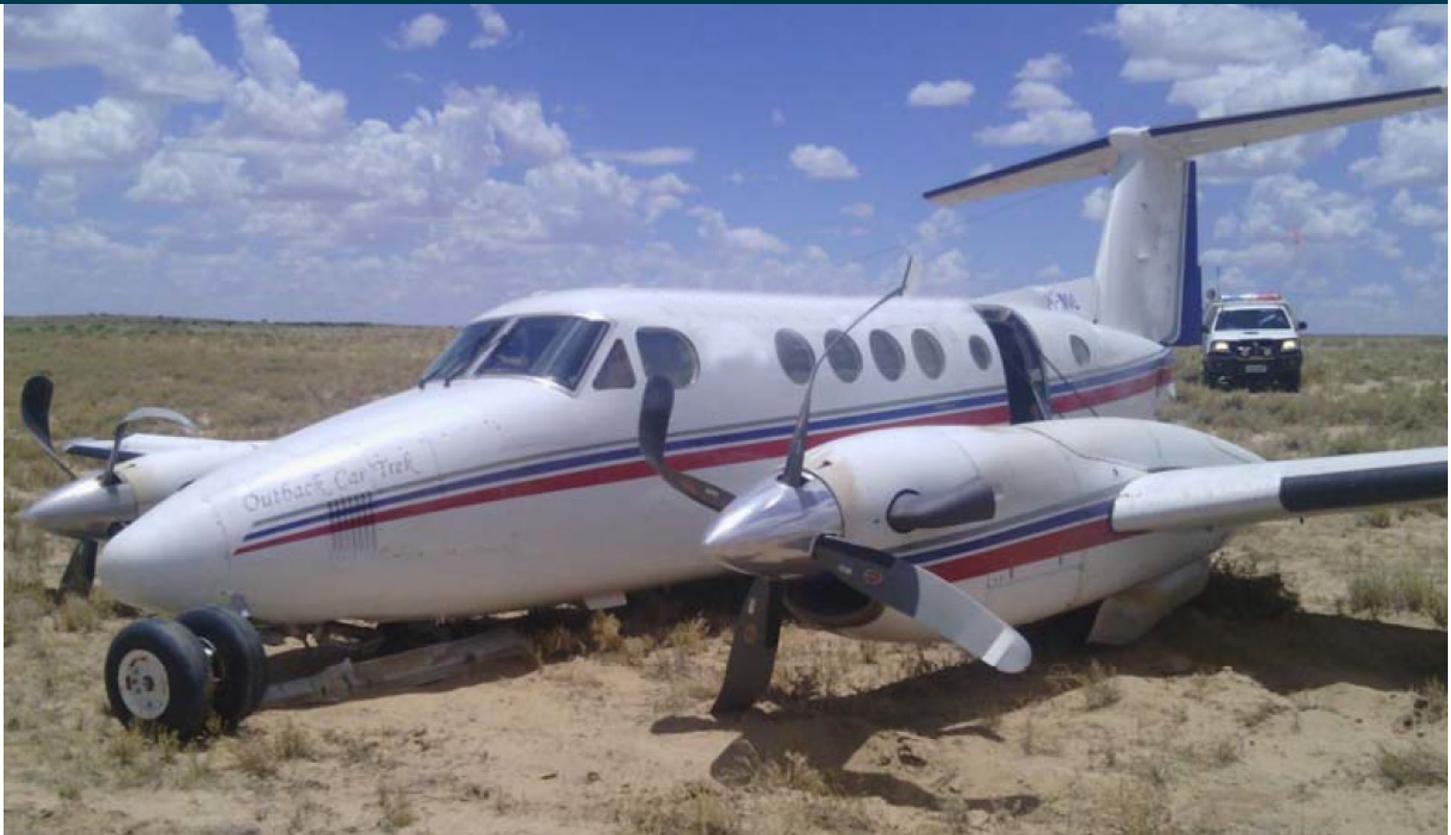
**Cover photo: Airport operator**

The aircraft landed in the sand to the left of the runway threshold and after a short ground roll spun to the left and came to rest (Figure 1). There were no injuries and the aircraft was substantially damaged.
