Loss of control and collision with terrain involving B200 King Air, VH-ZCR

Essendon Airport, Victoria | 21 February 2017

ATSB Transport Safety Report
Aviation Occurrence Investigation
AO-2017-024
Final – 24 September 2018

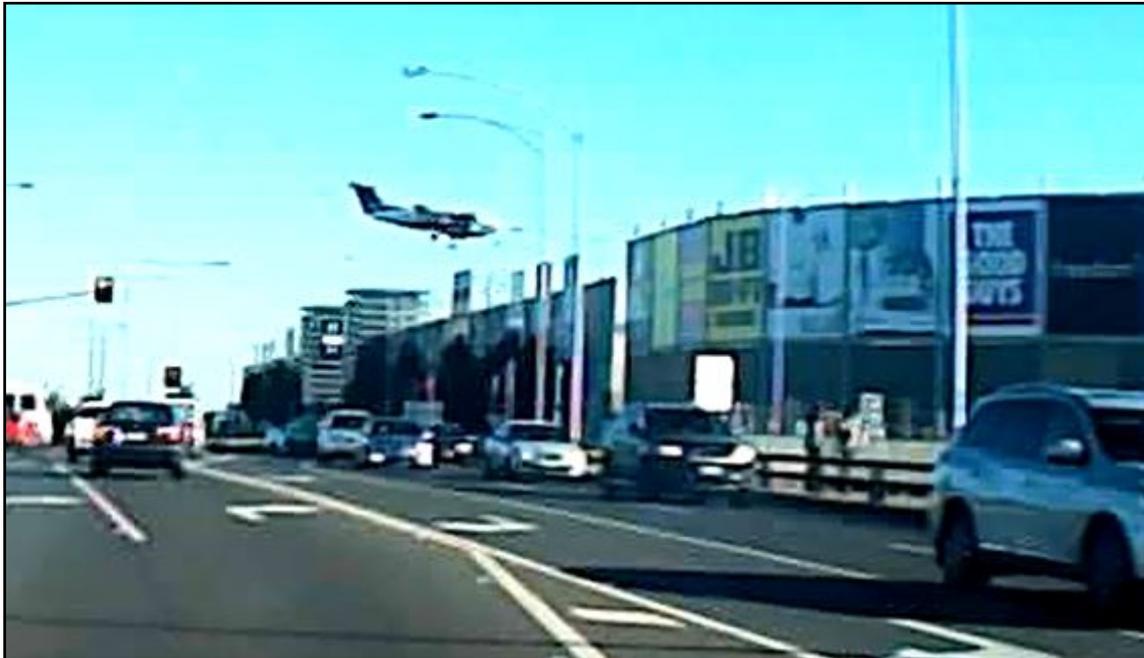
VH-ZCR immediately prior to collision with a building in the Bulla Road Precinct

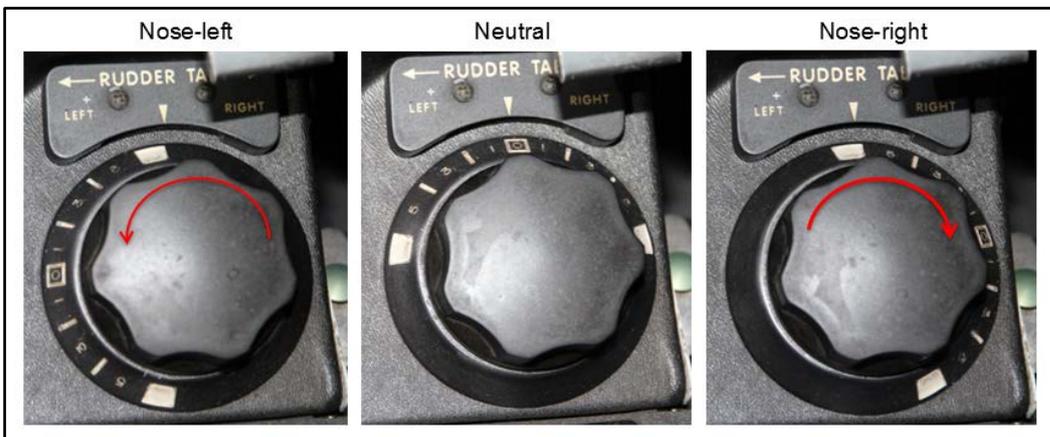
Figure 5: Rudder trim indicator in the full nose-left, neutral and nose-right positions

The ATSB found that the pilot did not detect that the aircraft's rudder trim was in the full nose-left position prior to take-off. The position of the rudder trim resulted in a loss of directional control and had a significant impact on the aircraft's climb performance in the latter part of the flight.

The rudder trim was manually controlled using a trim wheel located on the right side of the centre pedestal (Figure 5). Cables extend rearward from the wheel, through the airframe, to the rudder trim tab actuator. Rotating the wheel to the left moved the trim tab to the right, which in turn moved the rudder to the left, resulting in nose-left movement about the aircraft’s yaw axis. Rotating the wheel to the right results in yaw to the right. Operation of the rudder trim control showed that three turns through about 180 degrees were required in order to achieve full deflection either side of neutral.

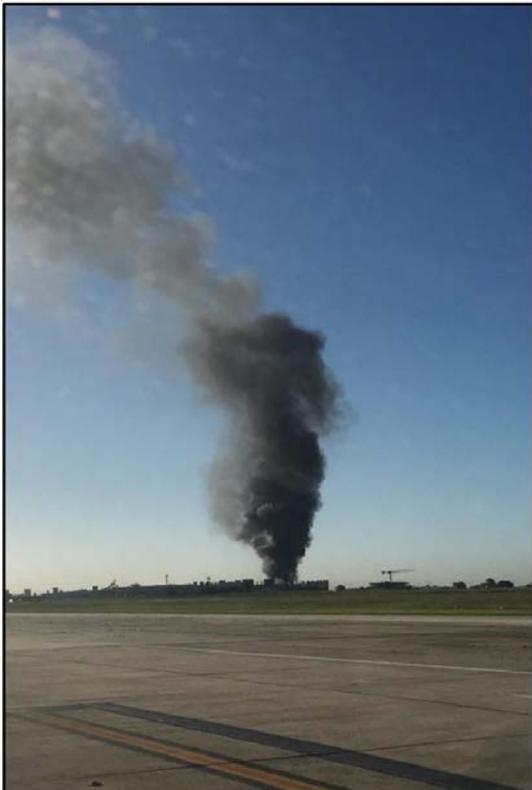
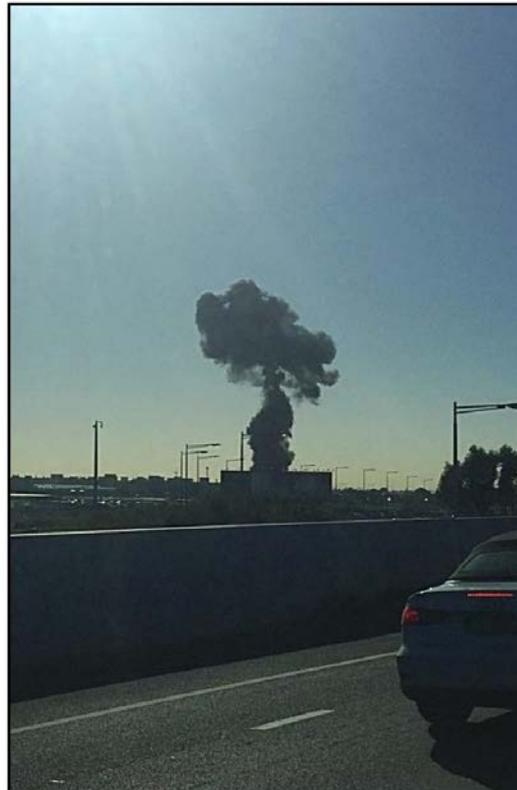
Figure 9: Photographs of the smoke plume that provided an indication of the wind conditions

Two witnesses, both of whom were pilots familiar with the B200 aircraft type, were positioned on the eastern side of runway 17/35 at the time of ZCR's departure. They recalled that the wind was 'fairly calm' and there was no adverse weather present at the time. Images of the smoke plume and video footage of the windsock adjacent to the northern end of runway 17/35 taken shortly after the accident also showed that the wind at ground level was negligible (Figure 9 and Figure 10).

Overall, the wind conditions around the time of the accident were likely to have been calm. However, it could not be ruled out that the wind conditions ranged to a maximum of 5 kt tailwind on runway 17, which was within the aircraft's limitations.

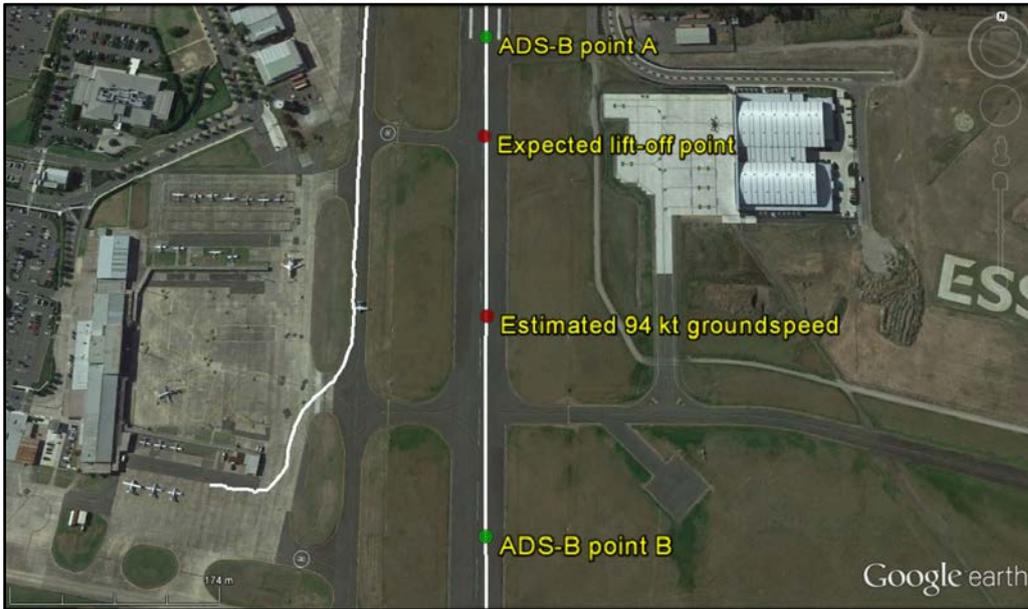
Figure 11: ADS-B data showing initiation of ZCR's divergence from the runway centreline between points A and B

- ZCR became airborne about 1,015 m from the threshold of runway 17. The aircraft's rotation point was confirmed using CCTV footage.
- The aircraft began to deviate to the left of the runway centre-line between ADS-B data points A and B (Figure 11). The rate of deviation was initially constant but then increased as the flight progressed (Figure 12).

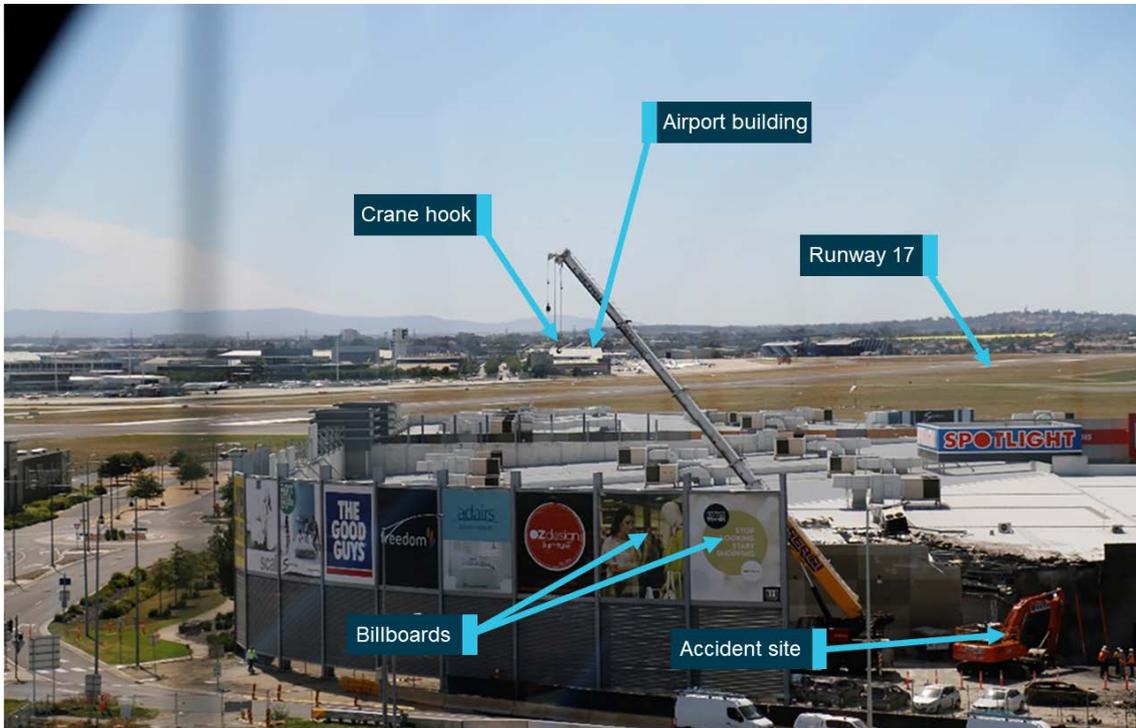
Figure 15: View of the accident site from the crane operator’s right cabin window

After this, the aircraft descended to the right over the billboard second from the right. The aircraft yawed further left, possibly an angle of 30-40°, before momentarily disappearing behind the billboard on the far right. The aircraft impacted the roof and parapet wall, and flames ensued immediately after. The aircraft continued moving forward and came to rest in the loading area at the rear of the building.

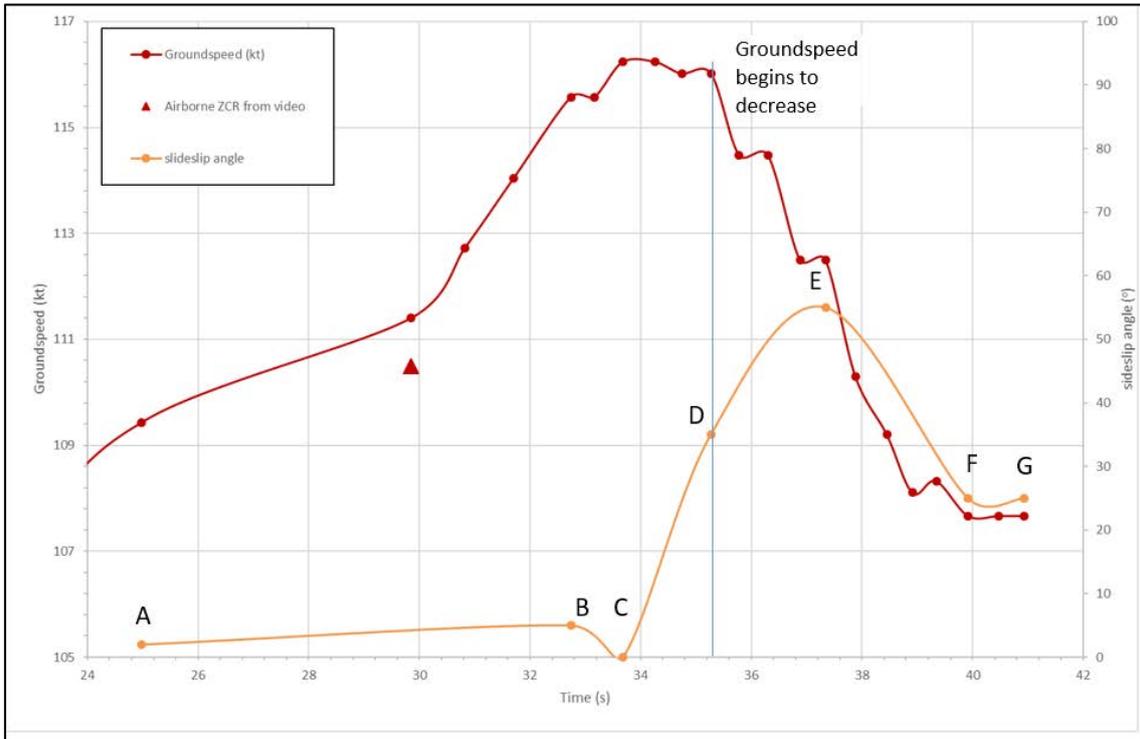
Figure 22: Comparison of groundspeed and sideslip angle against time measured from the beginning of the take-off roll

Sideslip information was correlated with Airservices ADS-B data to determine the relationship between the aircraft’s sideslip and performance. This comparison found that the reduction in ZCR’s airspeed, identified by the ADS-B data, correlated with the onset of the sideslip. This was most likely due to the increase in drag from the sideslip (Figure 22).

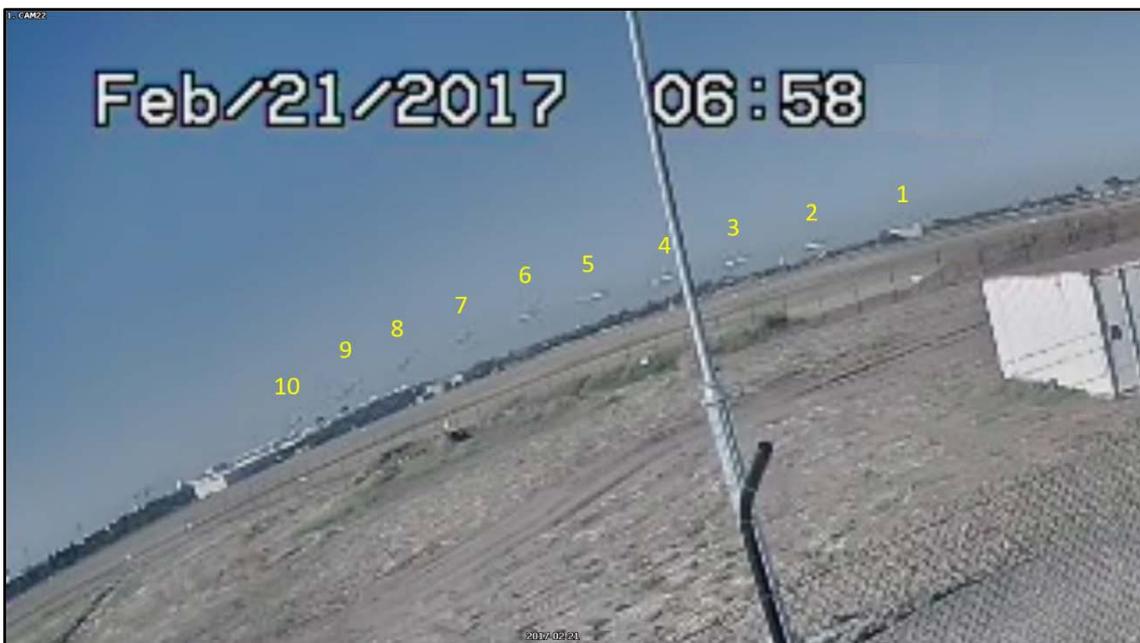
Figure 23: Time-lapse CCTV image of the ZCR's flight path, with images taken every second

Similarly, the aircraft’s climb performance also reduced at the same time as the onset of the sideslip. As the ADS-B barometric data was considered unreliable while the aircraft was in a substantial sideslip, a time-lapse image was produced to provide an indicative depiction of the aircraft’s vertical flight path (Figure 23). The substantial sideslip was first observed at point 6 in Figure 23, at this point the image shows the aircraft transitioning from a climb to a descent.

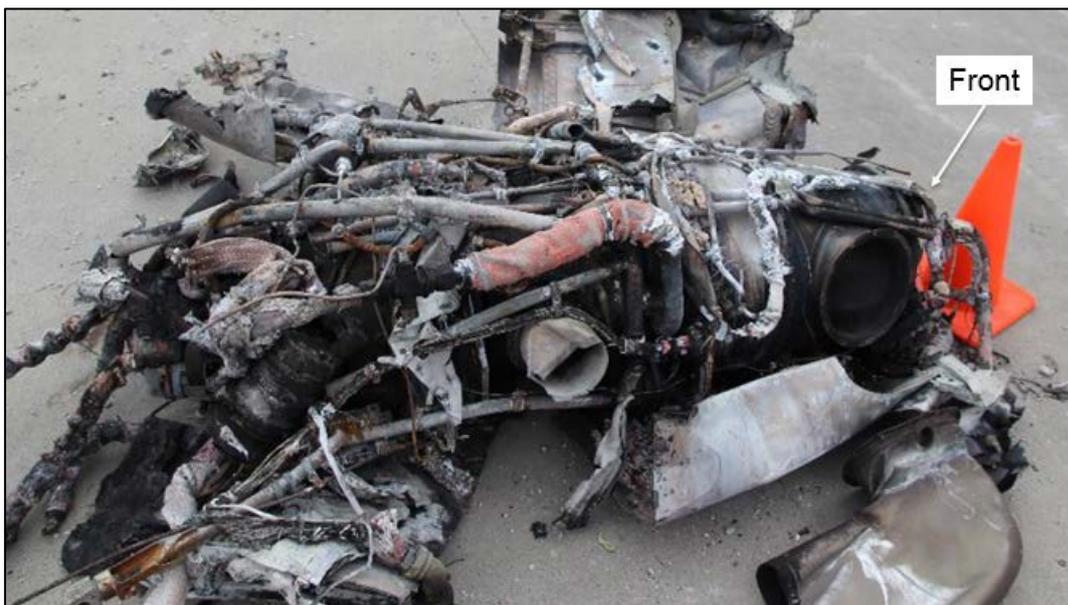
Figure 35: Right engine assembly, shown upside down and viewed from its left side

The right engine had detached from the aircraft and separated into two sections at the reduction gearbox. It sustained significant impact and fire damage (Figure 35). An external inspection of the engine was conducted with no pre-impact defects identified.

Right propeller with attached forward section of reduction gearbox not shown.
Source: ATSB

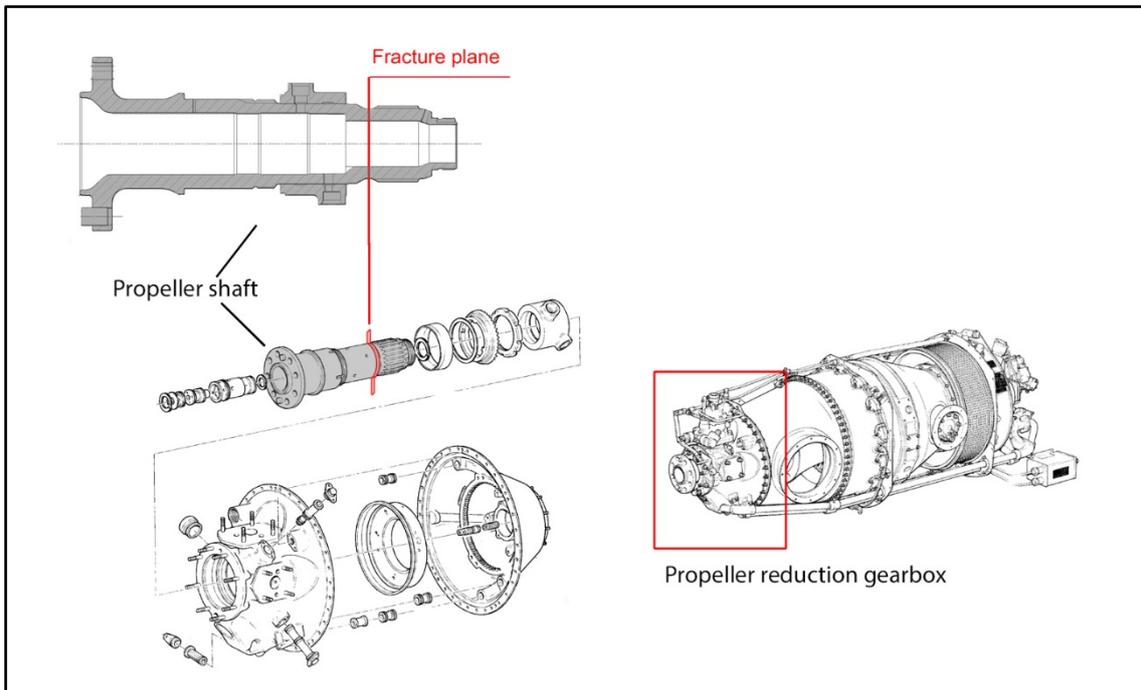
Figure 44: Pratt & Whitney Canada PT6A-42 engine showing the general layout of the RGB in relation to the location of the propeller shaft fracture

Visual examination of the propeller shafts from the left and right engines revealed that they had fractured at almost identical locations (Figure 44, Figure 45 and Figure 46). The fracture features from both shafts were also near-identical in appearance. Both were inclined at 90° to the shaft axis with a smooth and regular surface texture. A high-magnification examination of the fracture surfaces was completed using a scanning electron microscope (SEM), which confirmed the presence of ductile tearing from overstress associated with the accident sequence. No evidence of pre-existing defects that might have contributed to the propeller shaft fractures were identified. The fracture surfaces were consistent with torsional loads being the dominant load case that led to the failure of the shafts, rather than bending loads from ground impact.

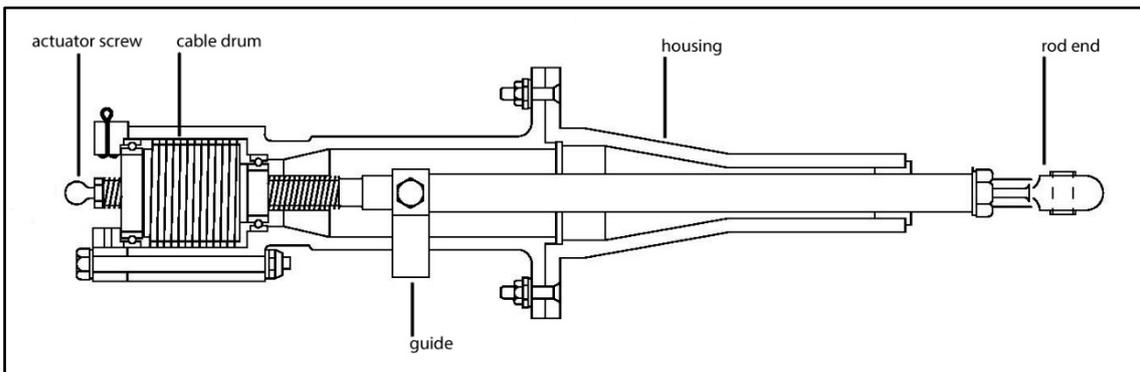
Figure 48: Schematic of the B200 rudder trim actuator

The range of movement of the rudder trim tab is 15 degrees either side of neutral. Adjusting the trim wheel position moves the left and right cables, which in turn either extends or retracts the actuator through its range of movement (Figure 48). Tension on the right cable translates the cable forward along the actuator barrel and retracts the actuator. Conversely, tension on the left cable translates the cable rearward along the barrel and extends the actuator (Figure 49).

When the actuator is fully retracted, the rudder trim tab is at 15 degrees to the right, corresponding to an aircraft nose-left yaw. When the actuator is fully extended, the trim tab is at 15 degrees to the left, corresponding to a nose-right yaw. (Refer to the 'Aircraft systems information' section of this report for more details on aircraft flight controls).

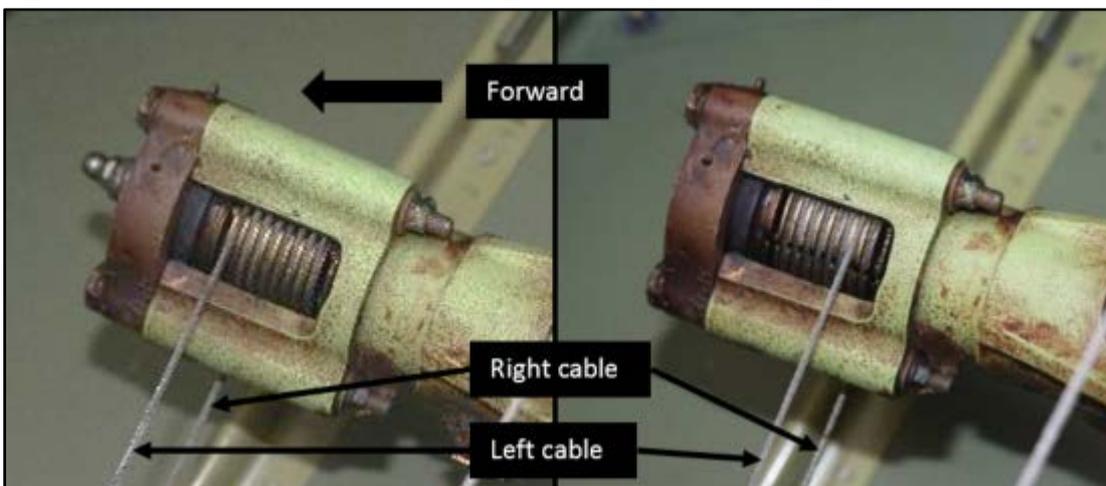
Figure 49: Rudder trim actuator showing the cable position along the barrel

Left image shows the actuator fully retracted and set to full nose-left position, right image shows the actuator fully extended and set to full nose-right.

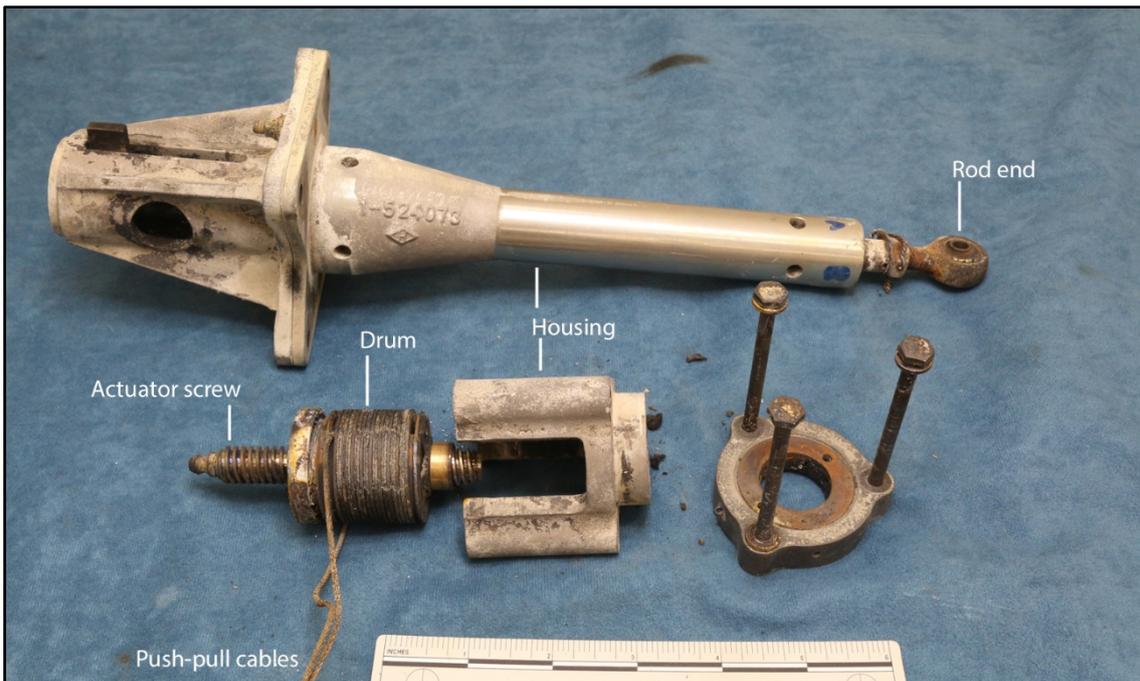
Figure 51: Disassembled and sectioned rudder trim actuator

In order to examine the internal components of the actuator with minimal disturbance to any potential witness marks that had been created during the accident sequence, the housing was sectioned between the guide and the cable drum. Once sectioned, the drum and cable were removed from the housing (Figure 51).
