**REPUBLIC OF KENYA**

**AIRCRAFT ACCIDENT INVESTIGATION**

DRAFT FINAL REPORT ON AIRCRAFT ACCIDENT TO  
CESSNA 208B REGISTRATION 5Y-JKN AT MARSABIT HILL  
ON 20 MARCH 2021

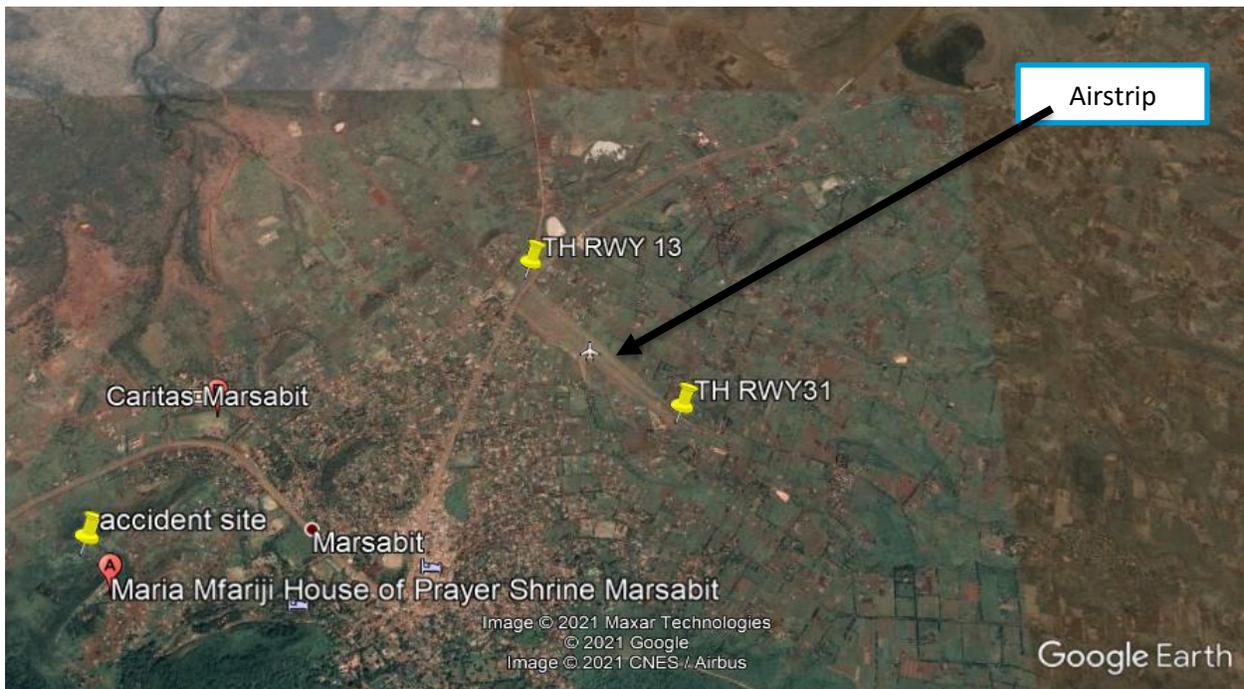
**Figure 2:** Google earth map showing the position of the accident and the airstrip

main landing gears leaving parts of the fuselage and iron box with its content kept in the lower baggage compartment on the spot. It then ballooned and missed a house before it flipped upside down and impacted the ground and came to rest facing opposite direction. It left a trail of aircraft parts along its path before it came to rest. The nose-wheel and its assembly separated and fell off and was found next to the house 110m from its first point of impact. There was no fire after impact but all the occupants received fatal injuries. Information obtained by eyewitness indicated that the accident occurred in poor visibility due to heavy presence of thick fog.

On 10 April 2006, a twin engine turboprop Kenyan military aircraft Y-12 carrying 14 VIP passengers crashed on the same spot in poor visibility while attempting to land at Marsabit airstrip. The aircraft caught fire on impact and all the 14 passengers received fatal injuries.

According to the information obtained from Flying Doctor's airfield information, booklet, it indicates that caution to pilots Marsabit has high ground, watch-out in low weather and use Segel airstrip as alternate. There are also aerial masts and wind turbines as well on top of the hills.

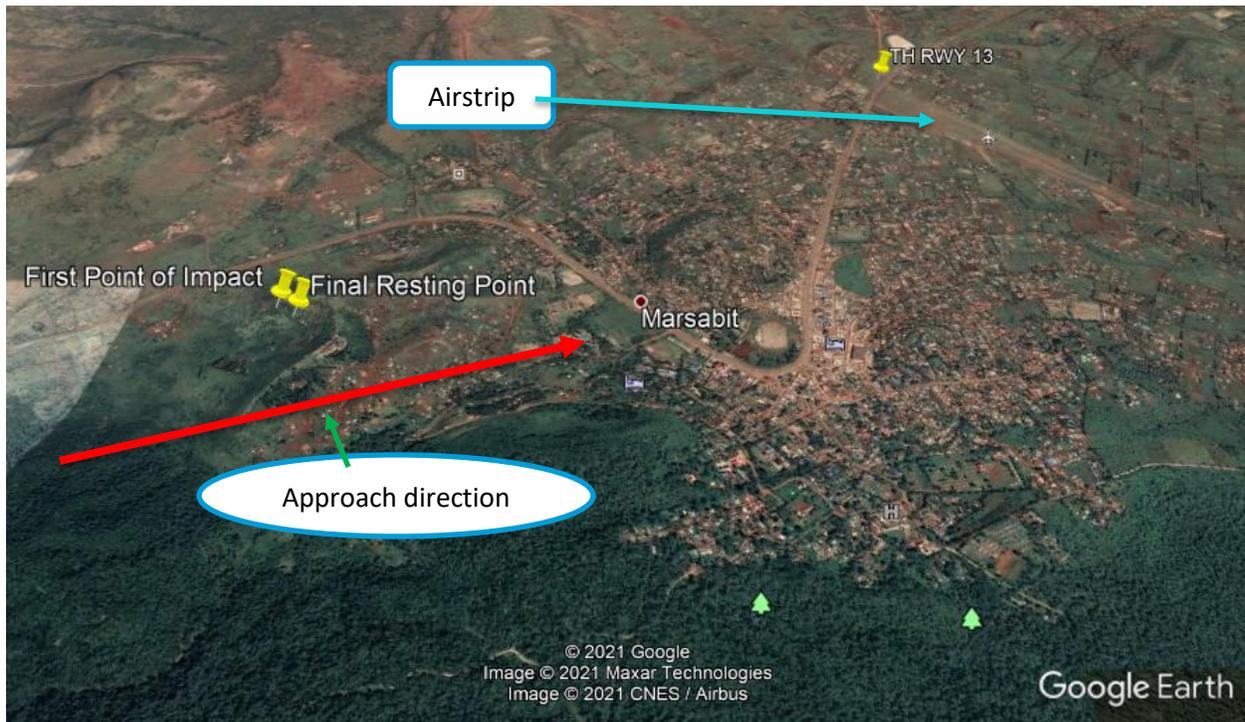
**Figure 4;** Google earth map showing the airstrip and the location of the accident

Marsabit is unmanned government airstrip with runway orientation of 13/31, positioned at GPWS coordinates N 02°20'49.5" E 037°59'03.2" with an elevation of 1339.9m, measuring length 1km, width 20m located 1km off Marsabit town. It is a gravel covered surface runway. It is surrounded by hills within Marsabit town.

Due to the terrain and natural weather formation around Marsabit hills, AAID recommends crew sensitization and enhanced Local Marsabit weather communication to inbound traffic.
