## **FINAL INVESTIGATION REPORT**

### **ACCIDENT OF PAKISTAN INTERNATIONAL AIRLINES FLIGHT PIA 8303 AIRBUS A320-214 AIRCRAFT REGISTRATION NUMBER AP-BLD CRASHED NEAR JINNAH INTERNATIONAL AIRPORT KARACHI ON 22<sup>ND</sup> MAY, 2020**

Dated: 20<sup>th</sup> April, 2023

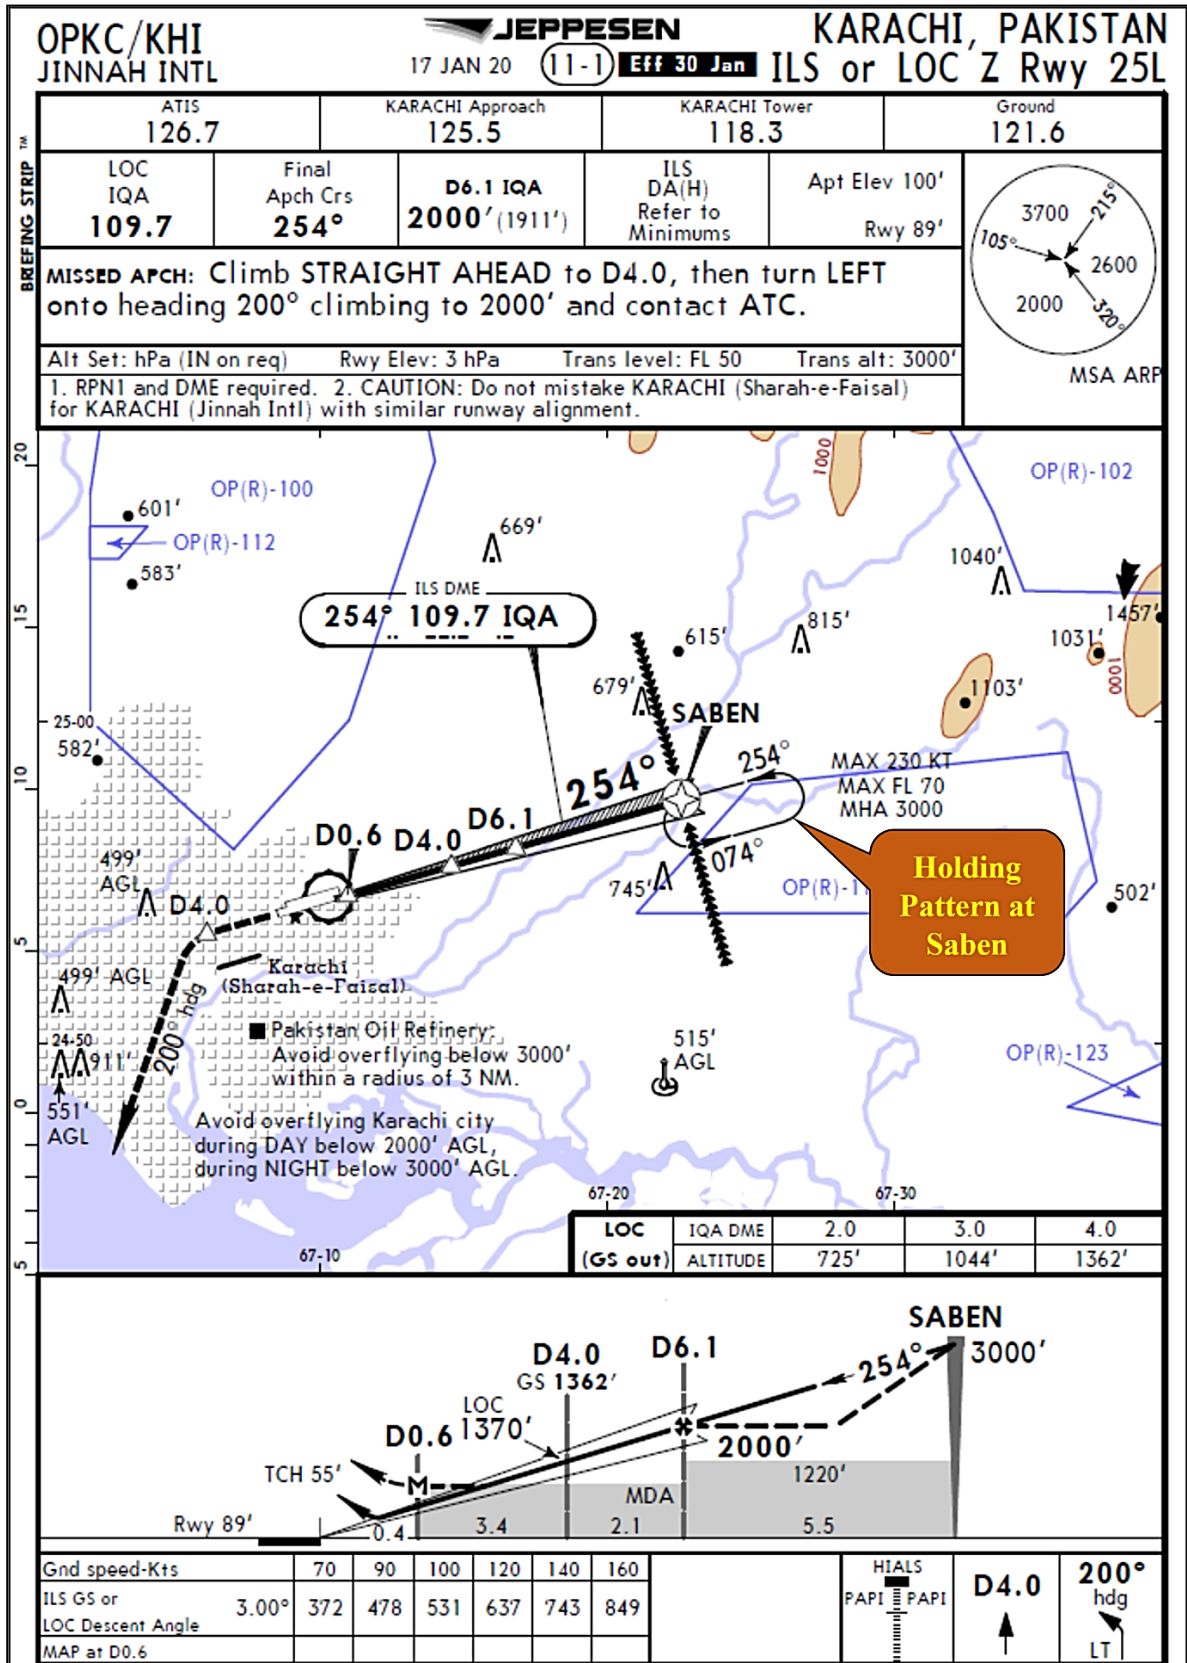
Figure 3 – ILS-Z R/W 25L Approach Chart

1.1.5.14. At 09:31:26, 11.4 NM from R/W 25L threshold, and 250 kts CAS, SABEN waypoint was overflowed at 7,830 ft baro altitude. As per the ILS-Z R/W 25L Approach Chart (Refer Figure 3), target altitude for set course from SABEN is 3,000 ft. Therefore, aircraft was excessively high (4,830 ft in excess) above the desired G/S.

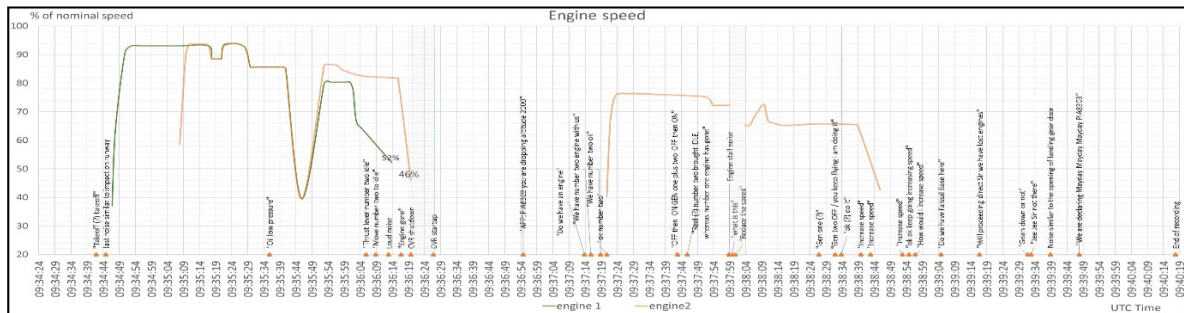
Figure 11 – Engine Speed from Lift-off till End of Flight

1.1.7.10. Following the TLA being pushed to TOGA, Engine No. 1 N1 command increased to 94%, Engine No. 2 N1 command decreased to 16% and the “L/G GEAR NOT DOWN” Warning stopped, as ENG 1 N1 increased above 75% (Refer Figure 11). As the Engine No. 2 N2 was below 47%, Engine No. 2 status changed to “START” and it waited for N2 to increase above 53.9% to command the increase of N1. This is coherent with the DFDR parameters showing the Engine No. 2 N1 command at IDLE during this period.

1.1.8.10. At 9:35:11, Oil quantity of Engine No. 1 dropped from 16 Quart (QT) to 4 QT in 64 s and at 9:35:15, Oil quantity of Engine No. 2 dropped from 15 QT to 5 QT in 64 s (DFDR sampling rate of Engine Oil quantity is 64 s). This is coherent with the Engine No. 2 examination, which showed that the bottom part of Engine No. 2 was rubbed with the R/W at the AGB and Transfer Gear Box (TGB) level.

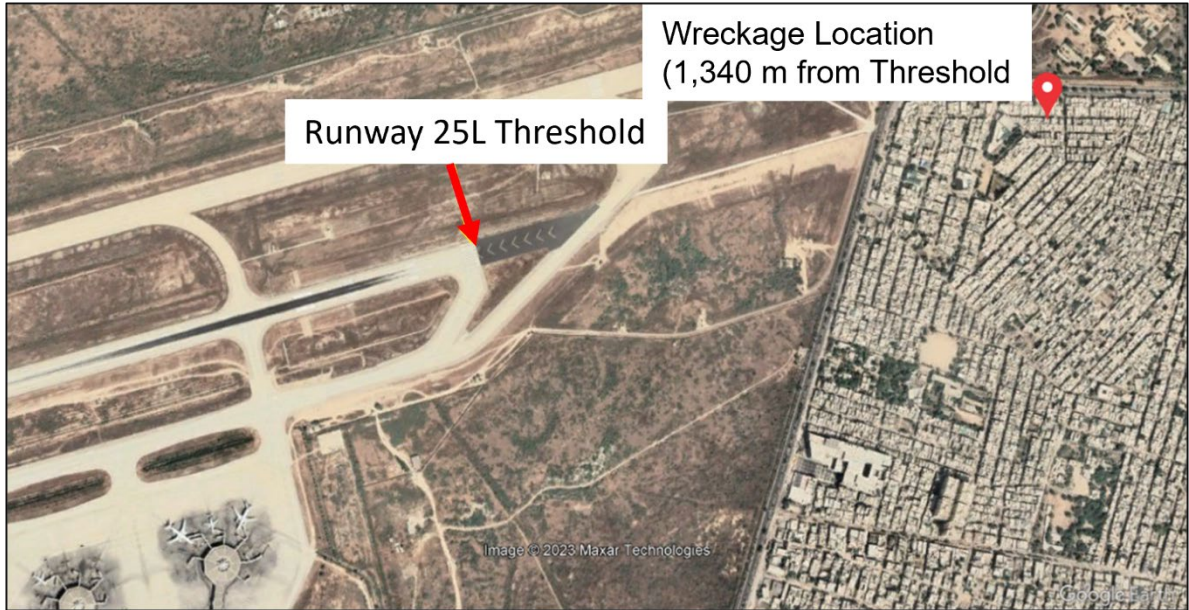
Figure 21 – Aircraft Wreckage Distance from the R/W 25L Threshold

1.12.2. **Accident Site Location** – The accident site was in a residential area North-East of JIAP, Karachi (24 54'42.07N 67 11'18.99E). The wreckage lies approximately 1,340 m from R/W 25L threshold on extended R/W centreline. Aircraft parts were spread out over 75 m in a single street.

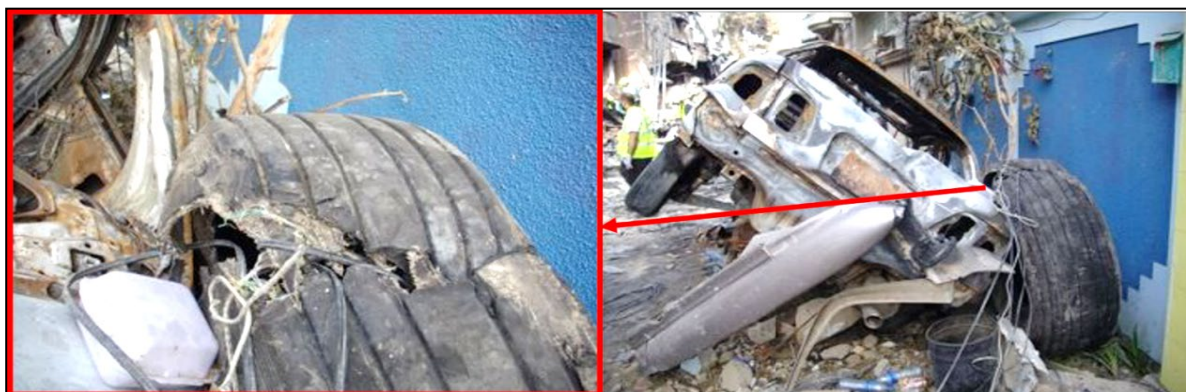
Figure 31 – L/H MLG Tyre

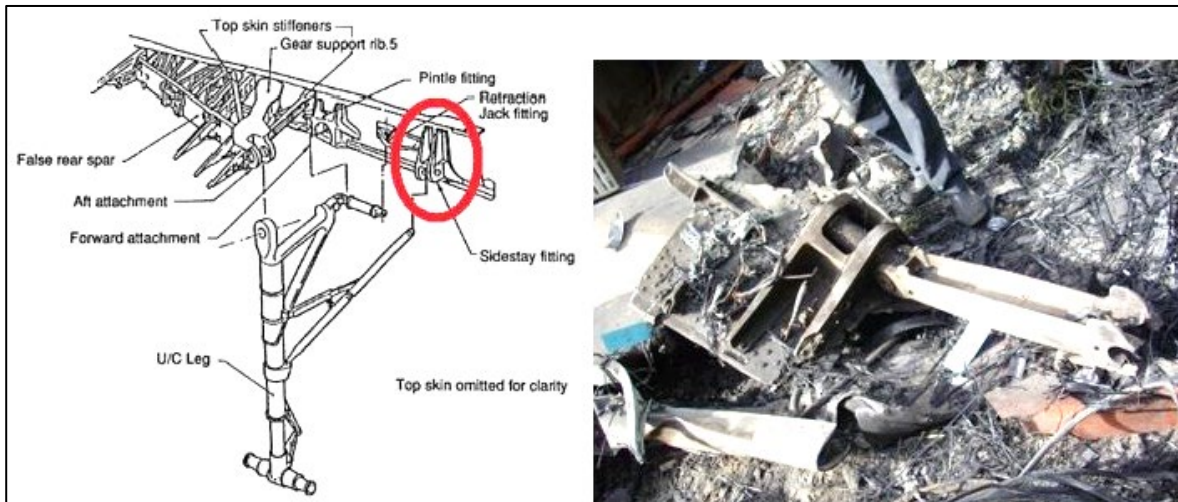
Figure 33 – MLG L/H Side Stay Fitting

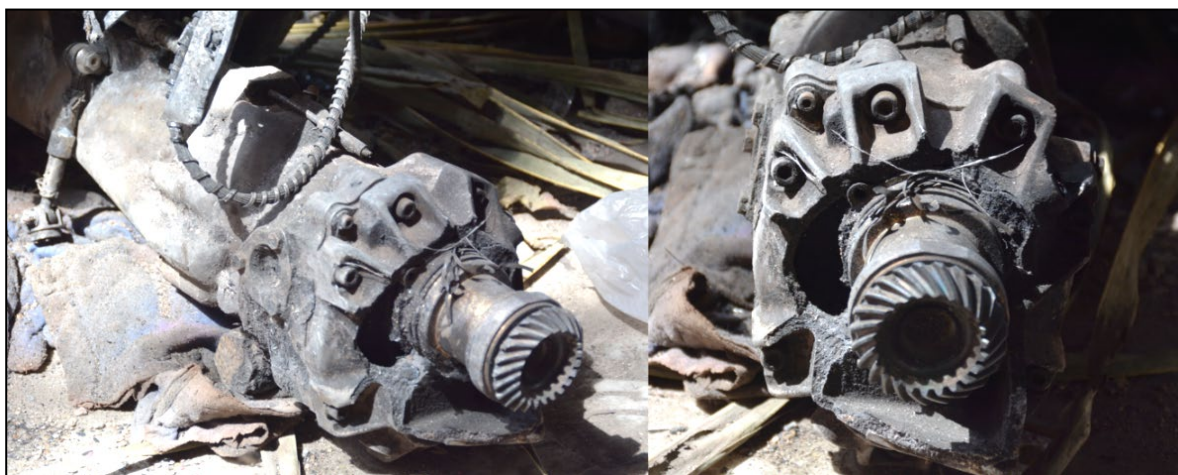
Figure 34 – RAT Without Blades and Cone

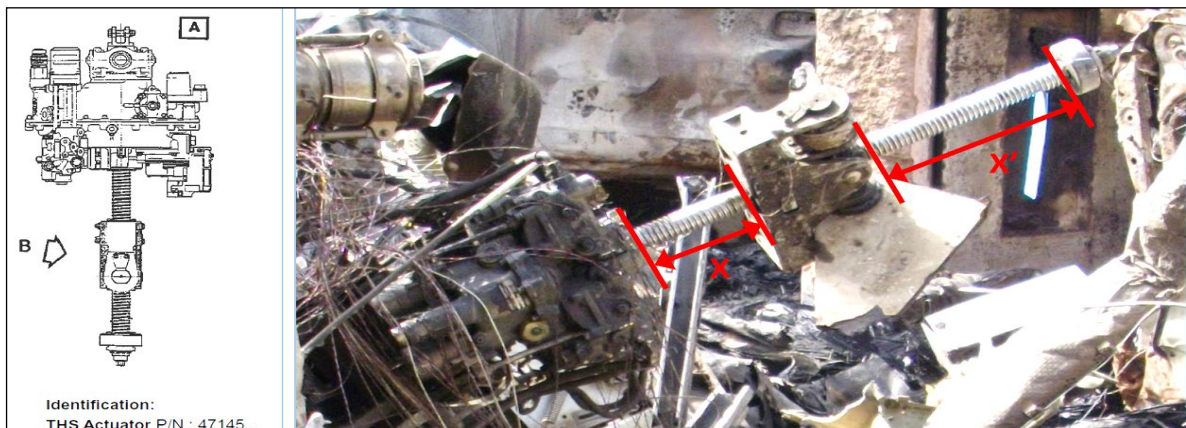
Figure 45 – THSA

(i) A Trimmable Horizontal Stabilizer (THS), hinged on rear part of the fuselage, ensures the pitch trim control. A THSA, with a fail-safe ball screw jack, drives the THS. The THSA P/N 47145-133, S/N 2357 was found complete and detached from the structure and horizontal stabilizer.

(ii) On the THSA screw jack, dimension X between nut and gearbox was measured to be 21 cm and dimension X' between nut and lower claw stop was 32.5 cm, consistent with a 2.8° aircraft nose up THS position before impact.

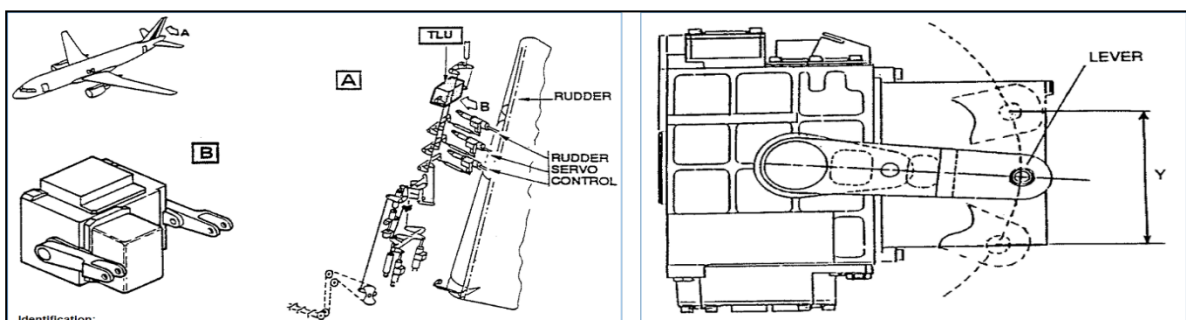
Figure 46 – Rudder TLU

(ii) Rudder TLU distance Y was measured to be 115 mm, corresponding to the maximum opening range of the rudder travel (+/-25°). This rudder travel limitation range is achieved when the aircraft speed is below 150 kts.

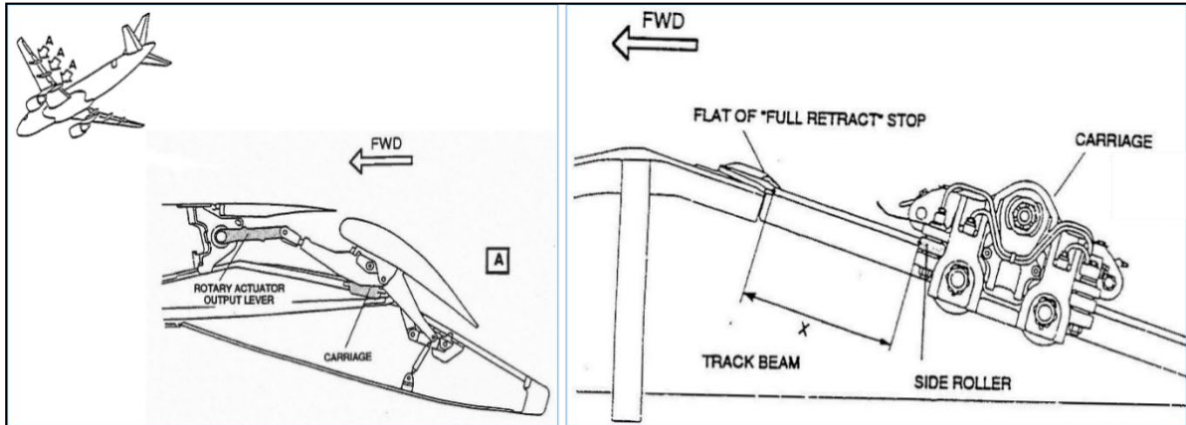
Figure 50 – FLAPS Description

(ii) A part of the L/H wing with FLAP Track 4 carriage was against its mechanical stop ( $X = 0$  mm), consistent with a FLAP retracted position.

(iii) FLAP Track 2 was severely damaged and Track 3 was not accessible and therefore measurement was not possible. However, the position of the actuator lever corresponded to a fully retracted position, corresponding to the position of the carriage against its stop.

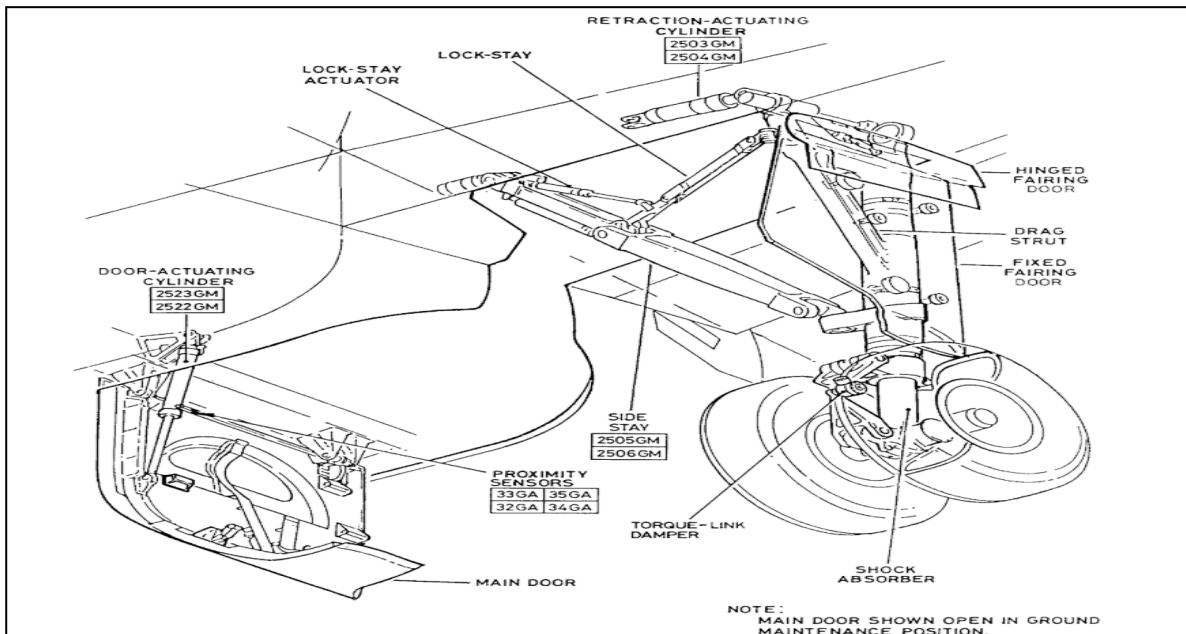
Figure 54 – MLG Description

(ii) L/H MLG was located at very beginning of accident site on the East side of the street. The retraction actuator was not attached to MLG and was found in a retracted position, corresponding to MLG in a DOWN position. The Uplock roller was in good condition.

(iii) R/H MLG retraction actuator was found in a retracted position, corresponding to MLG in a DOWN position. The Uplock roller was in good condition.

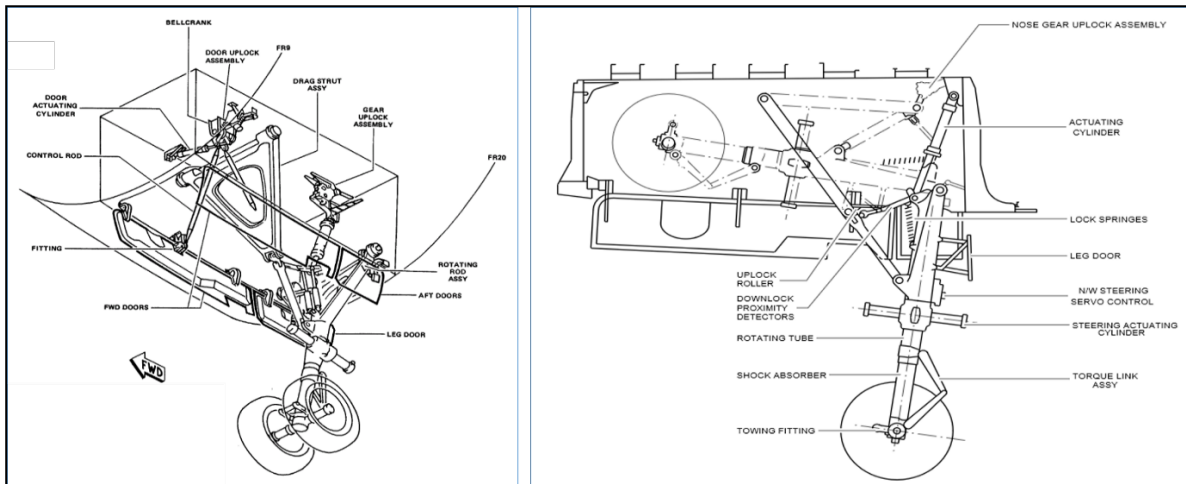
Figure 57 – NLG Description

(ii) The drag strut assembly of NLG was located on the top of a building. It was detached from NLG. The uplock roller was missing.

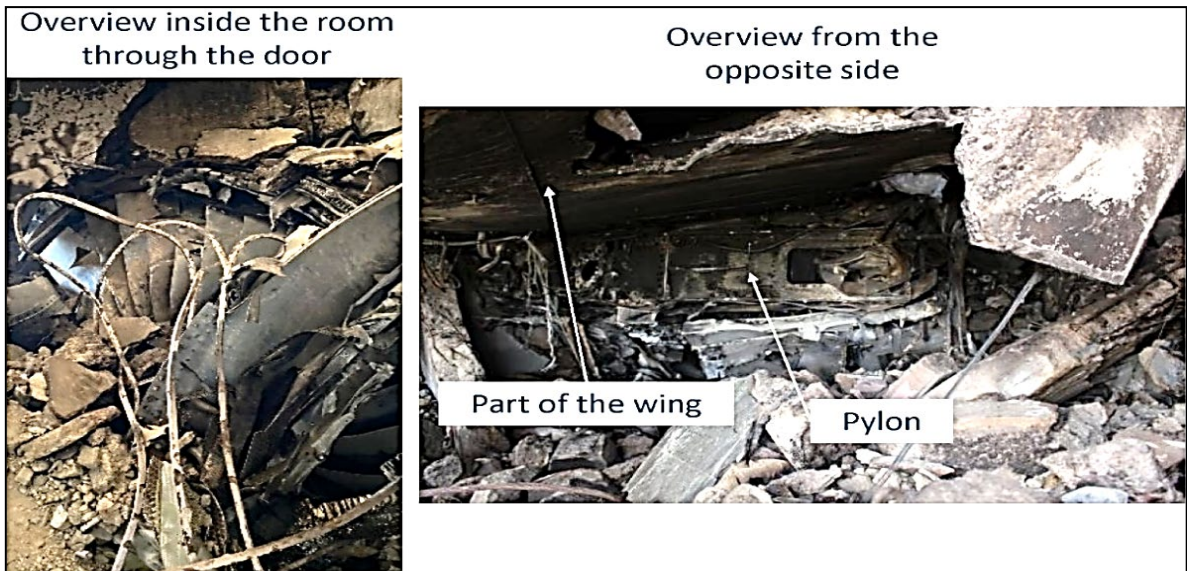
Figure 63 – Overview Through the Door (Left) and Opposite Side (Right)

(i) At the time of impact, the fan case was compressed disturbing the round geometry of the fan case and causing the fan blades to curl. Engine was running at a very low RPM.

(ii) Engine No. 1 showed evidence of external fire. Visible fan blades condition was consistent with the Engine No. 1 being at low rotational speed at the time of impact, most likely not producing any thrust.

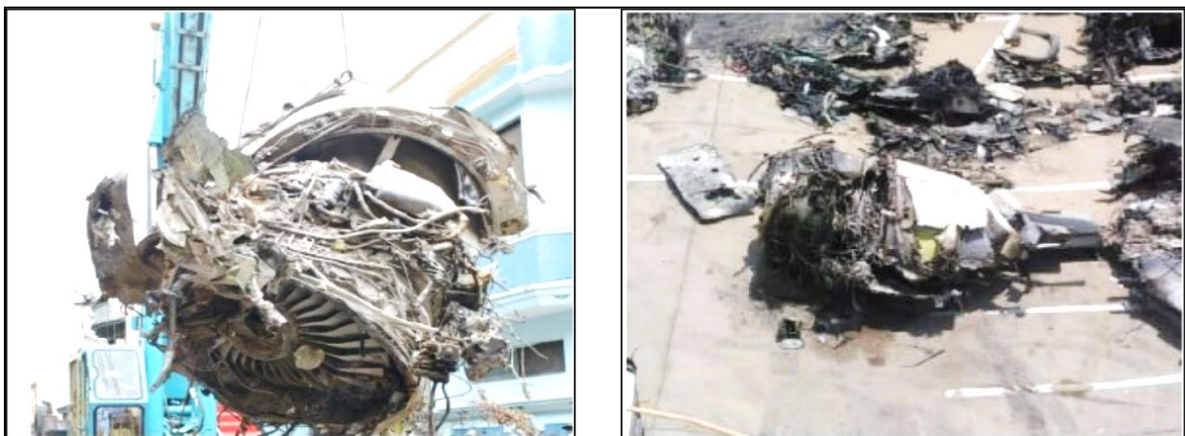
Figure 65 – Engine Lifted from Roof Top and Engine at Wreckage Storage Site

(iii) 6 O'clock localization of Engine had heavy rubbings traces on different parts (TGB, end fitting of pipes, flexible hoses etc.). TGB damages with punctured wall allowed oil leakage. These rubbing marks / Oil leakages are consistent with Engine R/W contact during the first landing attempt.

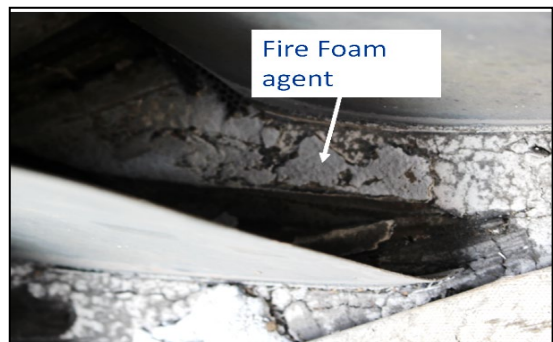
Figure 71 – Fan Blade's Fire Foam Agent Traces

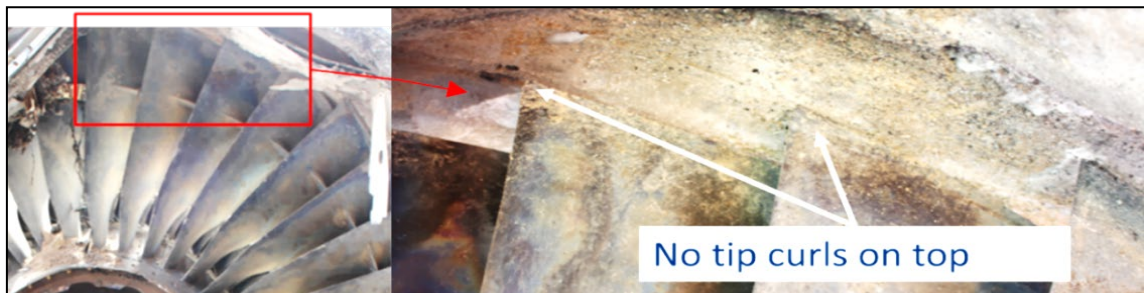
Figure 72 – Few Tip Curls, No Bent Blades. Indication of No or Low Rotation during Crash

- (i) Engine No. 2 showed evidence of external fire. Fan blades were in good condition being consistent with the Engine No. 2 at low rotational speed and most likely not producing any thrust at the time of impact.

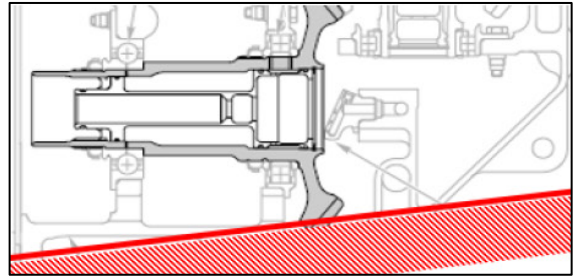
Figure 76 – TGB Conical Gear: Accident Case vs New

- (ii) TGB located at the Engine lower part showed marks of friction with hard flat surface, material displacement and loss of material. Damages on TGB along with punctured wall allowed Oil leakage. It was consistent with the lower part of the Nacelle and Engine No. 2 impacting the R/W during the first landing attempt.

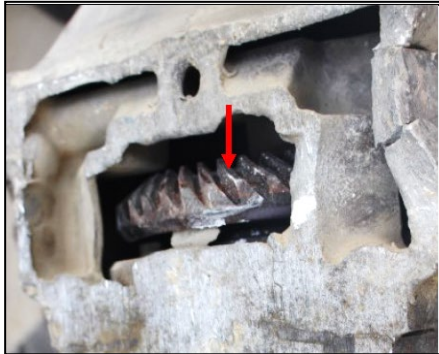
Figure 77 – TGB Conical Gear: Rubbing of the Outer End Gear Teeth: Cylindrical Shape

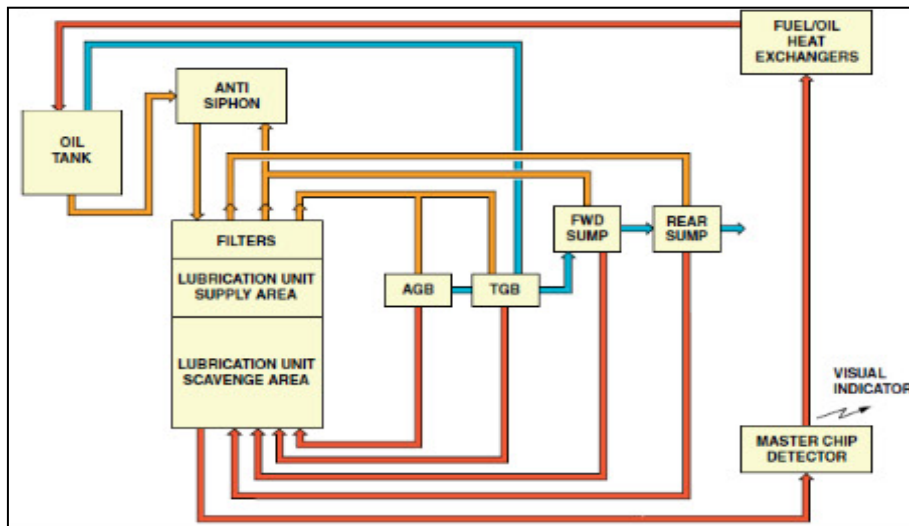
Figure 79 – Oil Distribution: Loss of Oil due to TGB (Possibly TGB and Pipes) Housing Hole

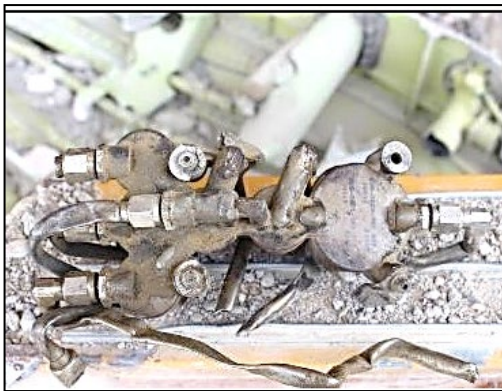
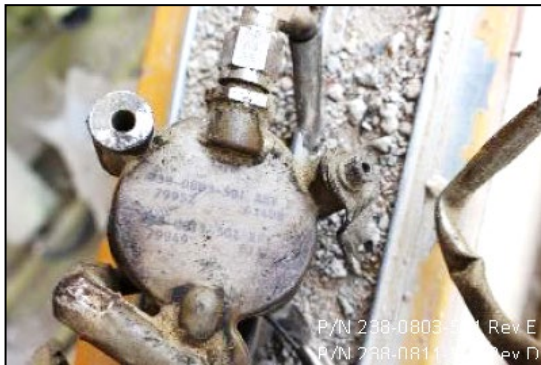
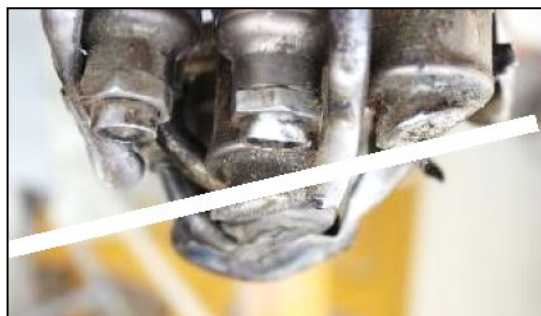
- (c) **Drain Case Assembly** – These lines are provided on Engines to collect waste fluids and vapours that come from Engine systems and accessories and drain them overboard. The system consists of a Drain Collector Assembly, a Drain Module and a Drain Master. Drain Collector Assembly is installed exactly at 6 O'clock position on the Engine. One Drain Case Assembly found from the accident site and it the corresponding Engine could not be identified. Accident Drain Case Assembly was compared with undamaged Drain Case Assembly. It was found that it made ~ 20° roll angle when rubbing with the R/W during the first landing attempt.

Figure 87 – Drain Collector Assembly (Accident Case)

Figure 89 – Drain Collector Assembly (Accident Case)

Figure 91 – Drain Collector Assembly Forward View (Accident Case)

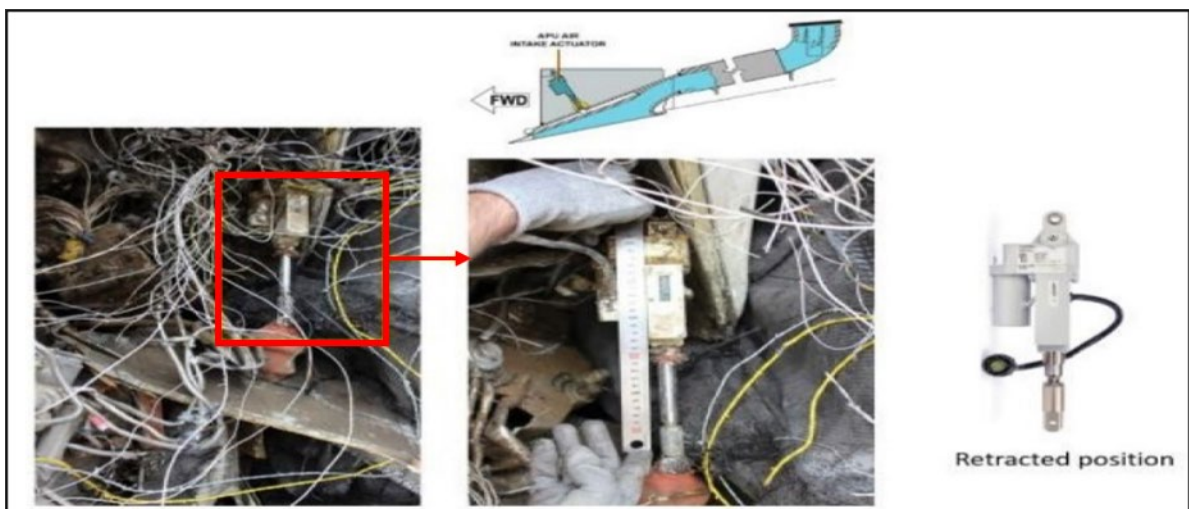
(d) **Auxiliary Power Unit (APU)** – APU air intake flap actuator was not in the “retracted” position meaning that the APU flap door position was closed or only partially open. It was consistent with the fact that the APU was not supplying bleed air pressure and electrical power at the time of impact.

Figure 97 – APU Air Intake Flap Actuator Position vs New Actuator Position

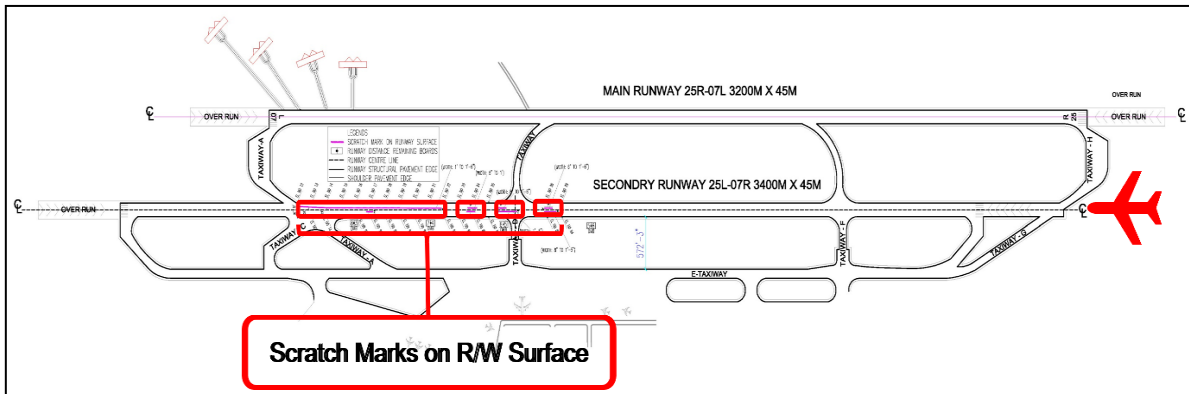
Figure 115 – Scratch Marks on R/W Surface

1.16.17.1. Post-accident inspection of R/W 25L at JIAP, Karachi indicated both Engines touched on R/W at four different locations leaving scratch marks of varying length and width. The Engines dragging occurred almost symmetrical about R/W centre line. R/W surface being concrete pavement remained intact; however, the surface got severely abraded due to scrubbing of both Engines at high speed.

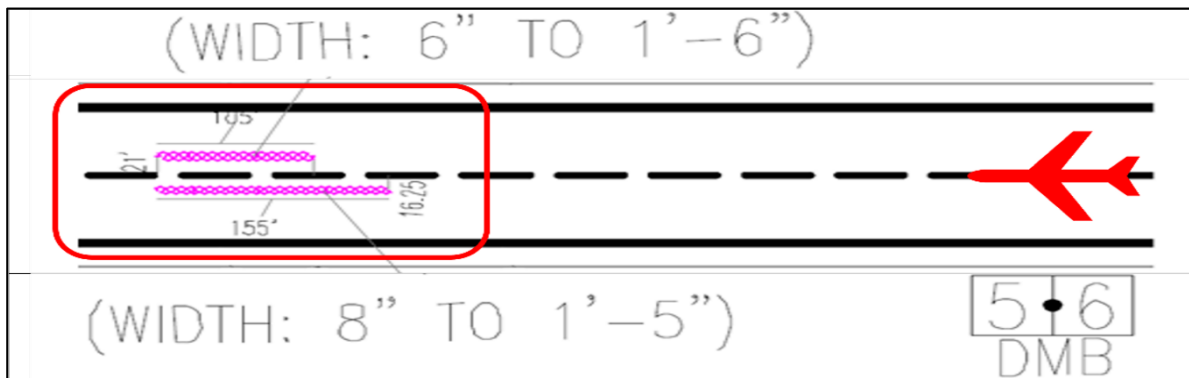
Figure 116 – First Touchdown Scratch Marks on R/W Surface

1.16.17.2. **First Touchdown** – Aircraft touched down almost 4,500 ft from threshold R/W 25L. Initially left Engine touched on the R/W followed by the right Engine. The total dragging distance of left Engine was 155 ft (with scratch marks width varying from 8 inches to 17 inches). Whereas, the total dragging distance of right Engine was 105 ft (with scratch marks width varying from 6 inches to 18 inches).

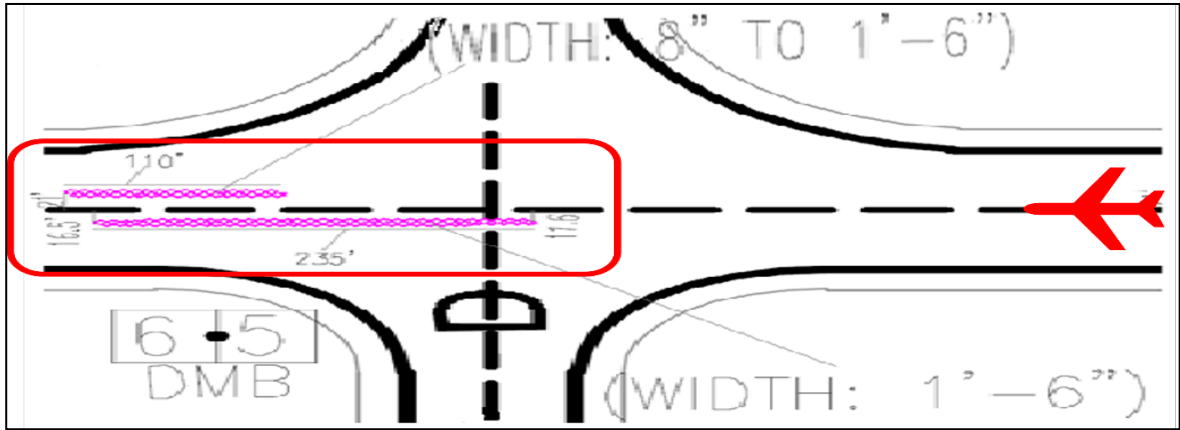
Figure 117 – Second Touchdown Scratch Marks on R/W Surface

1.16.17.3. **Second Touchdown** – Aircraft second touchdown was almost 6,000 ft from threshold R/W 25L. Initially left Engine touched on the R/W followed by the right Engine. The total dragging distance of left Engine was 235 ft (with scratch marks width of 18 inches). Whereas, the total dragging distance of right Engine was 110 ft (with scratch marks width from 8 inches to 18 inches).

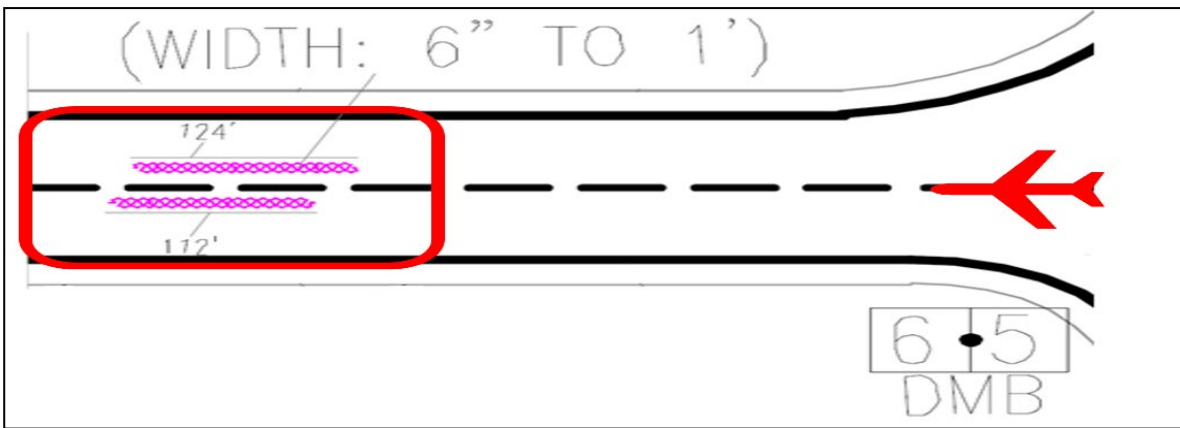
Figure 118 – Third Touchdown Scratch Marks on R/W Surface

1.16.17.4. **Third Touchdown** – Aircraft third touchdown was almost 6,330 ft from threshold R/W 25L. Initially right Engine touched on the R/W followed by the left Engine. Lengths of left Engine and right Engine scratch marks were 112 ft and 124 ft respectively and widths varying from 6 inches to 12 inches).

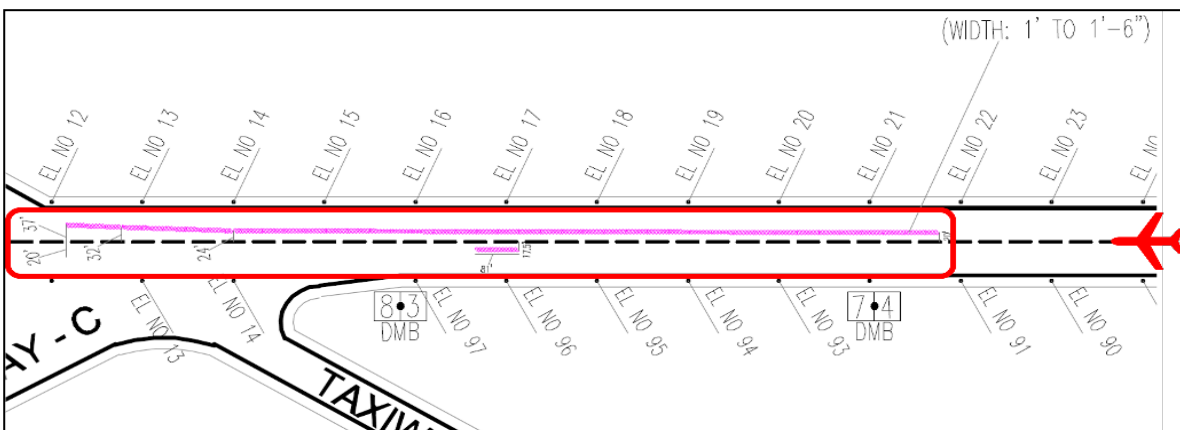
Figure 119 – Fourth Touchdown Scratch Marks on R/W Surface

1.16.17.5. **Fourth Touchdown** – Aircraft fourth touchdown was almost 6,810 ft from threshold R/W 25L. Initially right Engine touched on the R/W followed by the left Engine. The total dragging distance of right Engine was 1,855 ft (with scratch marks width varying 12 to 18 inches). Whereas, the total dragging distance of left Engine was 81 ft. It appears that right Engine dragged for a quite long time as compared to left Engine. Additionally, the right Engine marks were deviating from the centre line after the last 3/4 portion of total dragging distance in fourth touchdown.

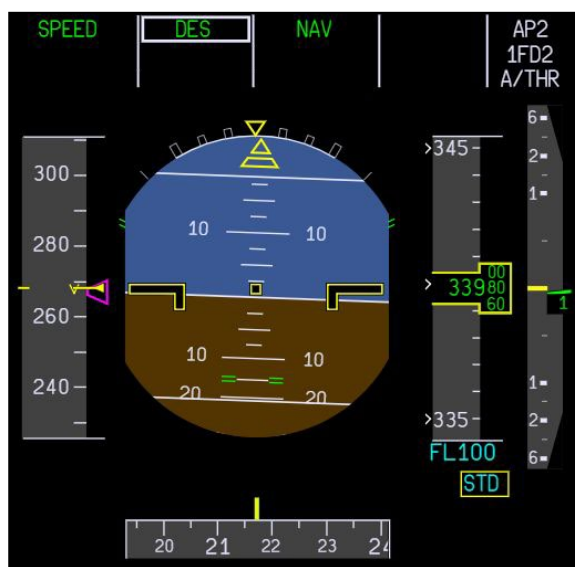
Figure 120 – Primary Flight Display (“DES Green - FL100 – check”)

(d) After clearance of PIA 8303 to descent FL100 direct to MAKLI, there was neither FMA callout nor cross check of FMS setting by flight crew (“DIR TO MAKLI” and “DES Green – FL100 – Check”). As per the Airbus Golden Rules for pilots provided in the FCTM, understanding / monitoring the FMA is required at all time and it also includes cross-checking of all FMA changes. Indicative of lack of application of procedures / adherence to SOP by flight crew (Golden Rules for Pilot FCTM / AOP / 40).

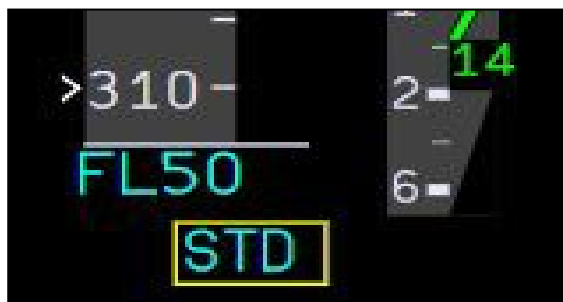
Figure 121 – Primary Flight Display  
("FL50 – check")

2.2.2.5 **During Descent, FL315 / 88 NM** – After clearance from Karachi Approach at 09:18:13 for 5,000 ft, at 09:18:36, aircraft was passing through FL310 with A/THR Thrust MODE engaged (N1 reduced to IDLE on both Engines), which indicated that the aircraft was starting to capture the FMS descent profile. V/S increased to 2,400 ft/min. CAS increased to a maximum of 284 kts before reducing towards the managed target air speed of 269 kts. A/THR MODE changed to IDLE MODE to adjust the thrust while AP followed descent profile. The selected altitude became 5,000 ft. It was observed that no FMA callout or check (FL50 - check) were performed by either of flight crew, they were discussing various topics not relevant to this phase of flight. Indicative of lack of application of procedures / adherence to SOP (Golden Rules for Pilot FCTM / AOP / 40).

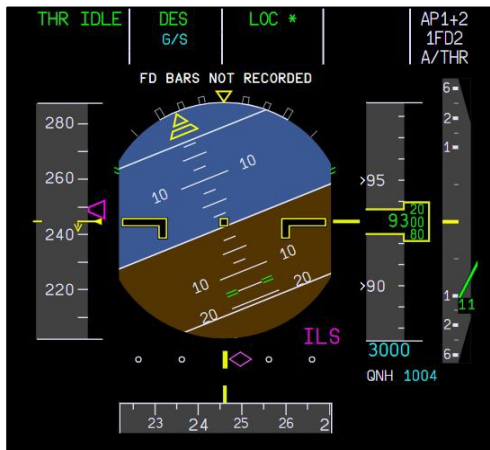
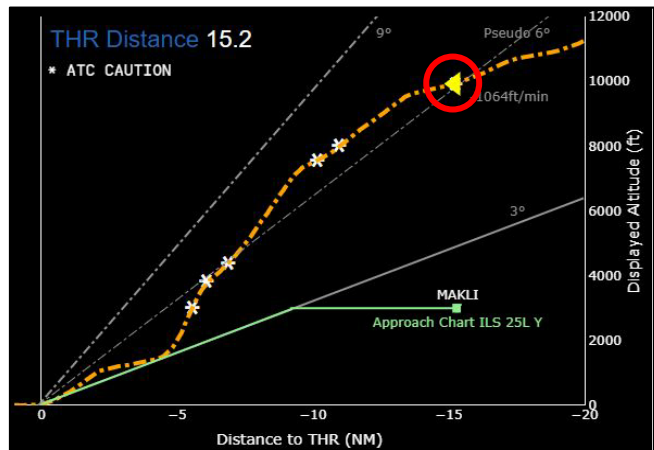
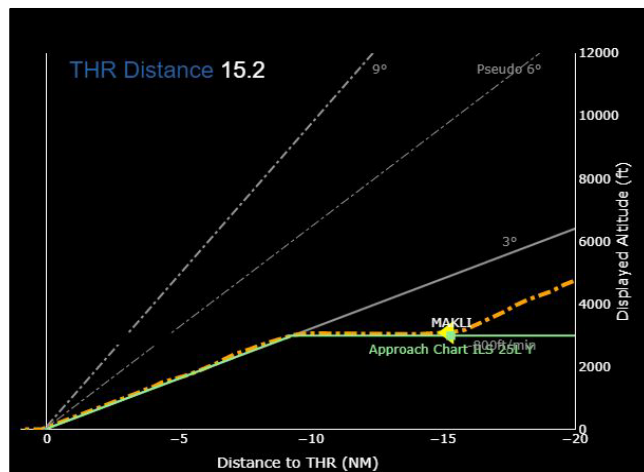
Figure 125 – PIA 8303 Approach vs Standard Approach at 15.2 NM

(b) There was no verbal re-calculation, no crosscheck between flight crew of the vertical flight path of aircraft [Situation Awareness, Flight Path Monitoring (FPM): Detection of Deviations vs Normal Flight Path and Profile Computation (FCTM / PR / NP / SOP / 170) and Human Factor Attitude: Overconfidence & Complacency].

PIA 8303 Approach: ALT 9,300 ft / Distance 15.2 NM ~ FPA 6.1°

Standard Approach: ALT 3,000 ft / Distance 15.2 NM ~ FPA 2.4°

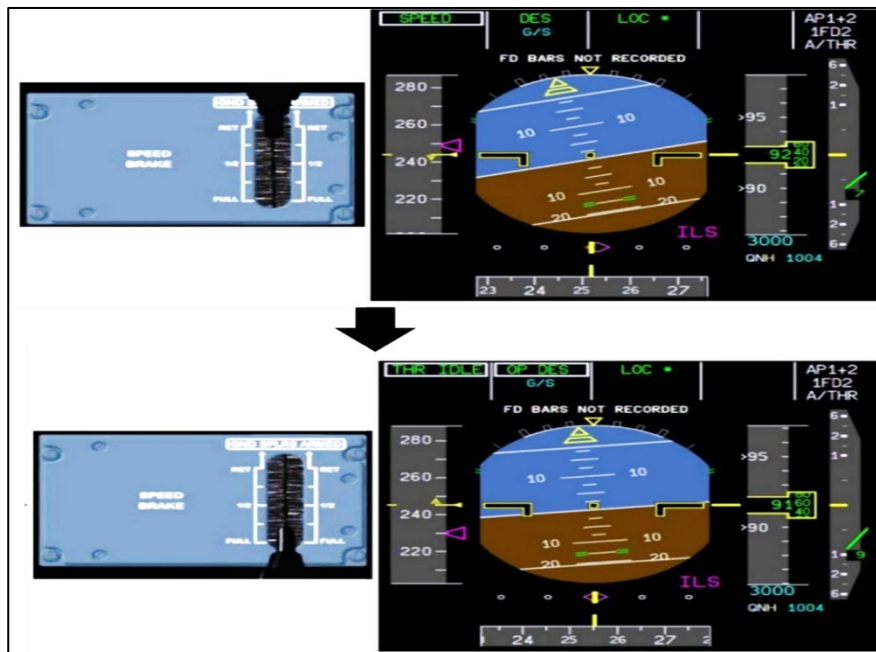
Figure 126 – PFD and FMA Display

(a) At 09:30:44, OPEN DES MODE was engaged with a target at 3,000 ft by pulling the ALT Knob on FCU. Aircraft was at 9,210 ft baro altitude, 245 kts CAS, Rate of Descent had reduced to 660 ft/min and distance from R/W 25L threshold was approximately 14.8 NM. Speed Brakes were extended at this time.

(b) For a 3° G/S at 14.8 NM from R/W 25L threshold, aircraft was required to be at 4,700 ft baro altitude. Aircraft was significantly above the published vertical Approach path and was actually at flight path angle of almost 6°. This was a scenario of Glide Slope Interception from above (FCOM / PRO / NOR / SOP / 18 Initial Approach / Flight path monitoring interception glide from above). V/S MODE should be used with an initial target at 1,500 ft/min. However, OPEN DES MODE was used which is not recommended on final Approach. This was the lack of airmanship due to non-adherence to SOP for G/S capturing from above. There were no FMA call out (THR IDLE, OP DES, G/S) and information sharing on descent strategy (FCOM / PRO / NOR / SOP / 18 / Approach using LOC G/S guidance and lack of situation awareness regarding vertical profile).

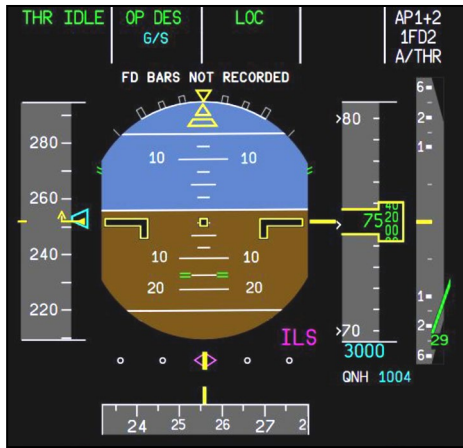
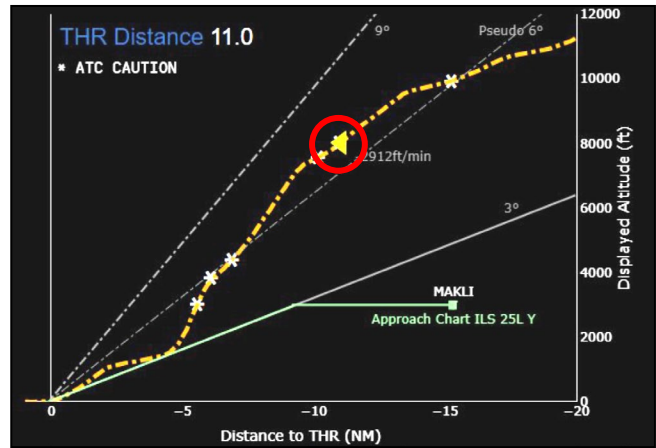
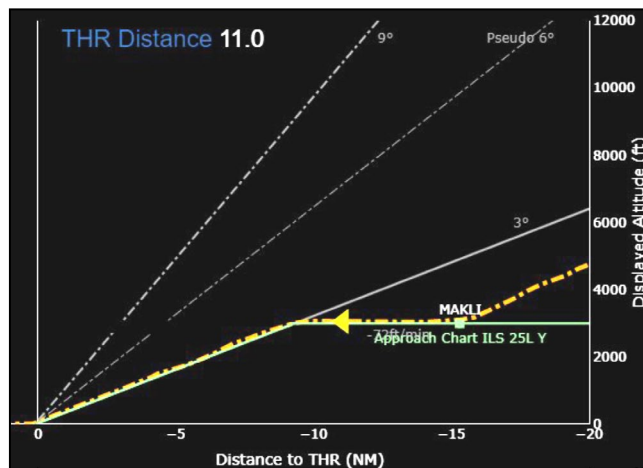
Figure 127 – PIA 8303 Approach vs Standard Approach at 11 NM

(c) At 09:31:26, 11.4 NM from R/W 25L threshold, 250 kts CAS, SABEN waypoint was overflowed at 7,830 ft baro altitude. As per the ILS-Z R/W 25L Approach Chart, target altitude for set course from SABEN is 3,000 ft. Therefore, aircraft was excessively high (4,830 ft in excess) above the desired G/S.

**PIA 8303 Approach: ALT 7,500 ft / Distance 11 NM ~ FPA 6.8°**

**Standard Approach: ALT 3,000 ft / Distance 11 NM ~ FPA 2.7°**

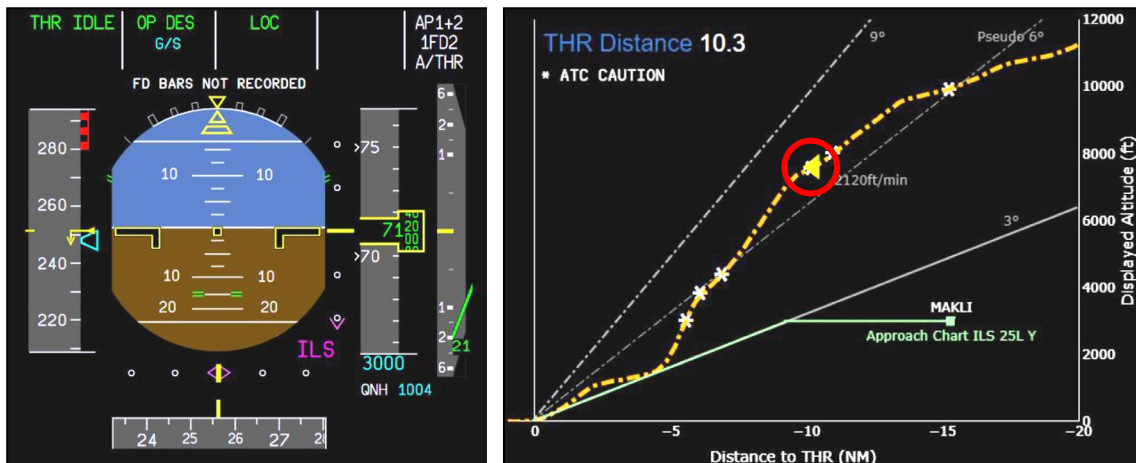
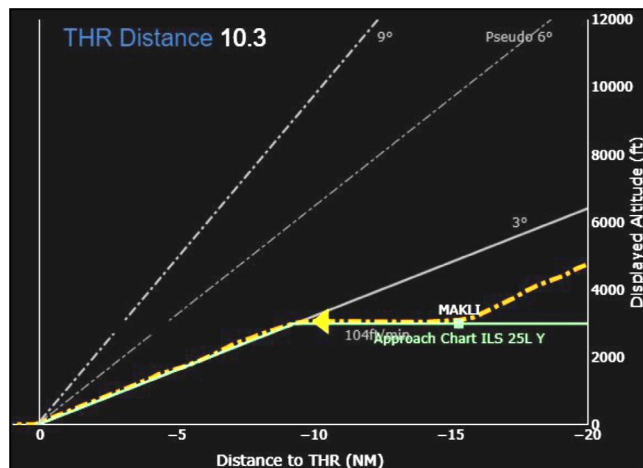
Figure 129 – PIA 8303 Approach vs Standard Approach at 10.3 NM

PIA 8303 Approach: ALT 7,100 ft / Distance 10.3 NM ~ FPA 6.9°

Standard Approach: ALT 3,000 ft / Distance 10.3 NM ~ FPA 2.9°

(b) At this time, aircraft trajectory was still excessively high (4,100 ft). ATC proposal for use of orbit pattern was aimed at losing altitude. However, flight crew did not consider this option, instead continued excessively high on Approach (lack of situation awareness).

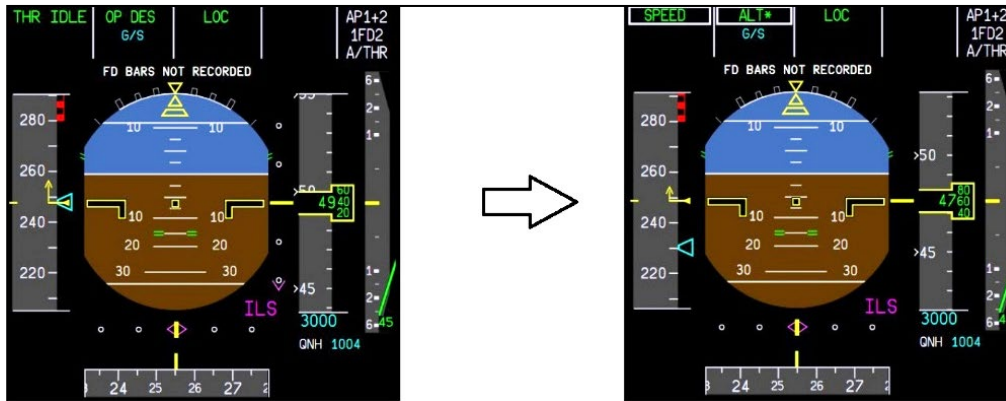
Figure 130 – PFD: Altitude Capture

2.2.2.16 **Altitude Capture** – At 09:32:18, 4,817 ft baro altitude, 7.7 NM from R/W 25L threshold, AP Vertical MODE changed to ALT\*, Rate of Descent was 4,115 ft/min. 2 s later, selected Speed target was reduced from 248 kts to 230 kts. Flight crew didn’t call FMA check, no call out of “SPEED”, “ALT\*” (Non adherence to SOP, Golden Rules for Pilot FCTM / AOP / 40).

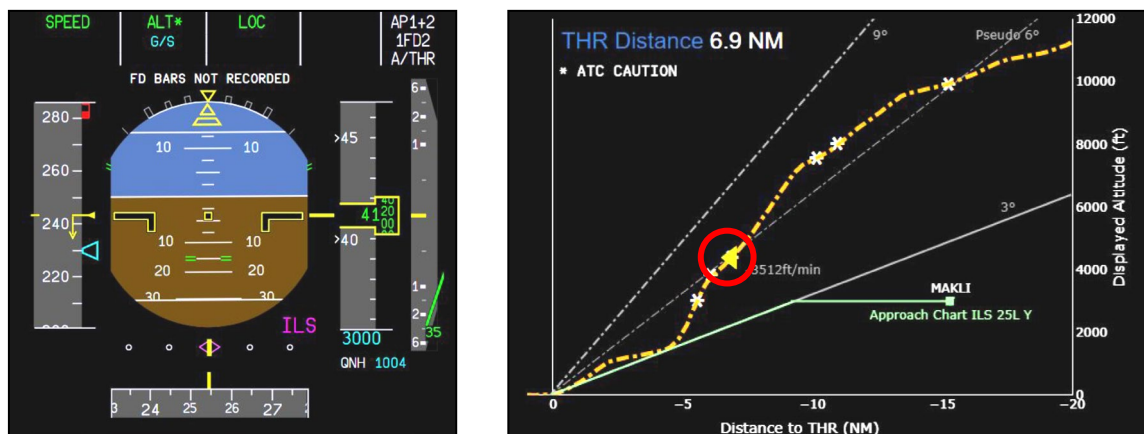
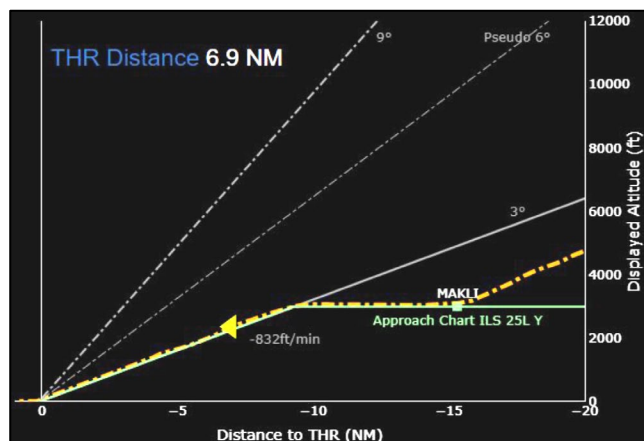
Figure 131 – PIA 8303 Approach vs Standard Approach at 6.9 NM

PIA 8303 Approach: ALT 4,100 ft / Distance 6.9 NM ~ FPA 5.9°

Standard Approach: ALT 2,300 ft / Distance 6.9 NM ~ FPA 2.9°
