## **FINAL INVESTIGATION REPORT**

### **ACCIDENT OF PAKISTAN INTERNATIONAL AIRLINES FLIGHT PIA 8303 AIRBUS A320-214 AIRCRAFT REGISTRATION NUMBER AP-BLD CRASHED NEAR JINNAH INTERNATIONAL AIRPORT KARACHI ON 22<sup>ND</sup> MAY, 2020**

Dated: 20<sup>th</sup> April, 2023

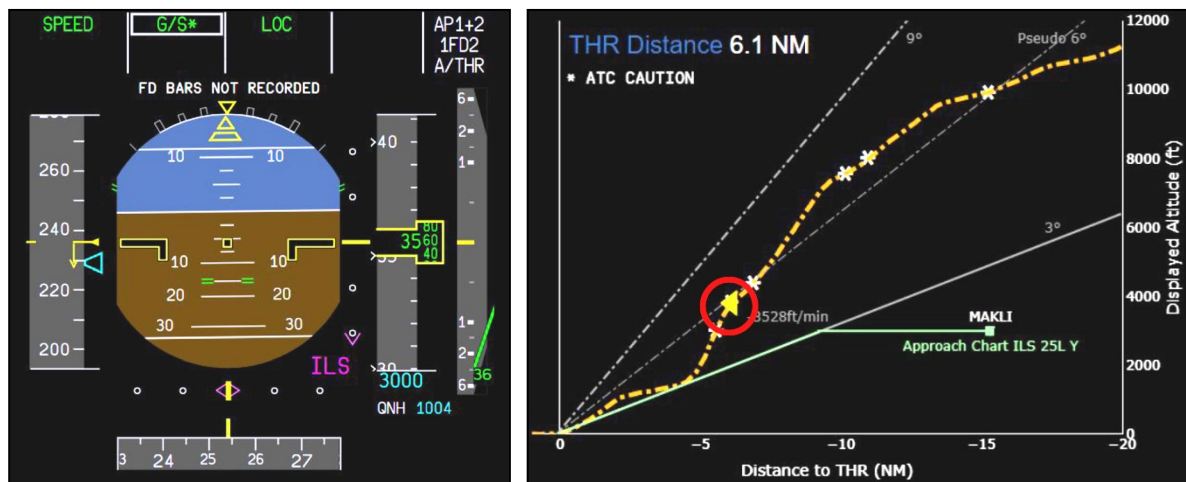
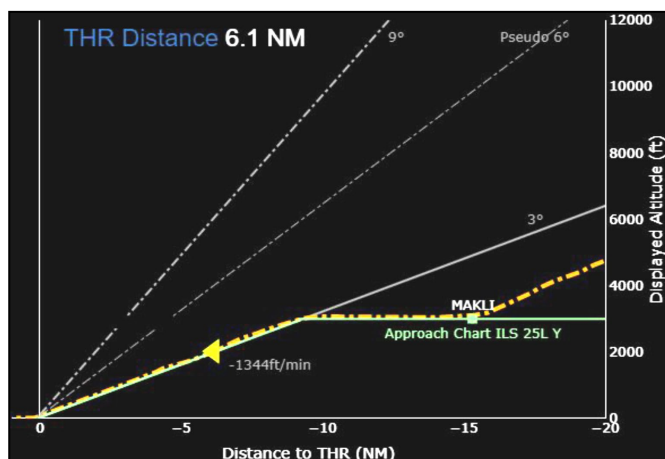
Figure 133 – PIA 8303 Approach vs Standard Approach at 6.1 NM

2.2.2.19 **ATC 5<sup>th</sup> Call (Turn Left Heading 180°)** – At 09:32:38, Karachi Approach again called PIA 8303, “Negative turn left heading 180”. PIA 8303 responded, “Sir, we are established on ILS 25L”. Once again ATC instructions were disregarded by flight crew despite being significantly above the standard flight path.

PIA 8303 Approach: ALT 3,560 ft / Distance 6.1 NM ~ FPA 5.8°

Standard Approach: ALT 2,100 / Distance 6.1 NM ~ FPA 3.0°

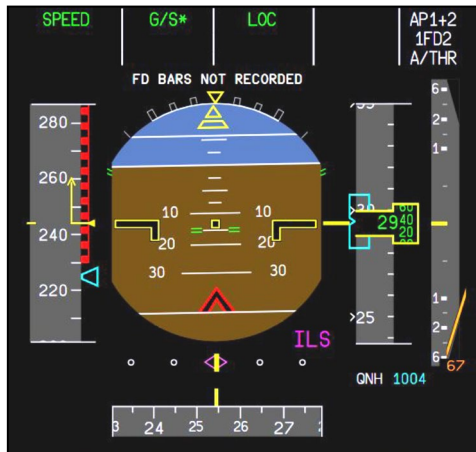
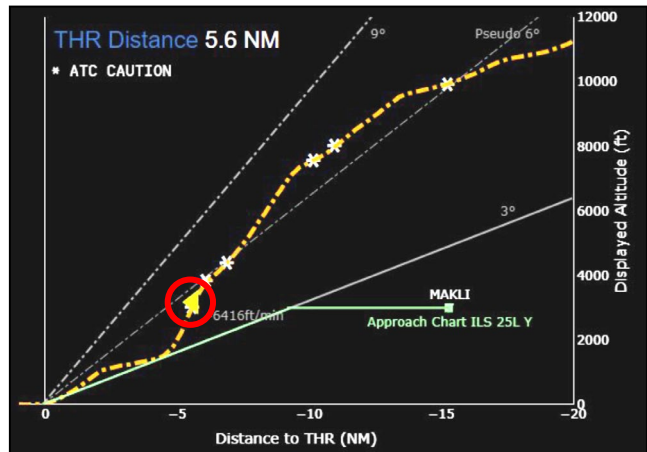
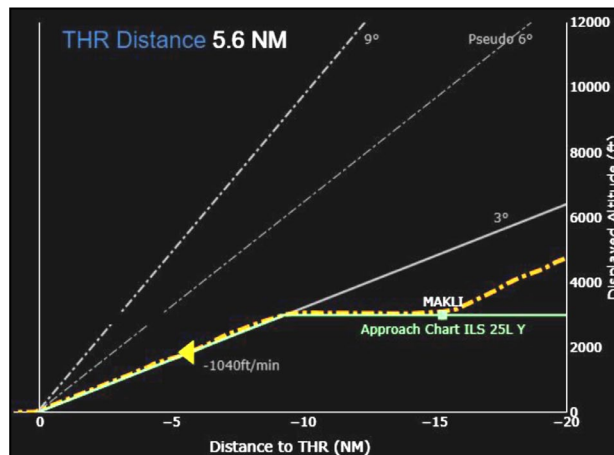
Figure 134 – PIA 8303 Approach vs Standard Approach at 5.6 NM

(b) At 09:32:46, Karachi Approach called, “Sir, you are five Miles from touchdown still passing 3,500”. At 09:32:51, PIA 8303 responded, “Roger”. Karachi Approach again cautioned that aircraft was still too high on the Approach path, however flight crew continued to press on high Approach.

PIA 8303 Approach: ALT 2,900 ft / Distance 5.6 NM ~ FPA 5.2°

Standard Approach: ALT 1,900 / Distance 5.6 NM ~ FPA 3.0°

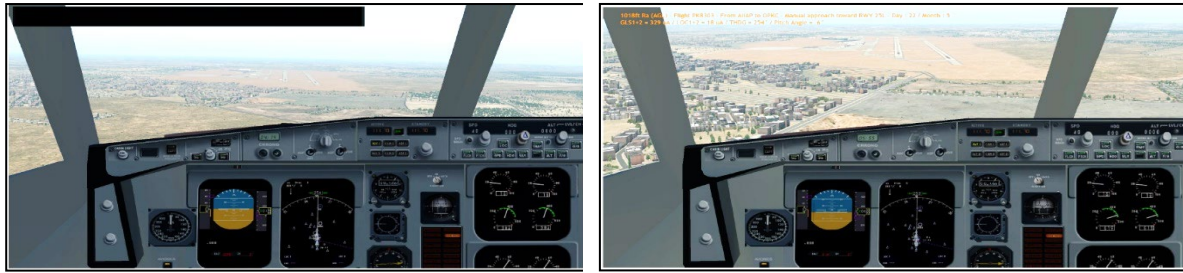
(b) The aircraft parameters deviation was more than the call out threshold. However, there was no “Un-Stabilized” call out by either of the flight crew, flight parameters exceedance was not monitored and no Go-Around was initiated. It indicated lack of procedure implementation in the domain of FCOM / PRO / NOR / SOP / 18 Intermediate and Final Approach, FCTM / PR / NP / SOP / 190 Trajectory Stabilization and FCTM / PR / NP / SOP / 260 Considerations about Go-Around.

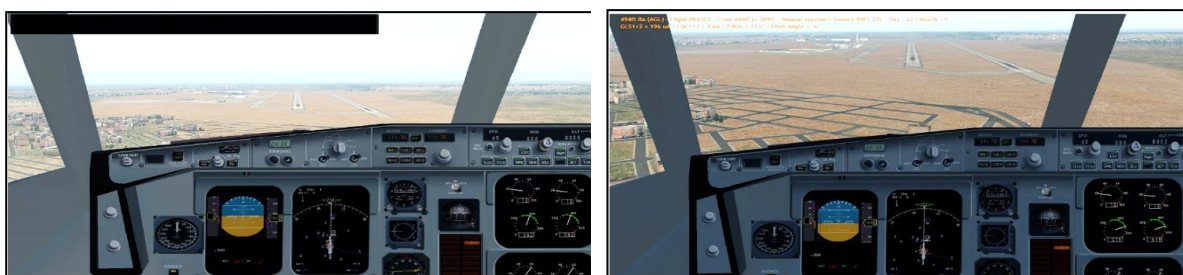
(b) The aircraft parameters deviation was more than the call out threshold. However, there was no “Un-Stabilized” call out by either of the flight crew, flight parameters exceedance was not monitored and no Go-Around was initiated. It indicated lack of procedure implementation in the domain of FCOM / PRO / NOR / SOP / 18 Intermediate and Final Approach, FCTM / PR / NP / SOP / 190 Trajectory Stabilization and FCTM / PR / NP / SOP / 260 Considerations about Go-Around.

Standard Approach at 500 ft AGL

PIA 8303 Approach at 500 ft AGL

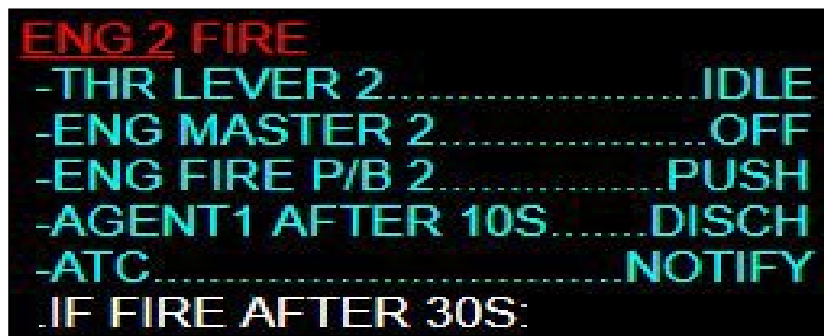
(a) At 09:34:28, aircraft both Engine nacelles made first contact with R/W. Maximum brake pedal inputs and opposite sidestick inputs were recorded from both flight crew (Captain: full nose down input, FO: 2/3 of full back input). At 09:34:36, Engine No. 2 Fire Alert triggered for 10 s along with associated Master Warning. At 09:34:42, FO said, “Take-off Sir, Take-off” (in Urdu), and 2 s later at 160 kts CAS, both TLA were advanced to TOGA for Go-Around. Aircraft got airborne at 09:34:45.

Figure 138 – ECAM Engine 2 Fire Warning

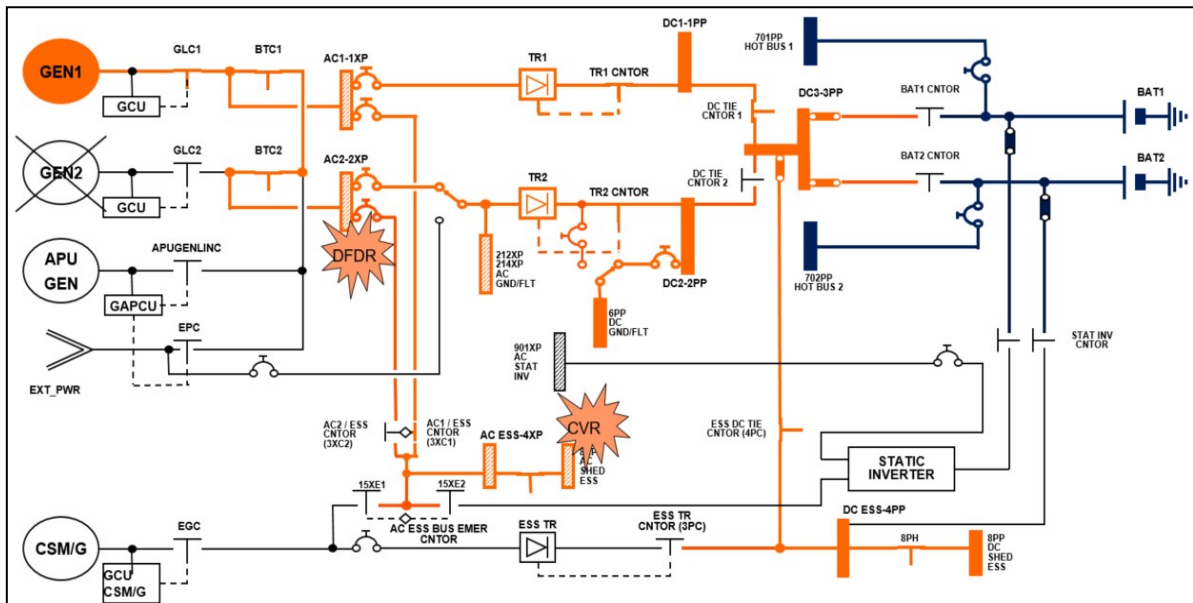
(a) Two Integrated Drive Generators (IDGs) named GEN 1 and GEN 2, driven by respective Engine through an integrated drive, supply electrical power to the aircraft. Each generator can supply up to 90 Kilovolt-Ampere (KVA) of three phase 115 / 200 Volt (V) 400 Hertz (Hz) constant Frequency AC power. In case of Engine failure, the generator will disconnect from its Engine if N2 drops below 56.3% (for 500 ms). One generator is sufficient to provide AC power to all electrical bus bars of aircraft, as shown below where GEN 2 is inoperative.

Figure 139 – GEN 2 Inoperative

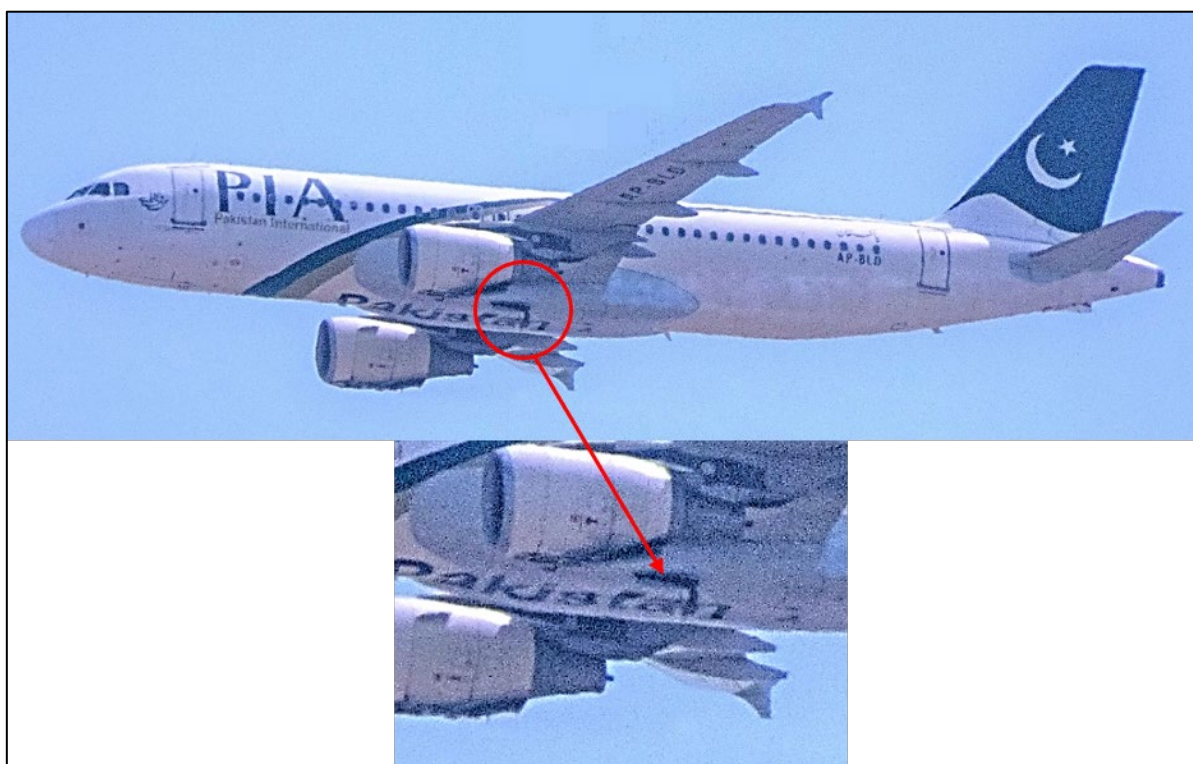
(a) The aircraft reconfigured into the EMER ELEC configuration, following the failure of Engine No. 1 during Go-Around. RAT extension can be seen in following picture taken during the event after Go-Around: -

Figure 141 – RAT Extended After Go-Around<sup>90</sup>

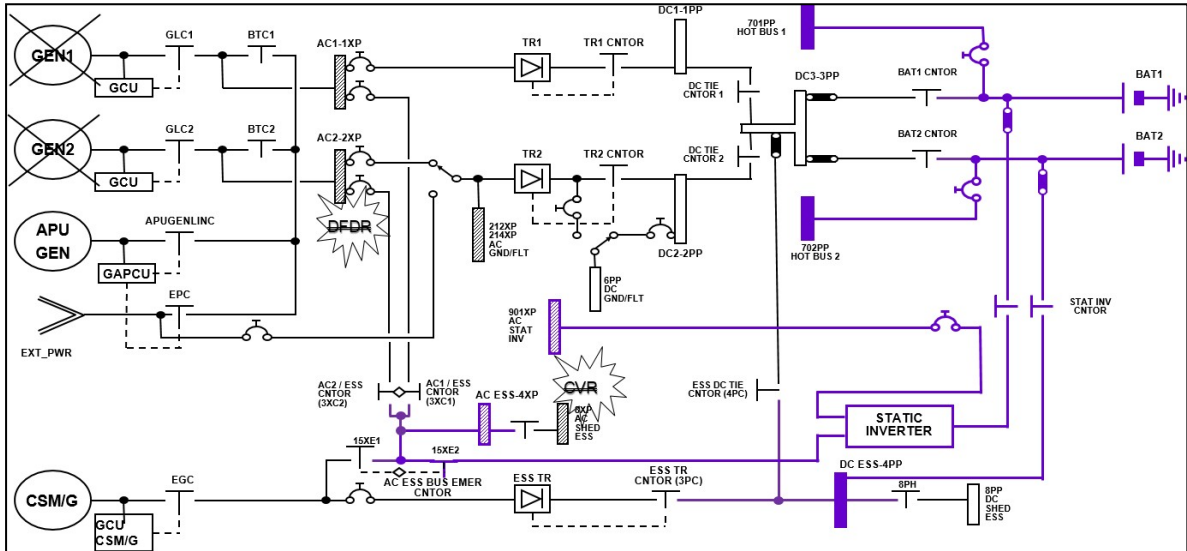
(i) **First Phase** – During this phase, RAT is in the process of deployment and only batteries are available. The batteries supply HOT BUS 1+2, Direct Current (DC) ESS Busbar and AC ESS Busbar through static inverter. The AC SHED ESS and DC SHED ESS are not powered to save electrical power. As the CVR is supplied by AC SHED ESS Busbar therefore it is transiently unpowered.

Figure 142 – First Phase of EMER ELEC Configuration

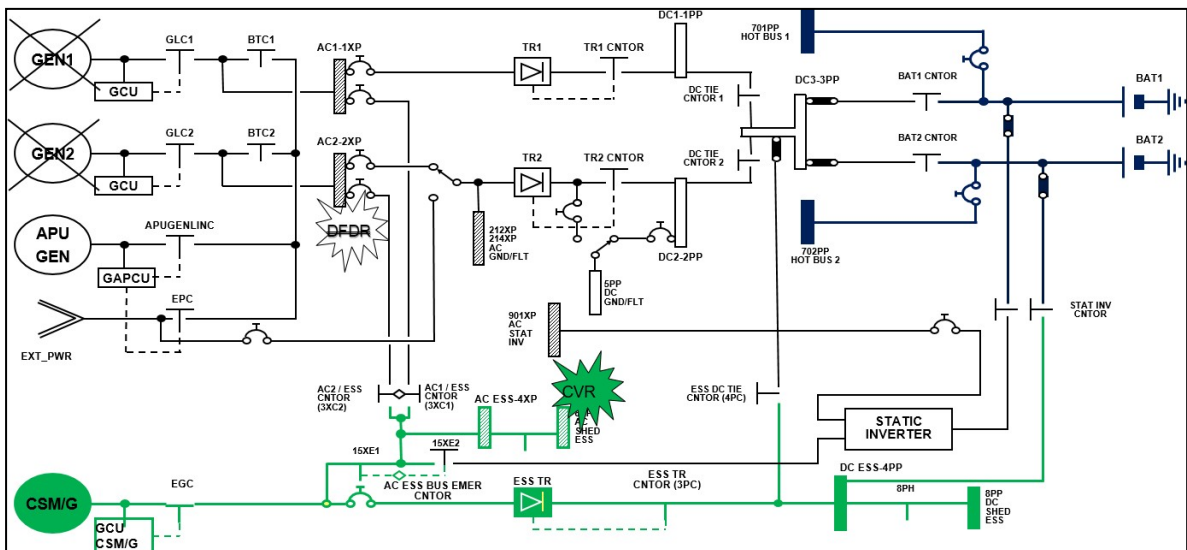
(ii) **Second Phase** – During this phase, RAT is fully extended and the Constant Speed Motor / Generator (CSM/G) is started. It supplies the complete AC ESS and DC ESS network; AC SHED ESS and DC SHED ESS Busbars are then supplied and therefore the CVR is recovered.

Figure 143 – Second Phase of EMER ELEC Configuration

(iii) As per the CVR recording, there was a transient CVR shutdown at 09:36:19. The CVR was then recovered (after 8 s) at 09:36:27 and remained powered until the ground impact. This is consistent with a nominal reconfiguration of the electrical system in EEC.

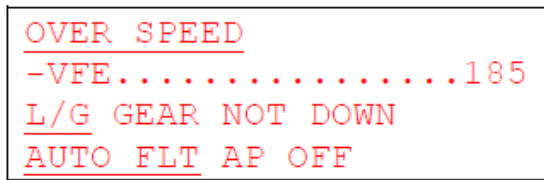
(e) From 09:33:27 to R/W contact (09:34:28): “OVERSPEED” VFE Warning (CONF3), “L/G GEAR NOT DOWN” Warning and “AUTO FLT AP OFF” Warning were active.

Figure 148 – “OVERSPEED” (CONF3), “L/G GEAR NOT DOWN” and “AUTO FLT AP OFF” Warning
