Investigation Report

Type of Occurrence: Accident
Date: 15 May 2023
Location: Hohn Military Airport

Aircraft: Airplane
Manufacturer: Learjet Corporation
Type: Learjet 35A

State File Number: BFU23-0311-1X

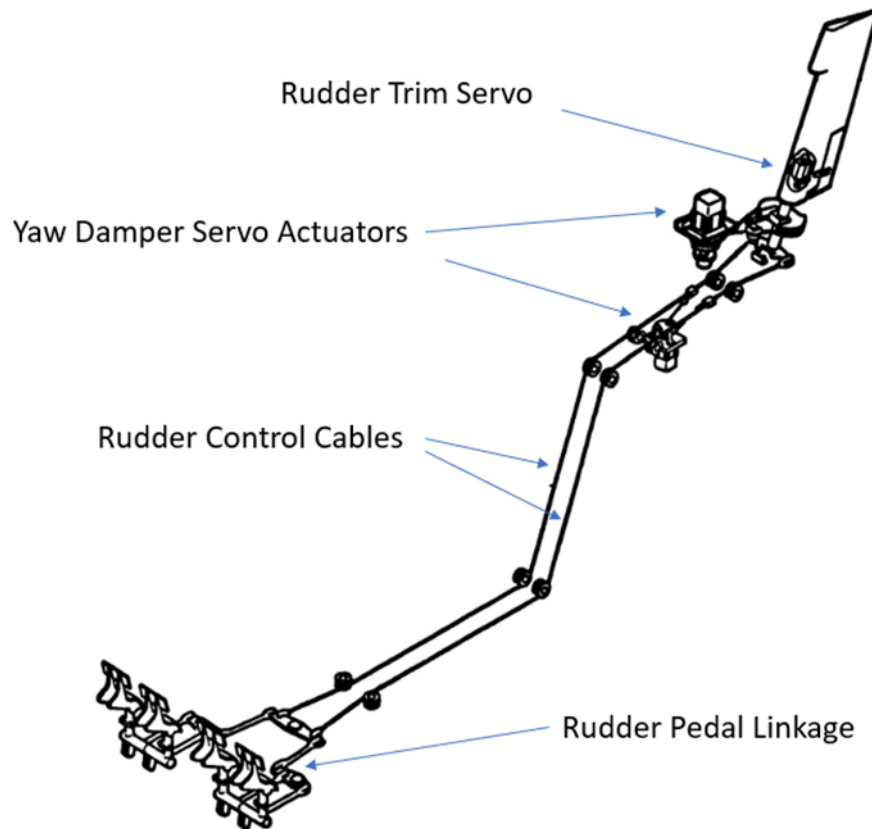
Fig. 4: Schematic diagram of the rudder control system

The static and dynamic test procedures to determine V_{mca} were performed with flaps extended by 20°. At about 100 KCAS, the maximum permissible pedal force of 180 lbs and the maximum rudder deflection of 30° were determined to maintain a coordinated flight attitude. At about 98 KCAS and flaps extended by 8°, a pedal force of 162 lbs and a required rudder deflection of 26° were determined.

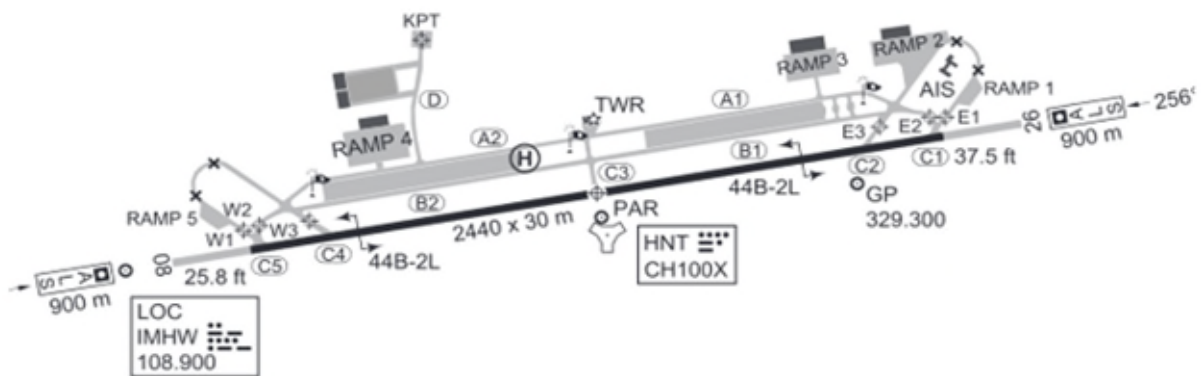
Fig. 7: Aerodrome chart

At the time of the occurrence, construction work was performed in the area of the eastern taxiways. Therefore, airplanes had to enter the runway via taxiway C3 and then backtrack to the beginning of runway 26.
