**REPUBLIC OF SOUTH SUDAN
MINISTRY OF TRANSPORT**

AIRCRAFT ACCIDENT INCIDENT INVESTIGATIONS DEPARTMENT

**Final Report of Antonov-26B, EX-126
Accident in Juba-South Sudan**

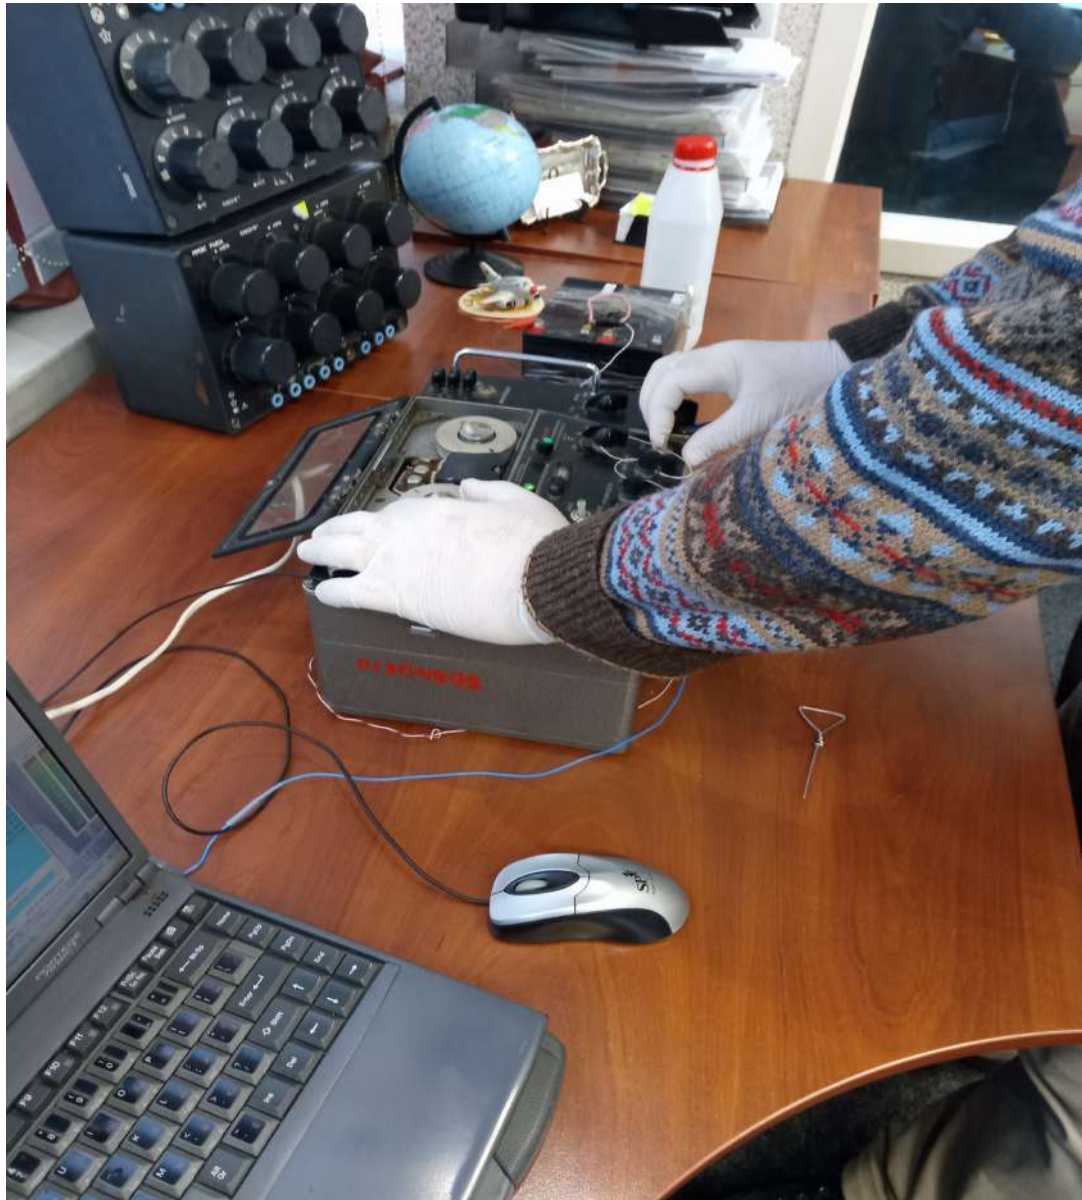
Figure 10: Read out Processing Machine

As a result of analysis performed by the laboratory experts, it was found that the accident data was missing on the (FDR) because by the time of the accident, the (FDR) did not record due to lack of maintenance and update as a result of the analysis, experts investigators at Laboratory have concluded that the lack of flight data information in FDR does not provide a chance to determine the cause
