Aviation Investigation Final Report

Location:	Miami, Florida	Accident Number:	DCA22FA132
Date & Time:	June 21, 2022, 21:38 UTC	Registration:	HI-1064
Aircraft:	McDonnell Douglas MD80	Aircraft Damage:	Substantial
Defining Event:	Landing gear collapse	Injuries:	4 Minor, 136 None
Flight Conducted Under:	Part 129: Foreign

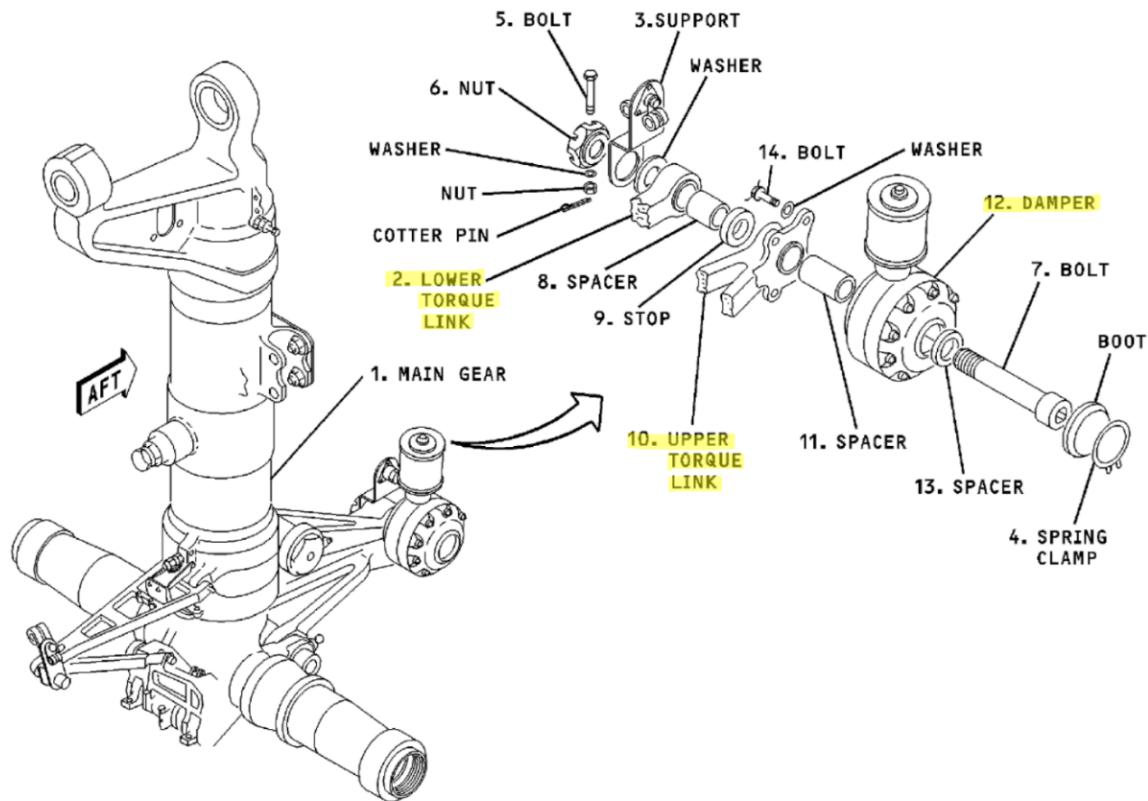
The airplane is equipped with shimmy dampers on both MLGs to prevent excessive vibration or shimmy buildup in the gear during high-speed taxi and heavy braking. The shimmy damper is connected between the upper and lower torque links and allows a small but highly damped motion to occur around the torsional axis of the gear. Shimmy damper effectiveness is maximized when the MLG strut is compressed. Limited dampening capability is available when the MLG strut is fully extended. Figure 5 shows the landing gear torque links and the shimmy damper installation.

Figure 5. Shimmy damper installation. (Image copyright © Boeing. Reproduced with permission, highlighting added for emphasis).

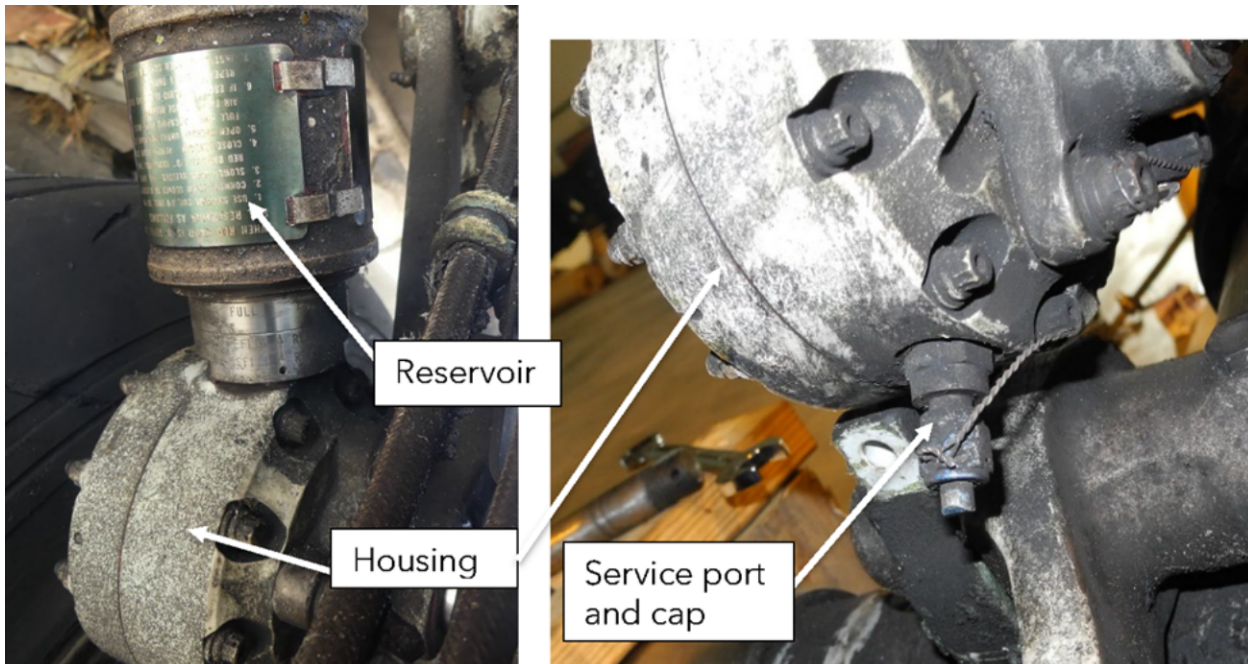
The left shimmy damper was examined and found to be assembled correctly. However, the check valve was found to be leaking and the cap for the check valve service port was missing. The damper requires sufficient hydraulic fluid to adequately dampen normal vibrations in the

system. For a significant amount of fluid to leave the damper, there would have to be failure of both the check valve and the cap for the service port.

Figure 6. Right main landing gear shimmy damper housing, hydraulic reservoir, service port and service port cap.

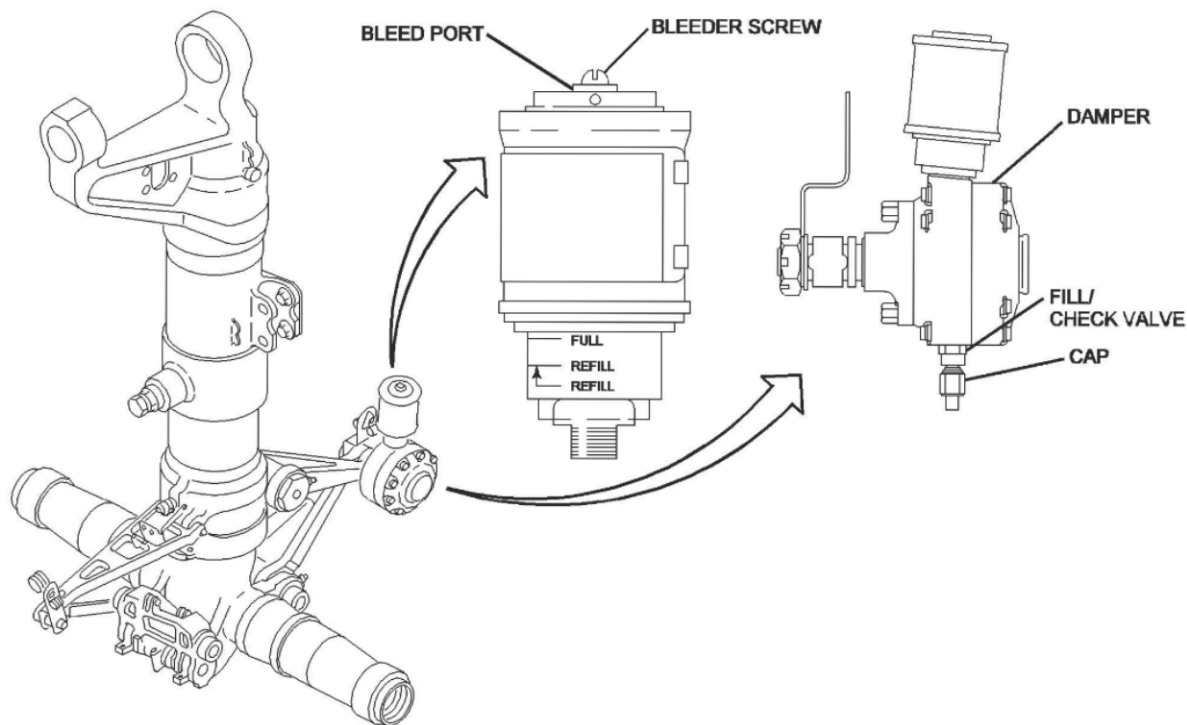
The hydraulic reservoir is attached to the damper housing. The reservoir contains a spring that pressurizes the hydraulic fluid in the reservoir and damper to 40 to 55 pounds per square inch. A bleed port is located at the top of the reservoir, and a check valve, service port and cap are located at the bottom of the damper housing (see figure 7). Hydraulic fluid is added to either the bleed port or the service port through the check valve, and air in the damper is removed via the bleed port.

Figure 7. Graphic showing location of bleed port, check valve and cap. (Source: Image Copyright © Boeing. Reproduced with permission.)
